# Post Incident Analysis Report

**MFB Burnley Complex  
450 Burnley Street  
Richmond VIC 3121**

Lacrosse Docklands  
673-675 La Trobe Street, Docklands  
25 November 2014

Report No: **1403134A**

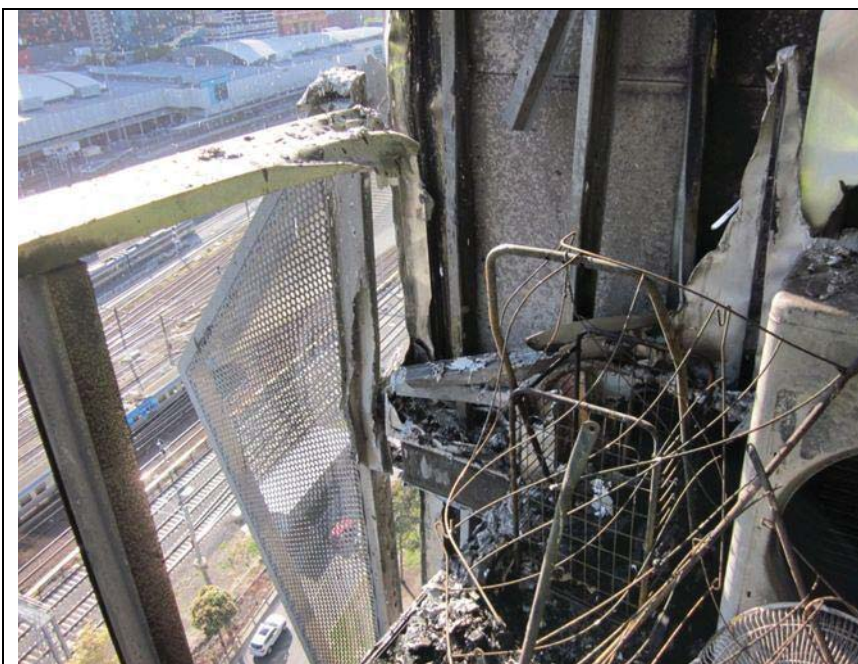
Wall between bedroom and balcony. Construction lightweight wall with steel studs, aluminium type external cladding plasterboard to internal. Material stored on balcony.

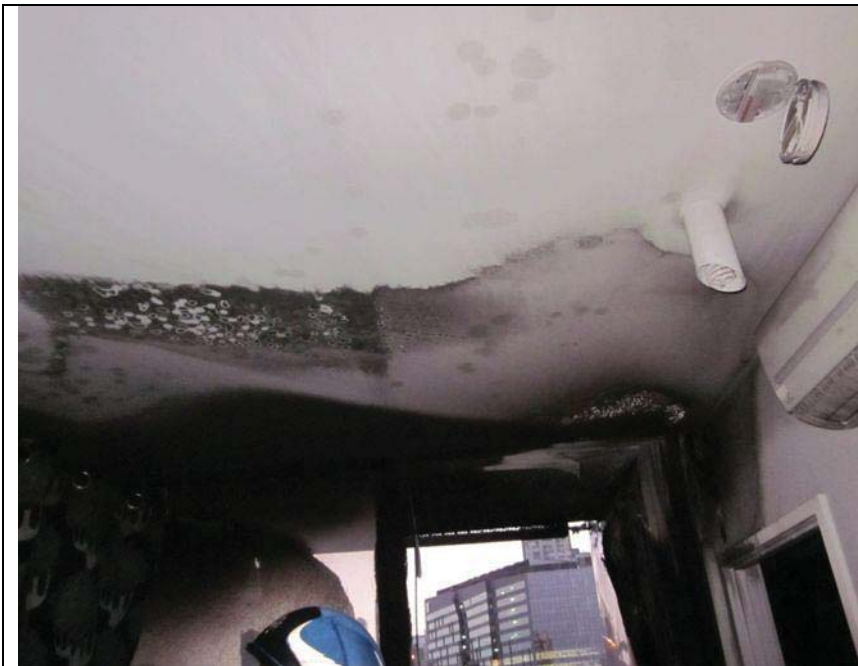
View of damaged wall and smoke detectors made inoperable. Others were covered over.

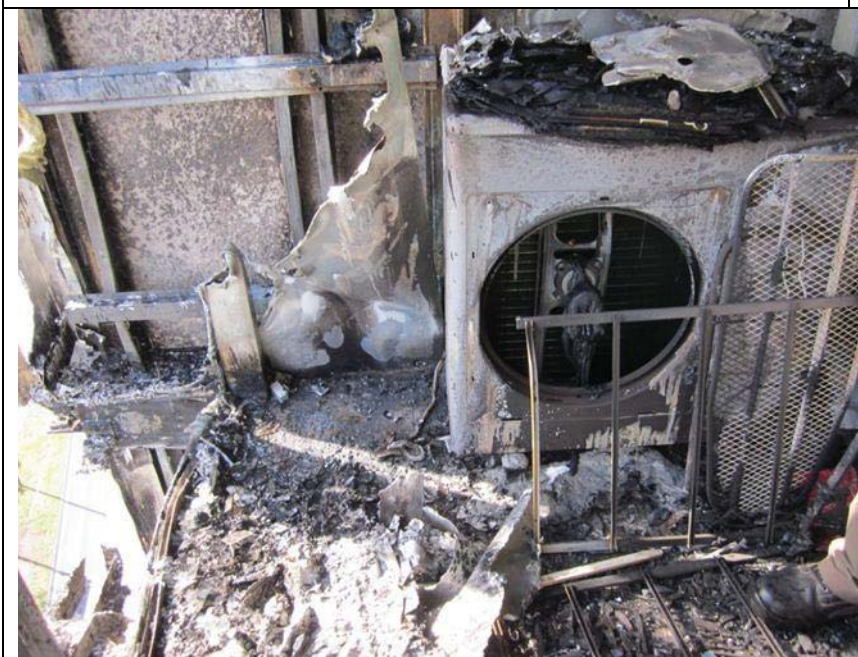
Photo of base of wall and penetrations plus overhang past balcony edge
