SUBMISSION TO THE AUSTRALIAN TRANSPORT SAFETY BUREAU,
A380 INVESTIGATION

SUBMISSION TO THE SENATE ENQUIRY INTO AIRLINE SAFETY.

PLEASE READ FIRSTLY THE COPY OF MY SUBMISSION TO THE ATSB REGARDING THE QANTAS A380 ENGINE DISC EXPLOSION OUT OF SINGAPORE ON NOVEMBER 4TH 2010. (ENCL)

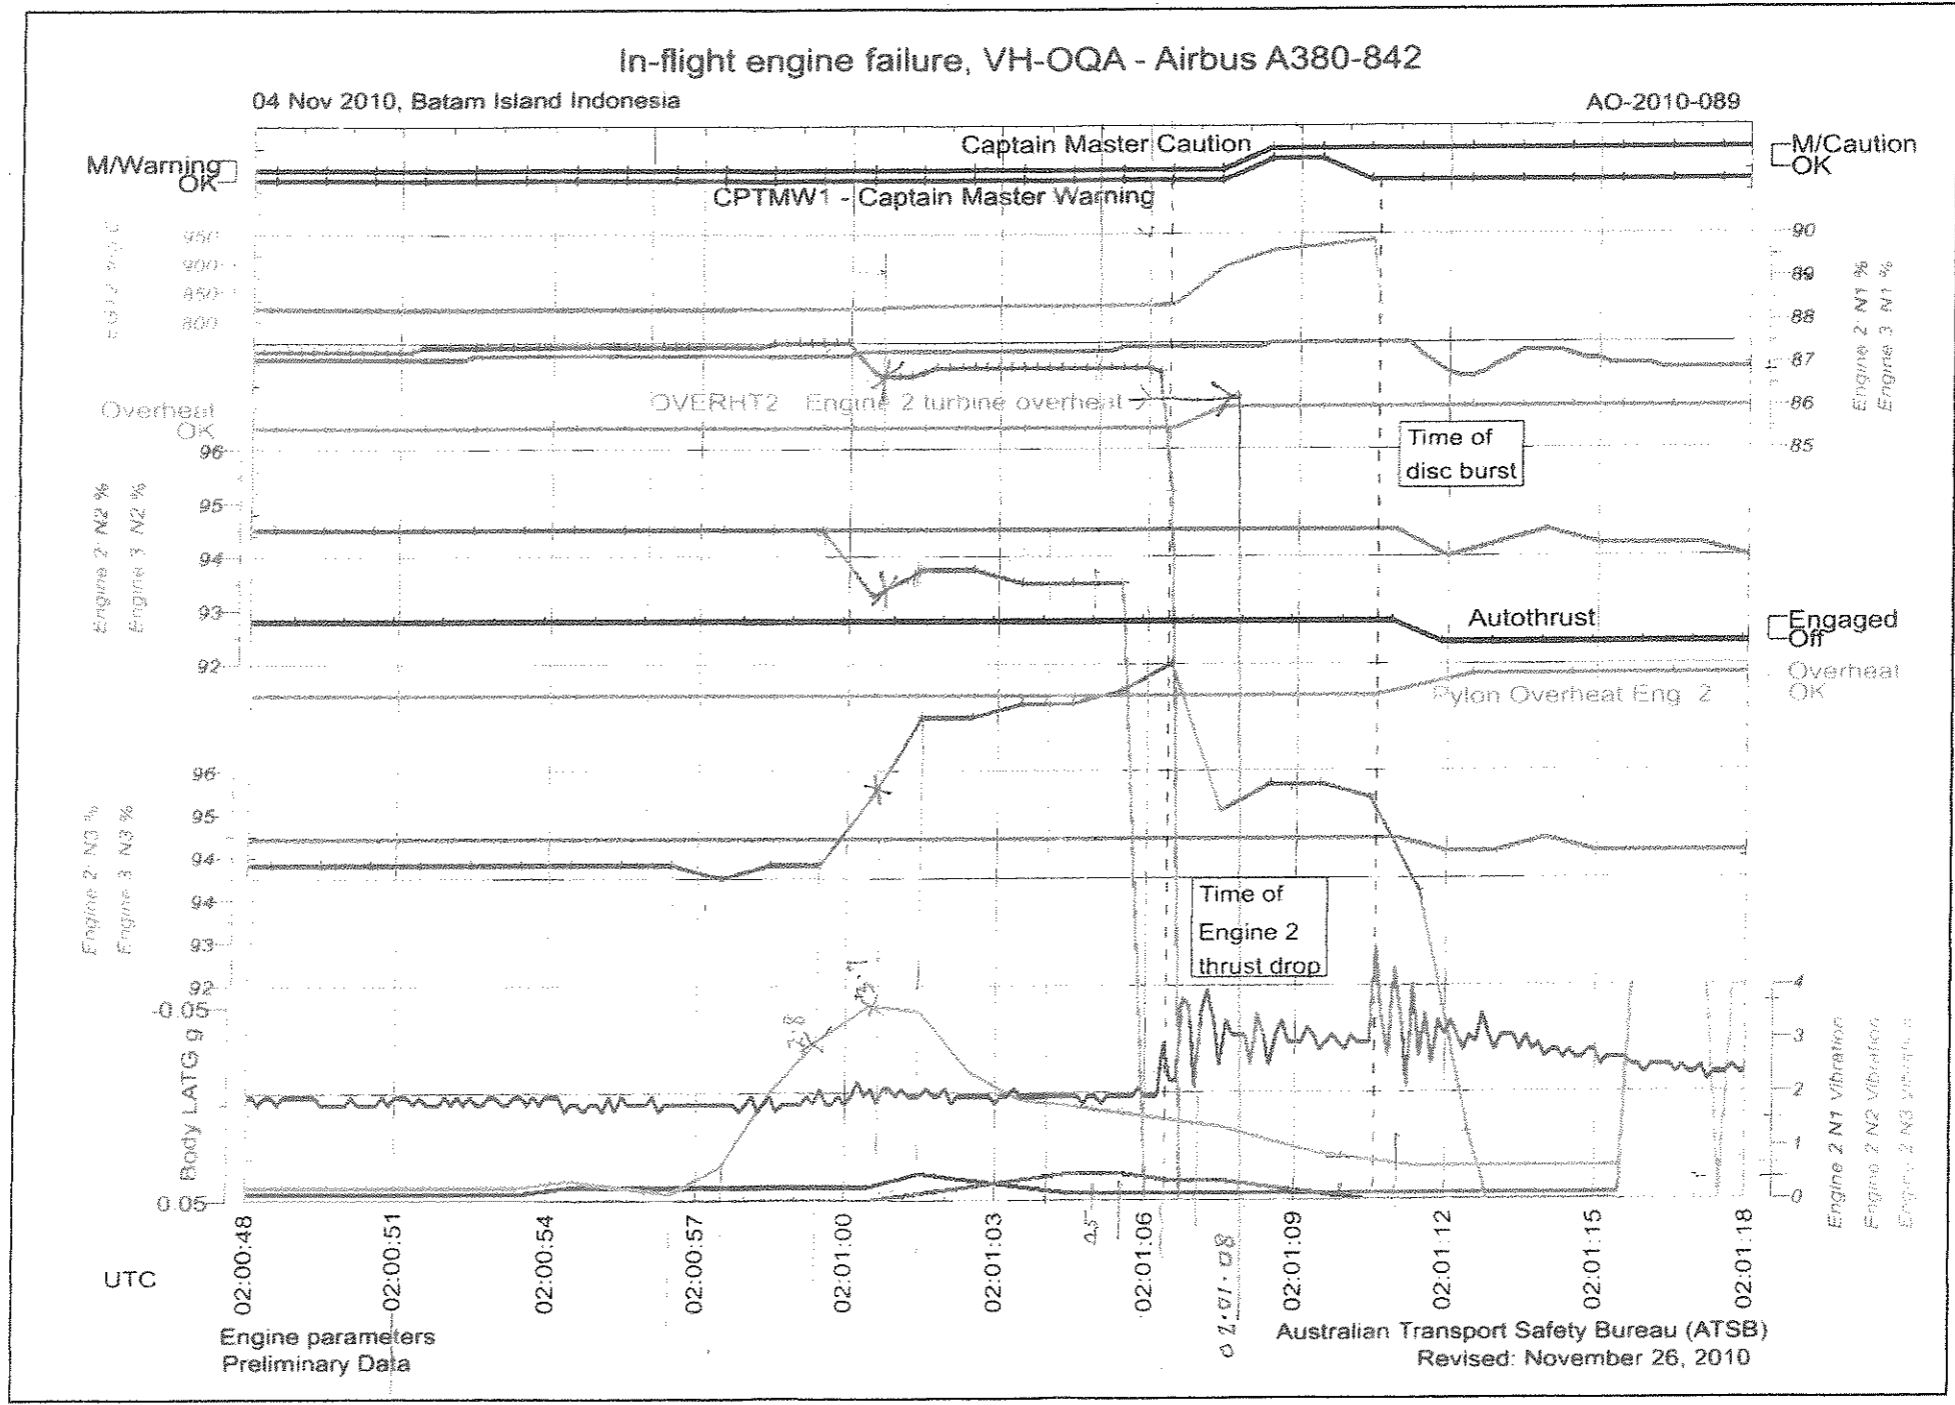
Figure A-2: Graphical representation of engine parameters around time of event

02:00:59.4
 DESTINATE SHUT DOWN READ
 RE. VIB/N1/N2/N3 PARAMETERS
 02:01:01.5
 EGT RISE 20°C
 OIL PRESS DROP 40%
 02:01:05.4
 LAST
 02:01:06.3
 00. TO SHUT DOWN
 ENGINE
 AND ESCAPE HURRIC DAMAGE
 TOO
 LATE 02:01:11 Disc Fail

Increasing vibration is often
positive indication
of a serious turbine problem
developing.

WINDOW OF OPPORTUNITY
12 SECS. FOR
ENGINE SHUT DOWN.
BEFORE DISC FAILURE

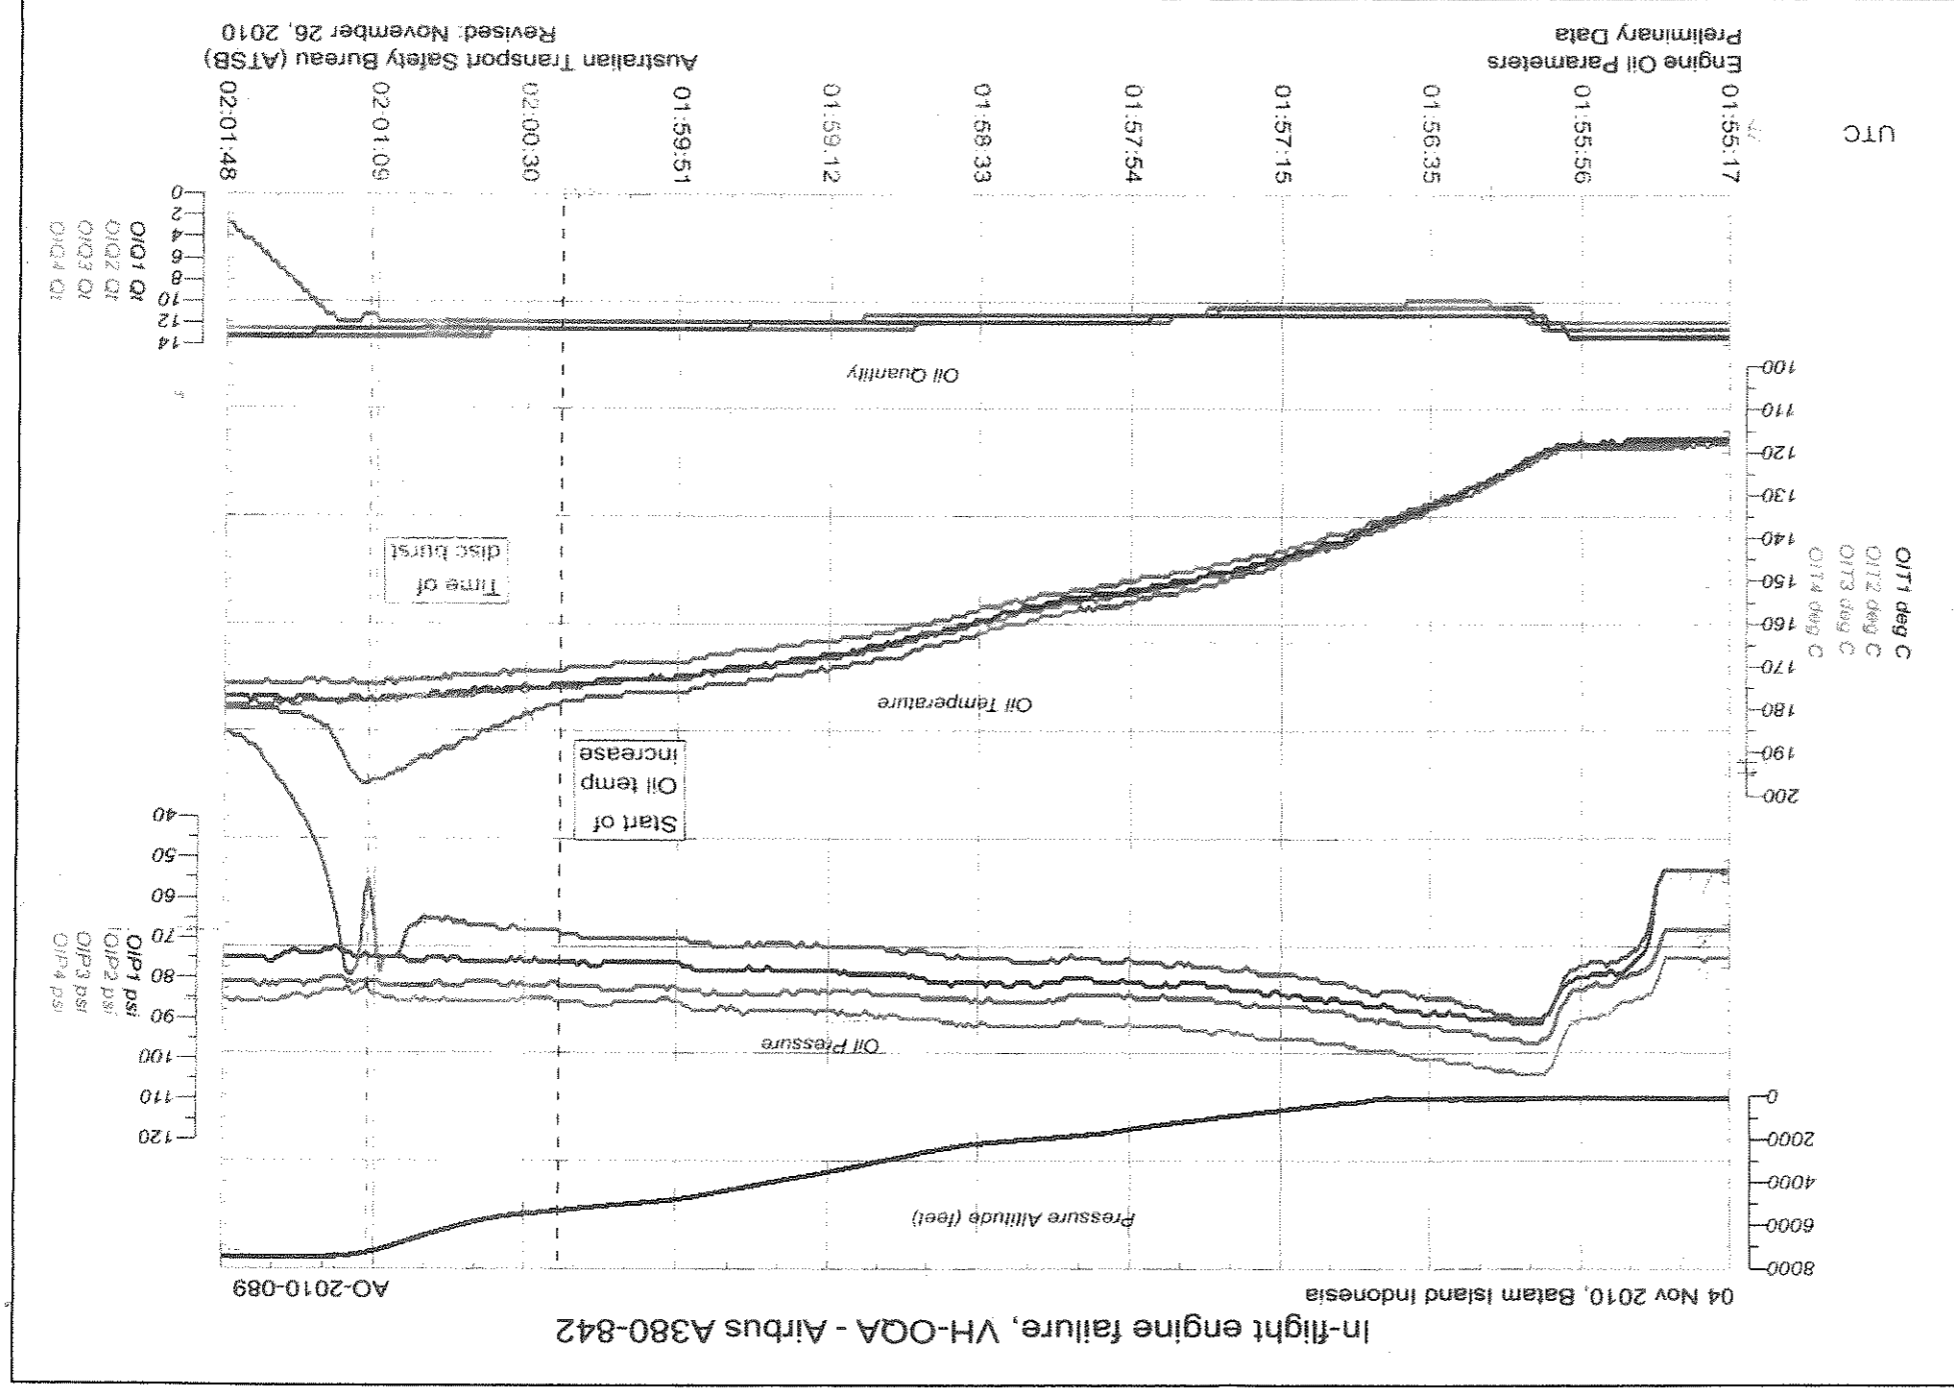
Figure A-3: Graphical representation of engine oil parameters prior to event

FOR SAME NI OF 87%
OP DROPPED 3 PSI
OT ROSE 12°C

* ENGINE VIBRATION
Early Warning of Problem
* THRUST NOT REDUCED!
Vibration increasing
Vib/N2 + N3 fluctuating
* Shut Down Engine
* Required
MAX VIBRATION LEVEL

LAST OPPORTUNITY TO
SHUT DOWN - PRIOR TO
CATASTROPHIC ENGINE FAILURE
& PERCENT DATA
EST. RISES RAPIDLY
TO MAXIMUM DUE TO
SOME FUEL PROBABLY STILL
SUPPLYING ENGINE
DISC FAILURE
PYLON OF HEAT
HR. BANGS
CAPT. SELECTS ALTO HOLD IN LEVEL. CALLS 11

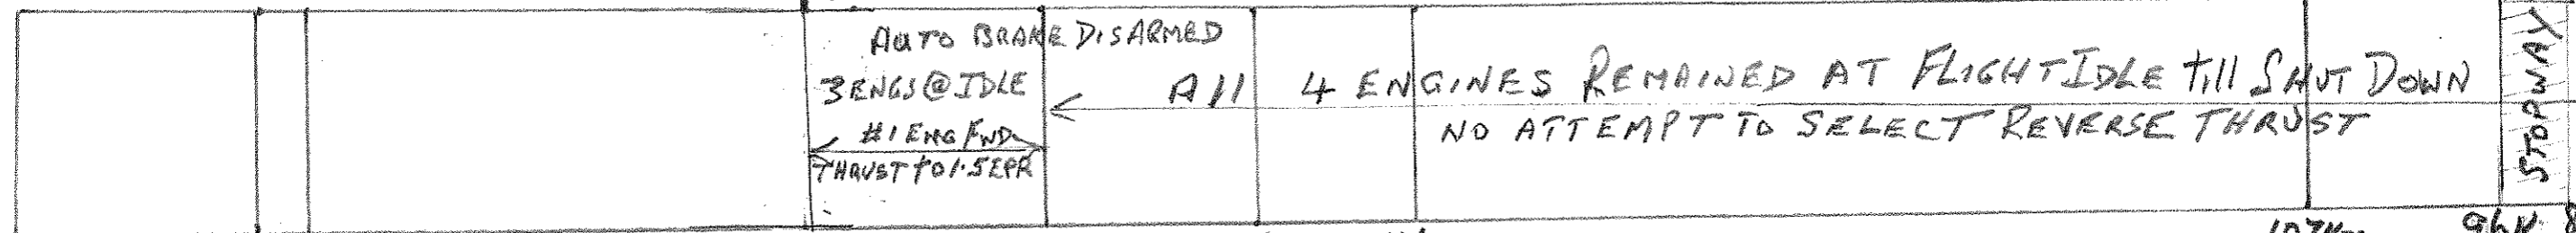
Runway 21L. 747-400 23 SEPT, 1999

TOUCH DOWN - Go Round / All 4 T. LEVERS ADV. 2246:30.1
 Capt. reduced #2, 3 & 4 to Idle 2246:31.6
 F/O reduced #1 " " 2246:33.0
 2246:33.1

NO CREW NOTICED AUTO BRAKE DISARMED 33.3

All 4 Engines remained at FLT. Idle 46:38
throughout the landing roll 46:41
 2247:04

at no stage was Rev. Idle or increased Reverse selected.

NO AUTO SPOILER
 #1 lift at fwd thrust reached 1.50 EPR for 1.4 Secs
 ACTION
 AUTO SPOILER DEPLOYED (DUE NO. 1 TO IDLE)
 AUTO BRAKE DISARMED (DUE #1 HAD BEEN ADVANCED)
 T/O CONFIG. WARNING. DUE T/levers adv with FLAPS + SPOILER LEVER IN L/D'S POS
 SPEED DECREASED (START) below touch DOWN SPEED 1625M. from THRESHOLD.
MANUAL Brake Commaned.
 NOSE wheel Contacts runway.
 A/c overran Stopway.
