8<sup>th</sup> May 2013

James Billamoria  
Visionstream

Local CEPU Official Michael Anderson and I attended 13 Visionstream sites yesterday that had contractors undertaking work for the NBN rollout. We have found that there are serious OH &S breaches occurring and no onsite leadership from Visionstream at all.

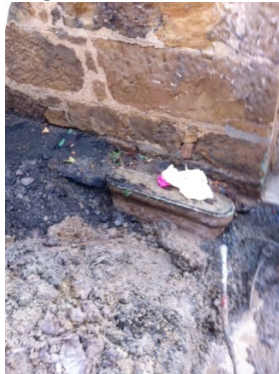
- Battery point- Rock solid excavation and Apex Communication. No NBN ACM training
- Sandy Bay- NBN Co employees auditing a fibre join. All good
- Hampden Rd Battery Point- Chaplain Construction. No NBN ACM training and had cleared around asbestos pit. They had broken a water pipe so the ACM was being kept wet. See photo below.

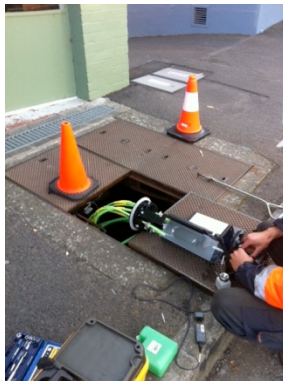
- Hampden Rd Battery point- Visionstream. One bloke had not received any ACM training!
- Hampden Rd Battery Point - Link Communications. No NBN ACM training. No gas detector in pit. The man hole cover was open but the individual would have to had leant into the pit to access the fibre!

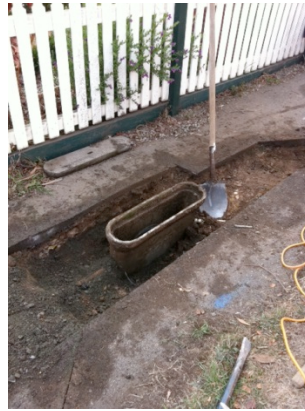
- Bellerive – Point Construction. No NBN ACM training. Had cleared around pit and were going to leave site to attend VPL yard for the ACM Training leaving the pit exposed. They said they were leaving immediately.

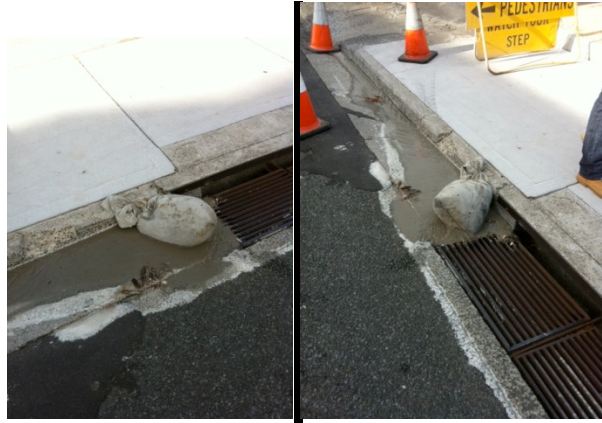
- Percy Street Bellerive– Spectran. 3 blokes , one ACM Trained. The contractor was cutting the concrete footpath to install pit & pipe. They had blocked of the council car park as they were cutting the driveway/ crossover. We observed that they were hosing the slurry and run off into the gutter that was then running into the storm water drain. The only environmental bund that was in place was insufficient for the task. When I pointed this out they threw a hessian bag over the storm water grate!!

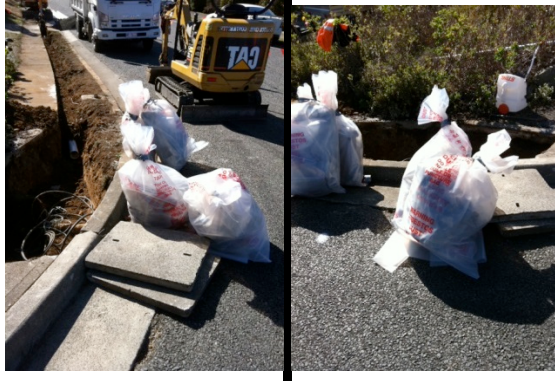
- Clarence Street Bellerive– Landworks. Had ACM training
- Redwood Rd Kingston – 20<sup>th</sup> Century Plumbing. No NBN ACM training. Had just removed and bagged an ACM Pit. They had a Leighton Contracting Safety Handbook that they were following as the process for removing the ACM Pit.
- Balamara Street Rosny – Bullock Contracting. Toolbox talk at casino about asbestos.
