# Senate Rural and Regional Affairs and Transport References Committee

## Inquiry into aviation accident investigations

**Questions Taken on Notice – Airservices Australia**

# Ditching – Israel Aircraft Industries Westwind 1124A, VH-NGA

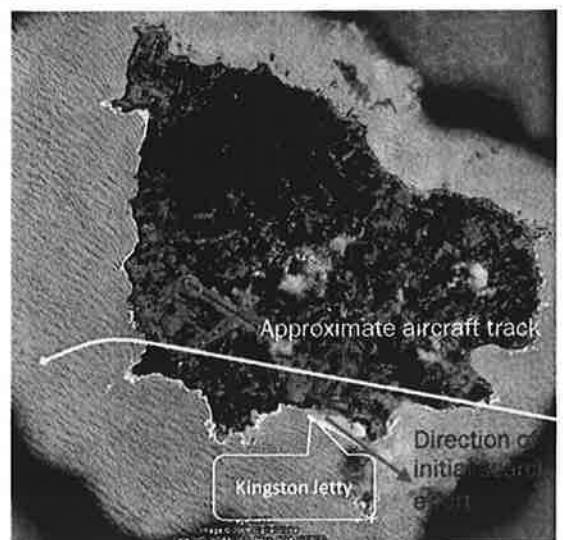
**Figure 4: Approximate runway 29 VOR/DME final approach and overshoot track (Kingston Jetty highlighted)**

The Norfolk Unicom operator had alerted the Norfolk Island emergency response agencies to a local standby condition when the weather first deteriorated to the extent that the Unicom operator felt it might be difficult for an aircraft to land. The Unicom operator subsequently initiated a deployment of the emergency services following the aircraft's second missed approach. In addition, two local boat owners prepared to launch their fishing vessels at Kingston Jetty to search for the ditched aircraft and its occupants (Figure 4).

When Norfolk Unicom lost contact with the flight crew, the airport firemen drove from the airport to Kingston Jetty to help if possible with the recovery efforts. The first rescue vessel departed to the

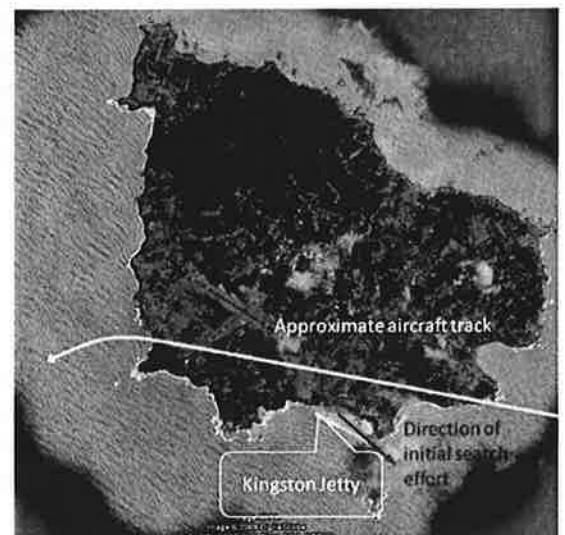
**Figure 4: Approximate runway 29 VOR/DME final approach and overshoot track (Kingston Jetty highlighted)**

The Norfolk Unicom operator had alerted the Norfolk Island emergency response agencies to a local standby condition when the weather first deteriorated to the extent that the Unicom operator felt it might be difficult for an aircraft to land. The Unicom operator subsequently initiated a deployment of the emergency services following the aircraft's second missed approach. In addition, two local boat owners prepared to launch their fishing vessels at Kingston Jetty to search for the ditched aircraft and its occupants (Figure 4).

When Norfolk Unicom lost contact with the flight crew, the airport firemen drove from the airport to Kingston Jetty to help if possible with the recovery

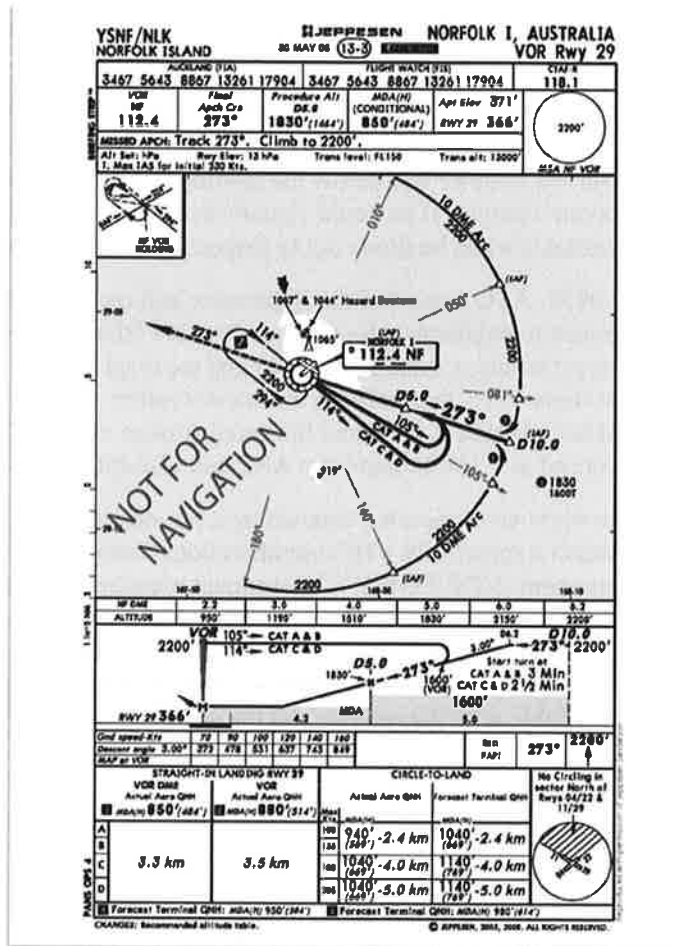
Figure 3: Runway 29 VOR instrument approach

The crew reported agreeing that the expected weather would mean that visual reference with the runway may be difficult to obtain, and that the PIC would closely monitor the approach by the copilot. During the briefing for the first approach, the crew agreed that, if visual reference with the runway was not obtained, the PIC would take over control of the aircraft for any subsequent approaches.

The Unicom operator contacted the crew again at 0938 and stated that the weather conditions had deteriorated because a rainstorm was ‘going through’, with ‘four oktas’<sup>26</sup> of cloud at 200 ft above the ARP and that the visibility had deteriorated. The operator also reported that the AWS indicated Broken cloud 600 ft above the ARP.

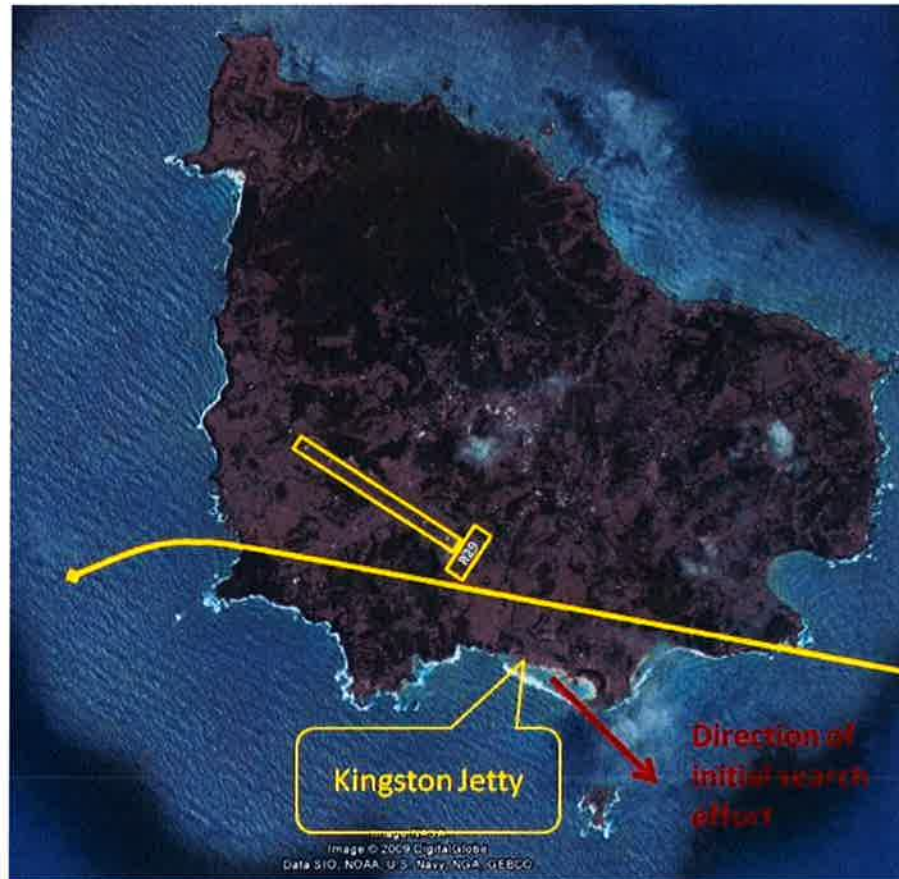
**Figure 5: Approximate aircraft track before the ditching**

The crew indicated that they climbed the aircraft to 1,200 ft above mean sea level (AMSL), turned left in a south-westerly direction (Figure 5), and configured the aircraft to land without extending the landing gear. The flight crew descended towards the water while monitoring the digital height readout from the aircraft's radar altimeter (RADALT)<sup>28</sup>, which was mounted near the attitude indicator in the cockpit instrumentation.

The crew reported initiating a landing flare at about 40 ft RADALT and that the aircraft first contacted the water at an airspeed of about 100 kts. The flight crew recalled that, although they had selected the landing lights ON, they did not see the sea before impacting the water. Although there was no recorded MAYDAY or other radio call coincident with the ditching, a short unintelligible radio transmission was recorded on the Unicom frequency at 1026:02.

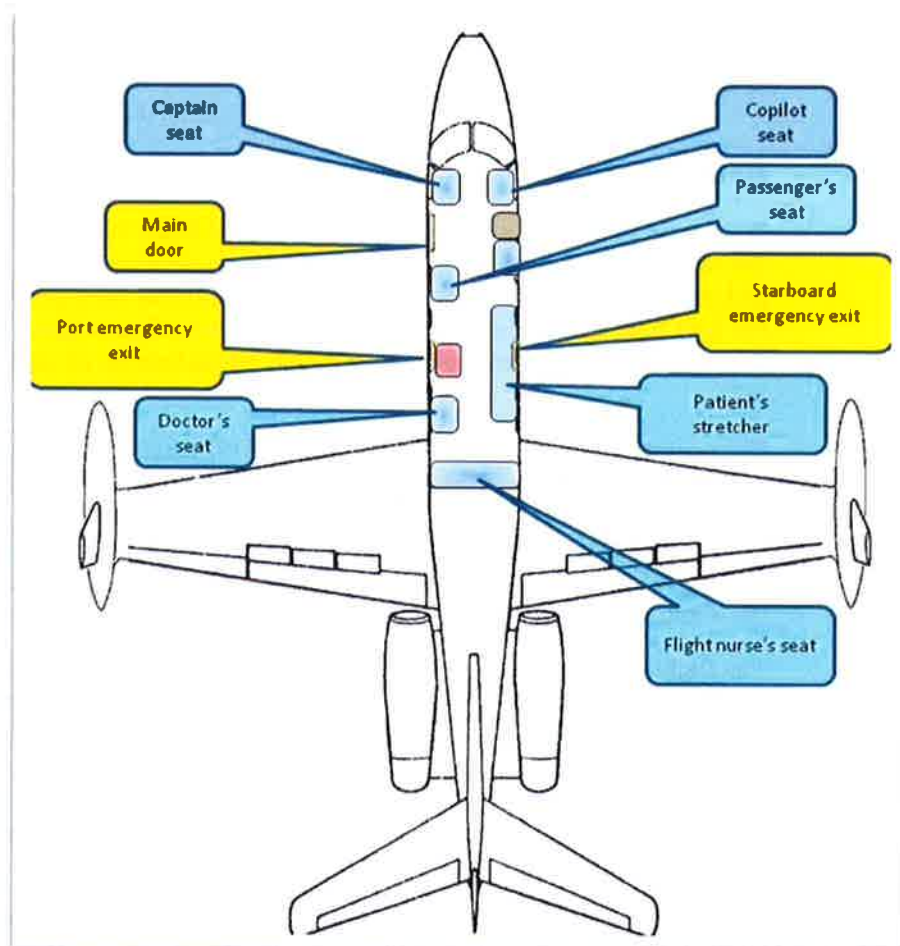
**Figure 7: Seating positions at the time of the ditching**

The life rafts were reported removed from their normal stowed position and placed in the aircraft's central aisle ready for deployment after the ditching.

The aircraft occupants recalled two or three large impacts when the aircraft contacted the water. Those in the front of the aircraft described the impact forces acting in a horizontal, decelerating direction. The flight nurse, who was seated in the rearmost seat in the aircraft (Figure 7), reported far stronger vertical accelerations during the deceleration sequence compared with the other aircraft occupants. That was consistent with the nature of the injuries sustained by the nurse.

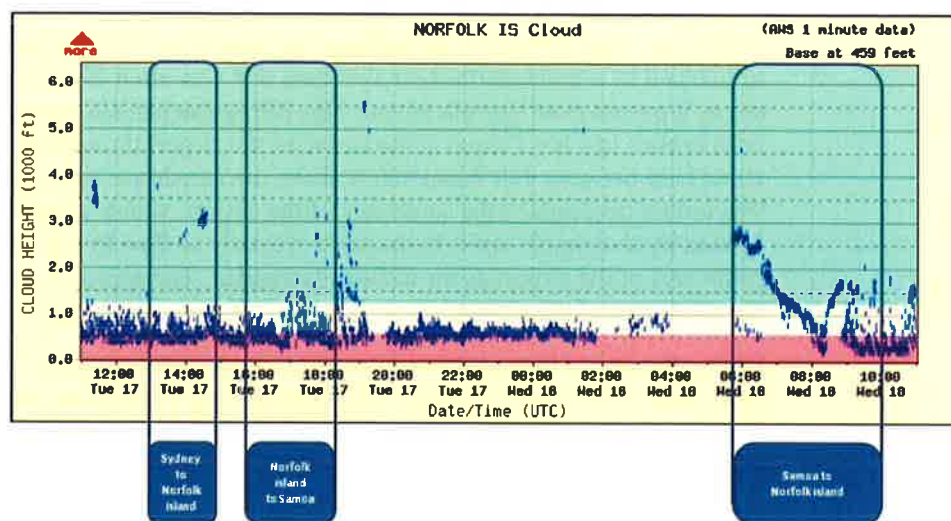
**Figure 8: Graphical representation of the cloud base observations at Norfolk Island during the period of the flights**

The aerodrome weather reports indicated a slight increase in cloud developing at Norfolk Island between 0600 and 0700. The end of daylight at Norfolk Island Airport was at 0750. The cloud base continued to descend (Figure 8), and at 0739, the automatic weather station (AWS) issued an extra report beyond its normal half-hourly reports. The extra report was issued as the weather conditions had deteriorated to the extent that the reported aerodrome weather report had changed from requiring the issue of a METAR to that of a SPECI (special), because overcast cloud had been observed 1,100 ft above the ARP, which was less than the highest alternate minima. The wind direction had not changed.

- The green area in the figure indicates a cloud base higher than the alternate minima.
- The yellow area in the figure indicates a cloud base lower than the alternate weather minima and higher than the landing minima.
- The red area in the figure indicates a cloud base lower than the landing minima.
