## Hydrologist Report –

## : Issues in report

### WMS Hydrologist Report Details

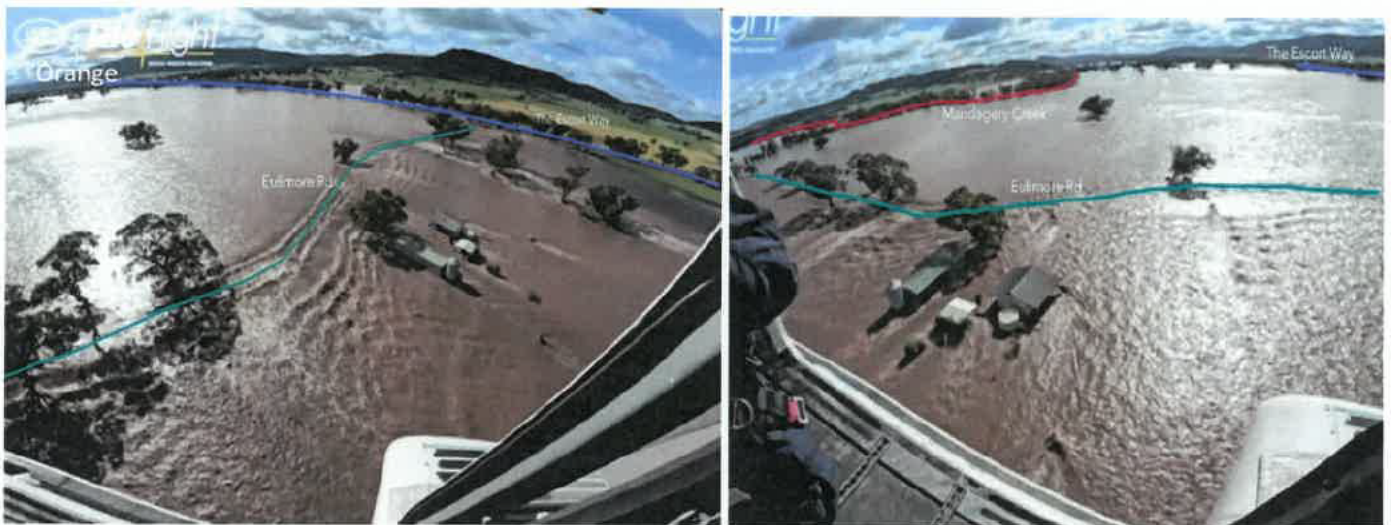
- v. Figure 2 shows the large amount of water travelling across Eulimore Rd, which is approximately 6.63 km north-east of the subject property. This figure clearly demonstrates the sheer scale of the water that was present. After observing this figure, it would be illogical to conclude that all of that water originated from Mandagery Creek, which was described as simply “a meandering stream” in the report, and no storm water had been collected across the region.

- i. As B.(v) of this document states, Figure 2 shows water over Eulimore Rd which is to the left of The Escort Way. To the right of The Escort Way is privately owned paddocks and then the hills of Nangar National Park.
- ii. Photo 3 in Appendix A shows a border fence of a privately owned paddock that faces the Escort Way and hence the Mandagery Creek. It is clear in this photo that the fence is flattened in the direction towards The Escort Way. This indicates that a significant amount of storm water run-off from the Nangar National Park hills has travelled down, flattened the fence, gone across The Escort Way and joined the large body of water moving towards Eugowra.
- iii. This adds further evidence that the large body of water moving towards Eugowra included a substantial amount of storm water.

Figure 2: Screenshots of footage taken by the Life Flight rescue helicopter during "the November event". The Escort Way (dark blue), Eulimore Rd (turquoise) and the Mandagery Creek (red) are outlined in the images. The right-side image shows clearly the enormity of water moving towards Eugowra and adds evidence to question whether this amount of water was in the Mandagery Creek to begin with (source: the footage from the Life Flight helicopter was posted by Life Flight themselves on Facebook and reposted on the forum of the Eugowra Facebook page).

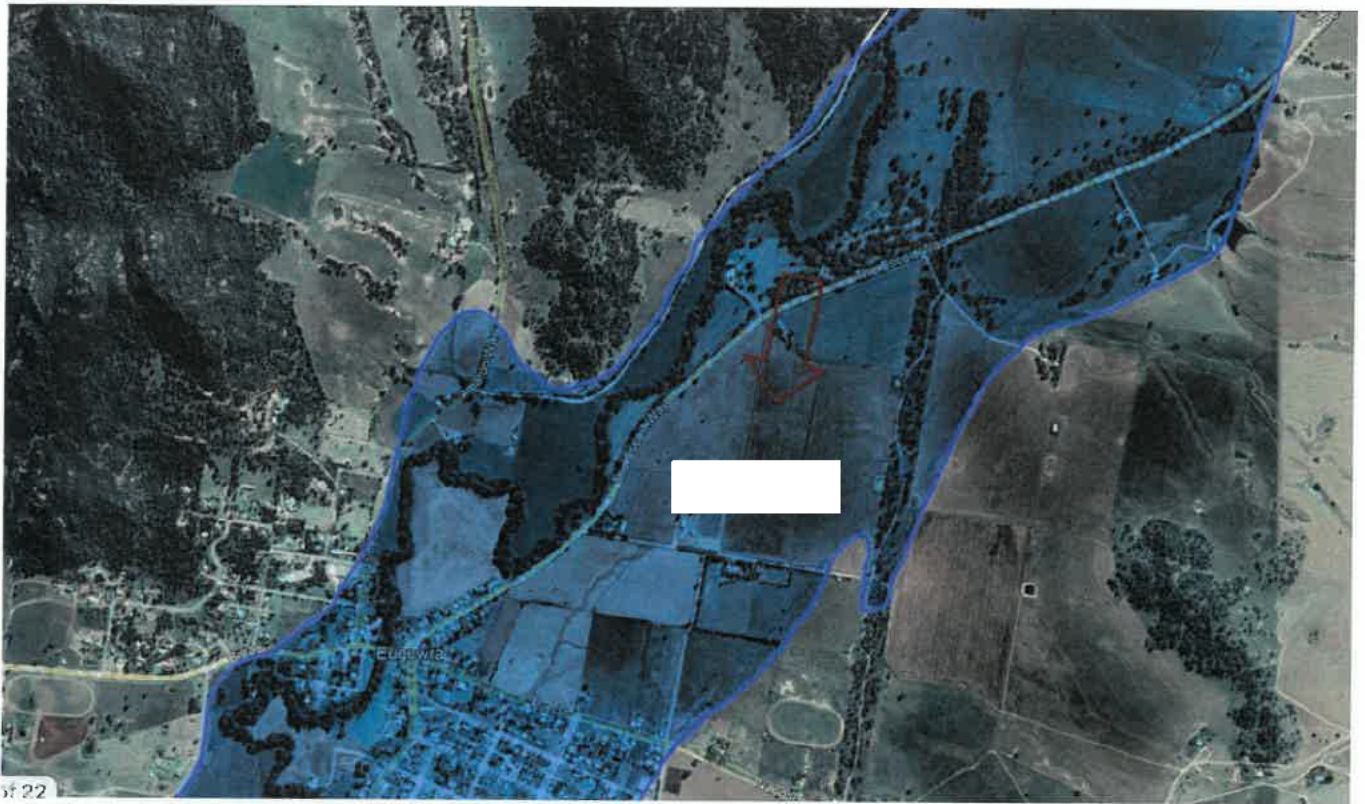
- ii. However, given the directionality of the water (including stormwater) flowing from Eulimore Rd and around Escort Rock, the water was moving in a south-westerly direction rather than southerly. Based off properties that are known to be impacted, such as ‘Karingah’ located 1.9 kilometres north-east of the subject property, directionality of fencing & property damage and a drone image showing water movement, the path of the water flow is shown in Figure 3. Images supporting this figure are included in Appendix A as photos 4-9. Photo 4 shows the two tree lines quoted from Rosemary. With the locality of tree line 2, water breaking solely from the Mandagery Creek U-bend north of the property would not have extended to meet the tree line.

- i. At the subject property, the peak water depth was estimated to be 274.55 mAHD while the peak at the Eugowra town bridge was 272.43 mAHD.
- ii. Reasoning as to why the water peak depth was larger at the subject property than in town may include the properties proximity to the south westerly water, as shown in Figure 3, it is in the centre of the water path.

Figure 3: Map of Eugowra with the flow of water highlighted in blue. The physical satellite image was provided in the hydrologist report and shows the location of the subject property via a yellow pin and proposed directionality of the water by the hydrologist shown via the red arrow. The proposed water flow was drawn over the image independently using knowledge of properties impacted and photos 5-9 from Appendix A (source: personal images and knowledge).

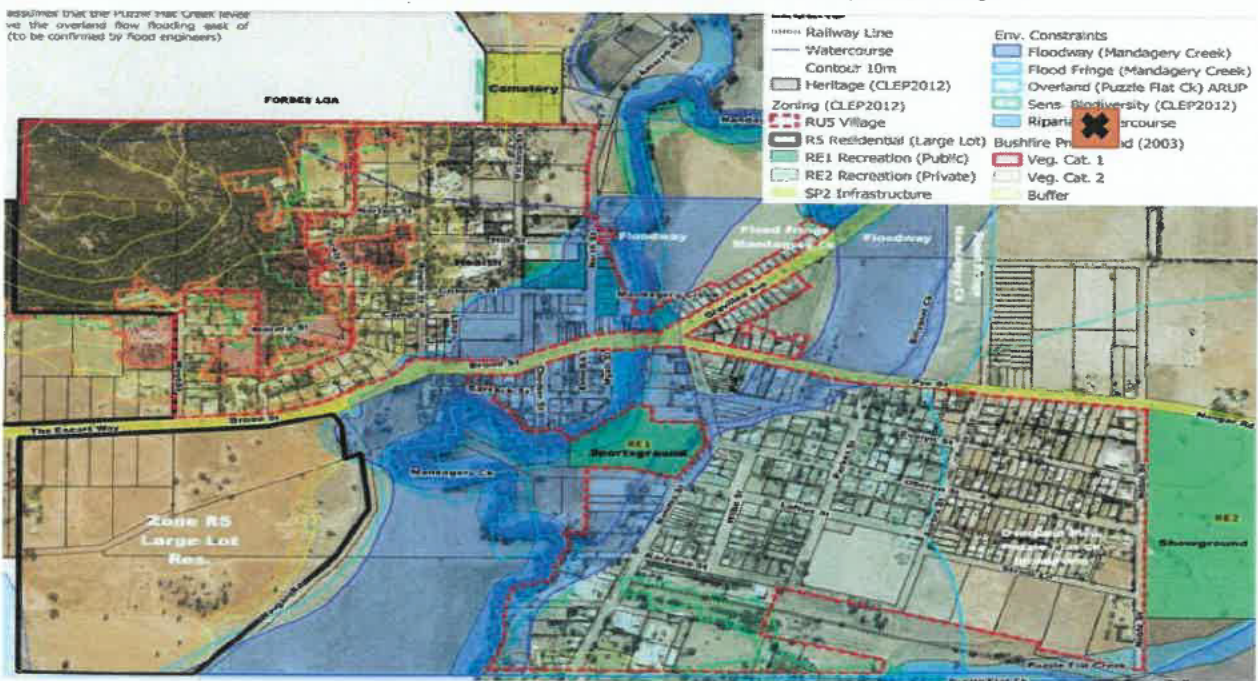
- Explanation from Allianz is required as to why flood insurance was not available under this farm package.
- Additionally, if flood insurance was refused based on the subject properties' location within the Eugowra region, a settlement strategy published in 2021 by Cabonne Council shows that the subject property would be outside the "flood fringe" of the Mandagery Creek. This design model is shown in Figure 4 on this document.

Figure 4: map showing the Eugowra floodway published in the Cabonne Council Settlement Strategy 2021-2041. This report was published in May 2021 and shows the Mandagery Creek floodway along with the fringe floodway. The legend of the map covers where the subject property would be, therefore, an orange square with a black cross has been placed on the legend to provide the subject properties location. It is evident that the subject property sits outside of the Mandagery Creek floodway fringe (source: Cabonne Council: Cabonne Settlement Strategy 2021-2041).

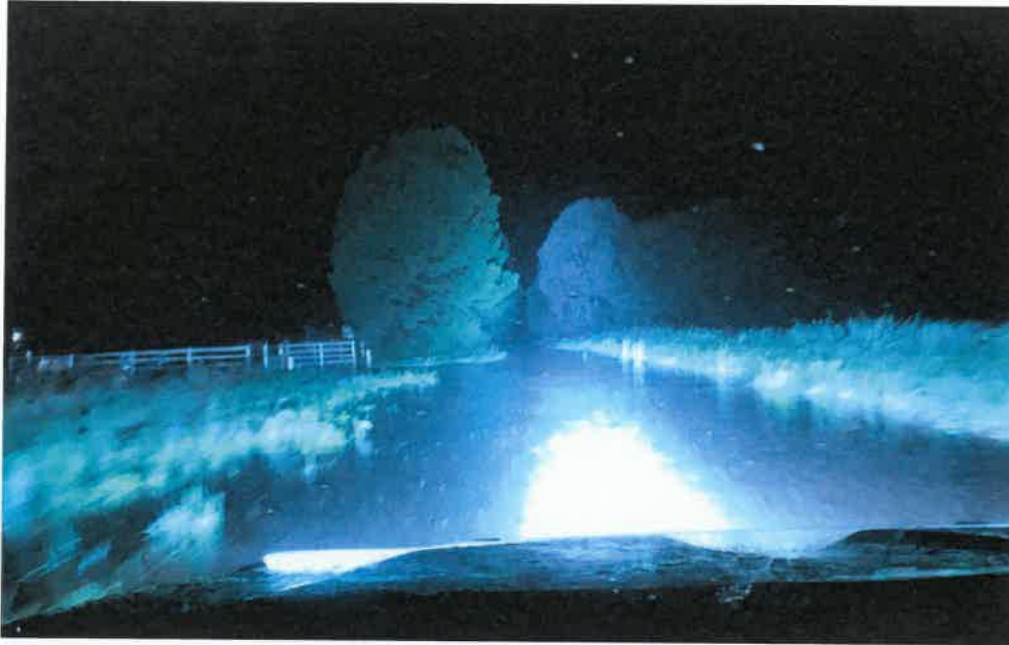
The statement that the water was ponding on the field is correct, however the water was not gone the following morning. There was still water on the ground and the lane, estimated to be ranging from 20- 40 cm in depth.

Photo 1 in Appendix A shows the water level present on Hillview Lane at approximately 0135 hours on the 14<sup>th</sup> of November and Photo 2 in Appendix A shows the water the was still present on Hillview Lane at 0908 hours on the 14<sup>th</sup> of November.

*Photo 1: Image of the water level present on Hillview Lane at approximately 0135 hours on the 14<sup>th</sup> of November 2022. The gateway to the subject property is shown on the left side of the image (source: personal image taken).*

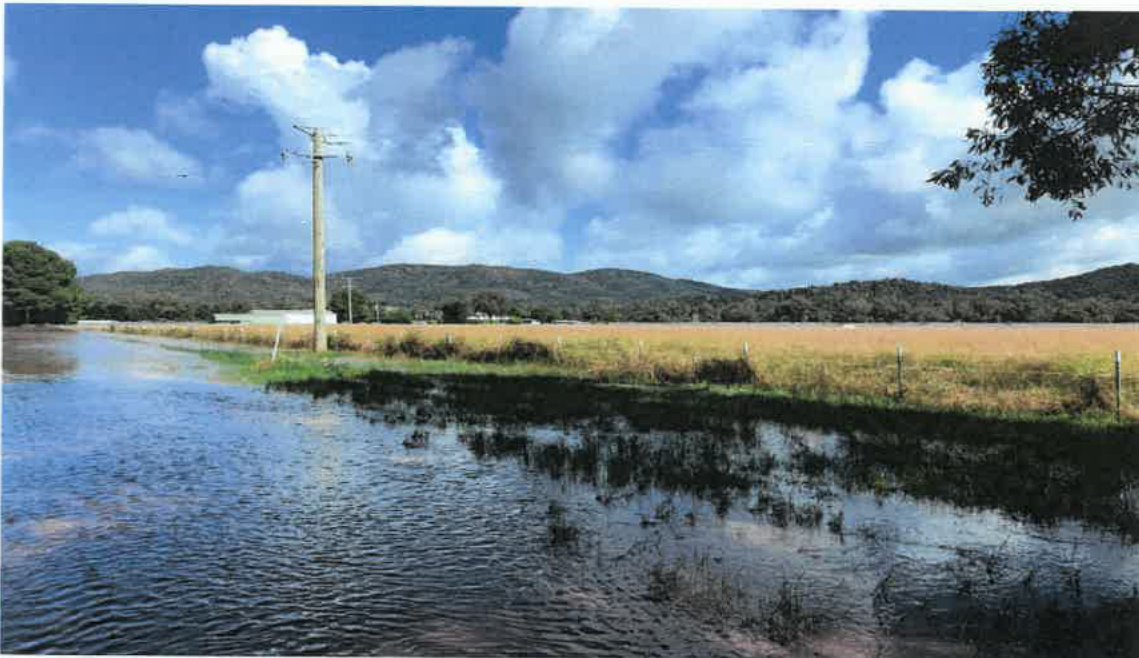
It is clear through photo 2, that a considerable amount of storm water run-off was still present on the ground before the “wave of water” hit.
- B. “Mandagery Creek had broken its banks several kilometres upstream of Eugowra in the November 2022 event” – page 4.
- i. The report mentions the rainfall recorded for the Toogong gauge and the Mandagery gauge as well as the Eugowra gauge focusing on the month of November.

*Photo 2: Shows the water that was still present on Hillview Lane at 0908 hours of the 14<sup>th</sup> of November 2022. The subject property is the main house and sheds shown in the image (source: personal image taken)*

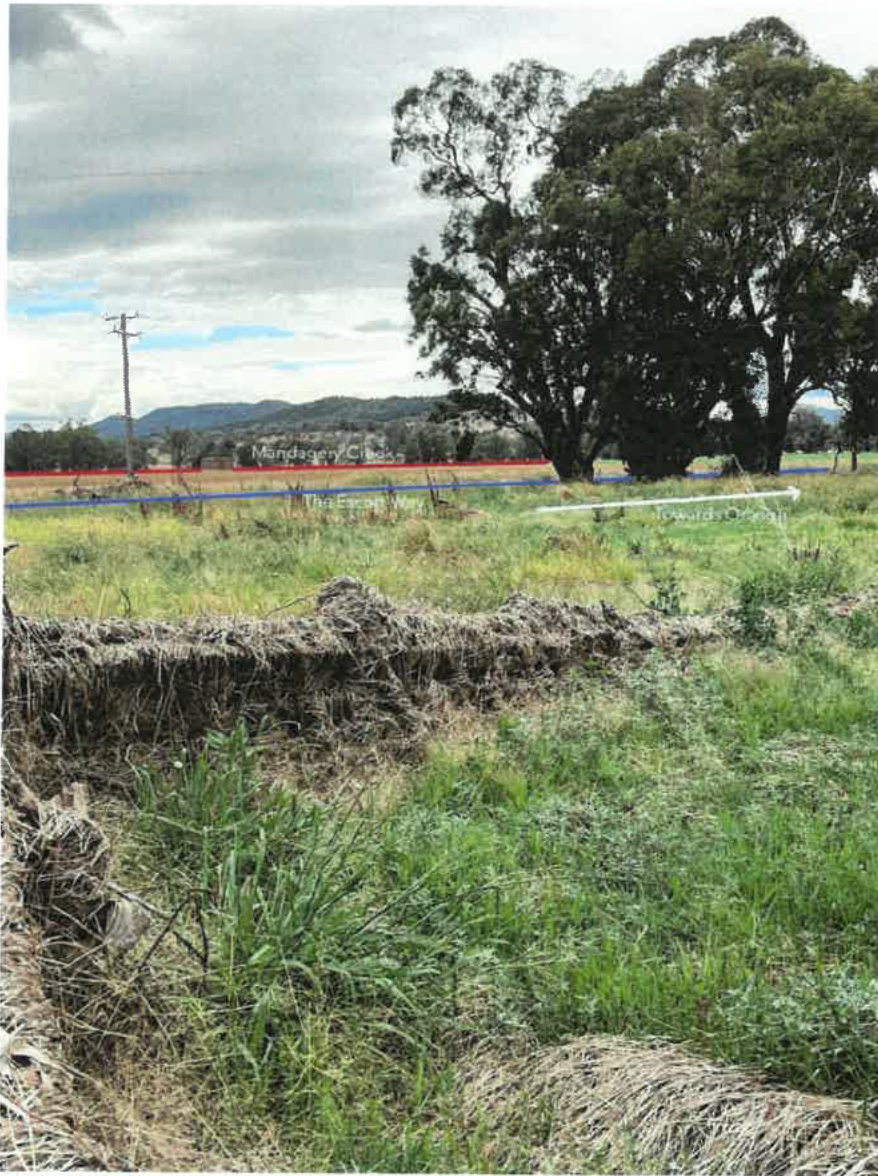
*Photo 3: Image taken of a fence of a privately owned paddock that borders the Escort Way. Coming from Eugowra heading towards Orange on The Escort Way, this paddock fence is on the right-hand side of the road whereas the water shown in Figure is on the left-hand side (source: personal image taken with permission from paddock owner).*

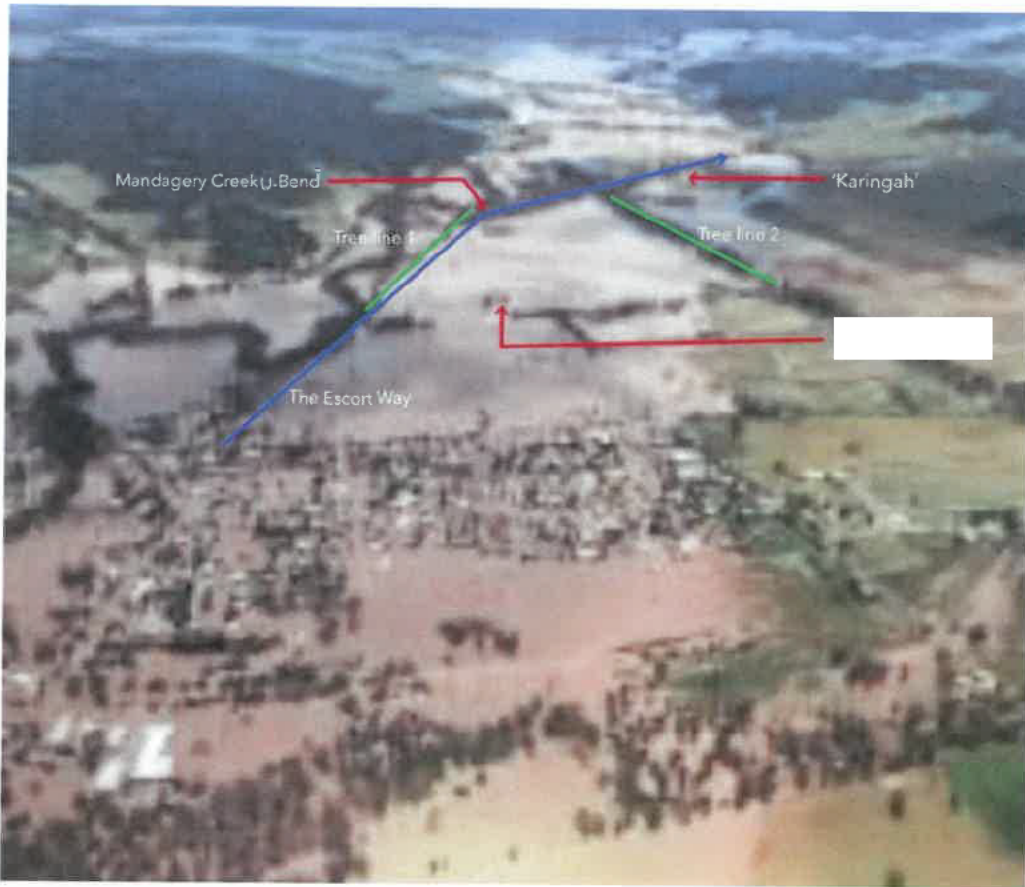
Photo 4: drone image taken of Eugowra during "the November event". On this image, the locality of the subject property is shown along with the location of 'Karingah', a property used as evidence in this document, the path of The Escort Way out of Eugowra and the two tree lines mentioned by homeowner representative Rosemary Townsend (source: posted on public forum Eugowra Supermarket Facebook page).

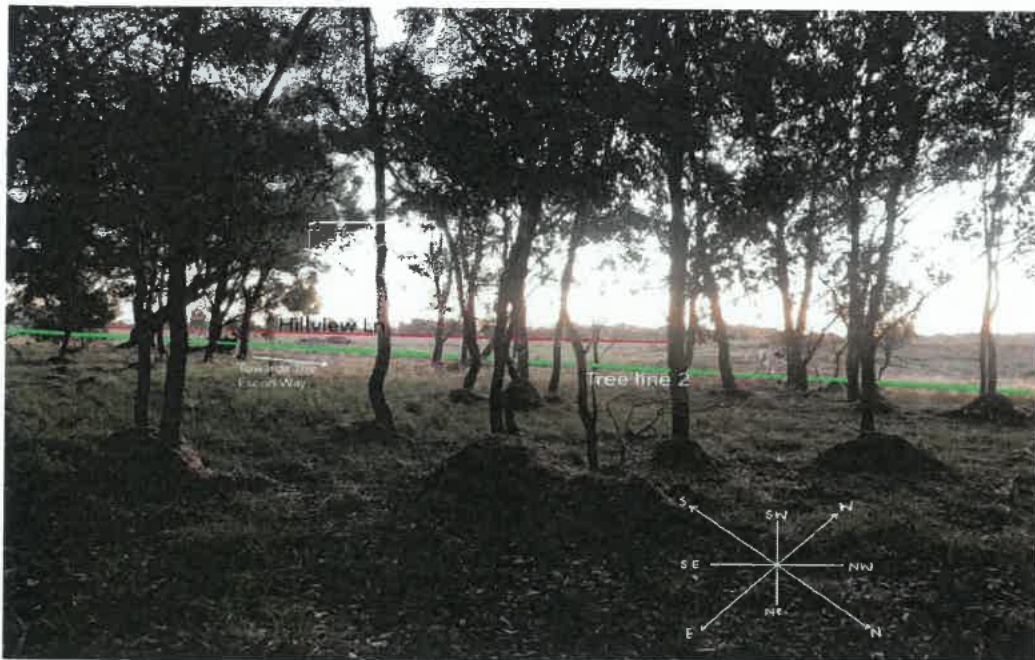
Photo 5: image taken amongst tree line 2 (from photo 4) showing flood debris on the north-eastern side of the trees, indicating water movement in a south westerly direction (Source: personal image taken on public land).

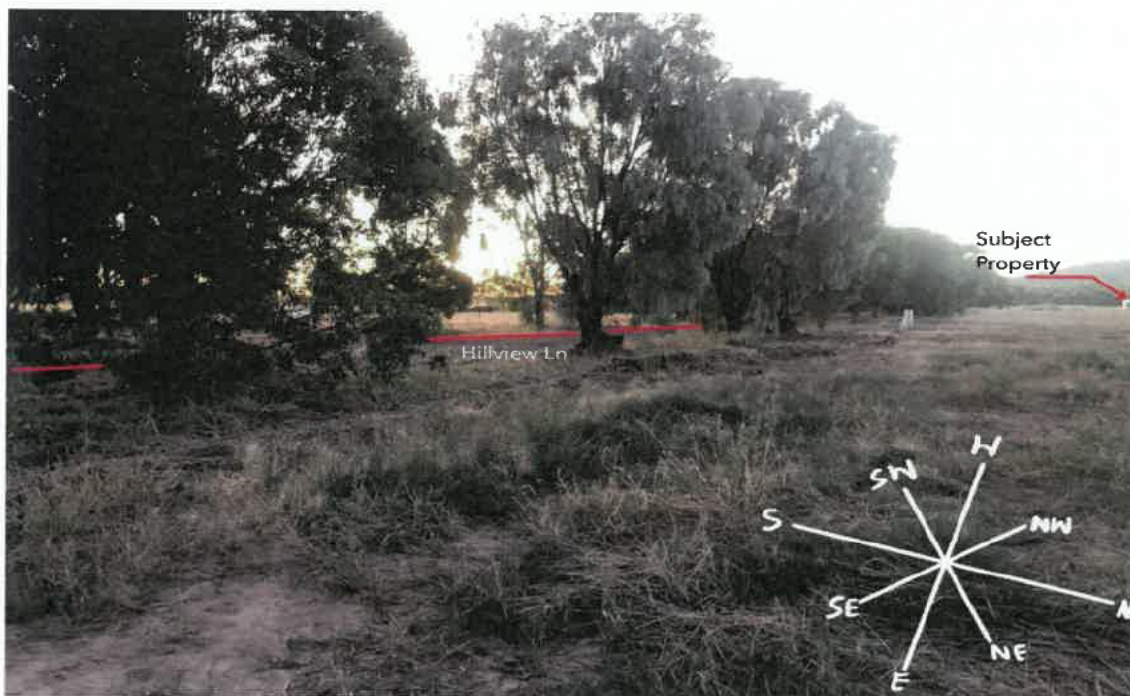
Photo 6: image taken of a fence line on a privately owned paddock that borders with Hillview Ln. It shows flood debris gathered on the north-eastern side of the trees, indicating water movement in the south westerly direction (Source: personal image taken with permission from land owner).

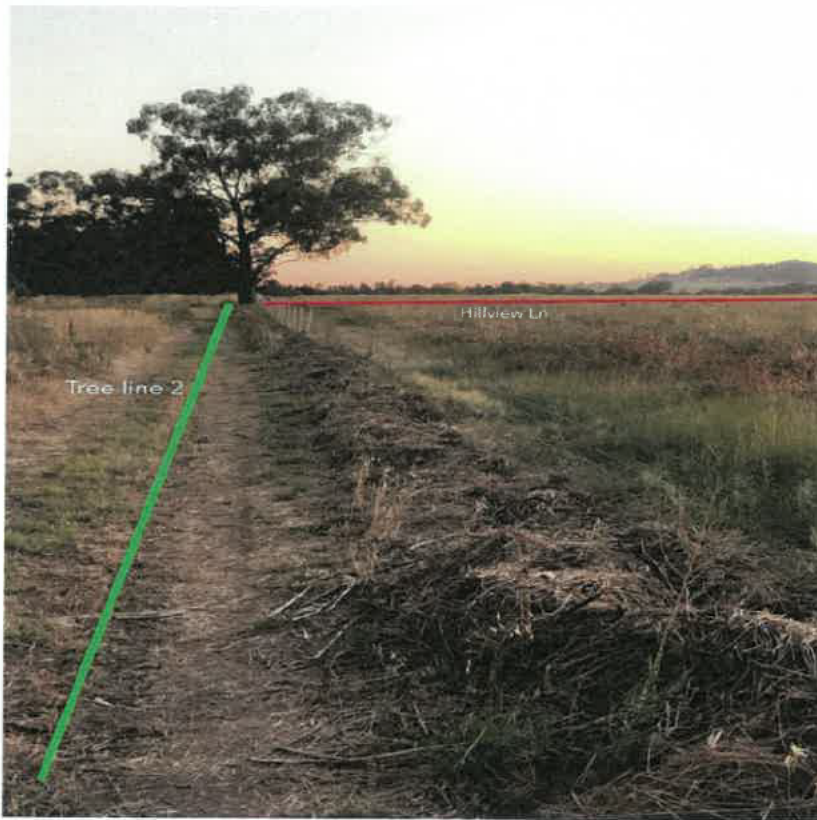
*Photo 7: image taken of a fence line of a privately owned paddock that borders both tree line 2 from Photo 4 and Hillview Ln. This image is taken on tree line 2 facing towards Eugowra with the subject property to the west of the photographer (source: personal image taken on public land).*

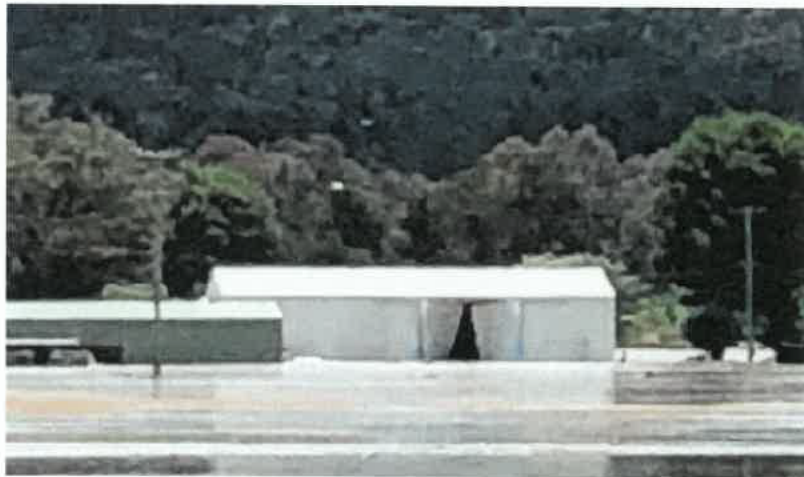
*Photo 8: Image of a machinery shed on the subject property. The photo shows the eastern facing side of the shed and a set of double doors that have been pushed inwards. Had the water only originated from the north, those double doors would not have been pushed inwards, rather outwards due to excessive water entry into the shed from the north (source: personal image taken of subject property from Hillview Ln).*

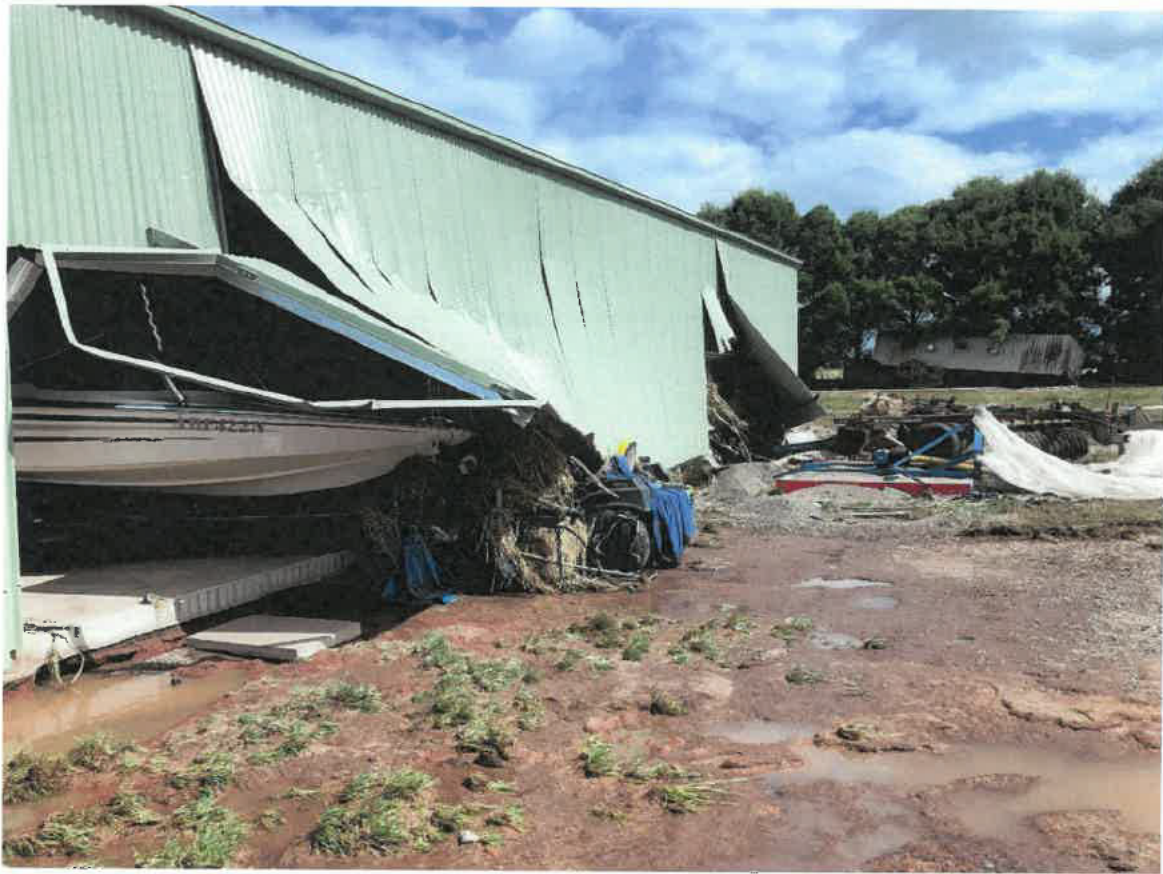
*Photo 9: image of another shed on the subject property. This photo shows the western side of the shed blown out and a boat that was originally parked pointing to the south, now pointing to the south west. Had that impact this property only originated from the north, it would have flowed in parallel with the sheds and pushed all that was inside out the southern end. Furthermore, the right-hand side of this image shows a shipping container that was originally placed east to west, it is now clearly on an angle (source: personal image taken on subject property).*
