Deepwater Horizon Accident Investigation Report

September 8, 2010

Analysis 5A. Well Integrity Was Not Established or Failed

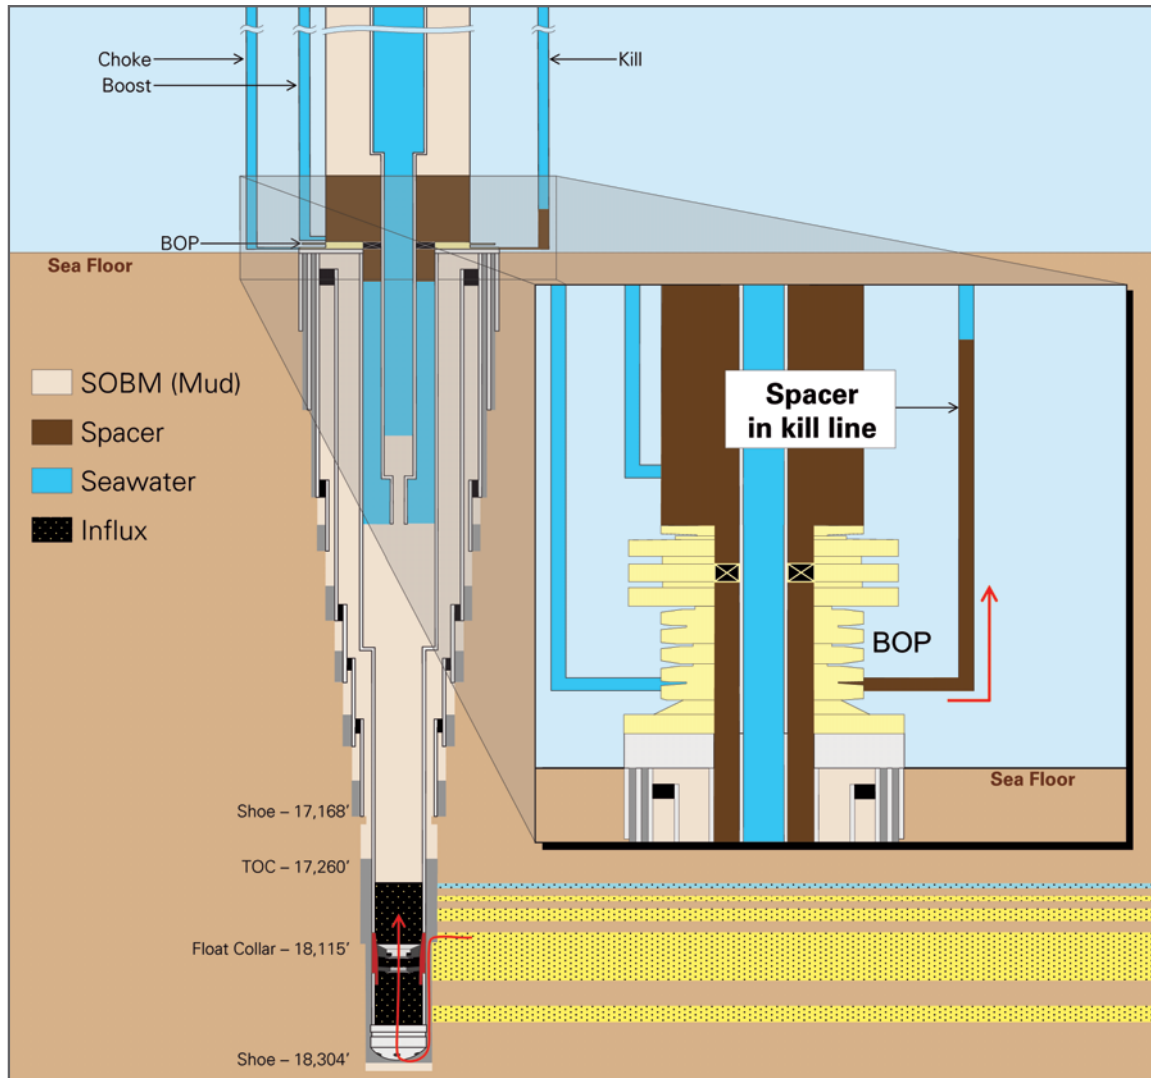
Figure 3. Possible Movement of Spacer into Kill Line.

As previously discussed in *2.2 Displaced Mud to Seawater* of this analysis, spacer material was unintentionally placed across the kill line at the BOP. At least 3 bbls of highly viscous fluid (occupying approximately 150 ft. in the kill line) could have been drawn into the kill line during this part of the test. (Refer to Figure 3.)

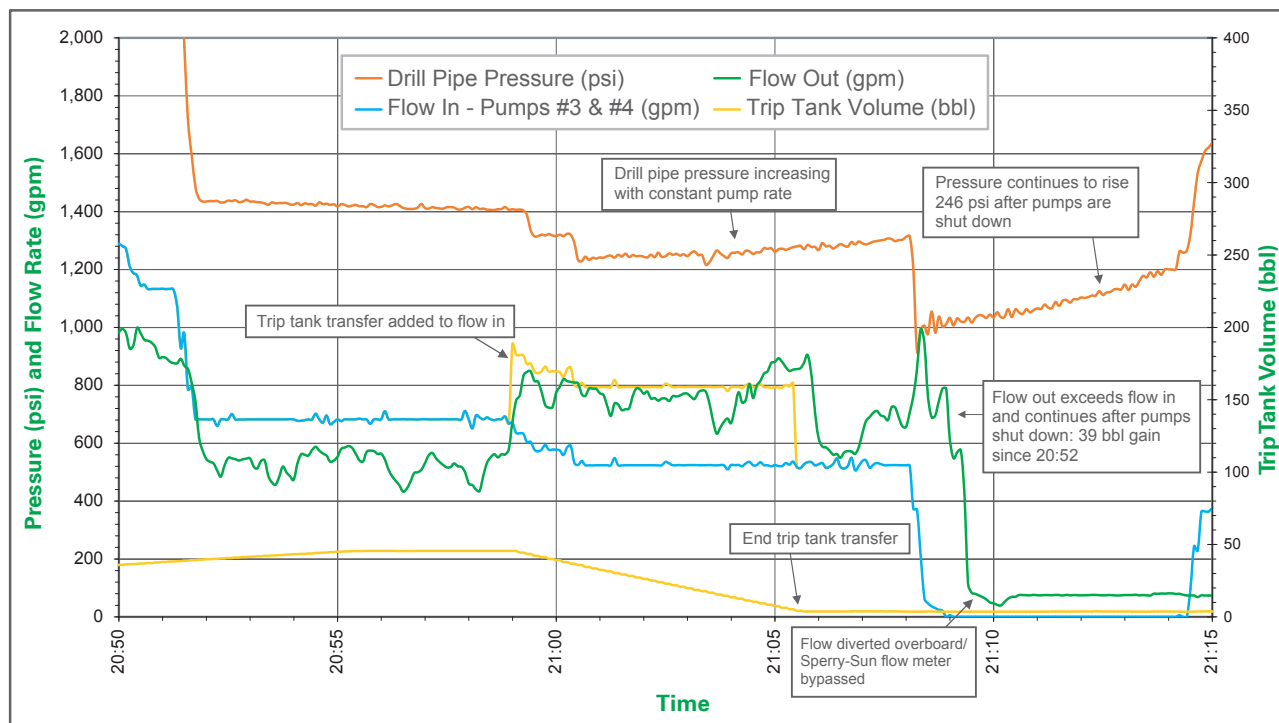
Figure 8. Flow Indication Graph Showing Anomalies (Real-time Data).

The first indication of flow likely would have been at 20:58 hours, but emptying of the trip tank could have masked this flow indication in the real-time data. The pressure abnormality starting at 21:01 hours would have been the first clear indication of flow visible to the rig crew and mudloggers.

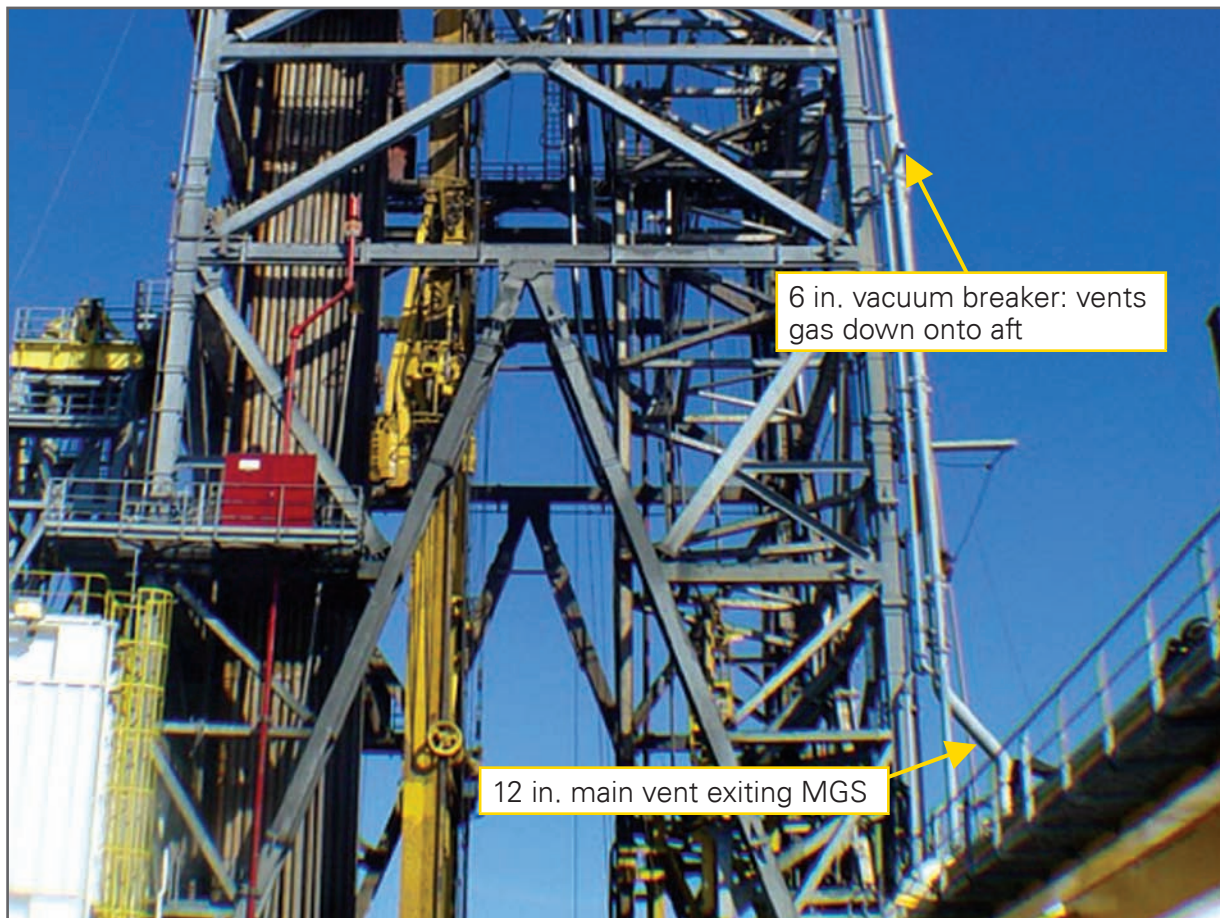
Figure 5. Photograph of 6 in. Vacuum Breaker Line Gooseneck Vent.

6 Diversion to the mud gas separator resulted in gas venting onto the rig. Once diverted to the MGS, hydrocarbons were vented directly onto the rig through the 12 in. goosenecked vent exiting the MGS, and other flow-lines also directed gas onto the rig. This increased the potential for the gas to reach an ignition source. *The design of the MGS system allowed diversion of the riser contents to the MGS vessel although the well was in a high flow condition. This overwhelmed the MGS system.*
