## Submission 40 - Welding Technology Institute of Australia

## **SUPPLEMENTARY SUBMISSION TO THE SENATE INQUIRY INTO: THE FUTURE OF AUSTRALIA'S STEEL INDUSTRY**

### **POLICY PROPOSAL: SAFETY OF FABRICATED STRUCTURAL STEEL**

### Bussellton Pedestrian Bridges Visual Examination and Commentary Regarding Weld Quality >

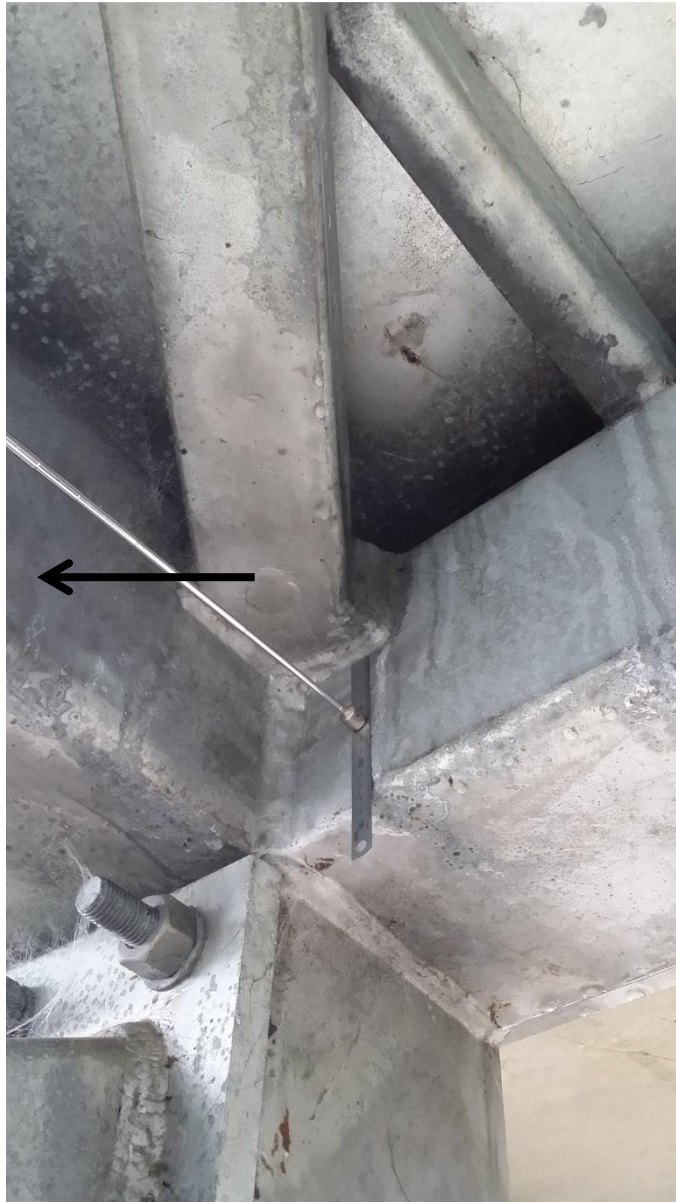
- **Weld Imperfections Evident**
  - Weld is excessive in size and a round bar approximately 16mm in diameter appears to have been used as filler within the weld.
  -

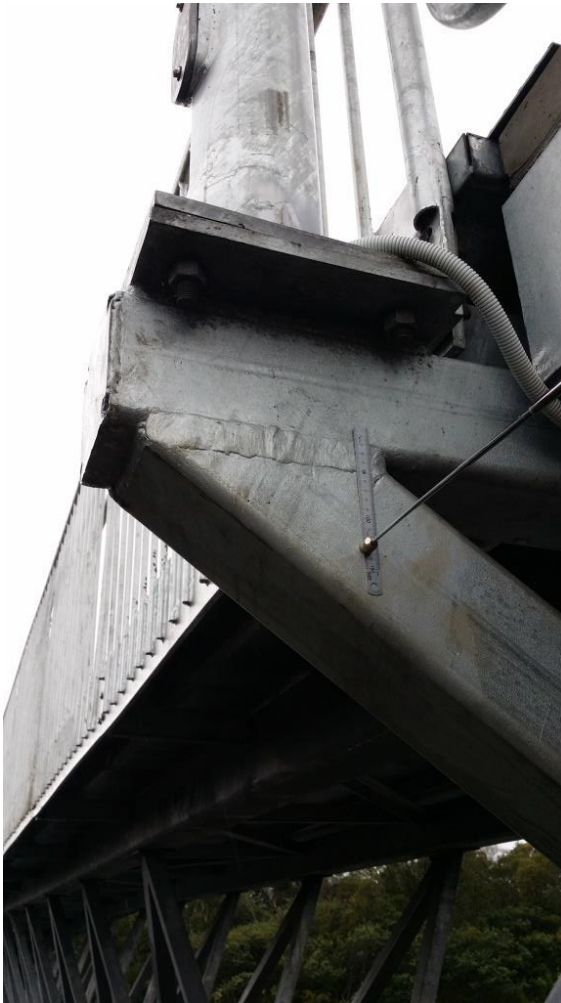
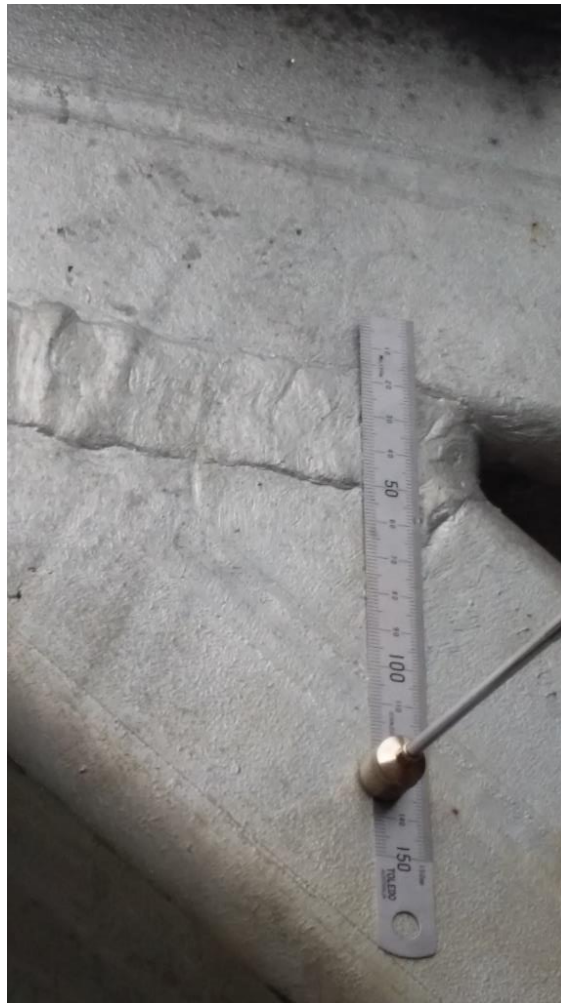
#### **Weld imperfections evident**

- Weld size is excessive – cap is over 30mm wide indicating that fit up may not have been in accordance with the standard.

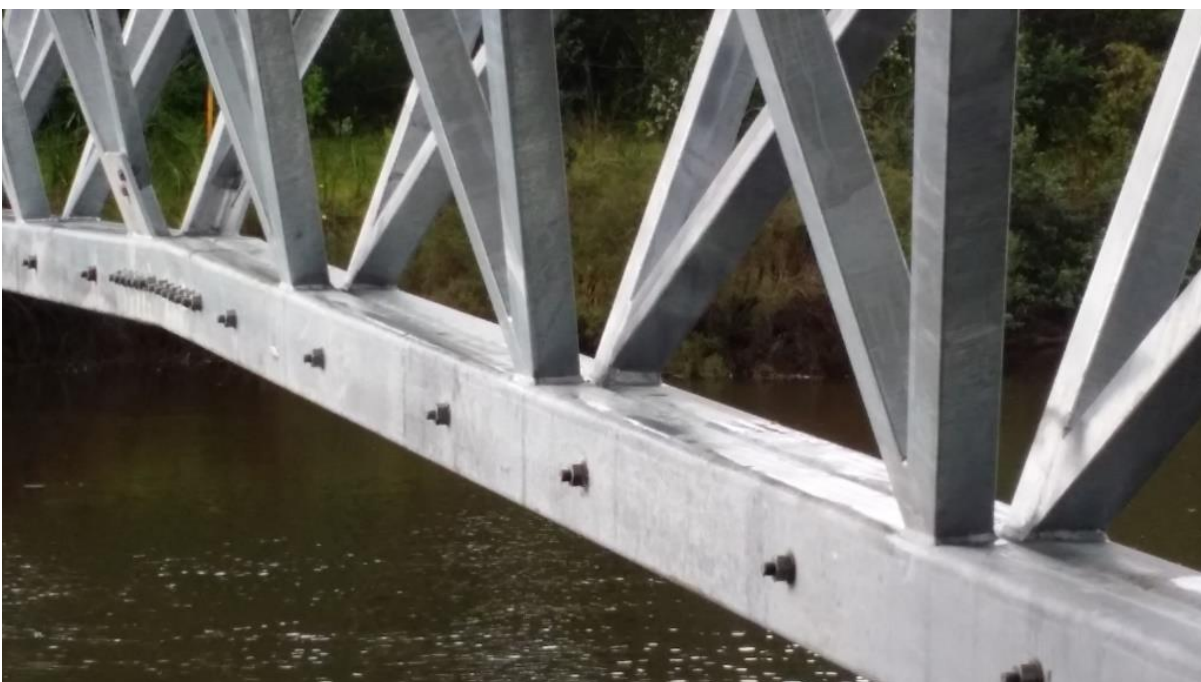
Welds joining similar joints varied substantially in size and quality. Overroll, Undercut, Incorrect bead shape, Excessive size and porosity were evident.

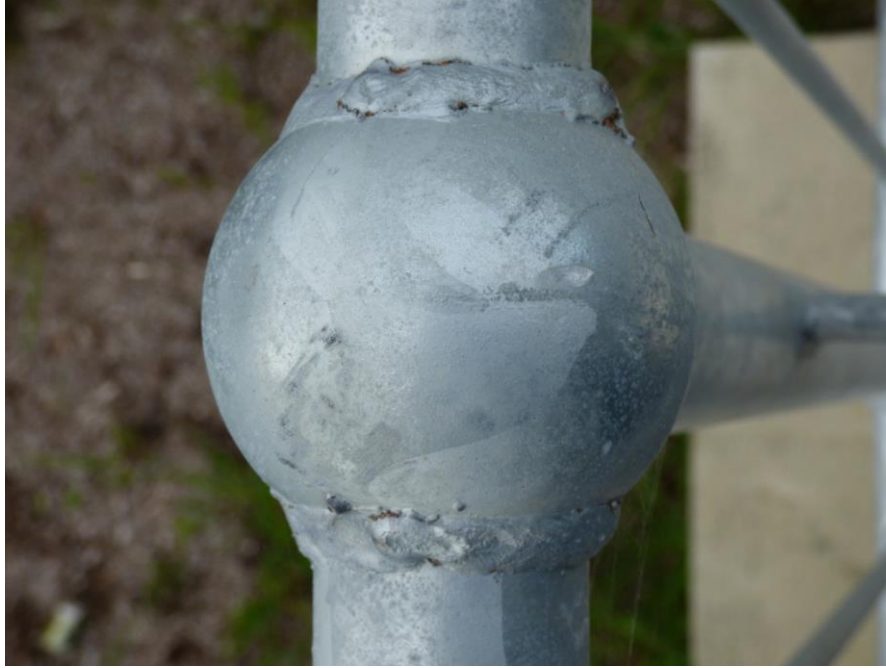
P1010070

**Weld imperfections evident**

- Lack of fusion
- Overroll
- Porosity
- Incorrect bead shape

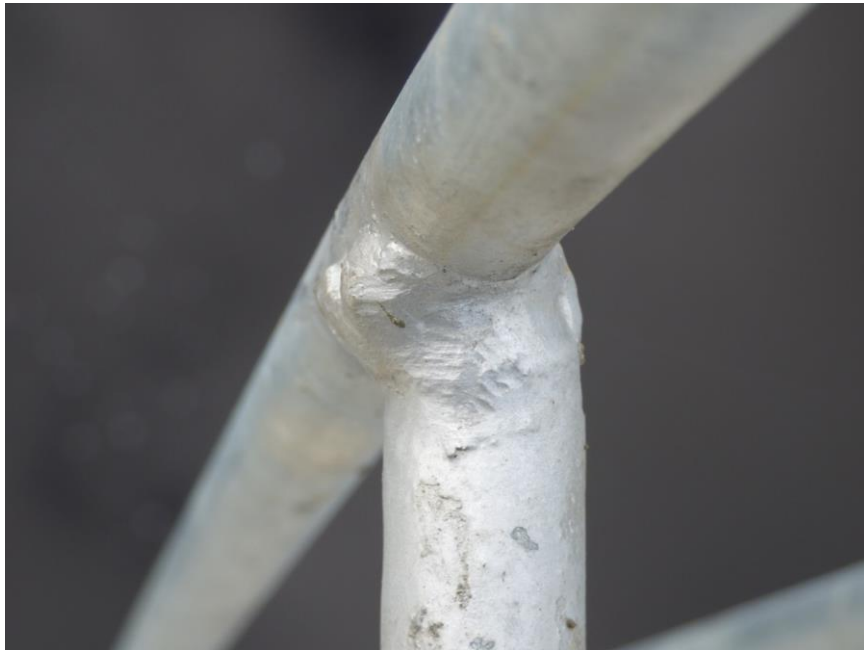
P1010070

**Weld imperfections evident**

- Misalignment
- Incorrect bead shape

The weld has been excessively ground and the extent of the welded zone is not clear. The weld shape is consistent with a joint that had very poor fit up.

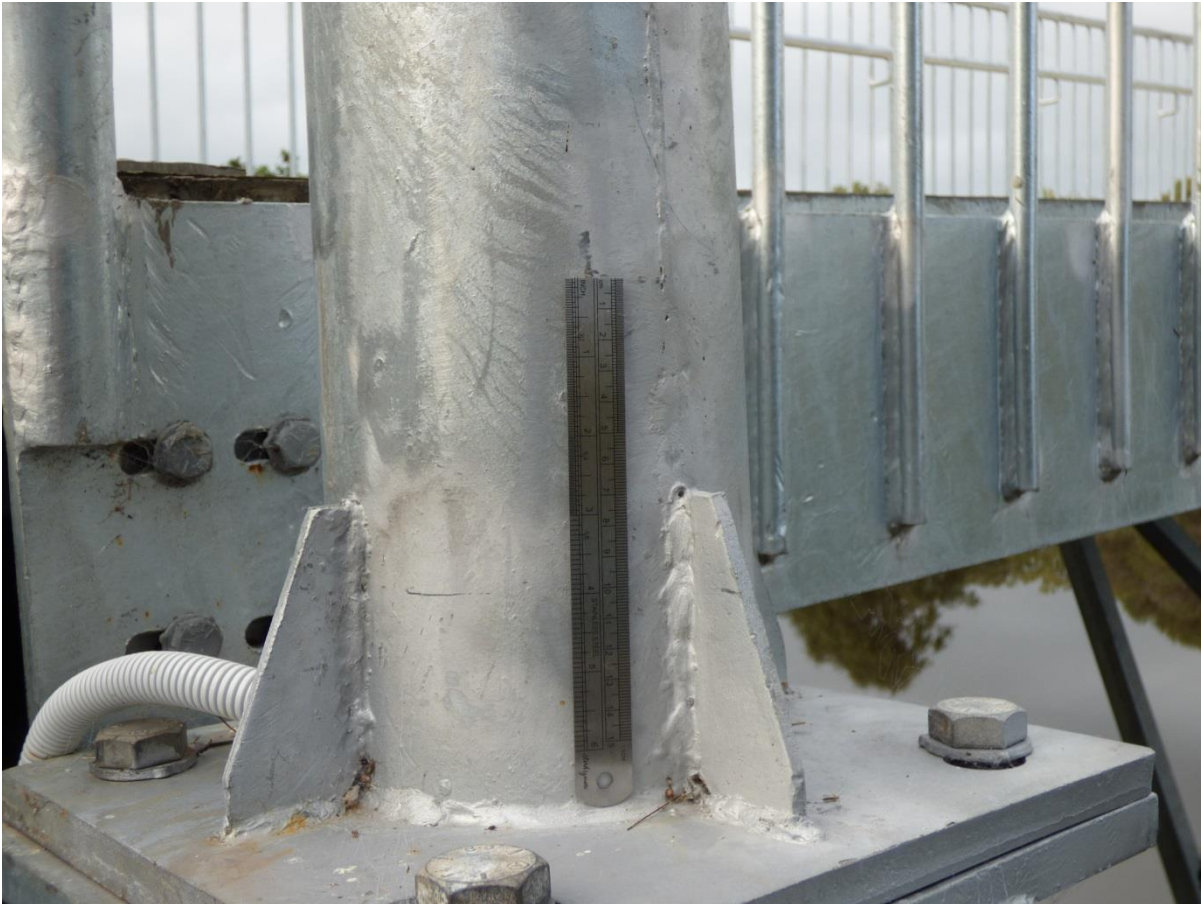
P1010117

**Weld imperfections evident**

- Porosity
- Incorrect bead shape
- Plate edges on the gusset plates have been poorly profiled and have a poor surface finish

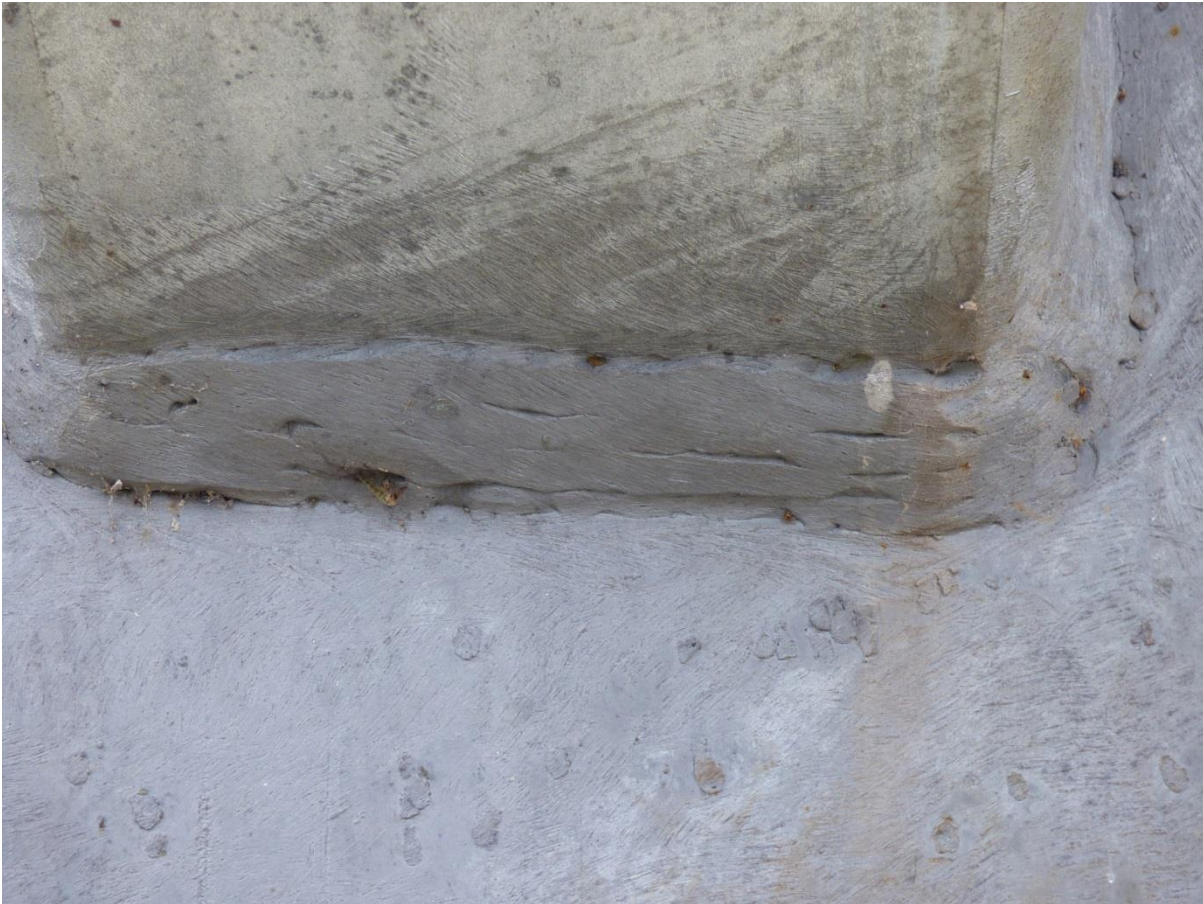
P1010119

**Weld imperfections evident**

- Lack of fusion
- Overroll
- Undercut
- Excessive spatter not removed before galvanizing

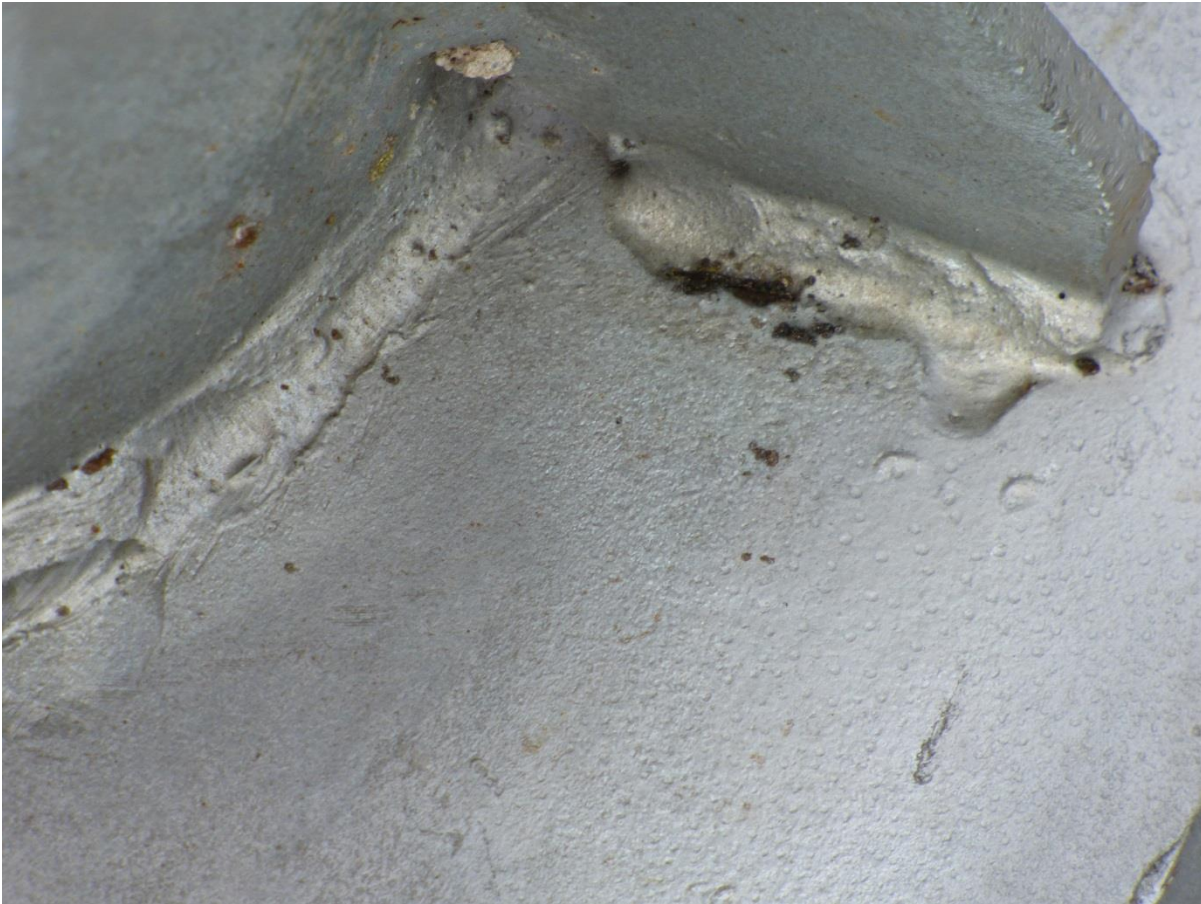
P1010020

- **Weld imperfections evident**
  - Incomplete welding at the gusset corner and around the end of the gusset
  - Overroll
  - Porosity
  - Incorrect bead shape

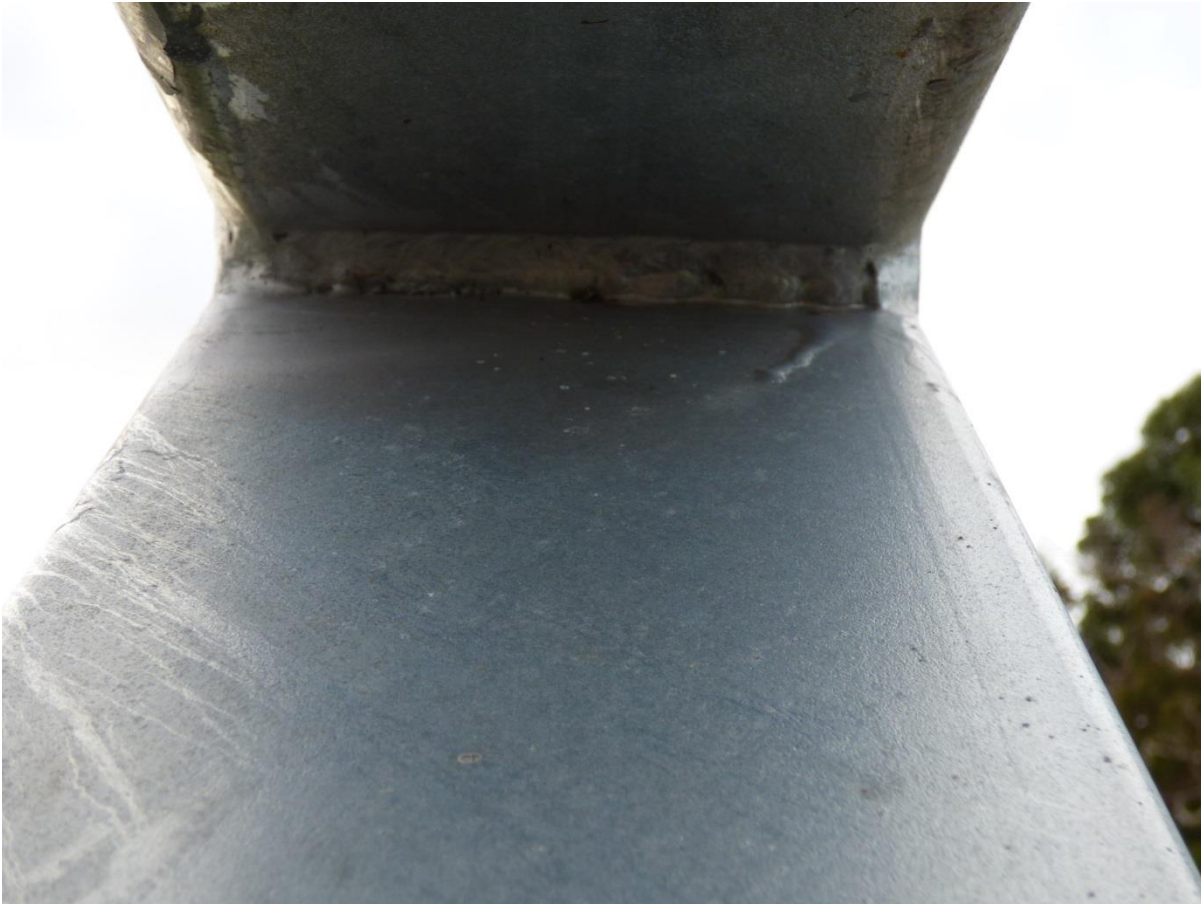
P1010051

- **Weld imperfections evident**
  - Overroll

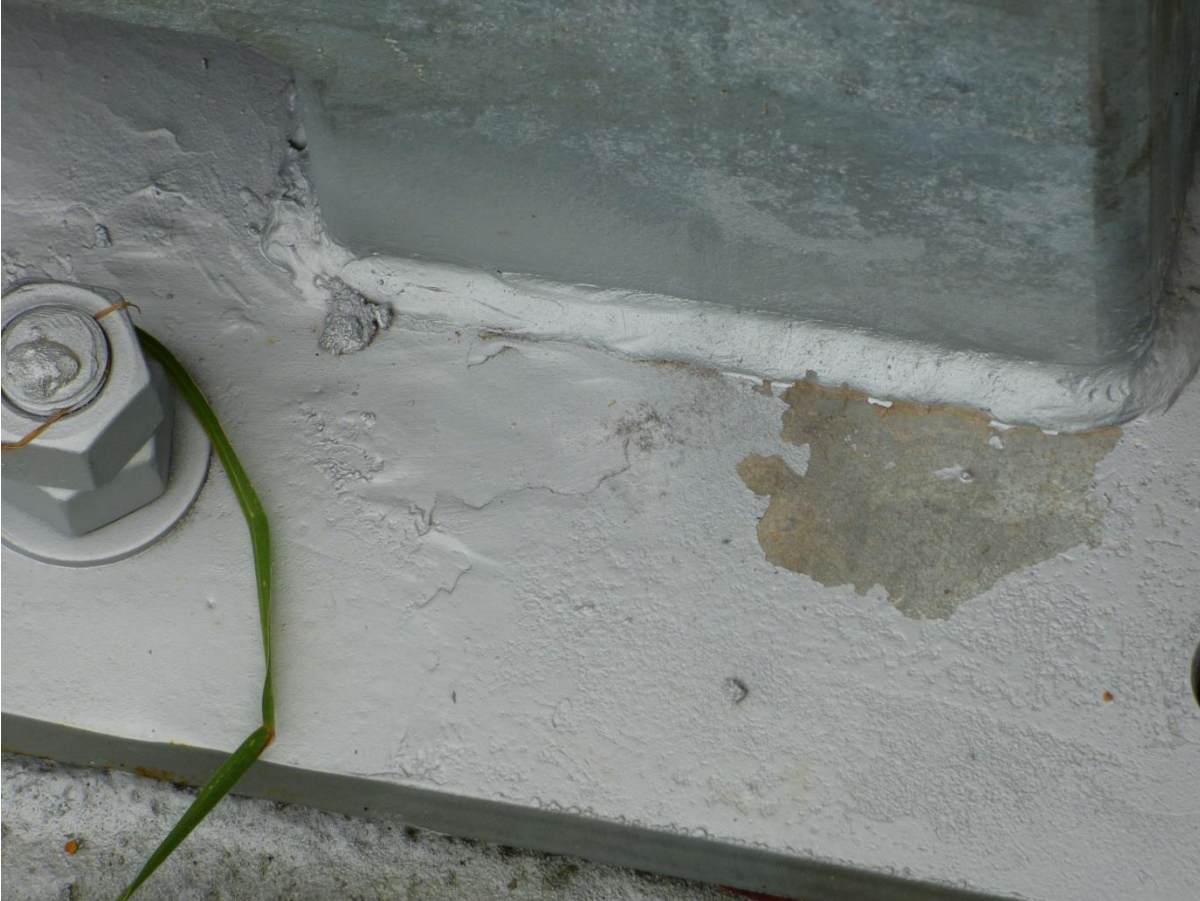
P1010059

- **Weld imperfections evident**
  - Overroll
  - Porosity and wormholes

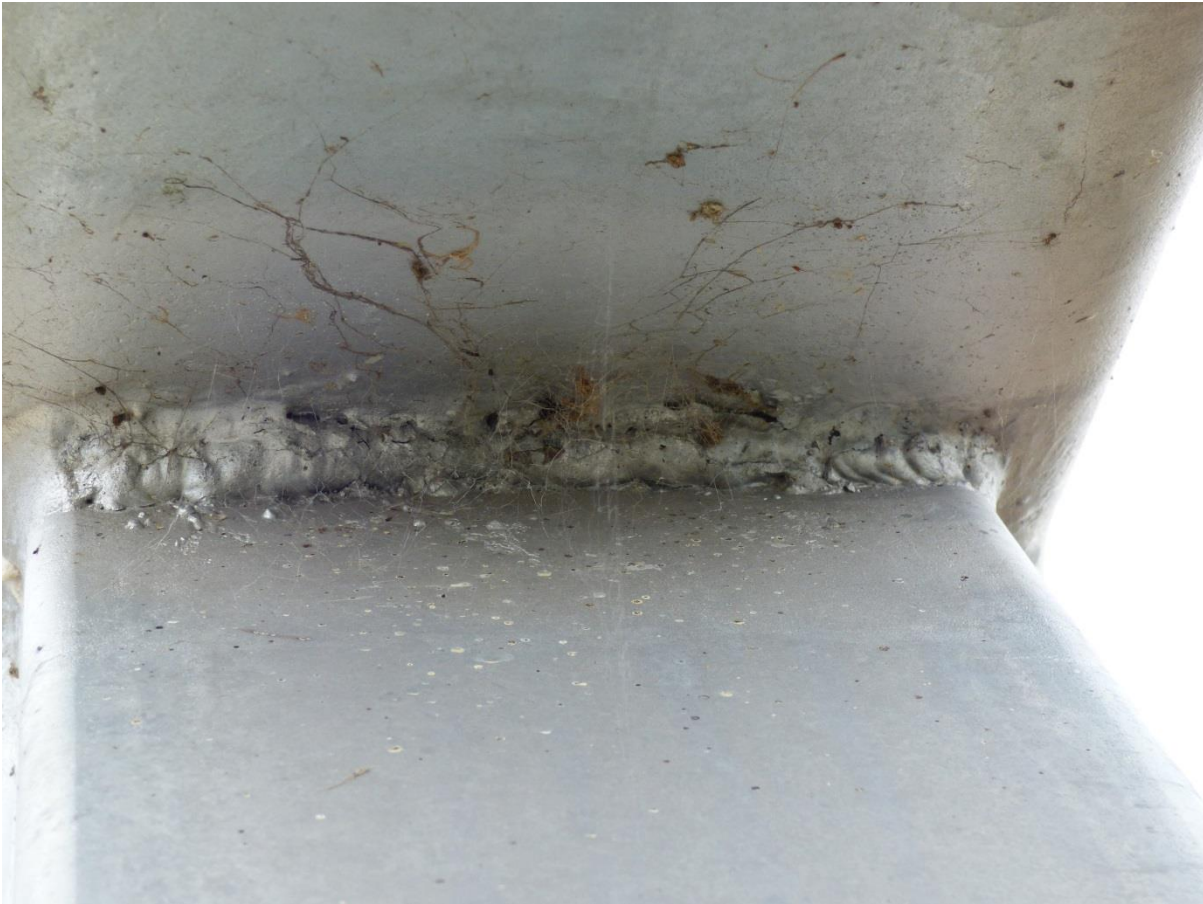
P1010163

- **Weld imperfections evident**
  - Lack of fusion
  - Overroll
  - Porosity
  - Incorrect bead shape

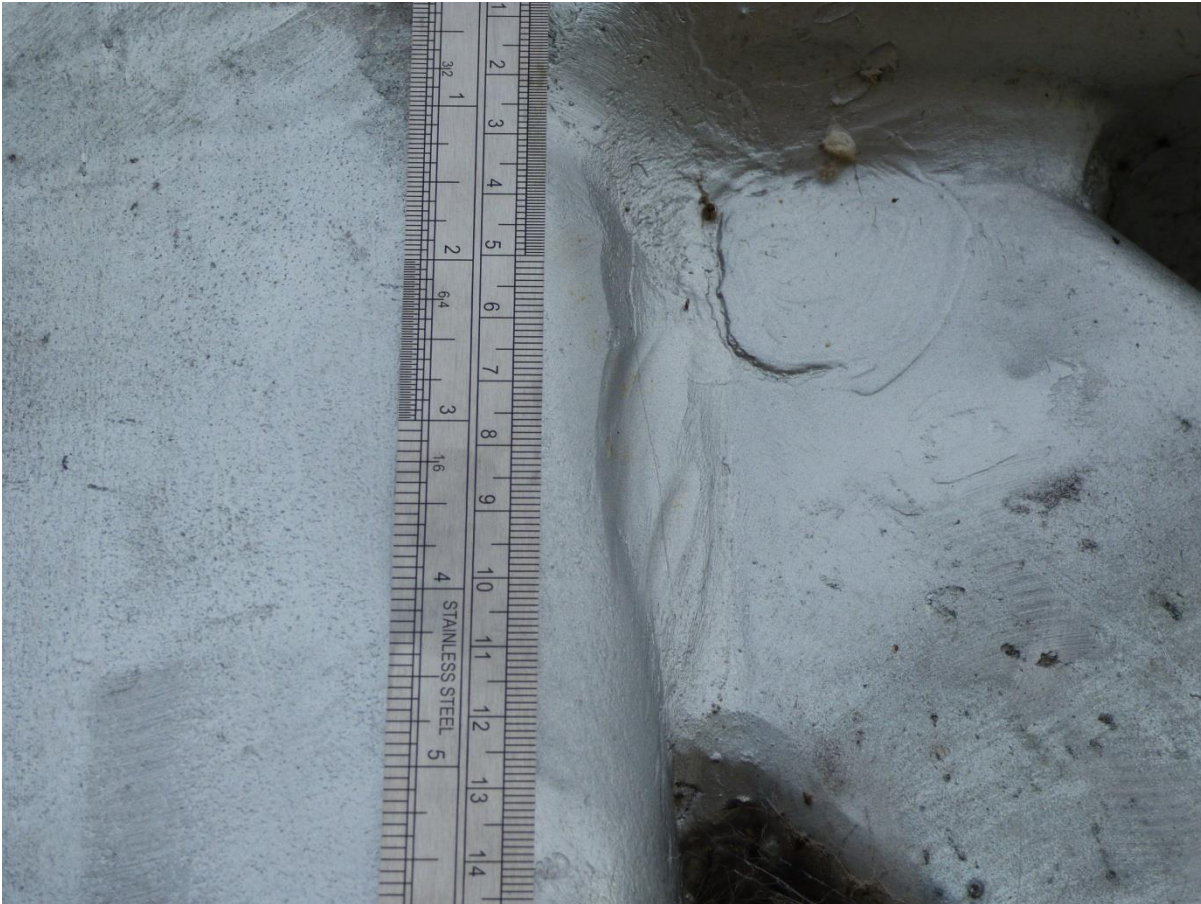
P1010166

- **Weld imperfections evident**
  - Excessive grinding
  - Incorrect bead shape

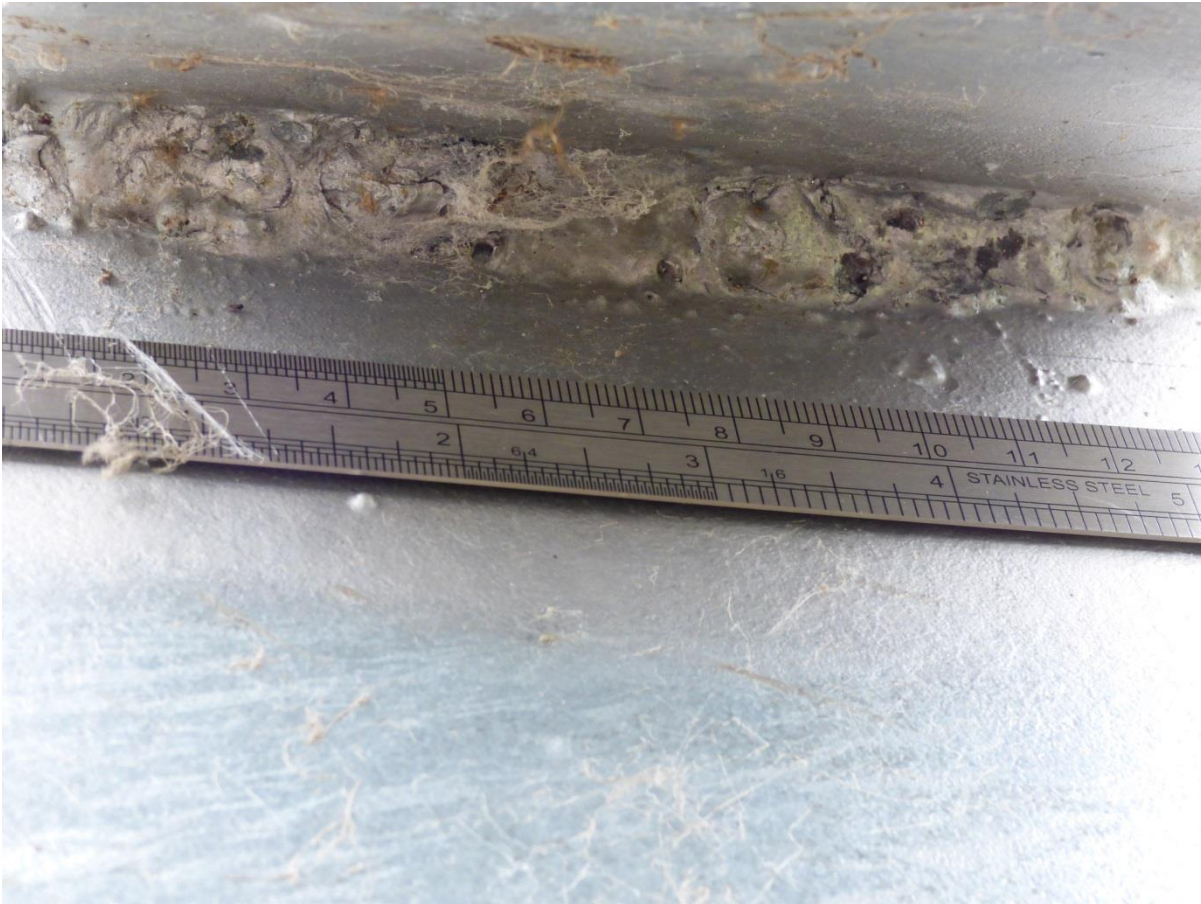
P1010167

- **Weld imperfections evident**
  - Slag inclusions
  - Lack of fusion
  - Overroll
  - Porosity
  - Slag not removed
  - Incorrect bead shape

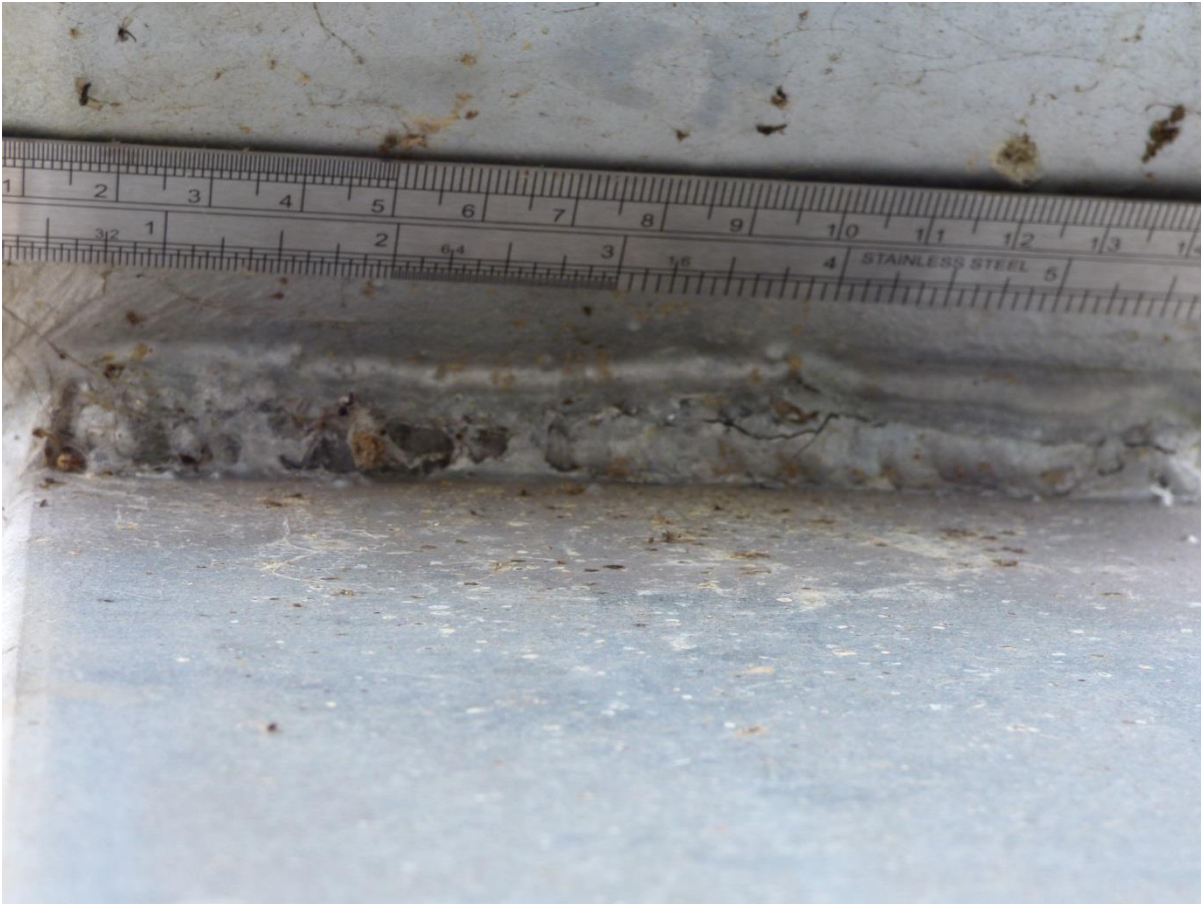
P1010168

- **Weld imperfections evident**
  - Slag inclusions
  - Lack of fusion
  - Overroll
  - Porosity
  - Slag not removed
  - Incorrect bead shape

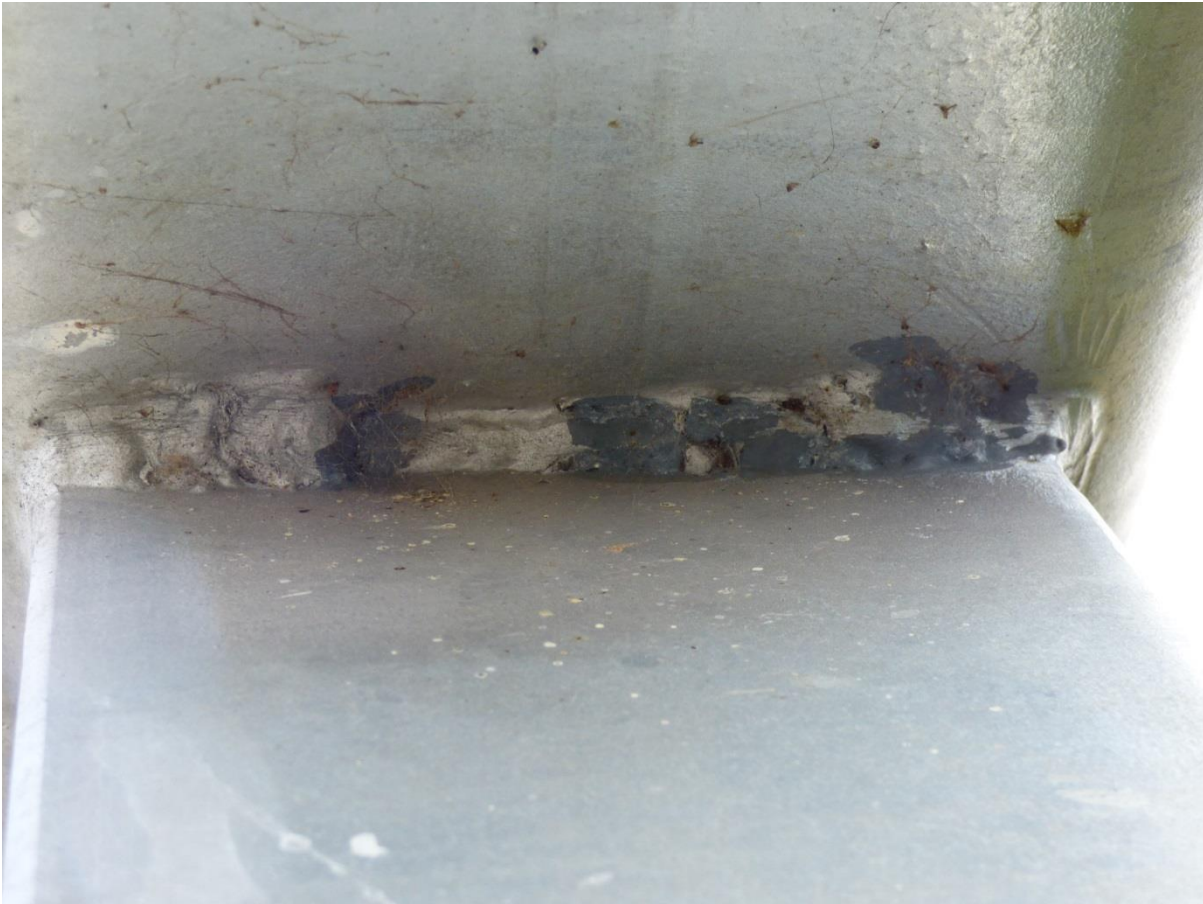
P1010172

- **Weld imperfections evident**
  - Slag inclusions
  - Lack of fusion
  - Overroll
  - Slag not removed
  - Porosity
  - Incorrect bead shape

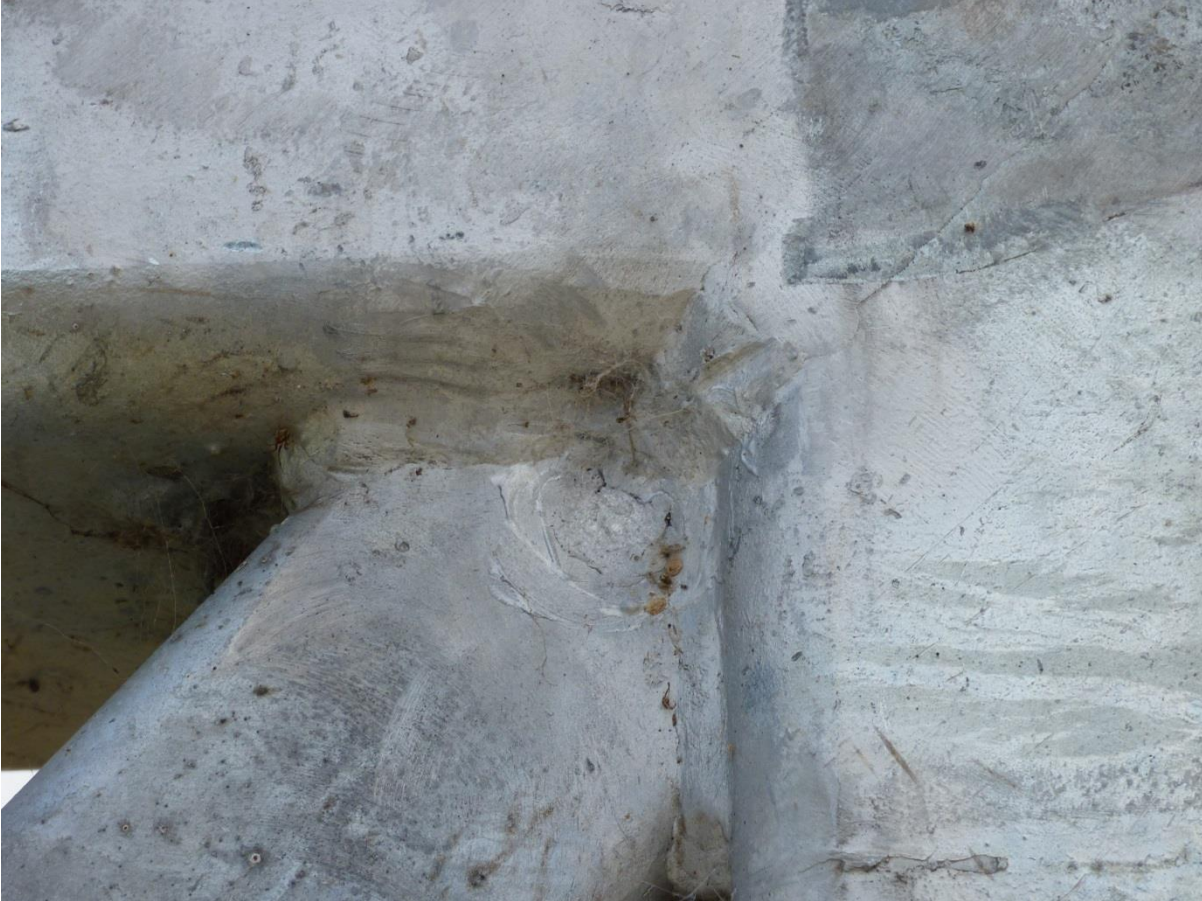
P1010175

- **Weld imperfections evident**
  - Lack of fusion
  - Overroll
  - Porosity
  - Incorrect bead shape

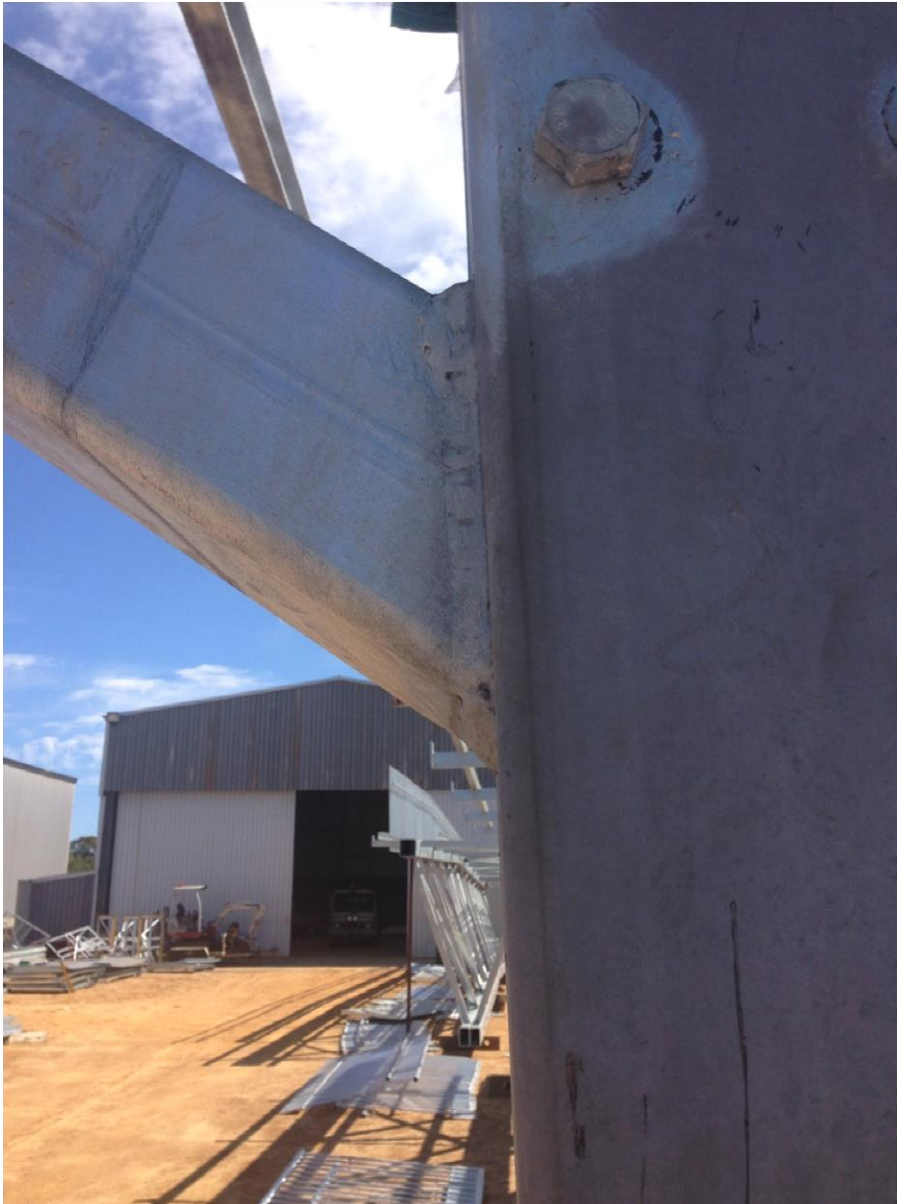
IMG\_005

- **Weld imperfections evident**
  - Slag inclusion
  - Porosity

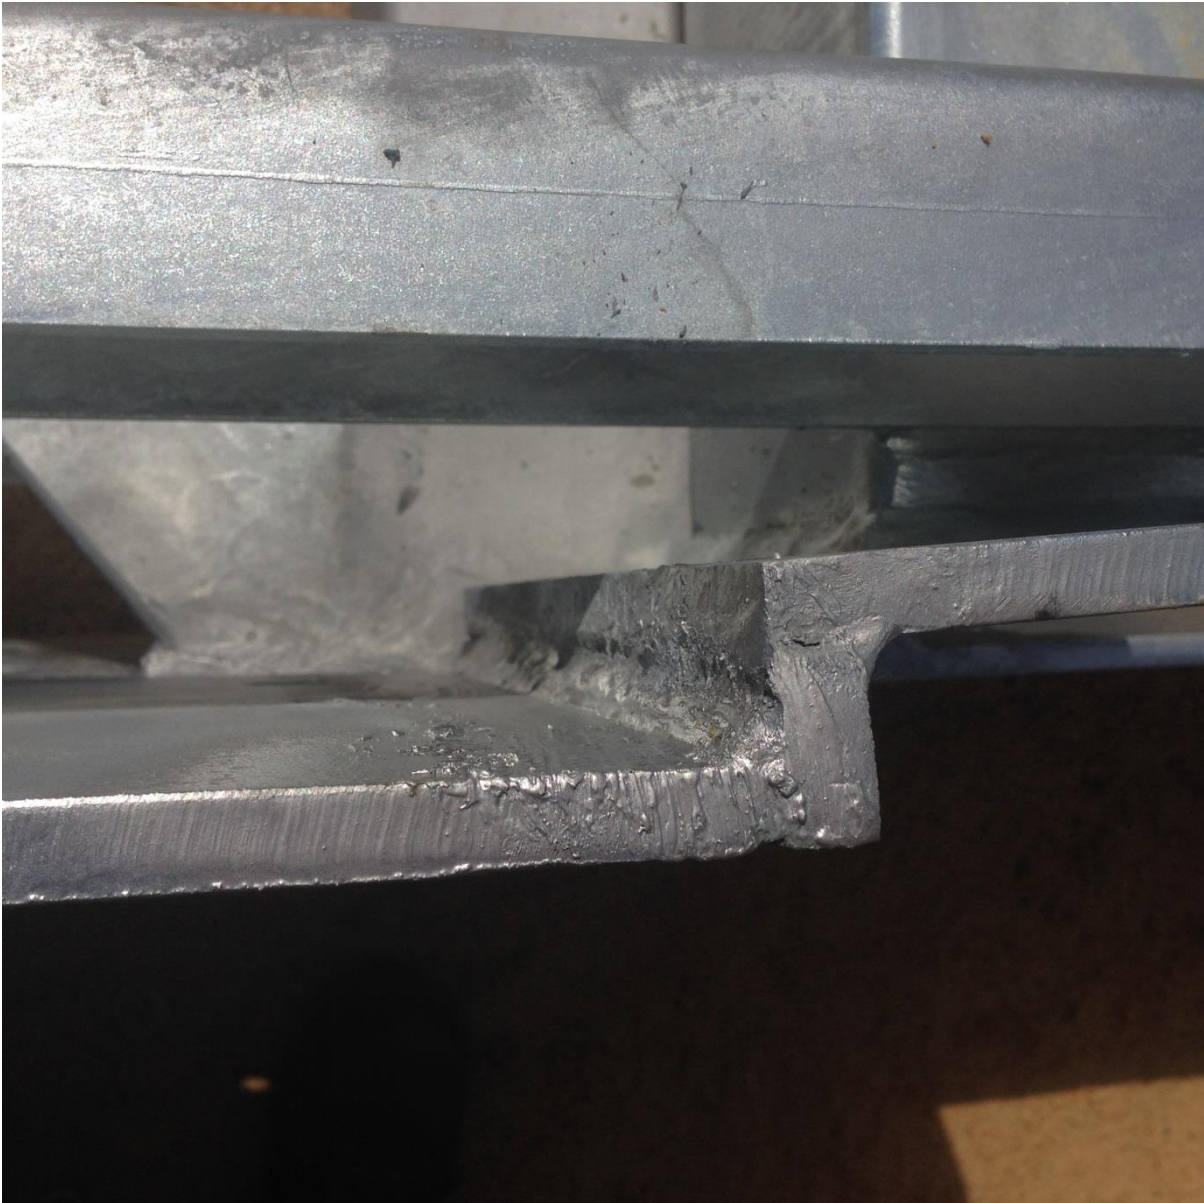
IMG\_0029

- **Weld imperfections evident**
  - Incorrect bead shape
  - Poorly finished flame cut edge

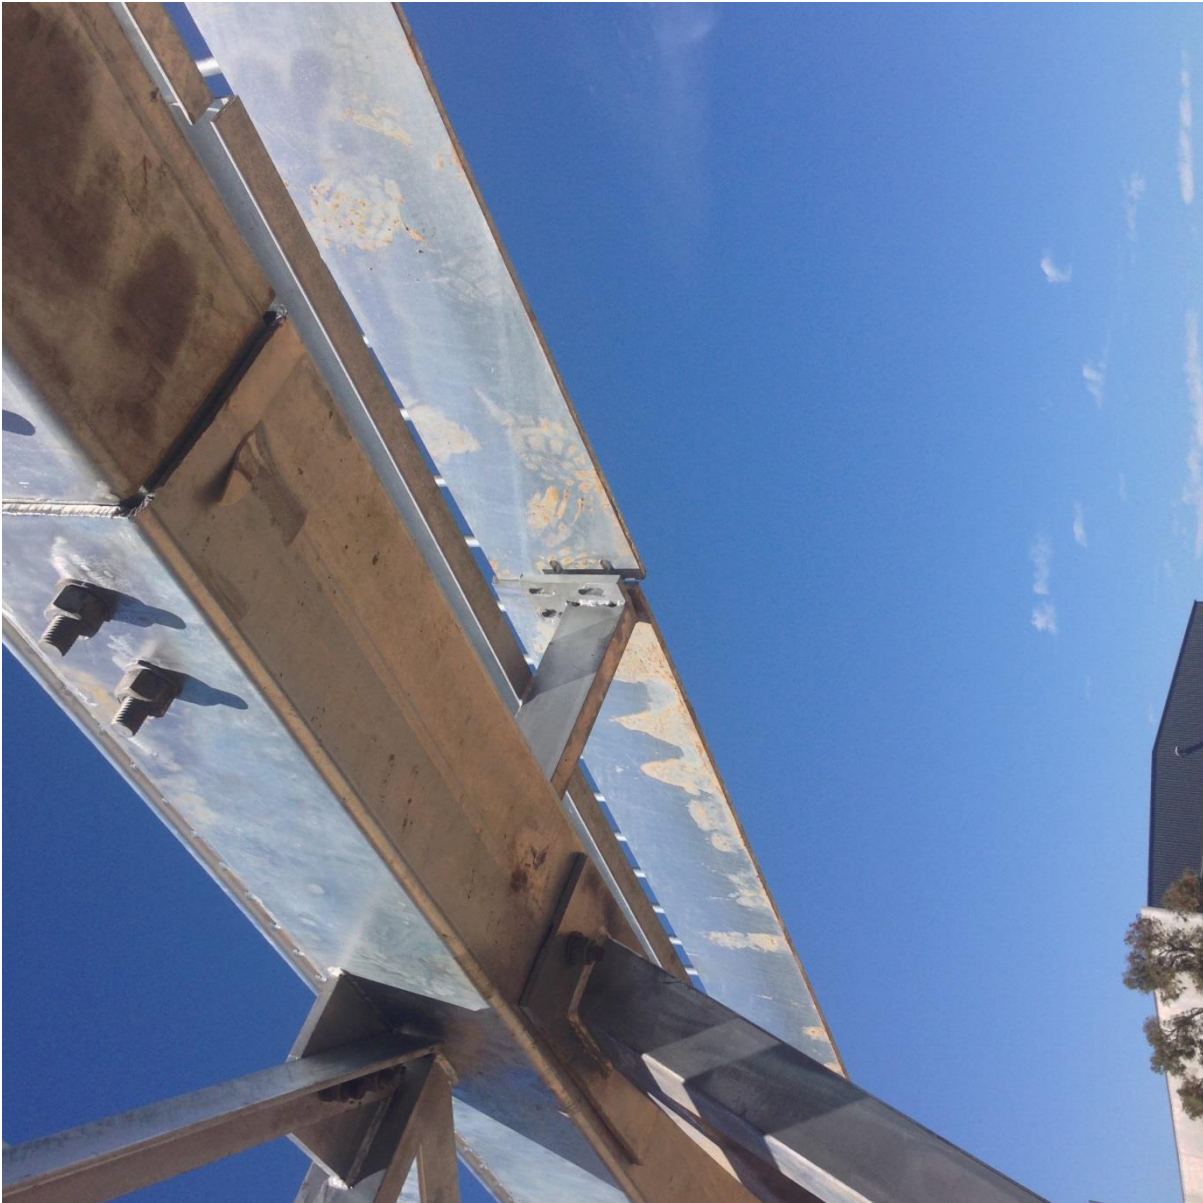
IMG\_0060

- **Weld imperfections evident**
  - Incorrect bead shape
  - Vent holes located incorrectly intersecting weld zone
  - 4<sup>th</sup> bolt hole?

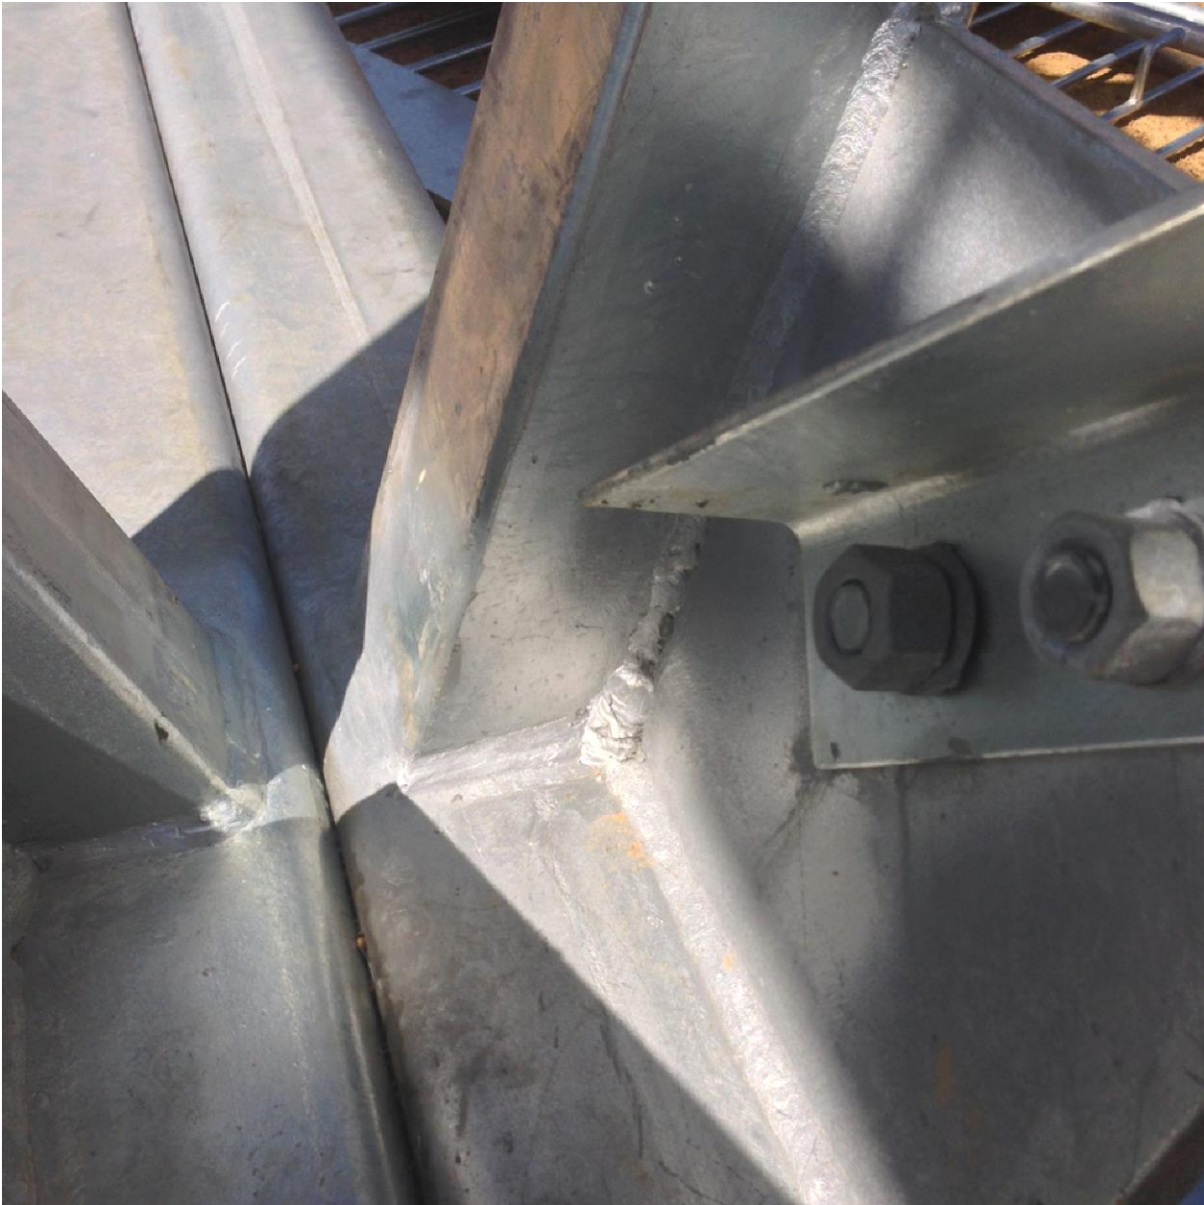
IMG\_0064

- **Weld imperfections evident**
  - Lack of fusion
  - Overroll
  - Porosity
  - Incorrect bead shape
