## Submission 40 - Welding Technology Institute of Australia

## **SUPPLEMENTARY SUBMISSION TO THE SENATE INQUIRY INTO: THE FUTURE OF AUSTRALIA'S STEEL INDUSTRY**

### **POLICY PROPOSAL: SAFETY OF FABRICATED STRUCTURAL STEEL**

### Bussellton Pedestrian Bridges Visual Examination and Commentary Regarding Weld Quality >

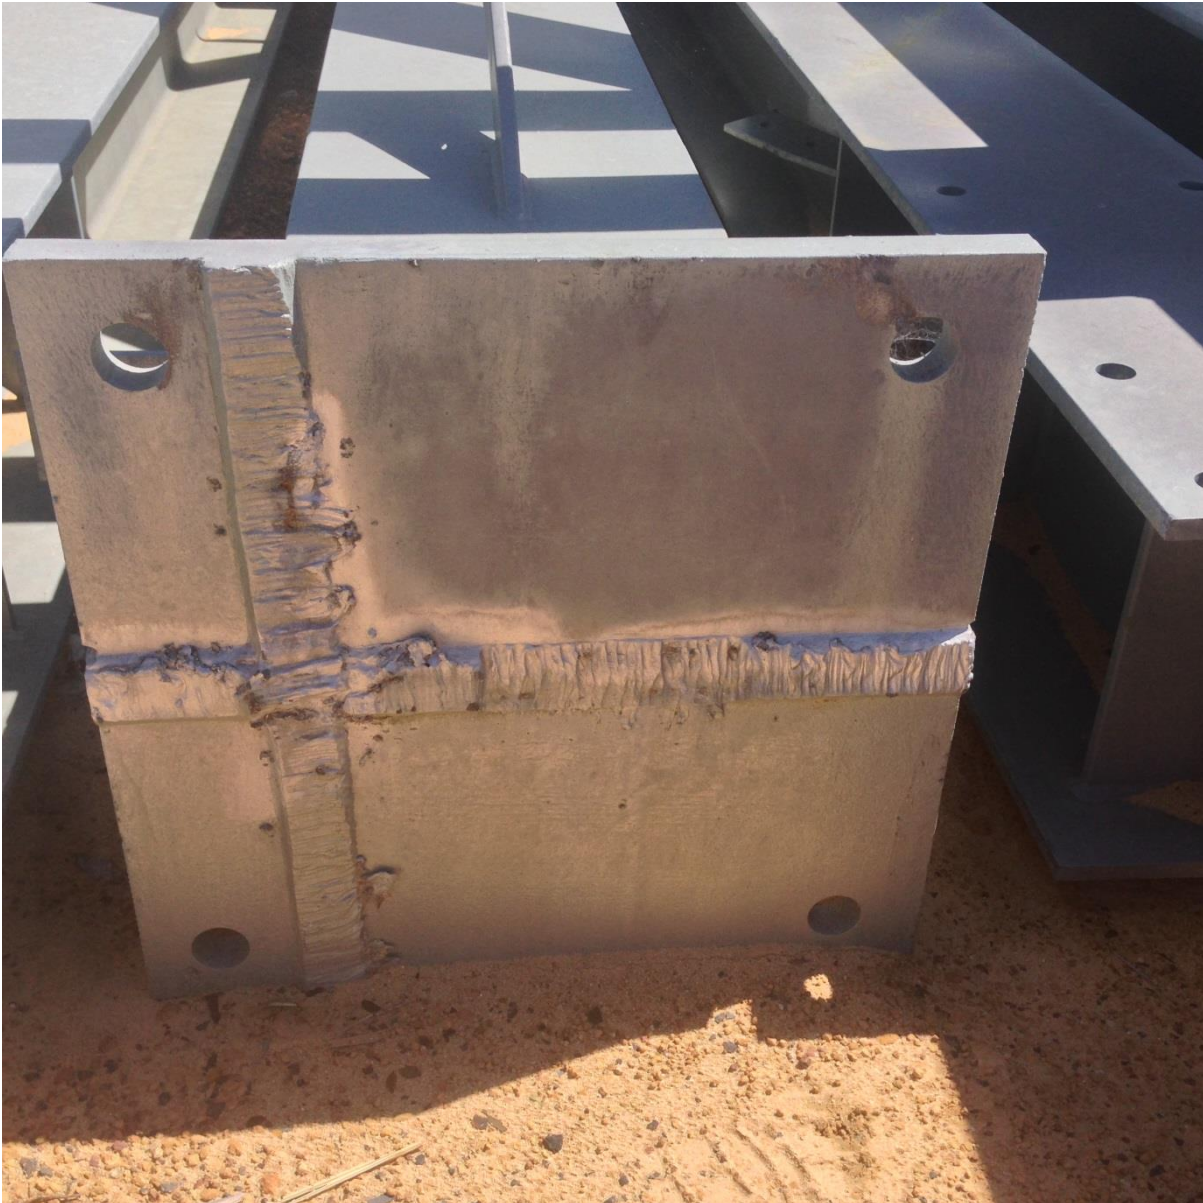
IMG\_0070

- **Weld imperfections evident**
  - Bottom of baseplate has had material removed by oxy-fuel gas cutting
  - The surfaces are as cut and undressed
  - Surfaces are unsuitable for galvanizing

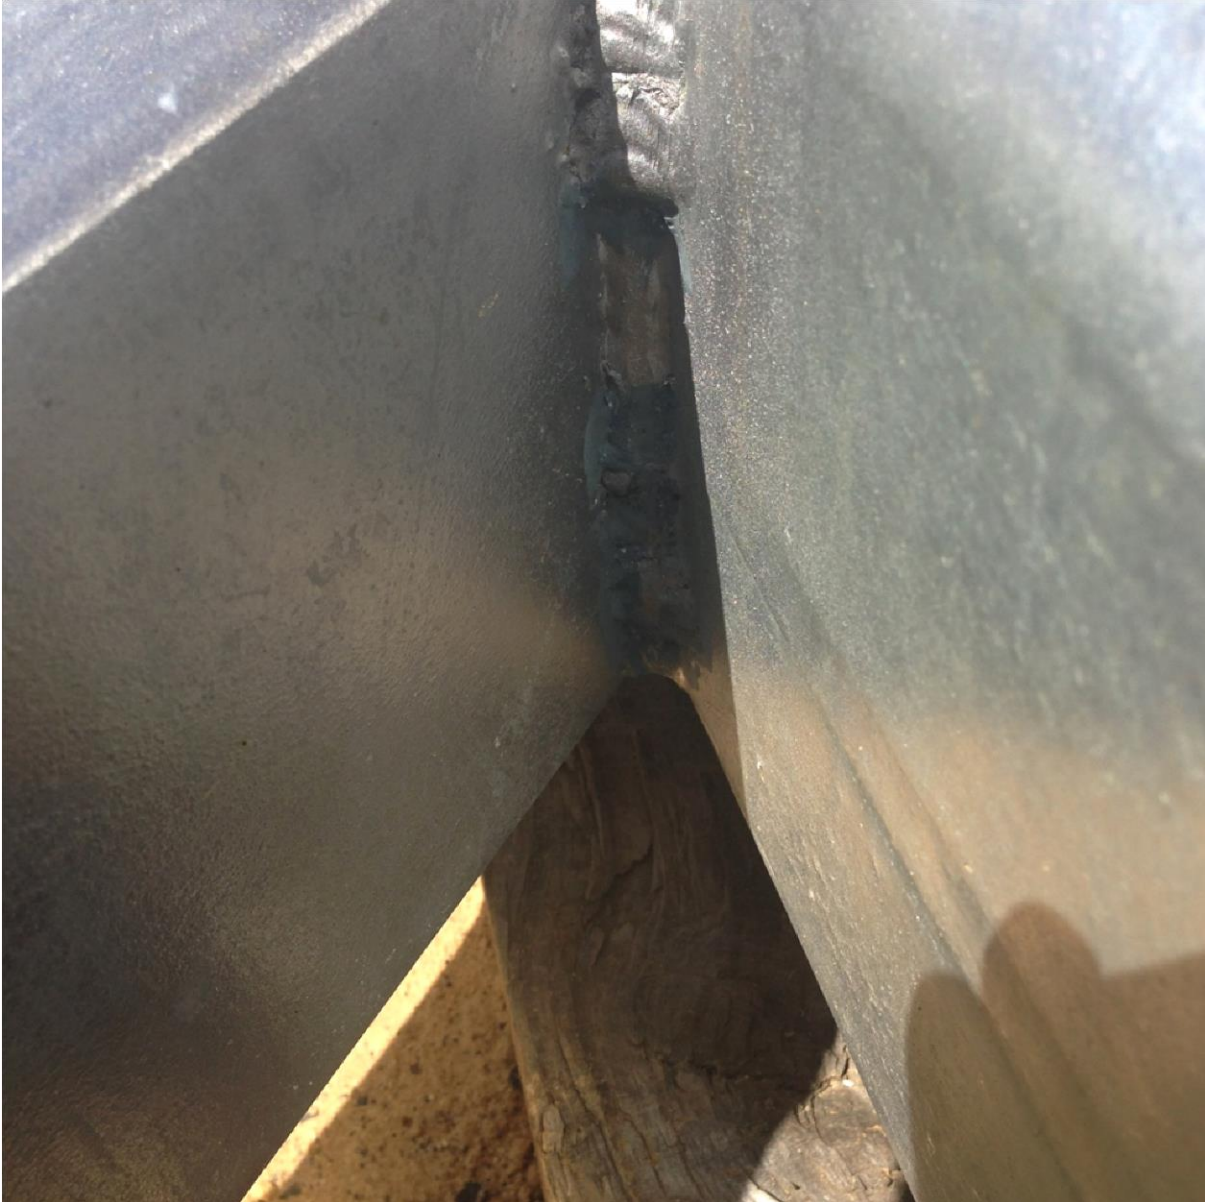
IMG\_0077

- **Weld imperfections evident**
  - Variable fillet sizes

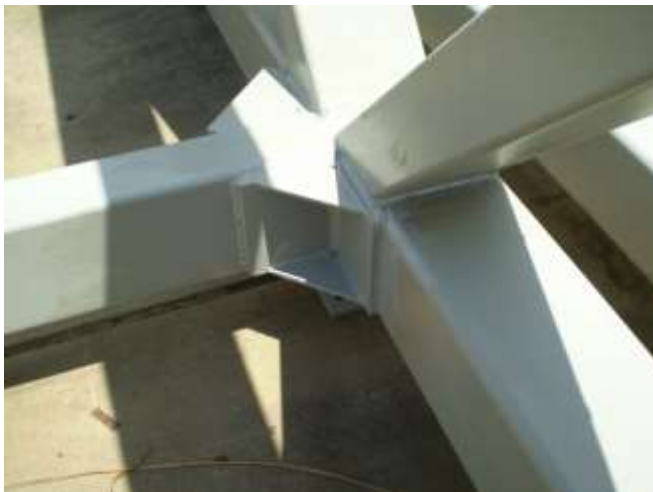
**Photo 1** Showing site rectification of split join of main and cross cords of the truss

This rectification work was deemed insufficient to stabilise the structure and as a result one of the local tenderers was engaged to rebuild the structure.

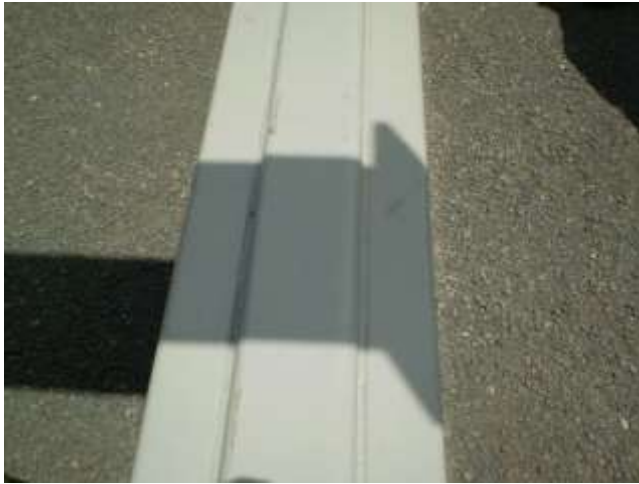
**Photo 2** Showing site rectification of the split cross cord of the truss. Tubing was welded each side of the split section.

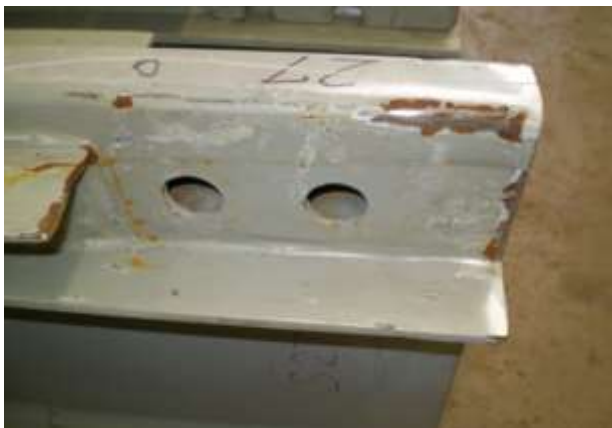
**Photo 3** 30mm holes were drilled to take 20 mm bolts. This is non-compliant

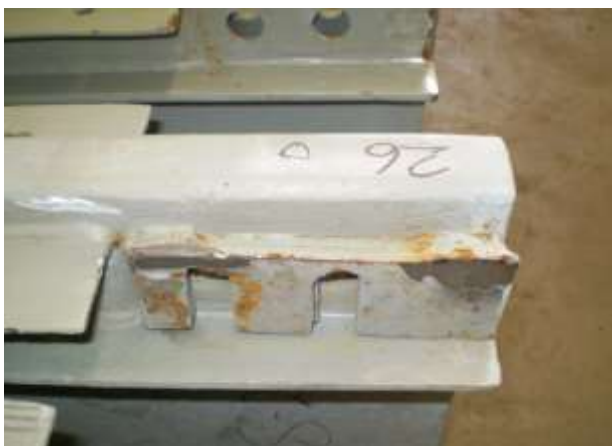
**Photo 4** It is thought that the connecting chords to this beam were cut too short, requiring spacers to be inserted at each join – poor workmanship

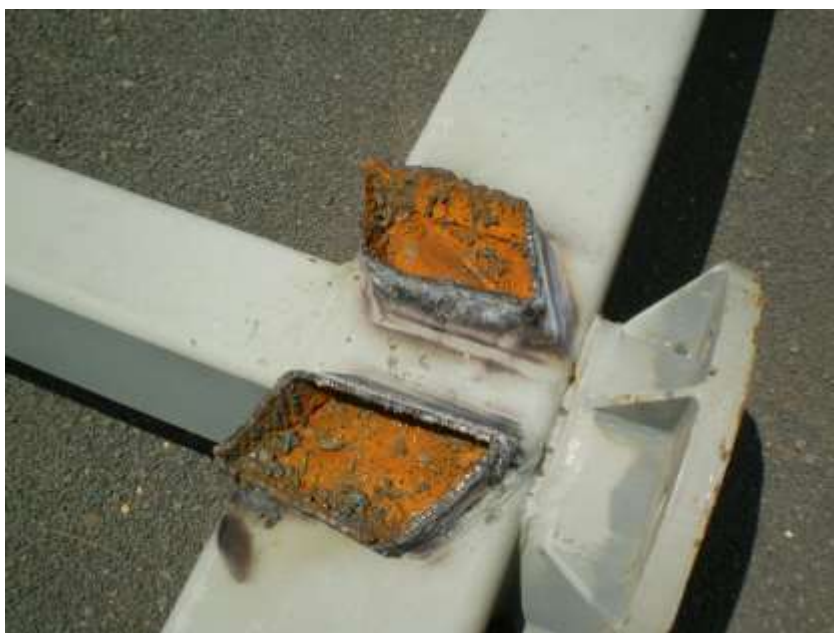
**Photo 5** The diagonal chords when cut were found to be filled with water. This is extremely unusual and is thought possibly to have been deliberate to build up the weight of the structure to have a mass within overall specification.

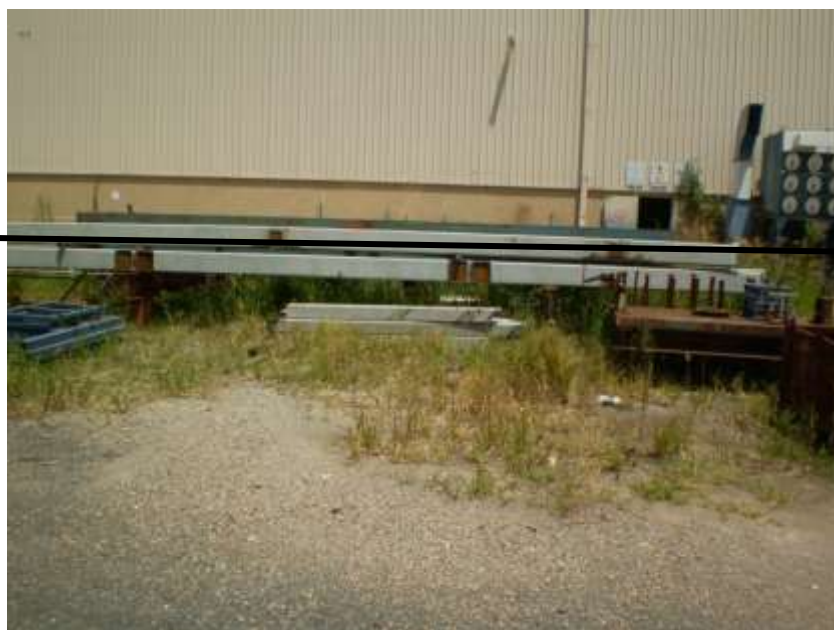
**Photo 6** Bottom chords showing bending

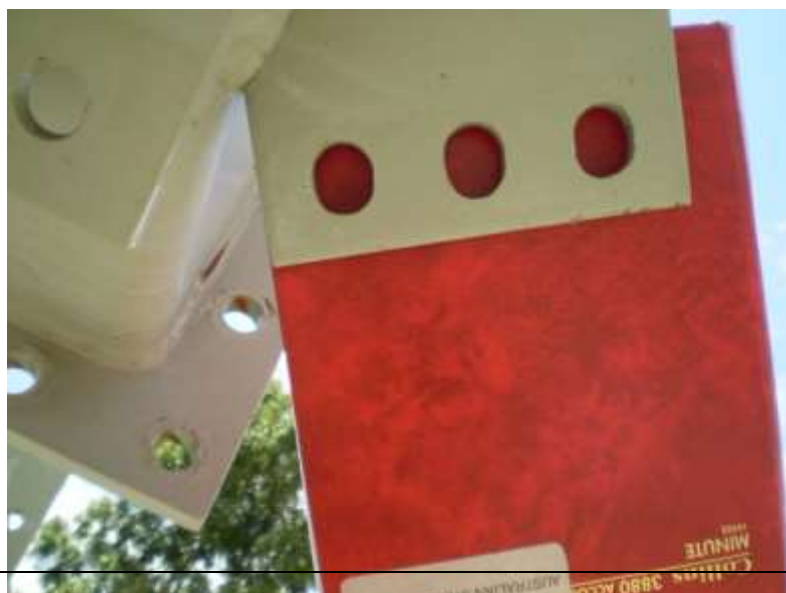
**Photo 7** Elongated holes to allow fit up and create potential for movement and slop.

Holes are approx. 28mm diameter for 20mm bolts

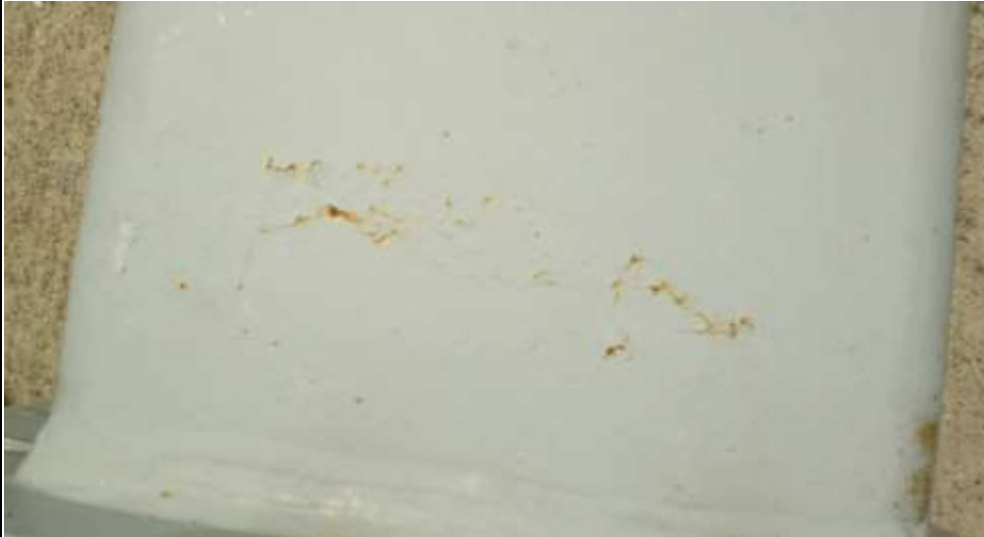
**Photo 8** Poor paint finish against a specification of 75um inorganic zinc silicate, 125um Epoxy and 75um urethane

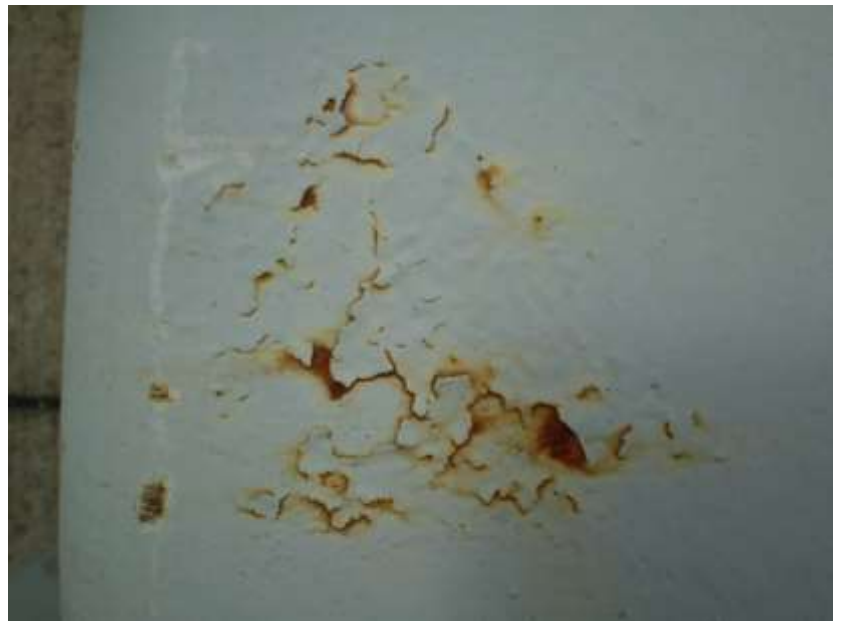
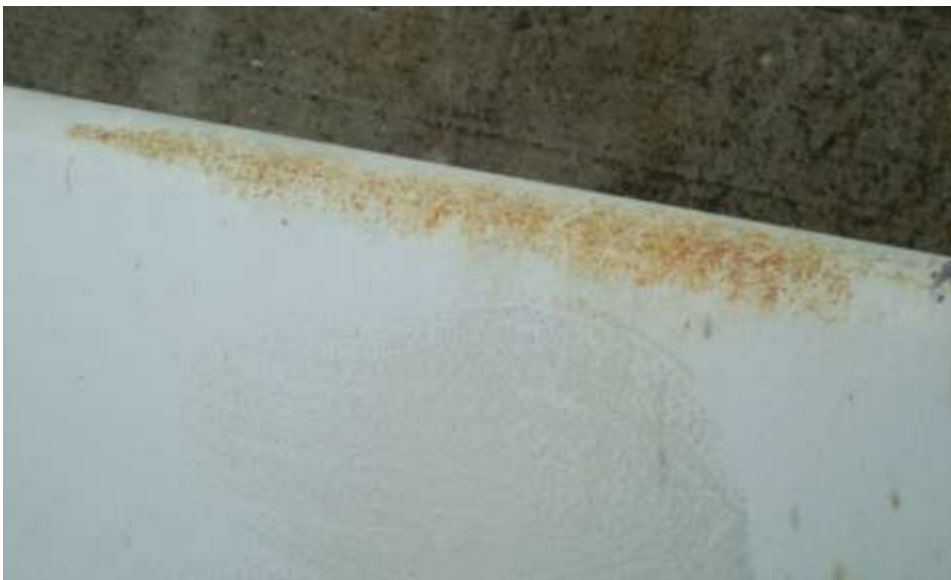
**Photos 9 and 10** Poor paint finish

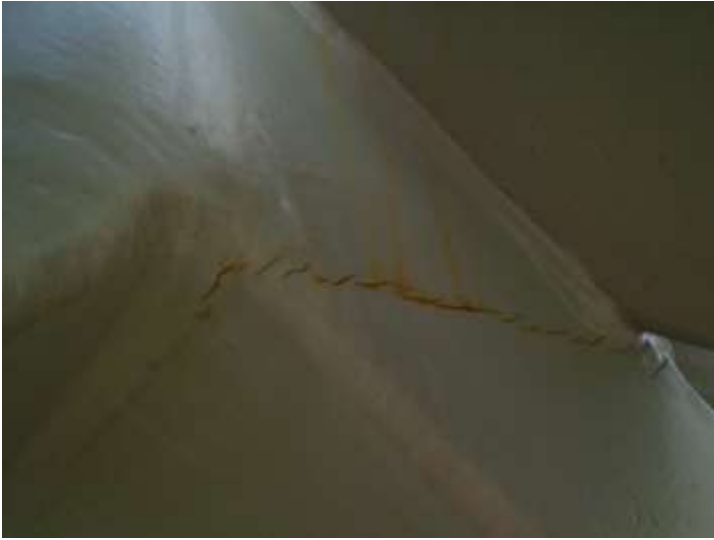
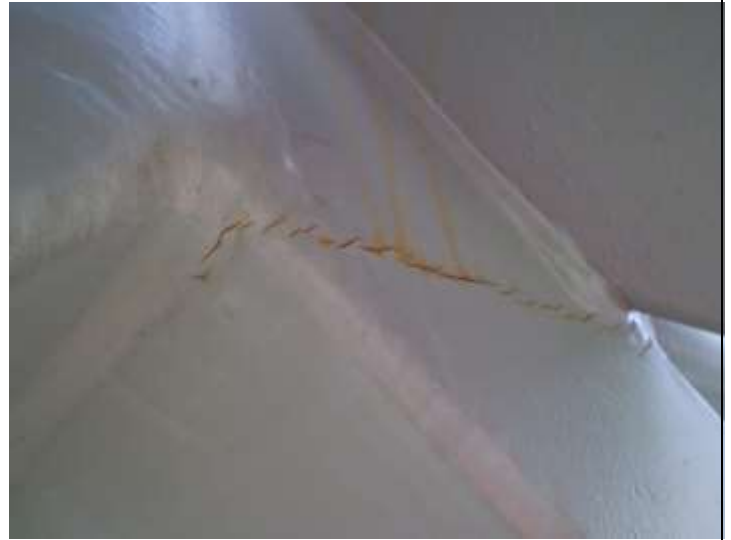
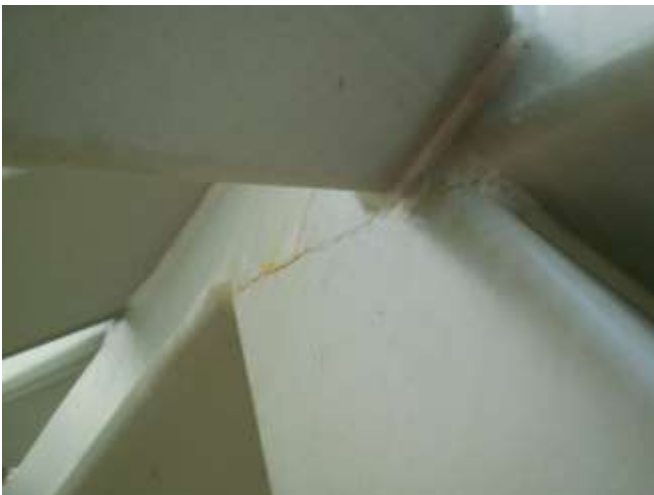
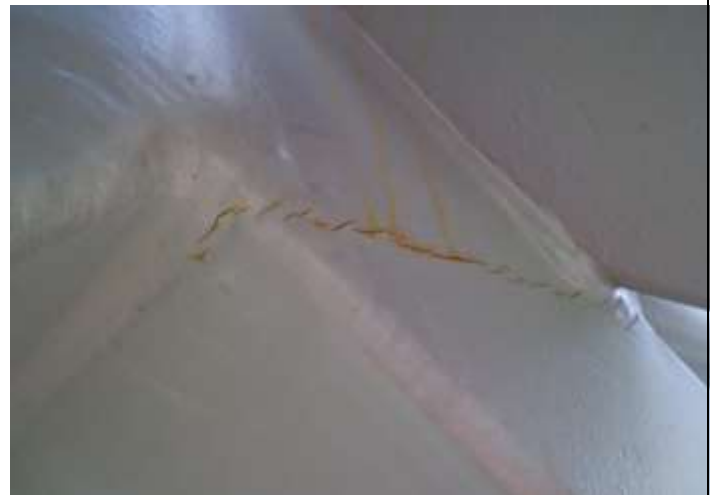
**Photos 11- 14** Cracking across the section

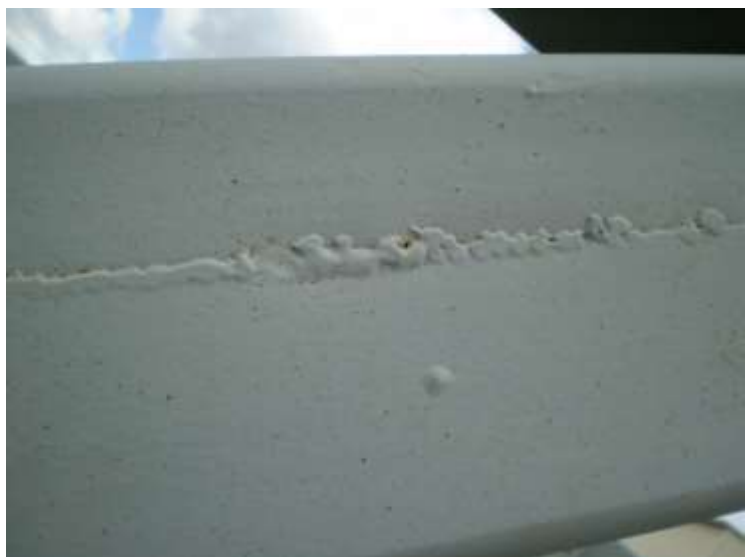
**Photo 15** Very poor seam welding or  
rectification of an unwelded section

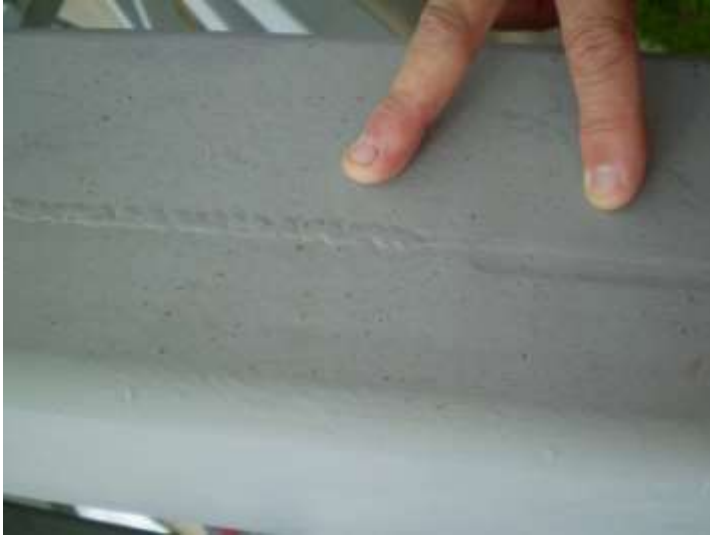
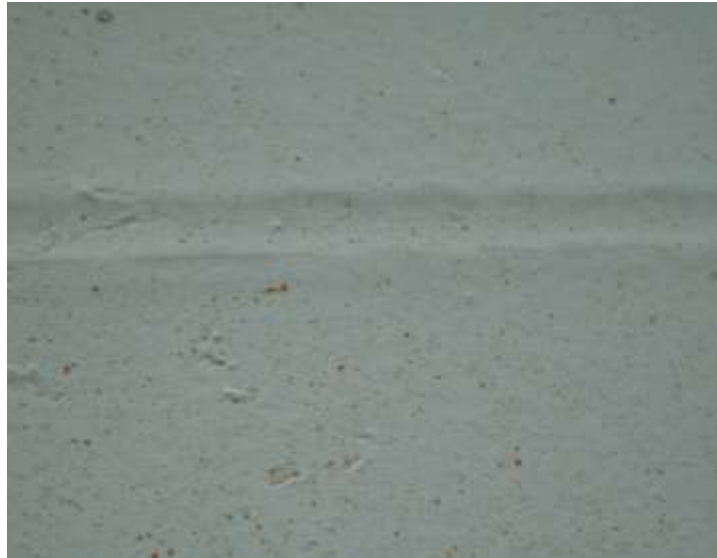
**Photo 16 and 17** Poor scarfing of the weld including undercut with potential to be below the wall thickness specification.

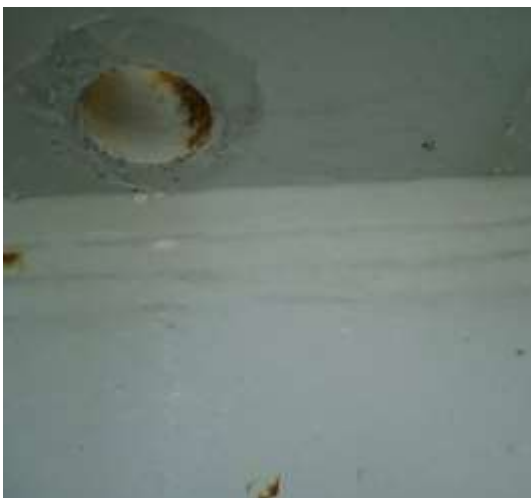
**Photo 18** Fillet welds instead of full penetration butt weld

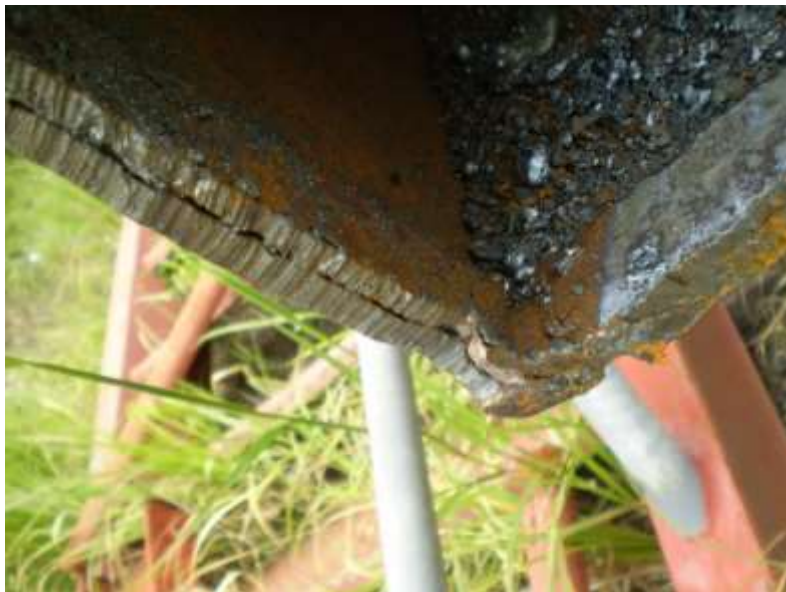
**Photo 19** Use of a sleeve instead of a full penetration butt weld as specified

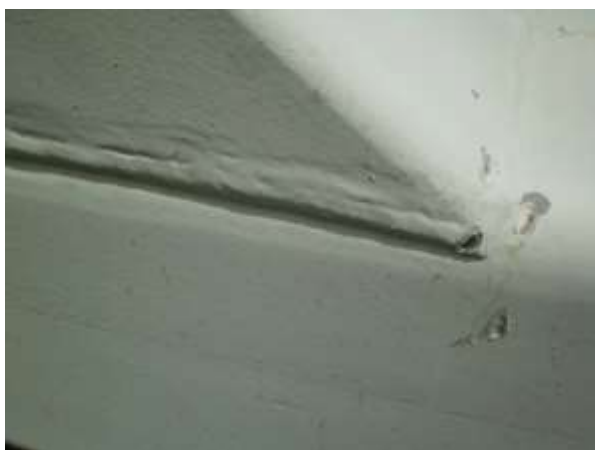
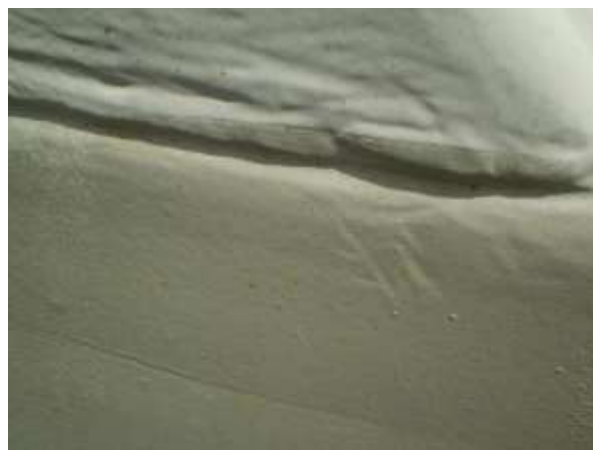
**Photo 20 – 23** Under cut on weld profiles
