# INTERIM REPORT

## Perth Children's Hospital asbestos

## PERTH CHILDREN'S HOSPITAL ASBESTOS

An interim report on the discovery of asbestos  
within imported atrium roof panel products  
used in the construction of the new  
Perth Children's Hospital

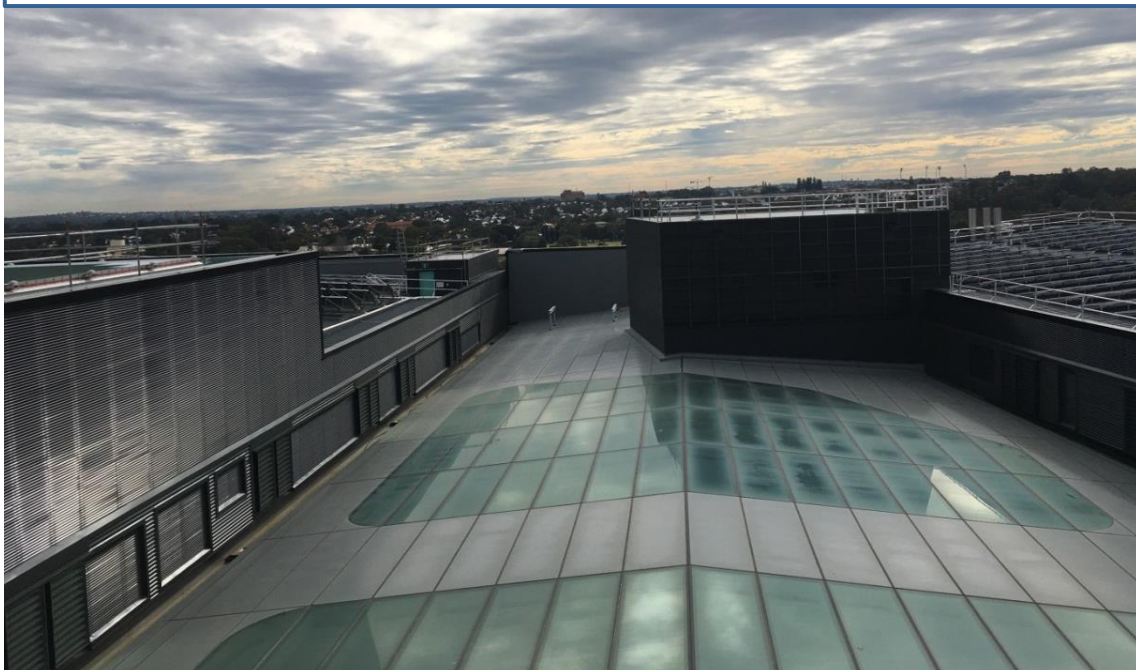
### Photograph 1

Unitised roof panels installed at Perth Children's Hospital
