Inquiry into the Aviation Accident Investigation (Pel-Air)

**BUREAU OF AIR SAFETY INVESTIGATION
REPORT**

Investigation Report 9301743

**Piper PA31-350 Chieftain
Young, NSW,
11 June 1993**

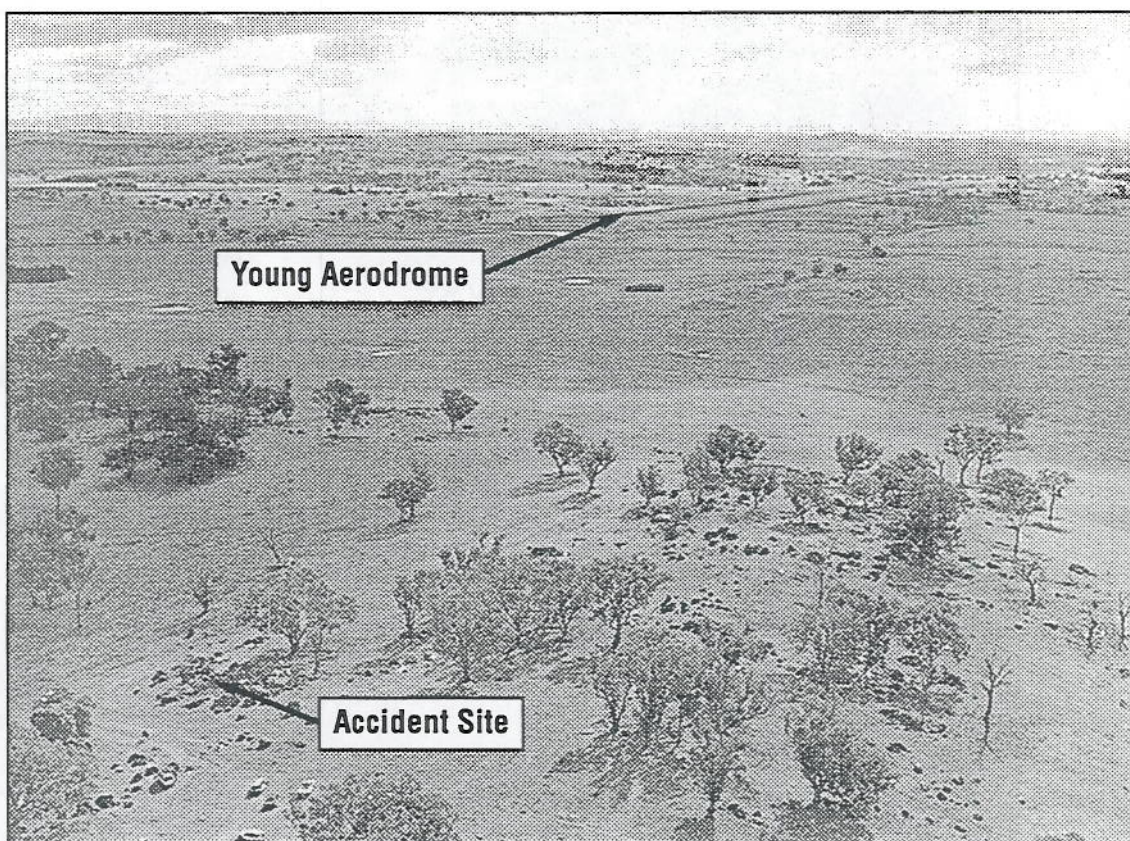
Figure 5 Aerial view (towards NNW) of accident site in relation to Young Aerodrome

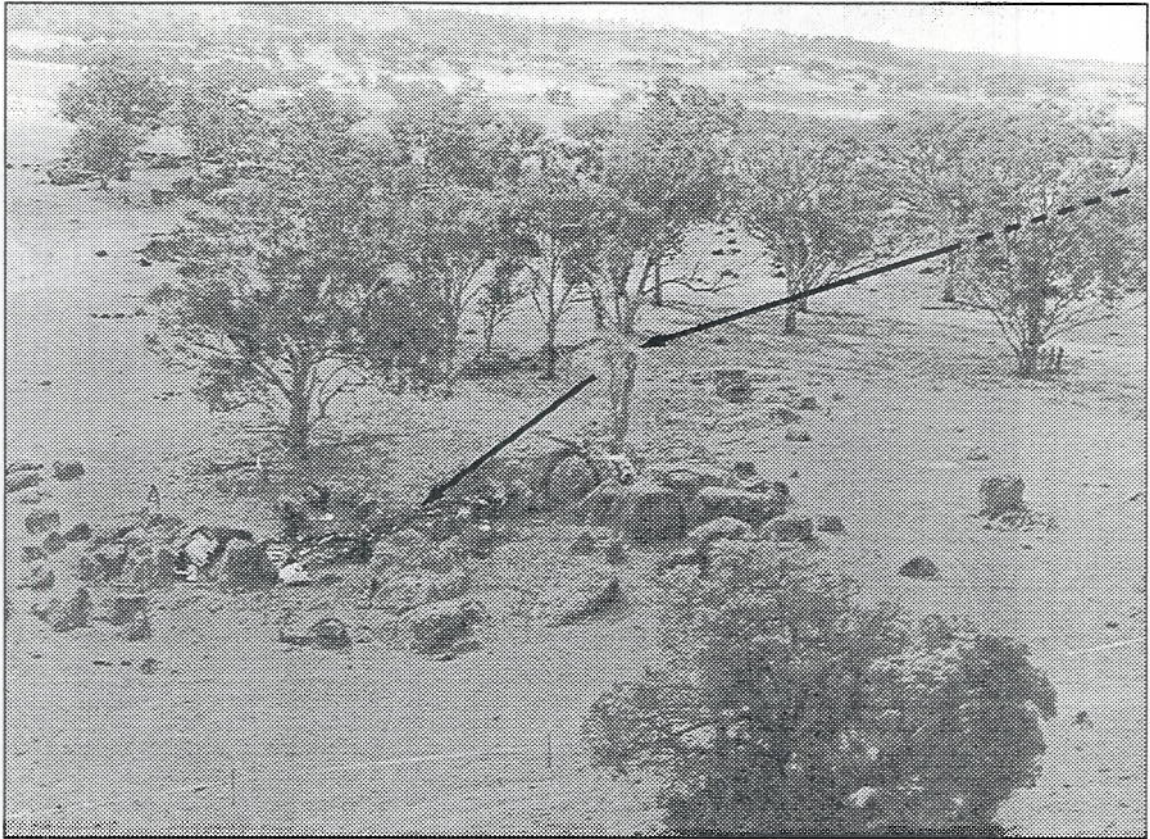
The accident site was located on 'Golambo', a property off Milly Milly Lane, Young, NSW. The main body of wreckage lay within a rocky outcrop on a hill, at a height of 209 ft above the elevation of Young aerodrome, bearing 161° from the threshold of runway 01, at a distance of 2,215 m (see figure 5). The height of the initial impact with trees was 275 ft above the aerodrome elevation. The geographical co-ordinates of the accident site were 34° 15' S, 148° 15' E. The hill was lightly timbered with trees to a height of about 20 m.

Figure 6 General view (towards NNE) of accident site showing direction of final flight path

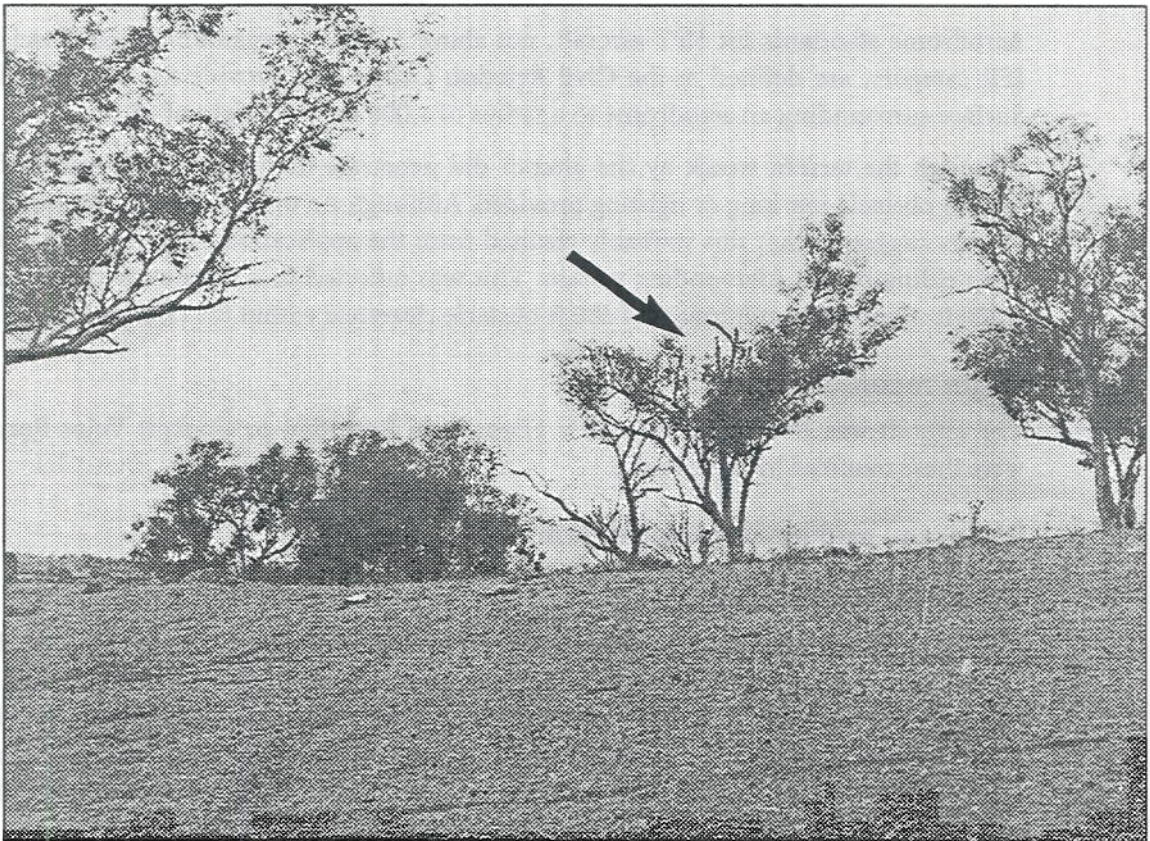
Figure 7 Photograph of the first tree struck by the aircraft looking back along the flight path

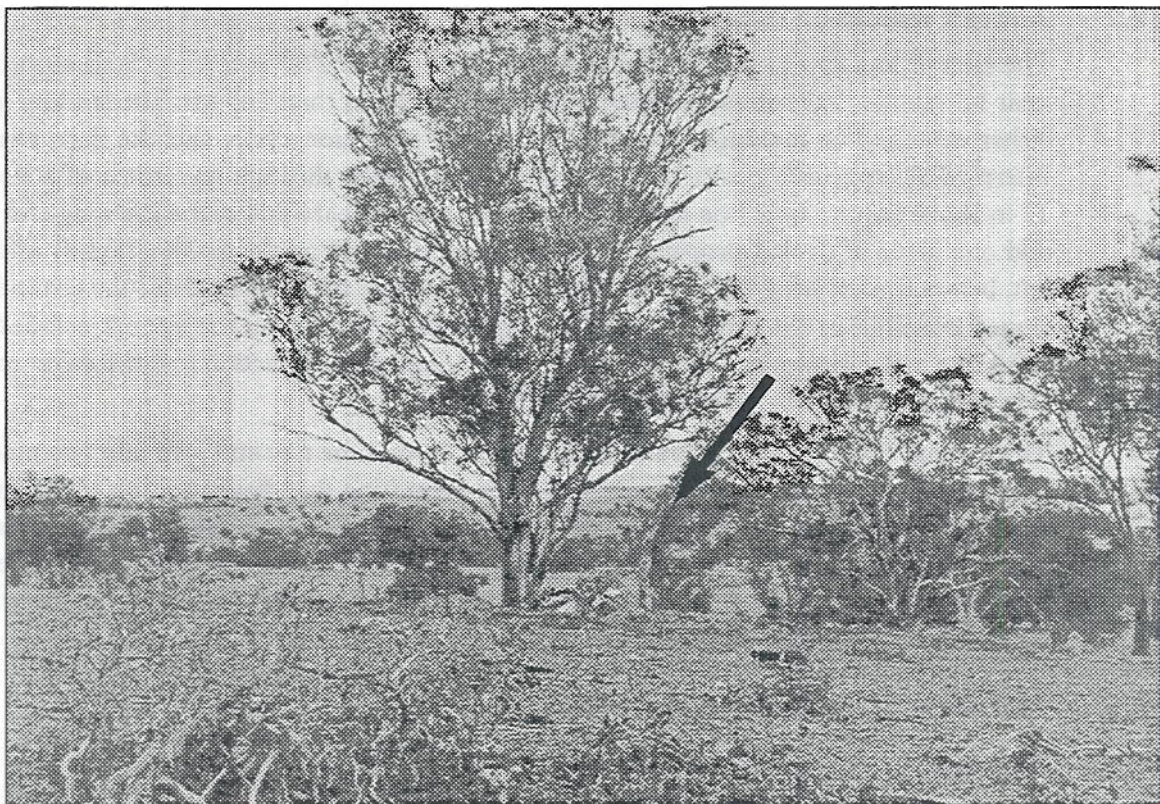
Figure 8 Photograph, looking along the flight path, from the first tree struck by the aircraft. The aircraft brushed against the tree (centre) before colliding with a third tree (arrowed).

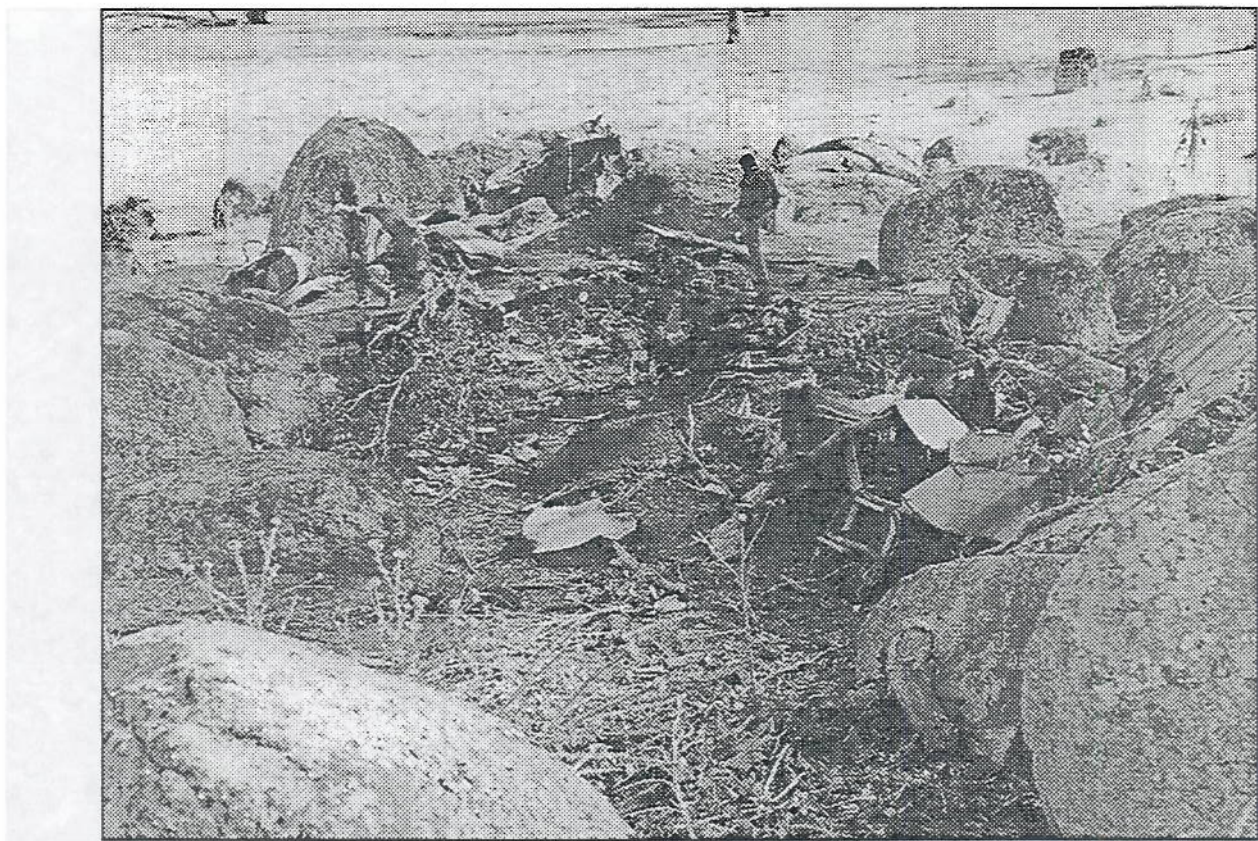
Figure 9 The forward section of the aircraft was totally destroyed by impact forces and fire.

The fuselage then fell onto a boulder, some 10 m beyond the tree and split into two pieces. The wreckage was confined to a generally small area suggesting that disintegration of the aircraft as a result of tree impact had dissipated most of the aircraft's kinetic energy (see figures 9 and 10). The forward section of the fuselage came to rest on the right wing. Both were subsequently incinerated by a fire fed from an estimated 366 litres of AVGAS remaining in the wing fuel tanks. No evidence of in-flight fire was found.

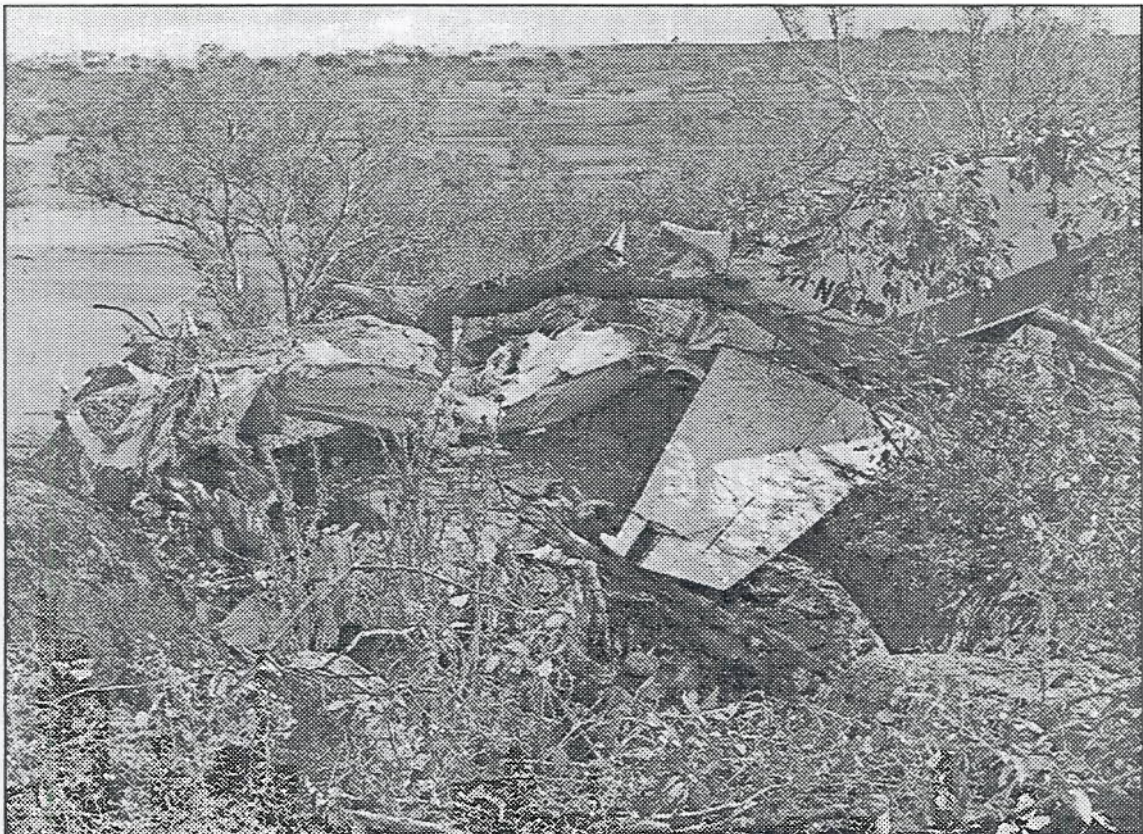
All aircraft extremities and control surfaces were accounted for on the site. The aircraft damage was consistent with the application of excessive loads during the impact sequence, and the

Figure 10 The tail section of the aircraft was torn from the forward section by impact forces.

effects of the subsequent fire. No pre-existing defects likely to have contributed to the aircraft break-up were found.

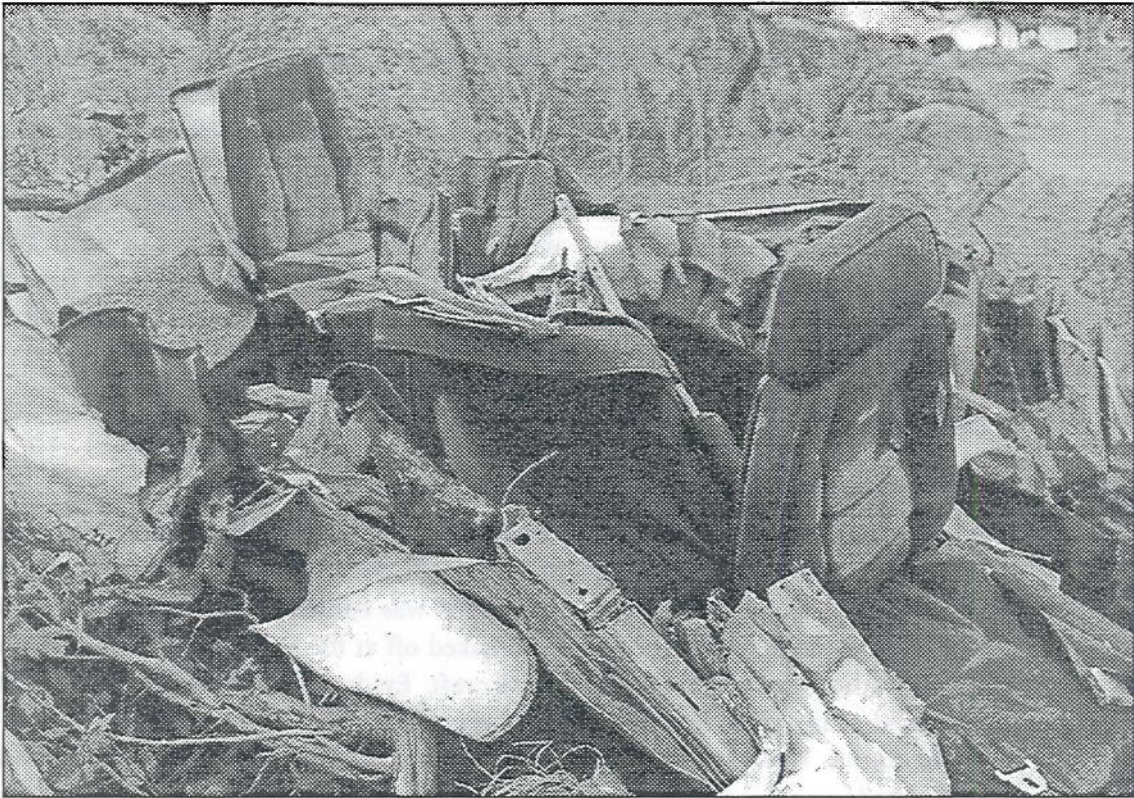
Figure 11 Photograph showing the seat (right) occupied by the sole passenger who survived the initial impact.
