QUALITY SYSTEM COMPLIANCE VENDOR / SUPPLIER AUDIT REPORT

Qantas Airways Limited

**Contracted Maintenance – SIAEC Singapore "D" Check on
Qantas Aircraft VH-OJO V/C: T7105**

AQD Audit ID: 06/SPT/10

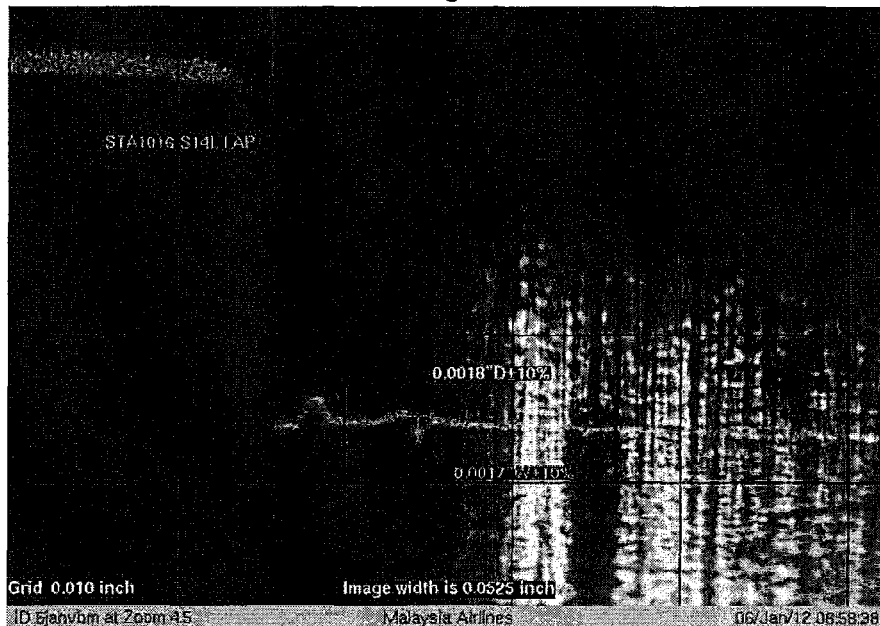
Image 1

2a) The Image shown below (from ID 6thjanvbm) was captured and measured with a software zoom setting of 4.5. This is the requirement of all Boeing documentation for the 1 thou scribe line limit (0.001"). The image CLEARLY showed that the lens WAS NOT set to match the Software setting of 4.5.

The Step in the Lap Joint is approximately 25 thou, (from the grid on the Image). See Drawing 1 below for what this should be.

The above shows the structure of the bonded doubler on a 737 Lap Joint, on the 737-700 each sheet is close to 40 thou in thickness, the step should therefore be in the order of 80 thou, NOT 25 thou as per **Image 1**.

It is my considered opinion that this error should have been rapidly noted by the personal conducting the Inspection. Also QC at MAS should have detected the error.

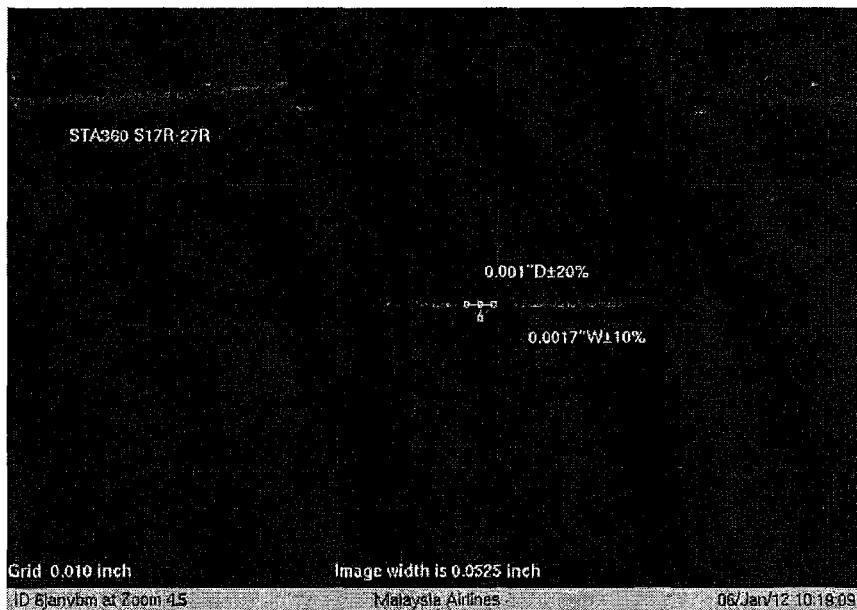
Image 2

2b) A second fundamental error can be established via the image below.

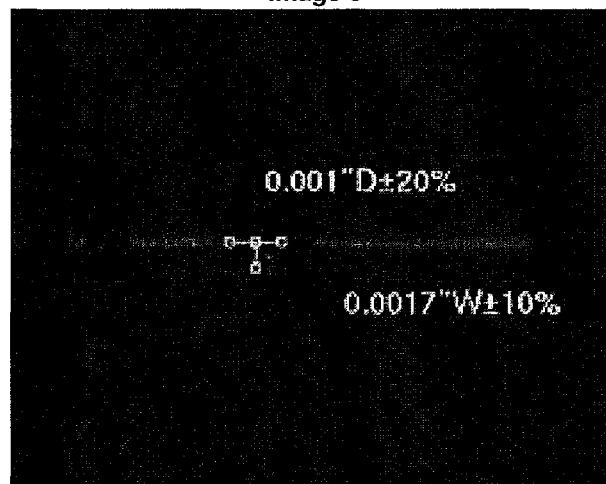
The errors in the above Image 3 are:-

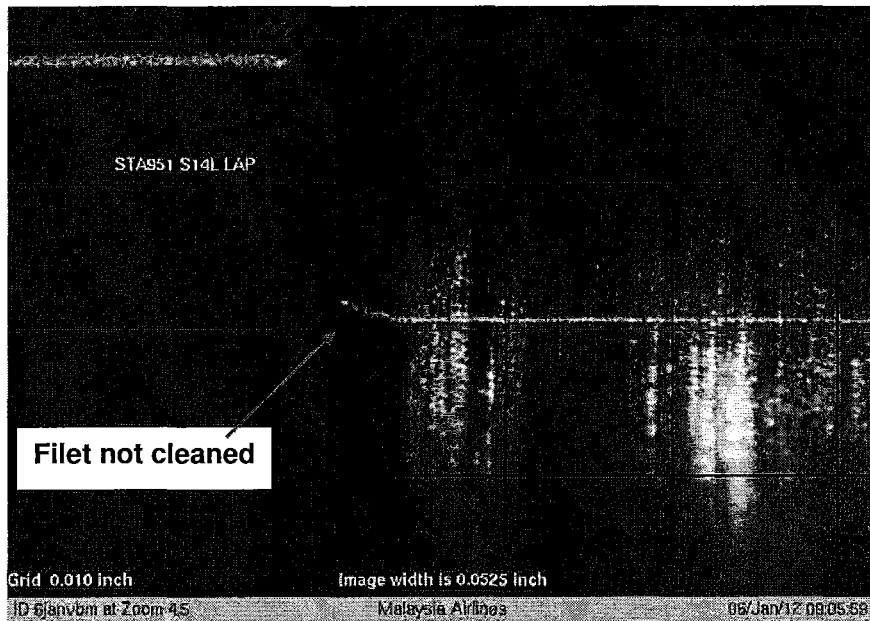
Image 4

The first and most important step in Scribe Line Inspection is Surface Preparation. This was clearly not carried out correctly at MAS for the Jan 6th Inspection. The area that MUST be observed very closely, is right up to the edge of the Lap Joint! The Sealing Filet must be removed. The Image below shows that was not the case. The image clearly shows a substantial amount of the filet still in place. This Image also shows, once again; incorrect setting of the Hardware Zoom. The image magnification should be about 4.3 times larger. This would give a filet of at least 18 thou width. Plenty of room to hide a Scribe Line! On all the areas Inspected on Thurs 1st Mar I carefully checked for this problem. All were clean. The question remains, how was the rest of the Aircraft? This is a concern!

Areas of the Butt points clearly showed a high level of surface working. I believe that NONE of the surfaces that I saw on the 1st Mar were the same surfaces as per the Jan 6th Inspection. Very substantial "Cleaning" had occurred since 6th Jan.

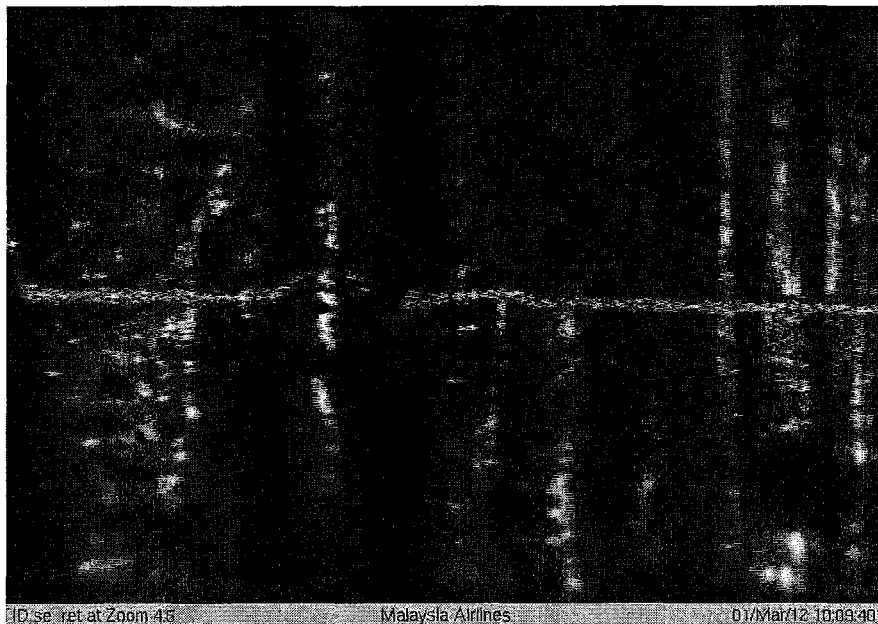
Image 5

This image shows a high level of "Surface Work". The surface shows that extensive rubbing has occurred, most likely with Scotch Brite. The "Land" is well rounded, a feature of Scotch Brite.

Remove paint and sealant from the inspection surface so as to not damage the part. Do not use abrasives such as abrasive paper or Scotch Brite pads. The use of Abrasives can cause the scribe line inspection or depth measurement to be incorrect. etc.

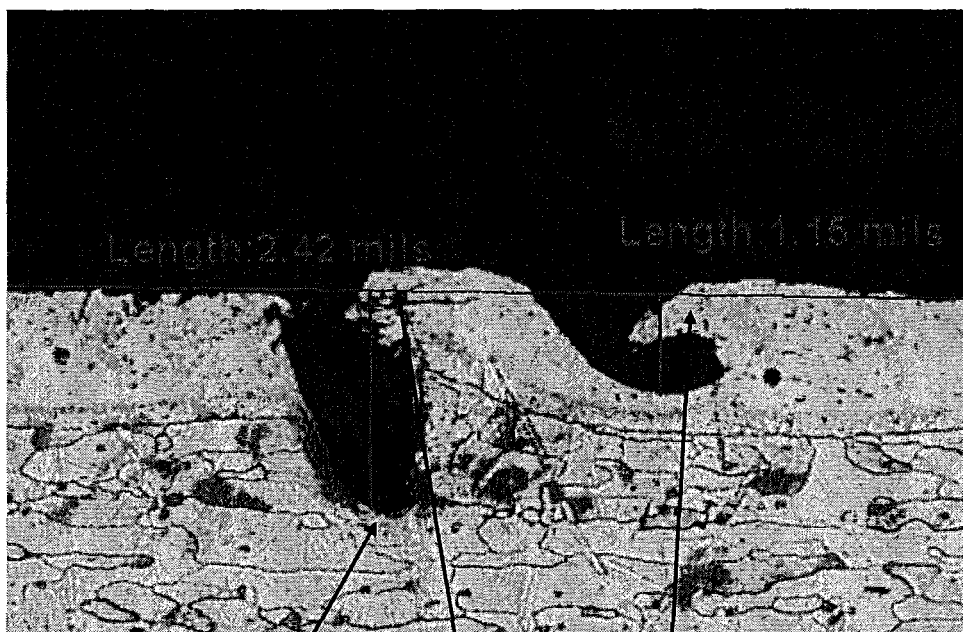
Image 6

**Contamination of Scribe
Impossible to Clean**

Folded Lands

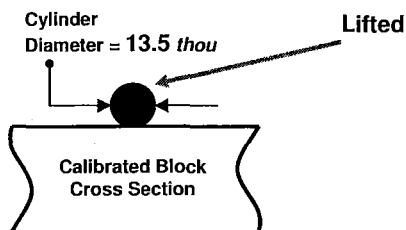
On first testing the Calibration Block S/N 197 was found to be faulty! It should have been 13.5 thou (WORST CASE +/- 3%) It was measured to be 14.1 thou! This is an error of over +4%. The block showed no sign of physical damage, but on close inspection it was found that the 13.5 thou steel wire had a "bow" in it, lifting it about 0.6 thou of the surface. The block cannot be easily repaired and was therefore destroyed! (As per the internal QC requirements of both STTR and Hextronics).

A new Calibration Block was manufactured, S/N 421.

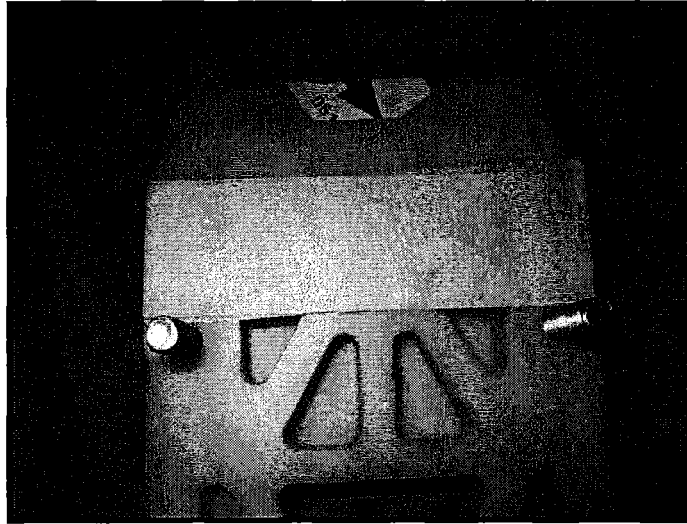
Tape on the Dings Plate!

b)
When we tried to make a Calibration measurement we found that the "Dings" Plate set had a broken Slider. See below!

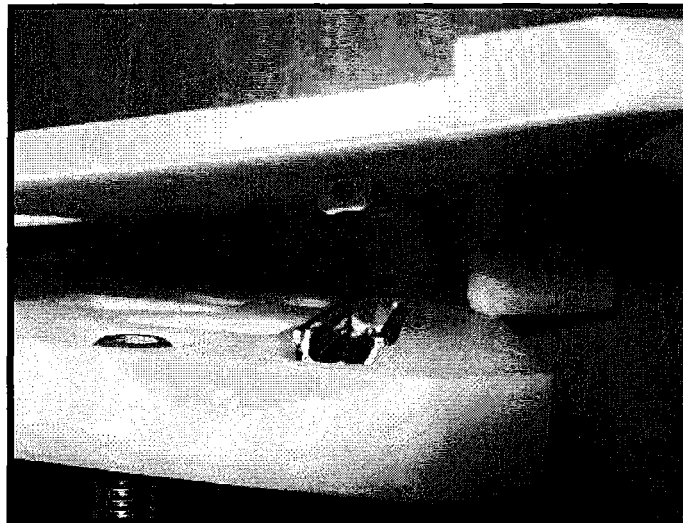
The Broken Slider!

I have sought feedback from ST Aerospace as to whether there are any reports the system was dropped! No reply!
The Slider was replaced!

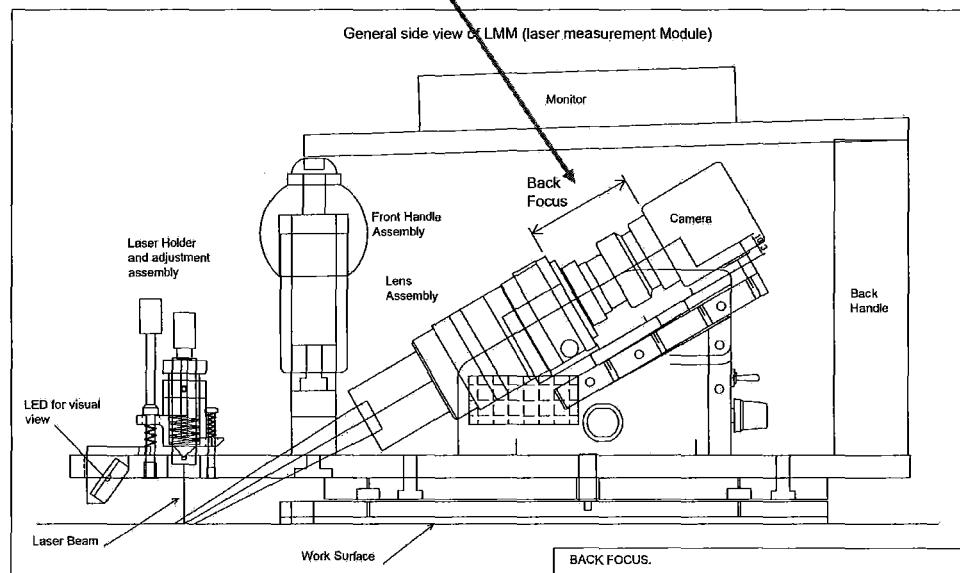
From our internal notes this should have been 50.4mm, I measured 50.9mm on the system as returned. Unfortunately it is not simple to just change this back to 50.4mm. Although we measured 50.4mm during production of this system, the actual dimension is much more critical. It required the lens/camera assembly to be put into our alignment jig! We decided to wait for the new Calibration Block before doing this.

On close inspection it was the Camera that had moved backwards by about 0.5mm. But I found the lock screw to be tight! This suggests a drop or VERY hard knock!

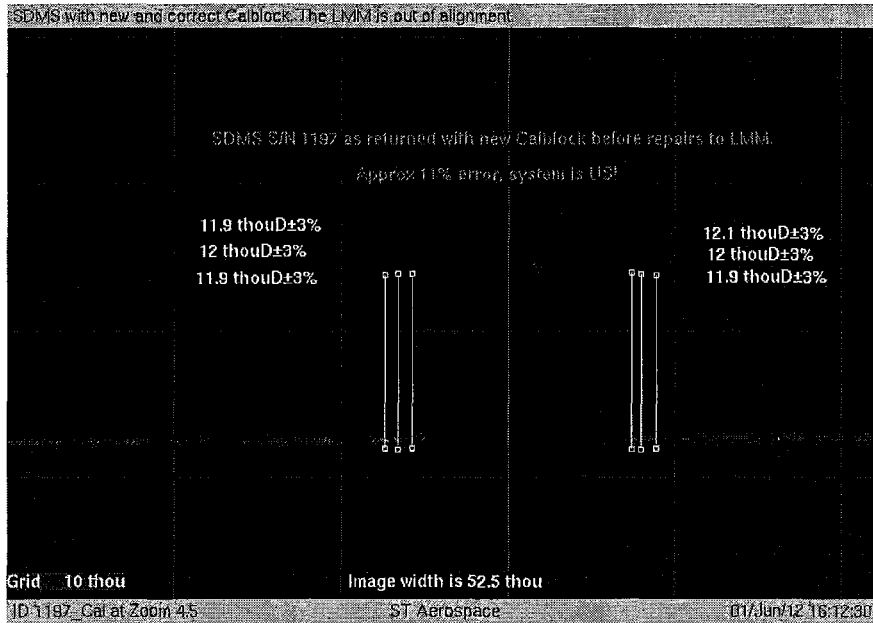
First result with new calblock 421. This is SDMS system AS RETURNED!
The Calblock 421 was known to be 13.5 thou! Taking 12 thou as the average for the 6 measurements below we have a measurement error of approximately of 11%.

In this condition the system is Un-Serviceable! And should not be used for an Inspection!

The Lens/Camera was removed, placed in a jig and realigned!
