# **ELECTRICAL INCIDENT REPORT**

## **BUSHFIRE NEAR RIVER and FOLEWOOD ROADS TOODYAY WESTERN AUSTRALIA 29 DECEMBER 2009**

15 February 2010

EIS 2009-2630

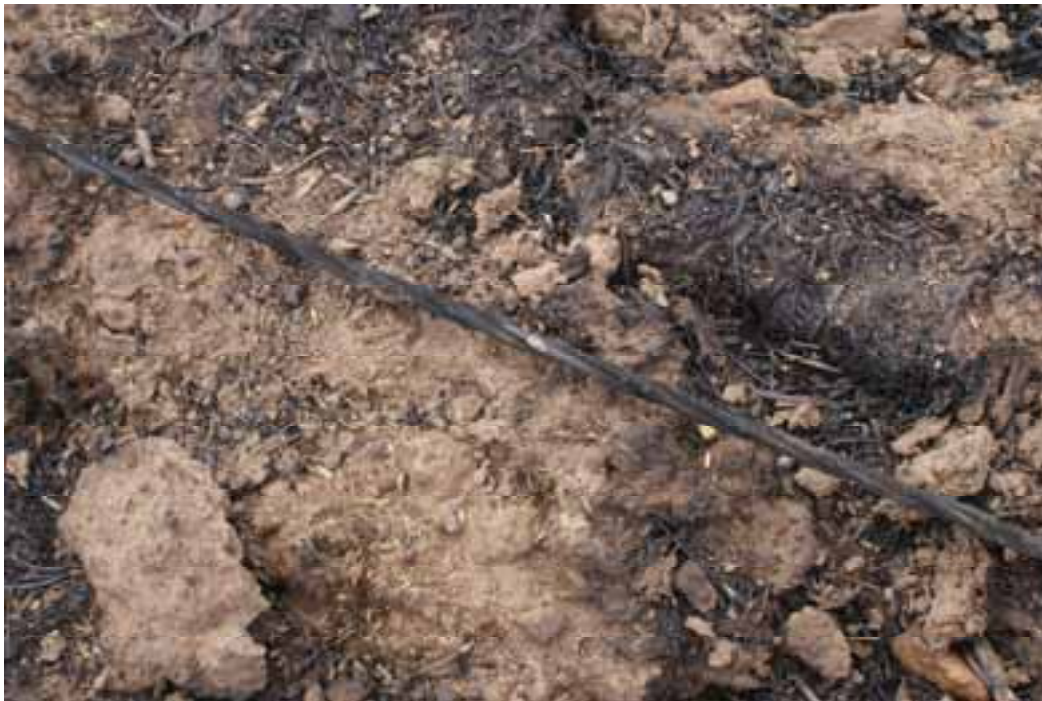
The investigation identified arc marks (melting of the steel) on the active and earth return conductors 9 metres and 14 metres out from Pole T303-43 towards pole T303-42. The arc marks at 14 metres were recent. The marks 9 metres from the pole were old.

**Arc Marks at 9 Metres. Photograph Taken by EnergySafety**

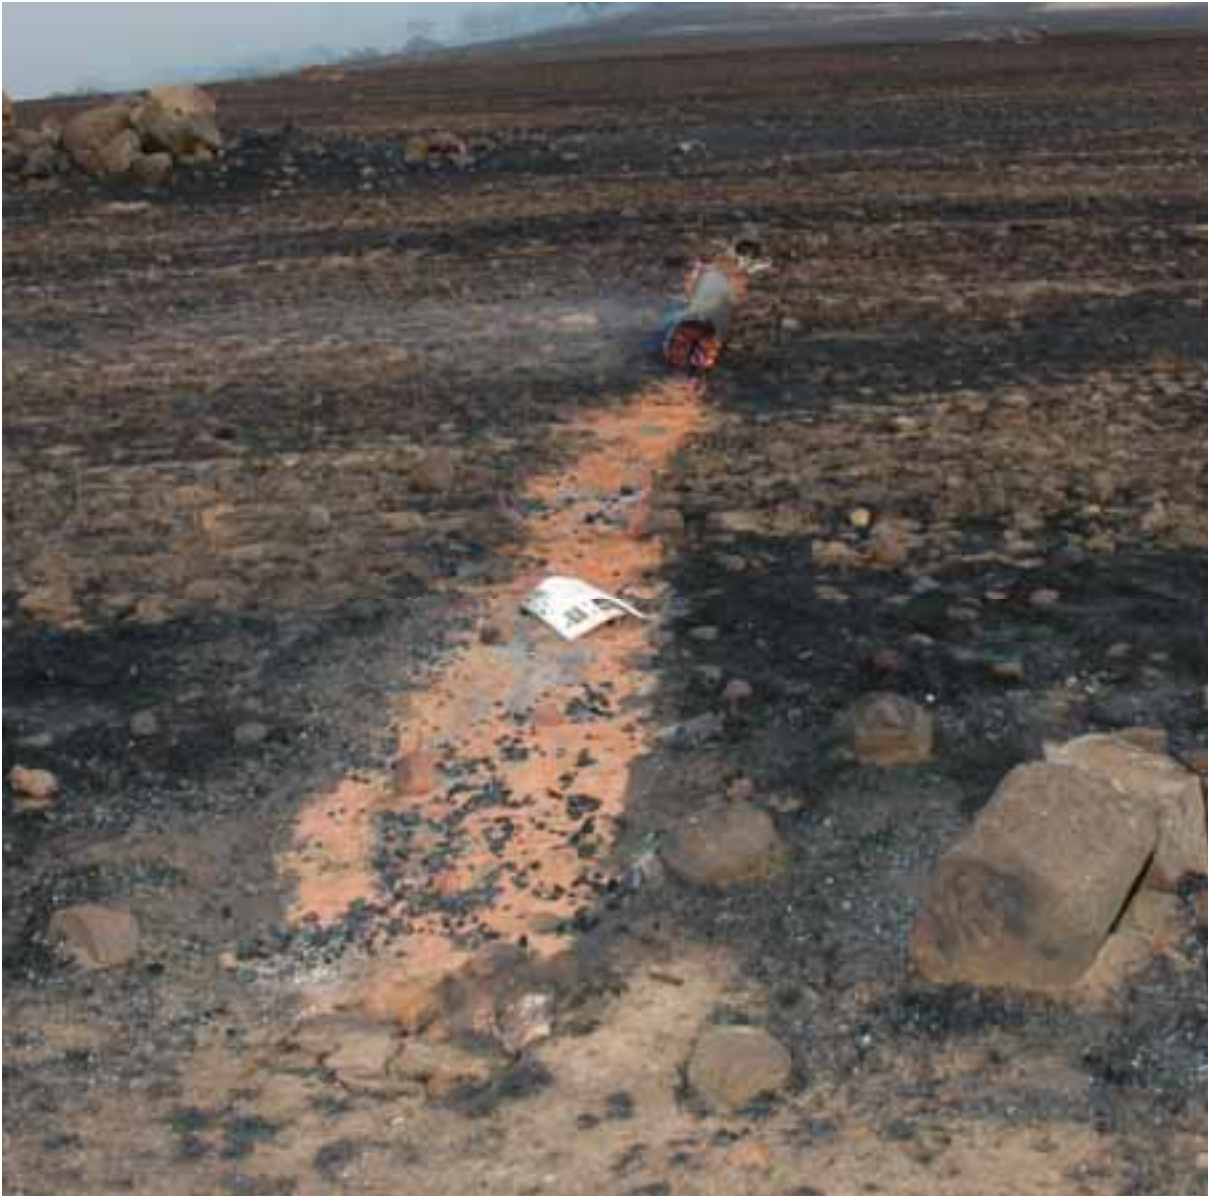
Pole T303-43 was also burning near the ground and then fell to the ground and continued to burn until it was completely consumed. Marks on the ground confirm that the earth return conductor then broke at Pole T303-43 and pulled away from the pole (after it was consumed by the fire).

Remains of Pole T303-43. Photograph taken by FESA on 29 December 2009
