Government of **Western Australia**  
Department of **Commerce**  
*EnergySafety*

## **2008 DISTRIBUTION WOOD POLE AUDIT REVIEW**

**A Review of Western Power's Response to the  
2006 Regulatory Compliance Assessment of Western Power's  
Distribution Wood Pole Management Systems**

**May 2009**

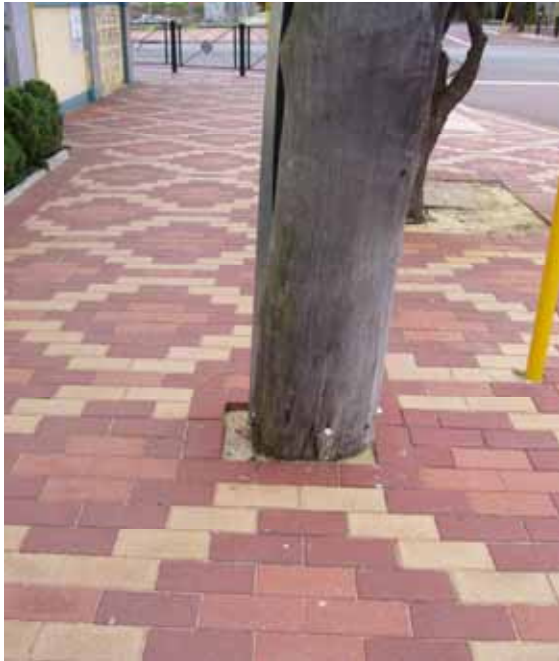
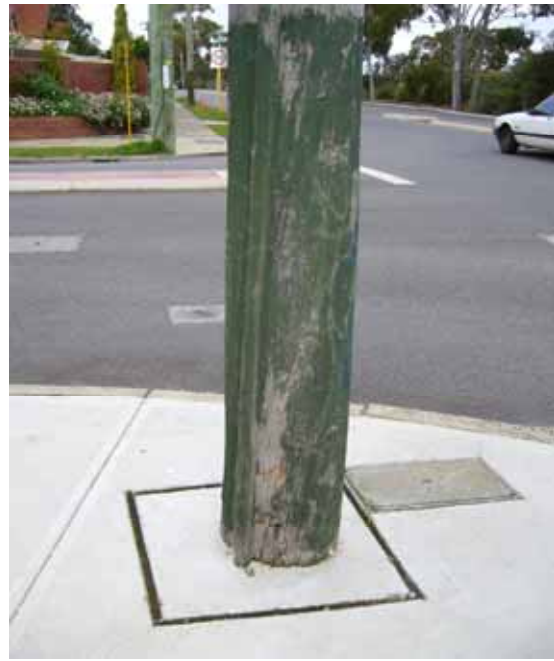
A further sample of poles surrounded by brick and concrete paving was also checked. As in the 2006 Audit, there again is no evidence that the below test results from these poles can or does represent the condition of these poles below ground.

**Recommendation 13:** Western Power should develop and implement a practice for inspecting and assessing the below ground condition and strength of wood poles installed in brick, concrete and other paving that precludes access to the pole below ground using a spade.

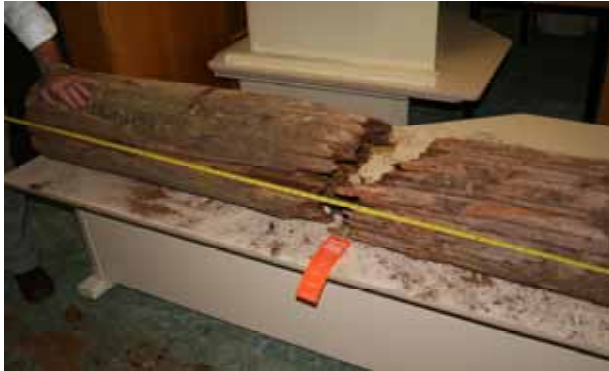
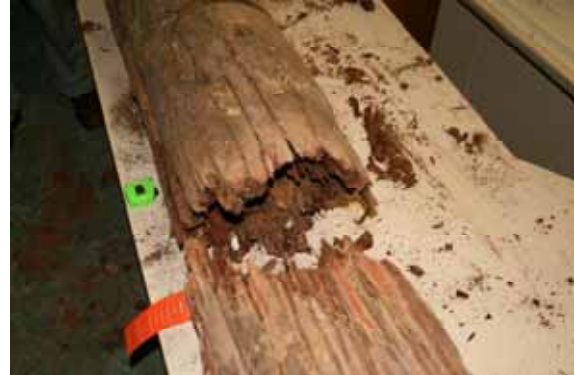
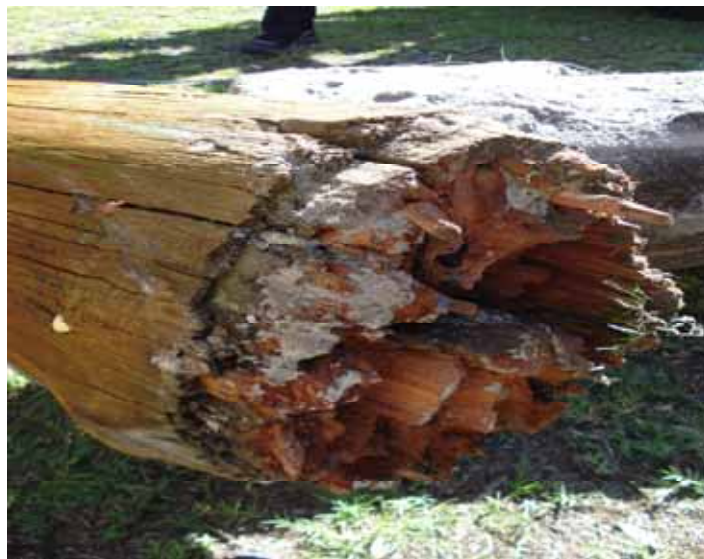
The inspection and service contract does not require the contractors to warrant their performance with respect to either the quantity or the quality of their inspection activities, or their accountability for any unassisted pole failure in the next 4-year pole

The contract does not detail the contractors' quality assurance requirements, or those used by Western Power when assessing the contractors work. The contract also does not include Western Power's 2009 improved QA processes. The contracts also do not include any specific inspection of the aerial and ground stays supporting the wood pole power lines.

It is unlikely that this inspection and service contract as it is presently structured will deliver an acceptable wood pole condition assessment, even with an effective pole inspection practice.

**Recommendation 14:** Western Power must immediately inform the existing contractors of the above deficiencies, ramp up the quality and number of the Service Delivery audits and exercise the maximum influence possible under the existing contracts to achieve an acceptable below ground pole condition assessment.

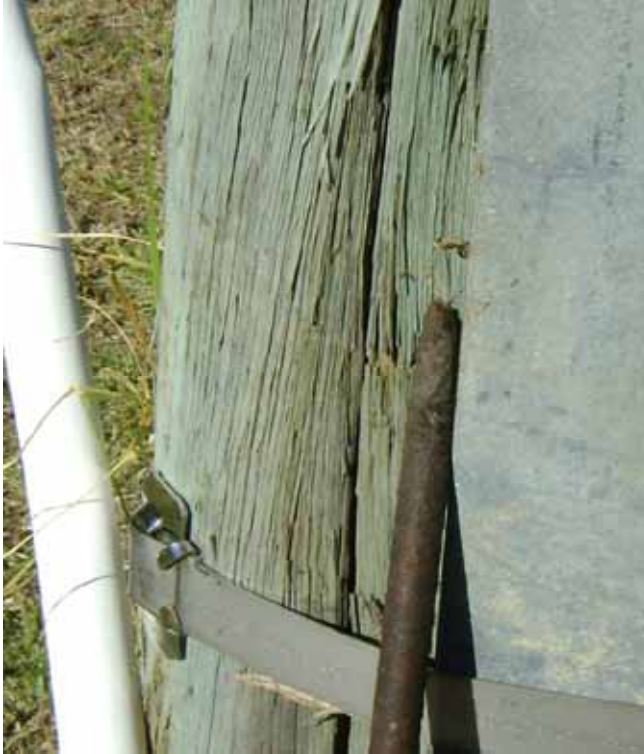
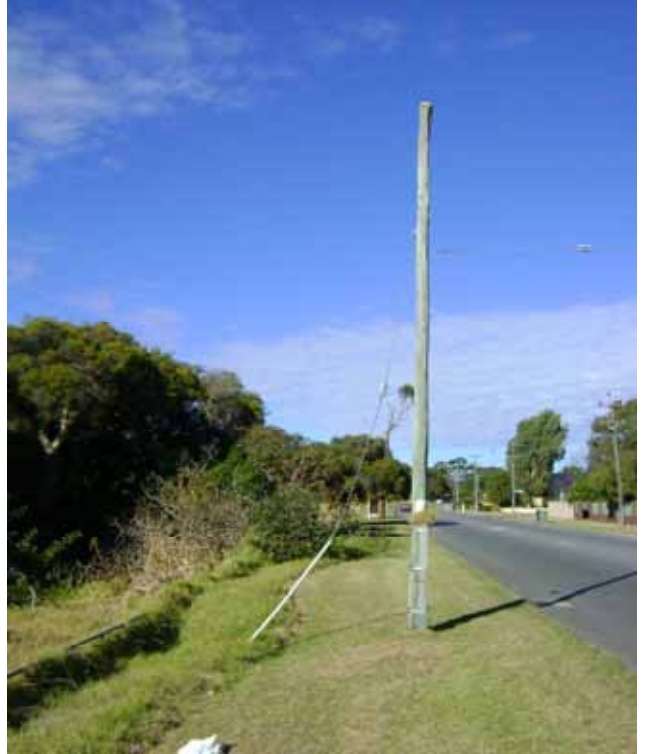
4. Western Power is now monitoring the pole inspection program weekly and reporting monthly to Network Performance.
5. Western Power still has not established an effective stay inspection and repair/replace program.

6. Western Power does not include embedment checks in its pole inspections.
7. Western Power's QA of contractor-inspected poles can now properly assess the below ground inspection and testing performed by the contractors. This improved QA process has been progressively developed over the last 12 months. Concerns remain about the below ground inspection and good wood records of the poles inspected before this period

8. Western Power is not yet inspecting the below ground condition of poles installed in brick, concrete and other hard-stand paving.
9. No comprehensive review and management of pole inspection quantity or quality take place, although some limited monitoring of quantity occurs.

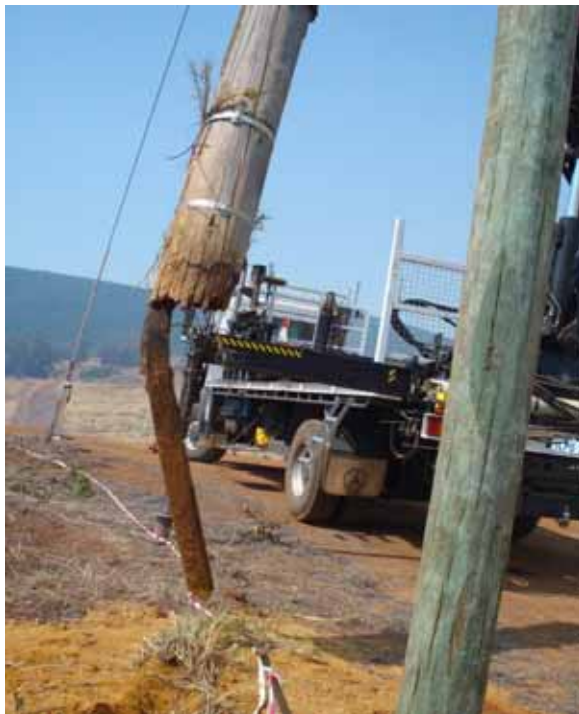
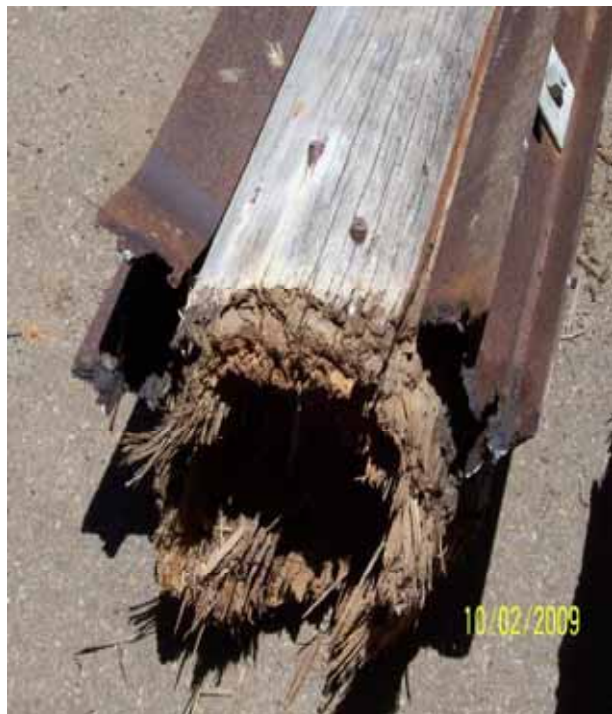
The UAM inspection recommendation above mentions termite activity, but does not identify the other “factors”, or deterioration sufficient to compromise the pole reinstatement. These factors would be the criteria for identifying UAM reinstated poles no longer serviceable and requiring replacement.

**Recommendation 21:** Western Power should develop and implement prudent reinforced pole replacement criteria, which should become part of the pole inspection manual and practice. This should include the reinforced poles in the network (before UAM) that are known to be unsafe and should be replaced.

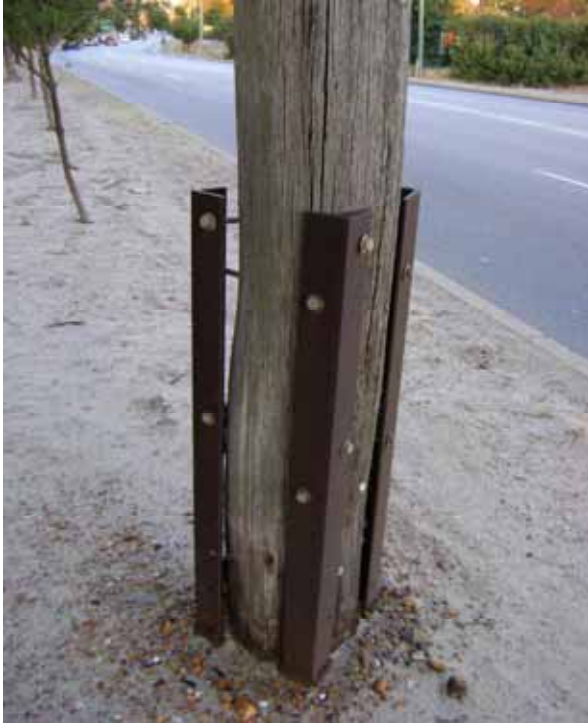
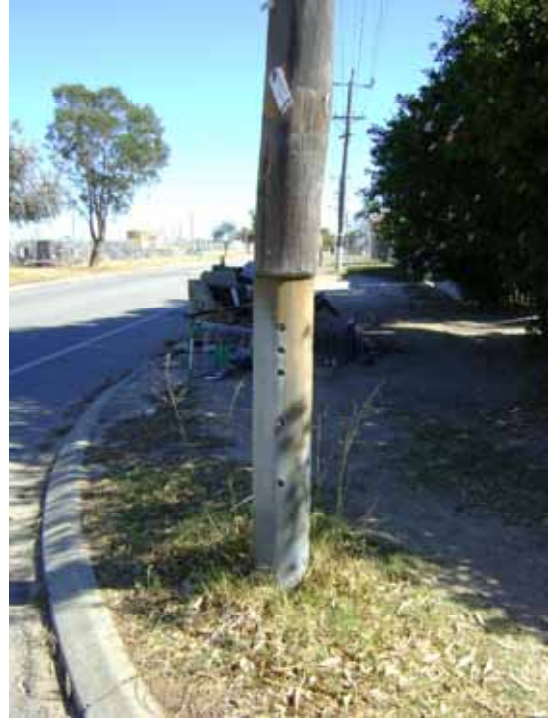
- Approximately 60 different types of pole base reinforcement systems installed in the distribution network.
- No calculations or trials to demonstrate any of these systems have the strength to ensure these reinforced poles are safe.
- No serviceability criteria to identify which reinforced poles that are no longer serviceable and should be replaced, and
- Reinforced pole failures:
  - Above the reinforcing stakes
  - Of the pole between the reinforcing stakes
  - Of the reinforcing stakes and the pole
