**PROJECT:** CS110010  
 Western Basin Main Works Dredging - Parcel 5

**SUBJECT:** Contract CS110010 - Western Basin Main Works Dredging - Parcel 5 -  
 Environmental Incident Report - 008 Hydraulic Oil Spillage Mutlicat Voe Jarl

**ENVIRONMENTAL INCIDENT REPORT**  
**WESTERN BASIN DREDGING AND DISPOSAL PROJECT**  
 Incident No. 008 Hydraulic Oil Spillage Multicat Voe Jarl

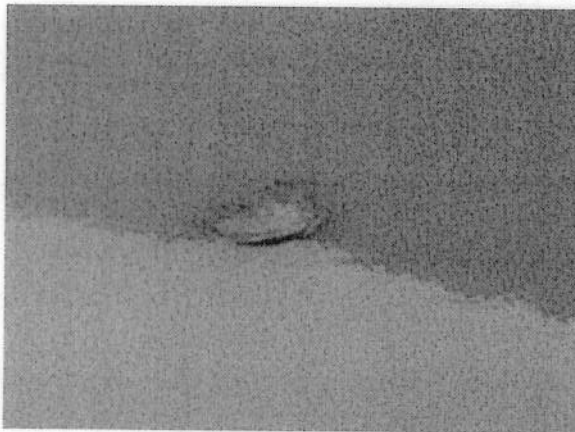
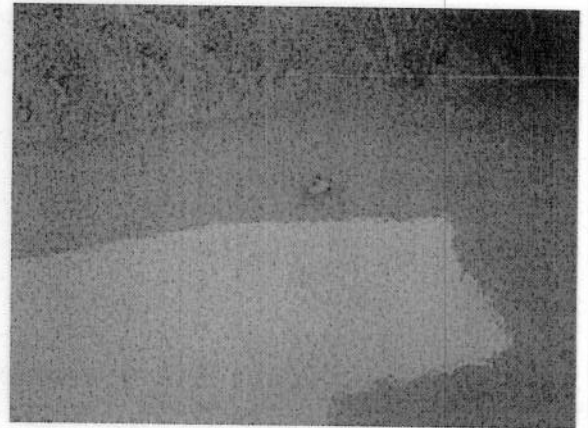
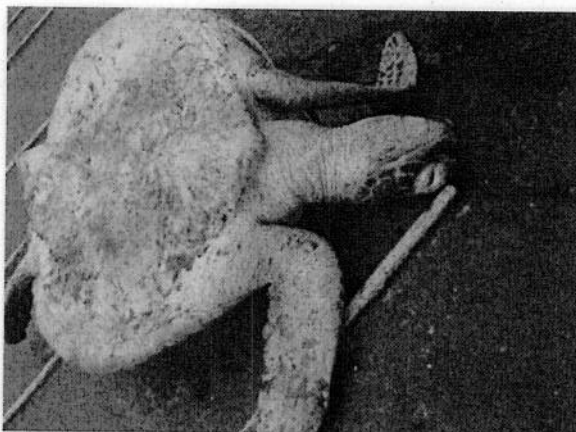
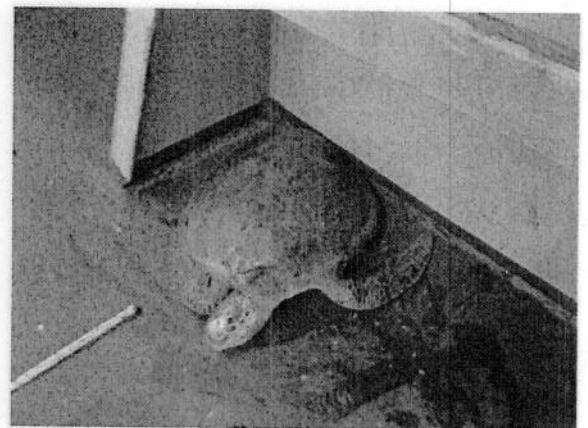
At the moment of recovery from the hopper, the turtle was intact and had no signs of physical injury. From the odour – spreading from the turtle – it is assumed that the animal has been deceased prior entering the hopper of the HAM 350.

Turtle trapped inside hopper as a result of closing bottom doors (assumed dead prior event).

Images included

No	Action/s Taken	Responsible Person	Due Date / Status
1.	Turtle was recovered and handed over to GPC representative	Bernie Manston (Vessel Master)	Successful
2.			
3.			
4.
