ENVIRONMENTAL INCIDENT REPORT
WESTERN BASIN DREDGING AND DISPOSAL PROJECT
 Incident No. 008 Hydraulic Oil Spillage Multicat Voe Jarl

Report: Hydraulic Equipment and Hoses Vessel: Heron October 2011

ENVIRONMENTAL INCIDENT REPORT

Incident No. 010 Hydraulic Oil Spillage BHD Simson

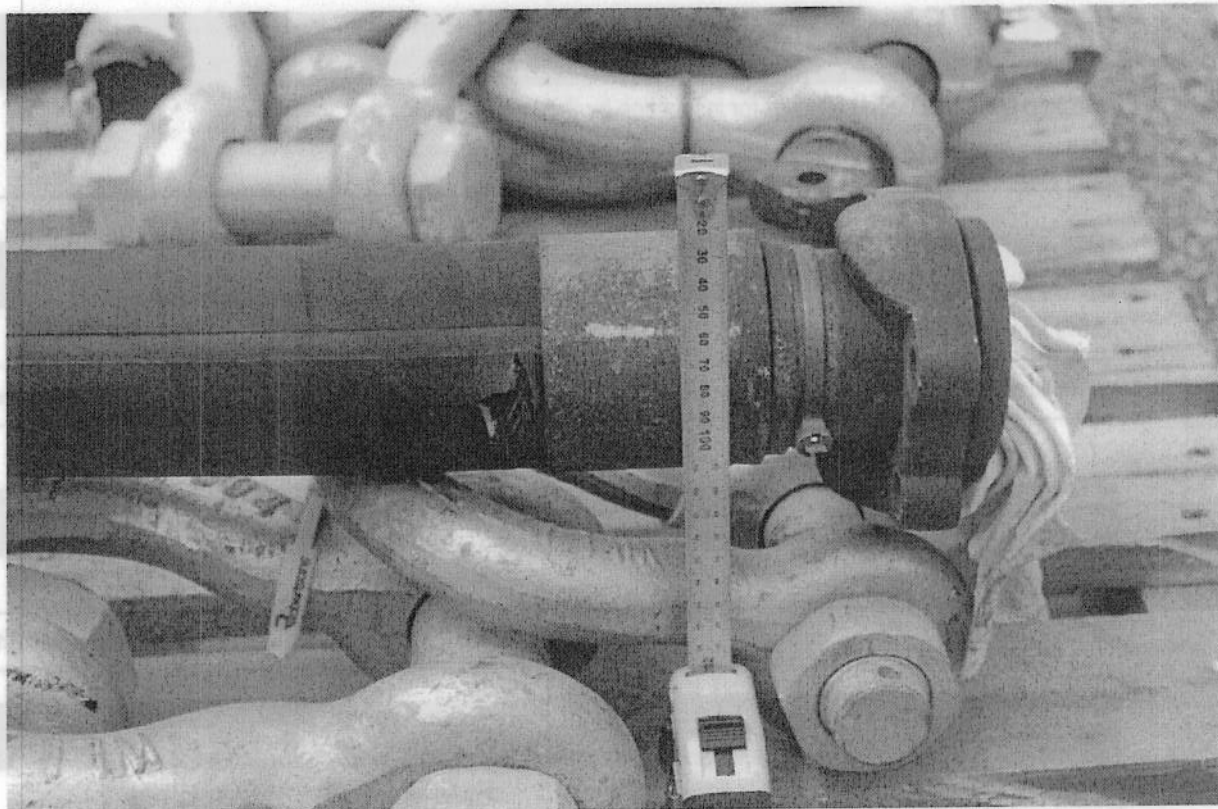
ATTACHMENT A

The excavator of the Simson was bringing up dredged material from the bottom when a failure of the rubber housing of one of the hydraulic hoses on the boom occurred. As a result, hydraulic oil leaked from the boom into the water.

Failure of hydraulic hose of the boom. Rubber housing broke near the flange. Cause of failure is currently under investigation by third party experts.

Proposed Actions to Prevent a Recurrence of the Release/Event			
No	Action/s Taken	Responsible Person	Due Date / Status
1.	Hydraulic hose sent to Hydraulic Solutions for third party inspection.	Technical superintendent	Ongoing
2.	Revision of replacement schedule for boom hydraulic hoses based on third party inspection results (Currently replaced every 6 months)	Technical superintendent	Ongoing
3.	Continued visual checks of hydraulic system prior and during excavator operations	Vessel Master / Crane operator	Ongoing
4.	Install central depot with additional oil spill contingency materials on Intan or Remora pontoon	Superintendent pontoons / Environmental Officer	Ongoing
5.	Reinforce Oil Contingency Response Procedures	Environmental Officer	Ongoing
6.	Perform Toolboxes concerning Environmental Incident Procedures for Vessel Master and Superintendent	Environmental Officer	Ongoing
