Le Hamel
War Memorial
FRANCE

Re: Condition of the Australian Monument at Le Hamel.

**Australian National Memorial
Le Hamel**

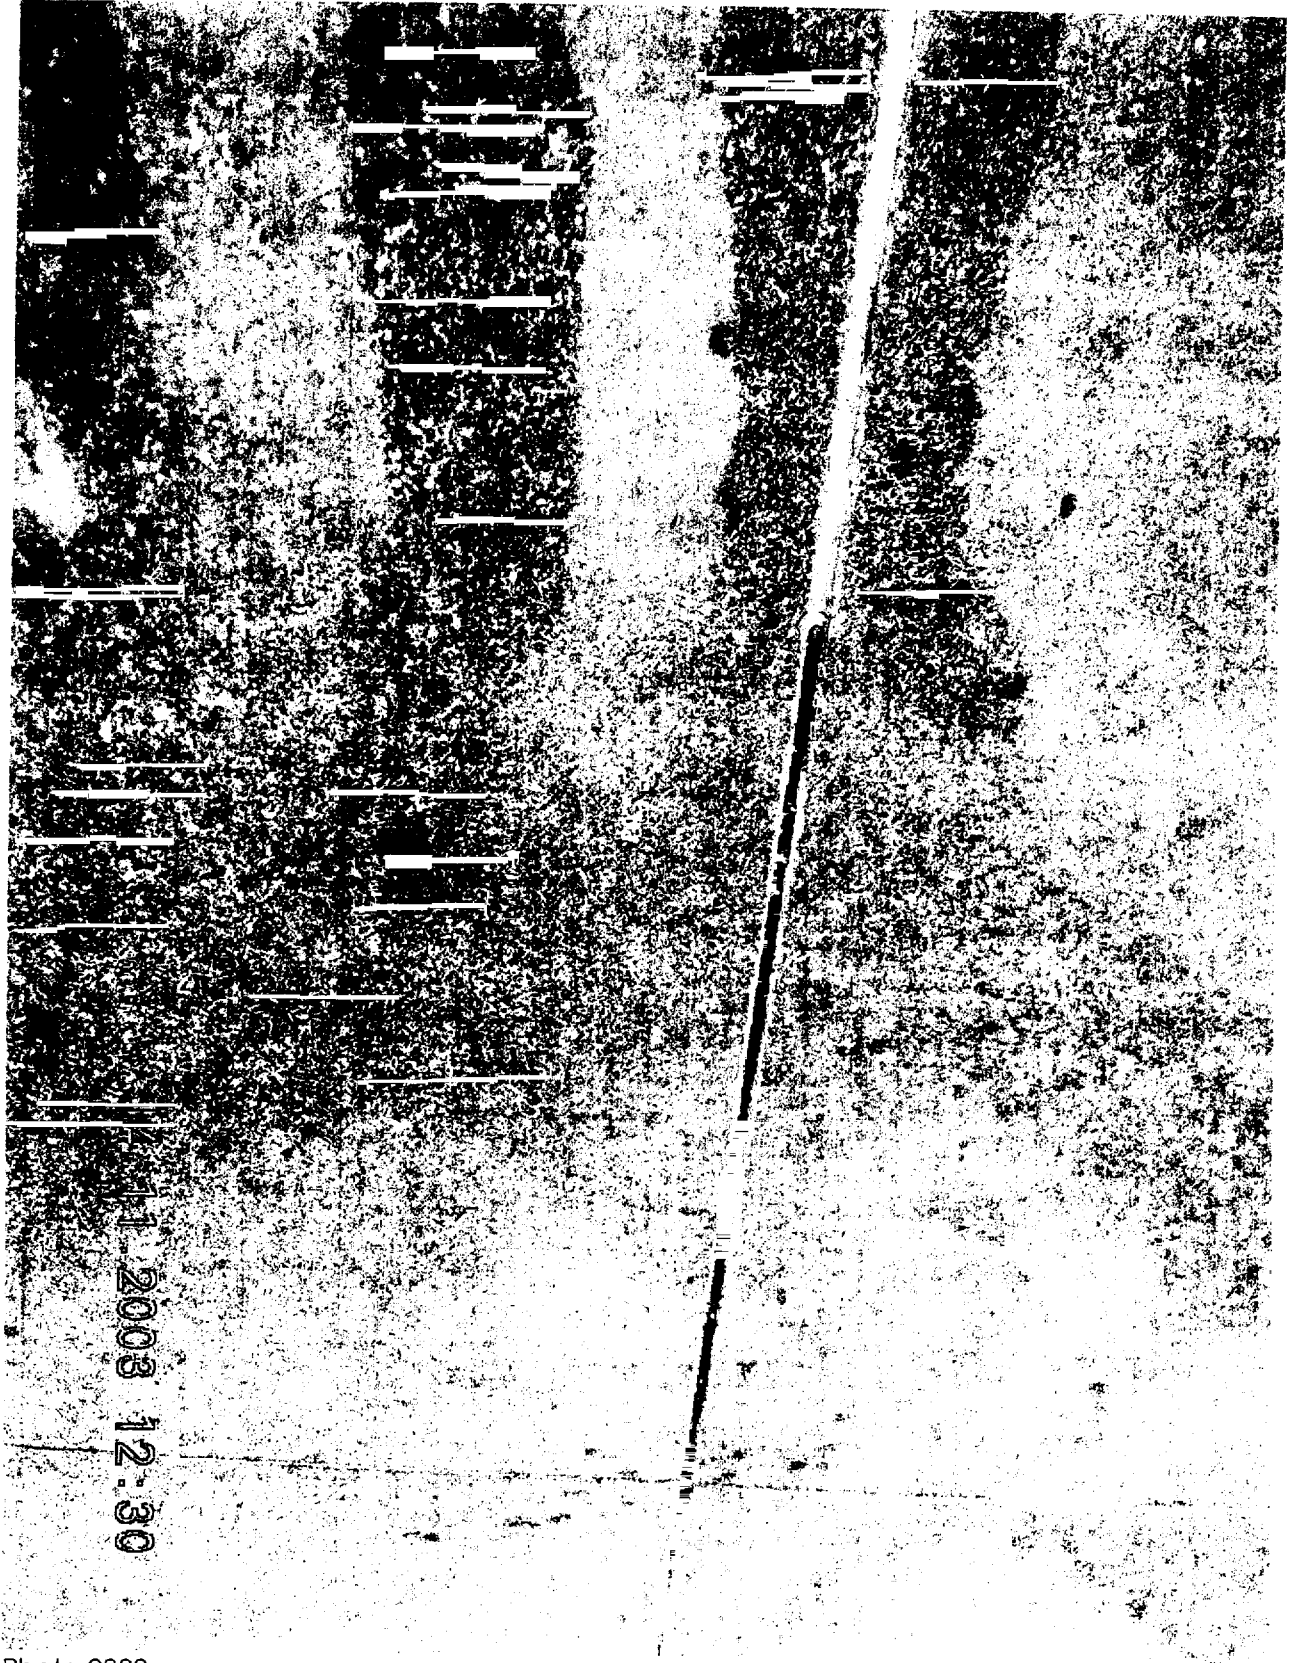
Photo 0339

There exists a joint of approximately 3mm around each tile but due to tolerances this joint varies down to 1.5mm & up to 5mm in some areas. The joint is filled with silicon mastic either black or clear in colour. There is no provision for any expansion anywhere in the granite cladding and it is obvious that the joint space allowed is not sufficient to accommodate the thermal movements that occur. (see photos 0341, 0342, 0343, 0339 attached).
