**TRAFFIC MANAGEMENT REPORT**

**PARLIAMENT DRIVE**

**ROAD SAFETY ASSESSMENT**

R D Gossip Pty Ltd Pty Ltd  
2 Lawry Place  
Macquarie ACT 2614  
Australia  
Telephone :+61 2 6251 6313  
Facsimile :+61 2 6253 1989  
Date : 30 August 2007  
Reference : Report RG 06055-2/0  
Status : Final

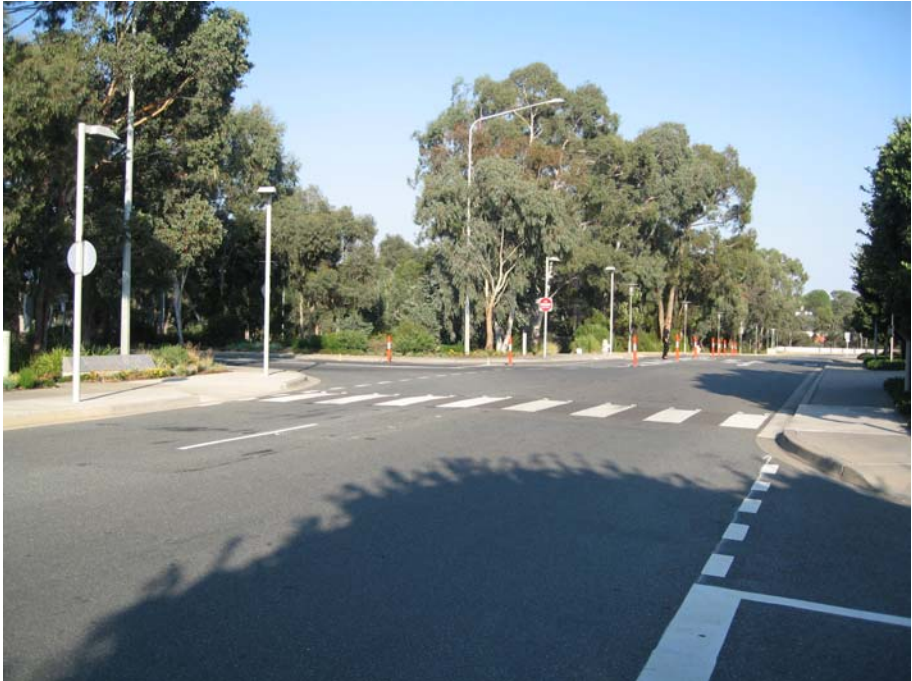
2.4.2 The intersection of Parliament Drive with Melbourne Avenue does not function efficiently.

2.4.3 Currently the intersection operates as a standard T intersection with traffic on Parliament Drive having priority over traffic on Melbourne Avenue. This results in the development of significant queues in Melbourne Avenue even though the volume of traffic on Parliament Drive is not heavy.

Photograph 1 – Melbourne Avenue/Parliament Drive intersection

- 4.4.4 Overall it is recommended that the intersection be converted to traffic signal control.

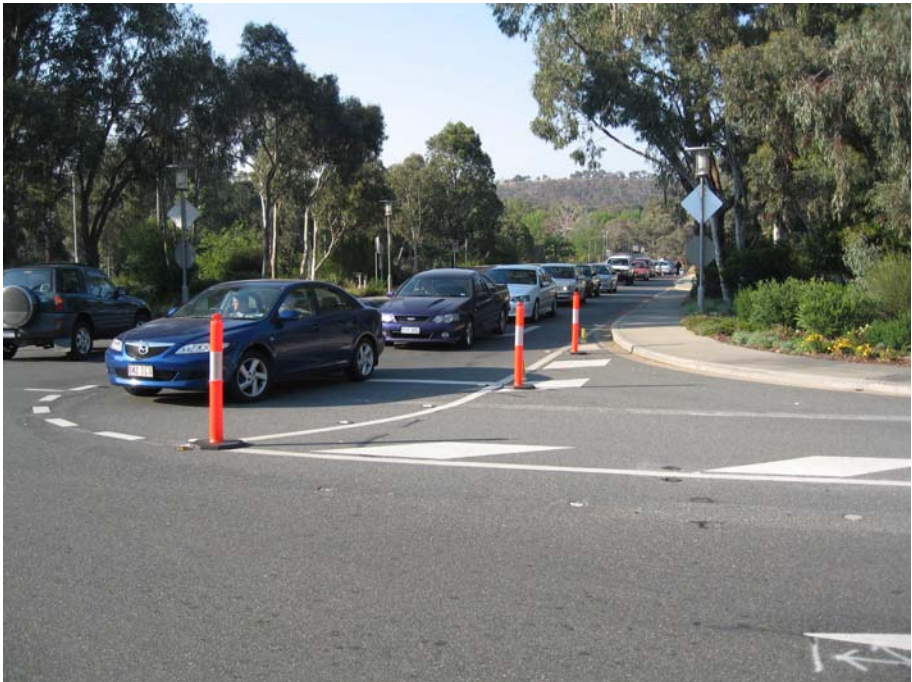
2.4.10 Particularly during the morning peak period, the entrance to the staff carparks off Melbourne Avenue becomes blocked leading to queues of southbound vehicles in Melbourne Avenue which occasionally extend back to Parliament Drive resulting in a situation where Melbourne Avenue is blocked in both directions. This could be a security concern.

Photograph 2 – Queuing on Melbourne Avenue blocking the staff car park entrance

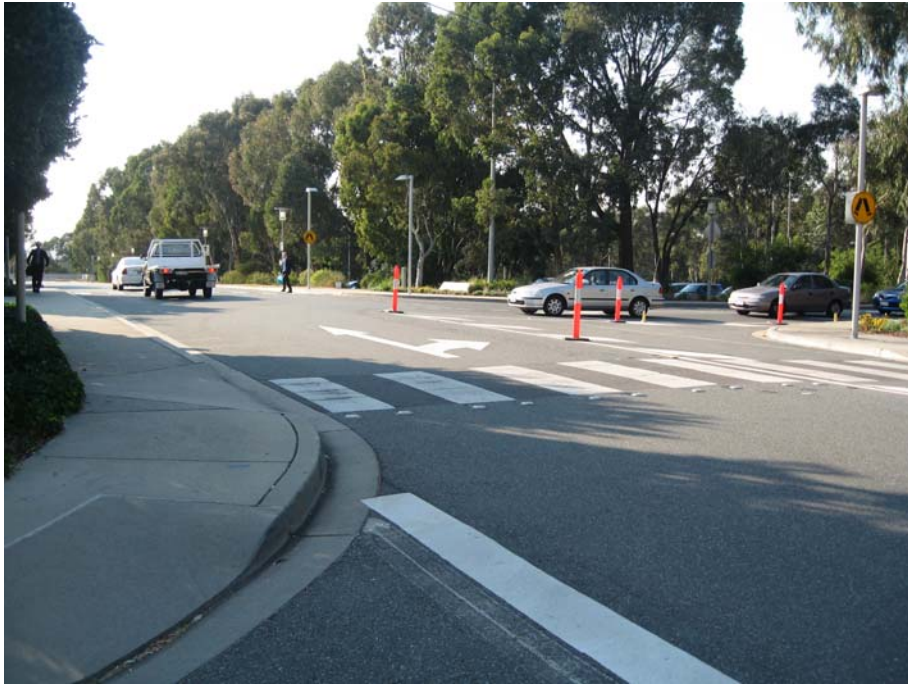
Photograph 3 – Non standard pedestrian crossings with reduced conspicuity for drivers

- 5.1.9 Standardise traffic control devices including the zebra pedestrian crossings, speed humps and the replacement of Stop signs with Give Way signs (cost estimated to be \$20,000 inclusive of GST);

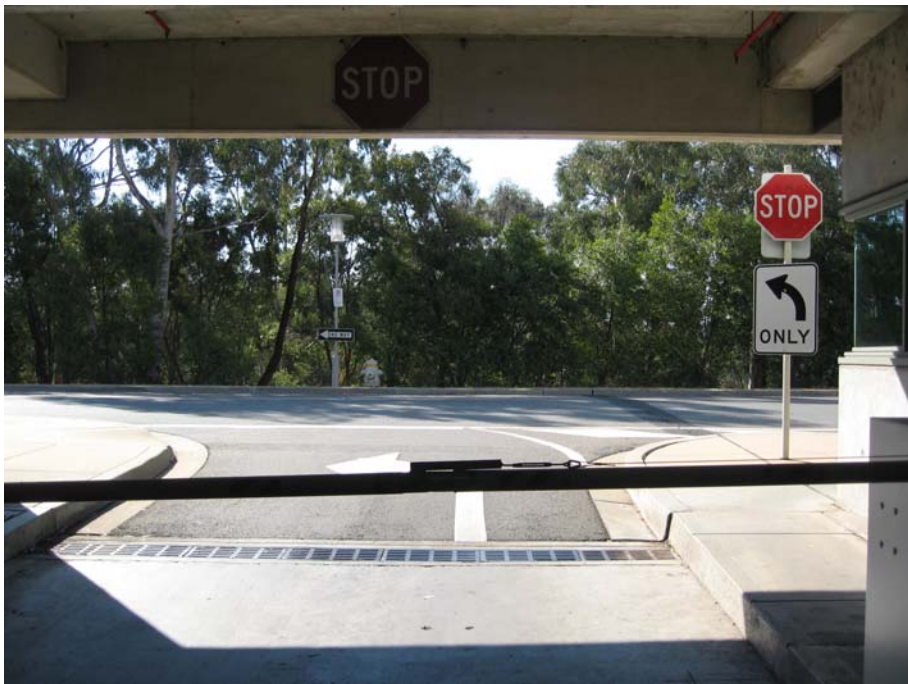
- 2.2.11 The bollarded exits to each of the slip roads feature signage directing motorists to only exit left out of these restricted driveways. Even though it is unlikely that drivers unfamiliar with the traffic arrangement would be driving out of these exits, during the relatively short time of our site inspection, one driver was observed turning out of the Ministerial wing exit road the wrong way.

Photograph 4 –Direction signage at underground staff carpark exit

- 2.2.14 This suggests that physical directional barriers need to be added at each of the exit points to reinforce the appropriate direction of travel. Such barriers should where possible prevent inappropriate turns or at least make them physically difficult.

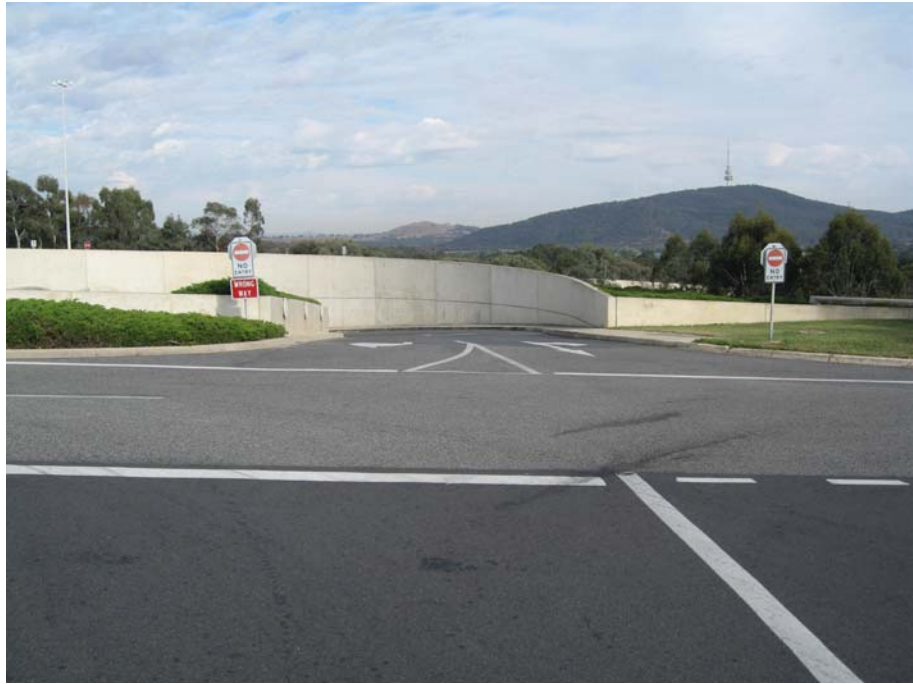
Photograph 5 – Misleading linemarking at public car park exit

- Replace all Stop signs with Give Way ;
  - provision of additional One Way signs at a number of turning points;
  - Linemarking adjustment at the exit to the Forecourt public car park;

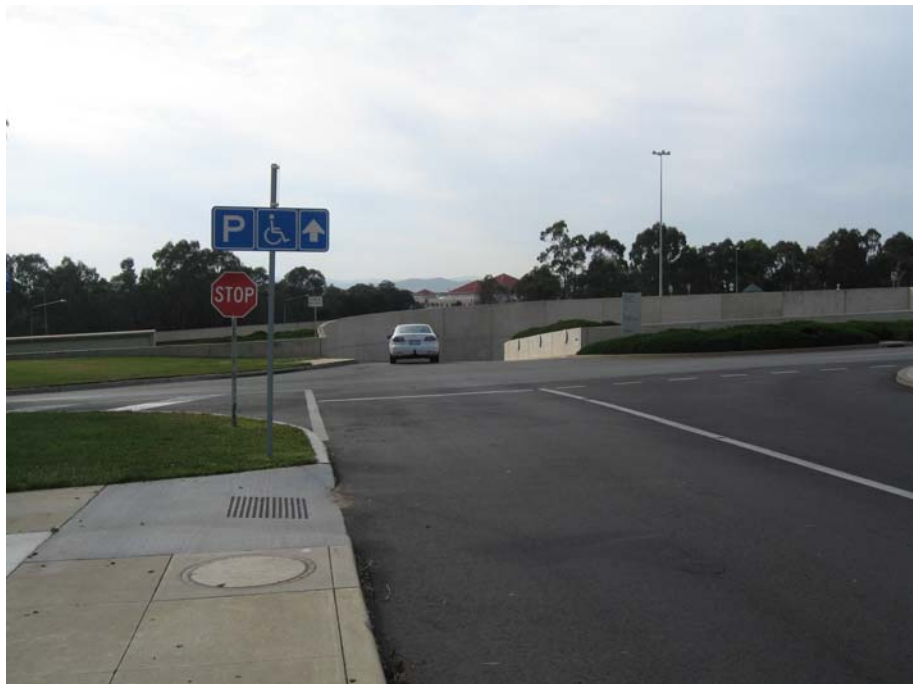
- 2.7.6 Where Stop sign warrants are not met, the signs should be replaced with Give Way signs.
- 2.7.7 There is a noticeable lack of pavement arrows approaching intersection points particularly around carpark entrance points. Pavement arrows quite effectively provide allowable direction of travel clues to drivers.

Photograph 6 – Lack of pavement arrows to assist motorists with available options

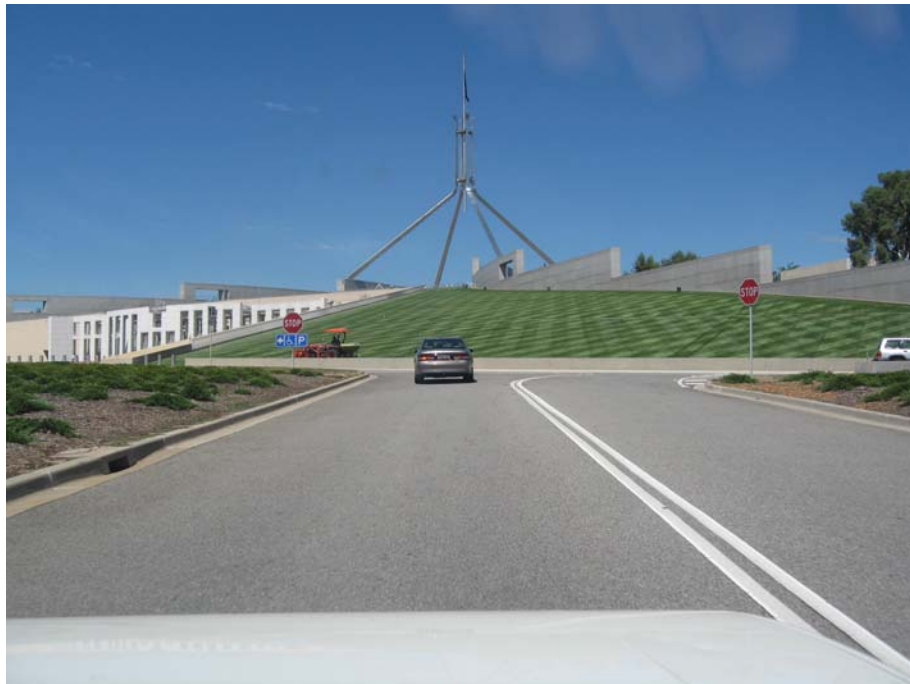
- 2.7.1 A number of other locations require some modification
- 2.7.2 At each of the intersections along Parliament Drive and Federation Mall, Stop signs have been installed. Measurement at each location revealed that the Australian Standard conditions warranting provision of a Stop sign are not met.

Photograph 7 – Commonwealth Avenue approach to Parliament Drive where motorists turning left are required to stop unnecessarily

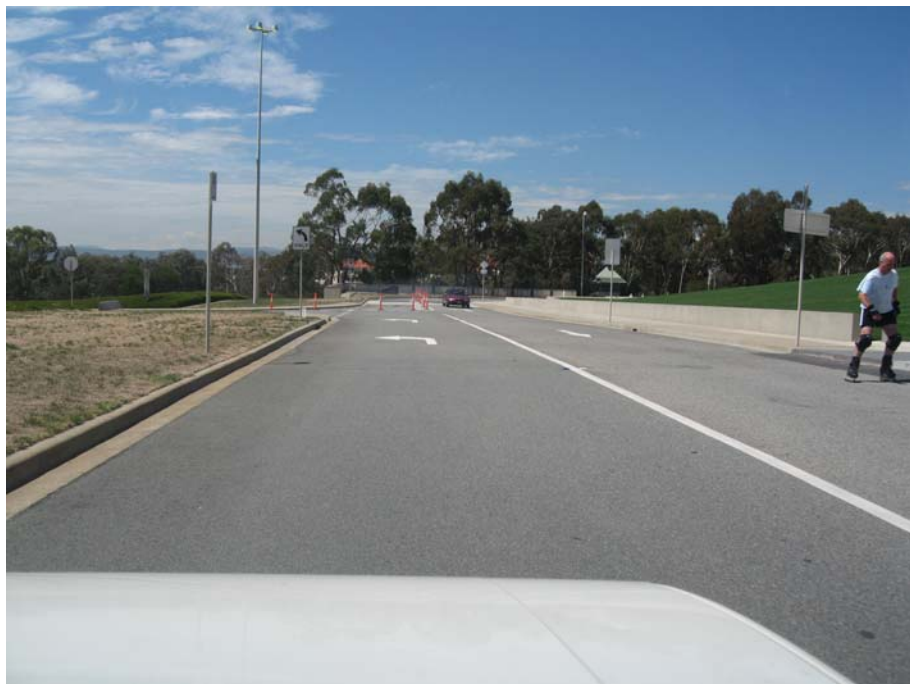
Photograph 8 – Approach to Kings Avenue. Report recommends reversing priority on this approach

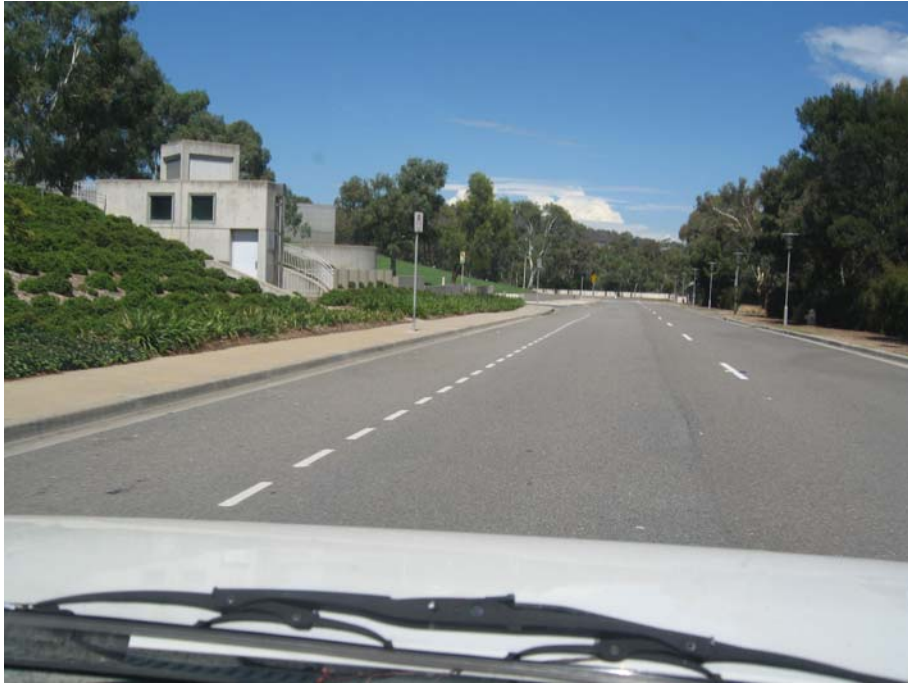
2.1.4 The open width also encourages travel at speed and several vehicles were observed travelling at well in excess of the speed limit.

Photograph 9 – Wide open road space (Senate side) encouraging high travel speeds

- 5.1.4 Replace linemarking on Parliament Drive to constrain traffic and encourage, where possible, use of the outside lane by vehicles not looking to stop or enter a car park (cost estimated to be \$30,000 inclusive of GST);

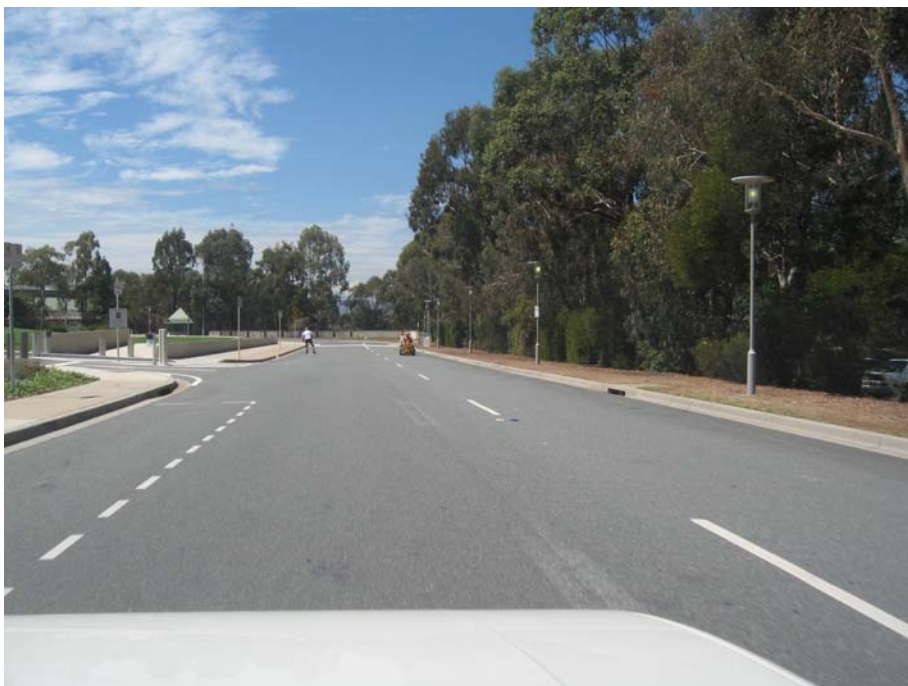
Photograph 10 – Motorised landscape machine travelling the wrong way on Parliament Drive six months after the one way scheme was implemented
