DEPARTMENT OF PARLIAMENTARY SERVICES

PARLIAMENT HOUSE, CANBERRA

ACCESSIBILITY REVIEW

6th May 2011

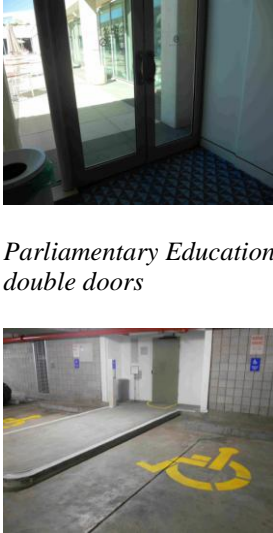
<p><i>Parliamentary Education double doors</i></p> <p><i>Typical powered entry doorway from Reps/Senate car parks</i></p>
Passenger Lifts			
13	Passenger lifts – carpet	Ensure carpet pile height in lifts is not greater than 11mm; or replace altogether with hardstand surface.	N/A
Taxi			
14	Taxi Bay - location	<p>Ensure one taxi pick-up/setdown point is accessible. Ensure any accessible public taxi pick-up/set-down point is located wholly located on a level area. Currently, the entire taxi rank is located on an area which is at an unsuitable grade.</p> <p><i>Rationale:</i> Safety and accessibility for wheelchair users. Taxi stands are akin to accessible car parking in that a level surface is required for boarding and disembarkation.</p>

No	Item	Recommendation(s)	Photo
			<p><i>Marble flooring at Marble Foyer.</i></p>
12	Doorways - automation	<p>Ensure the doors connecting the Parliamentary Education room with the Queens Terrace and doors connecting to rooftop domain are power operated. Currently doors are heavy to operate.</p> <p>Investigations to be undertaken for heavy-weight entry doorways that connect to key or high-traffic areas – eg, the double doors at the bridge links – to be power operated.</p> <p>Ensure fully automated hinged doors are programmed to remain open for a reasonable period of time – 15 seconds is recommended.</p>

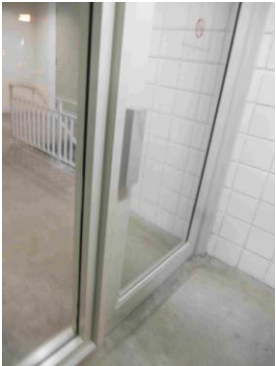
<p><i>View into the basement public accessible toilet. The door latch is at far right.</i></p>

Sanitary Facilities			
18	Accessible toilet door	<p>Provide a minimum 300mm internal latch-side clearance at the entry doorway to the accessible toilet at the public car park on basement level. This can be achieved by re-hanging the door. Currently, the internal latch-side clearance is less than 100mm.</p>

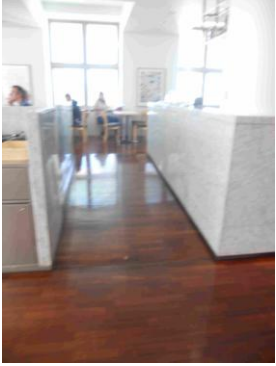
<p><i>Internal ramp at Queen's Terrace Café</i></p>
6	Corridor lighting fixtures	<p>Consideration to be given for the provision of a minimum vertical clearance of 2000mm above FFL under wall lighting fixtures.</p> <p><i>Rationale:</i> The principal potential safety issue is in relation to a person with a visual impairment using the wall as a means of orientation.</p>

5	Queens Terrace Café – internal ramp	<p>Consideration to be given to providing handrails on either side of the internal ramp within the Queens Terrace Café.</p> <p><i>Rationale:</i> There is already a continuous accessible path of travel to the majority of the floor area within the Café. The upper area to which the ramp leads contains no features or amenities which are unique, or different to those on the main floor level.</p>
