PARLIAMENT HOUSE, CANBERRA

STONEMWORK CONDITION REPORT

JULY 1990

REPORT NO. C 179

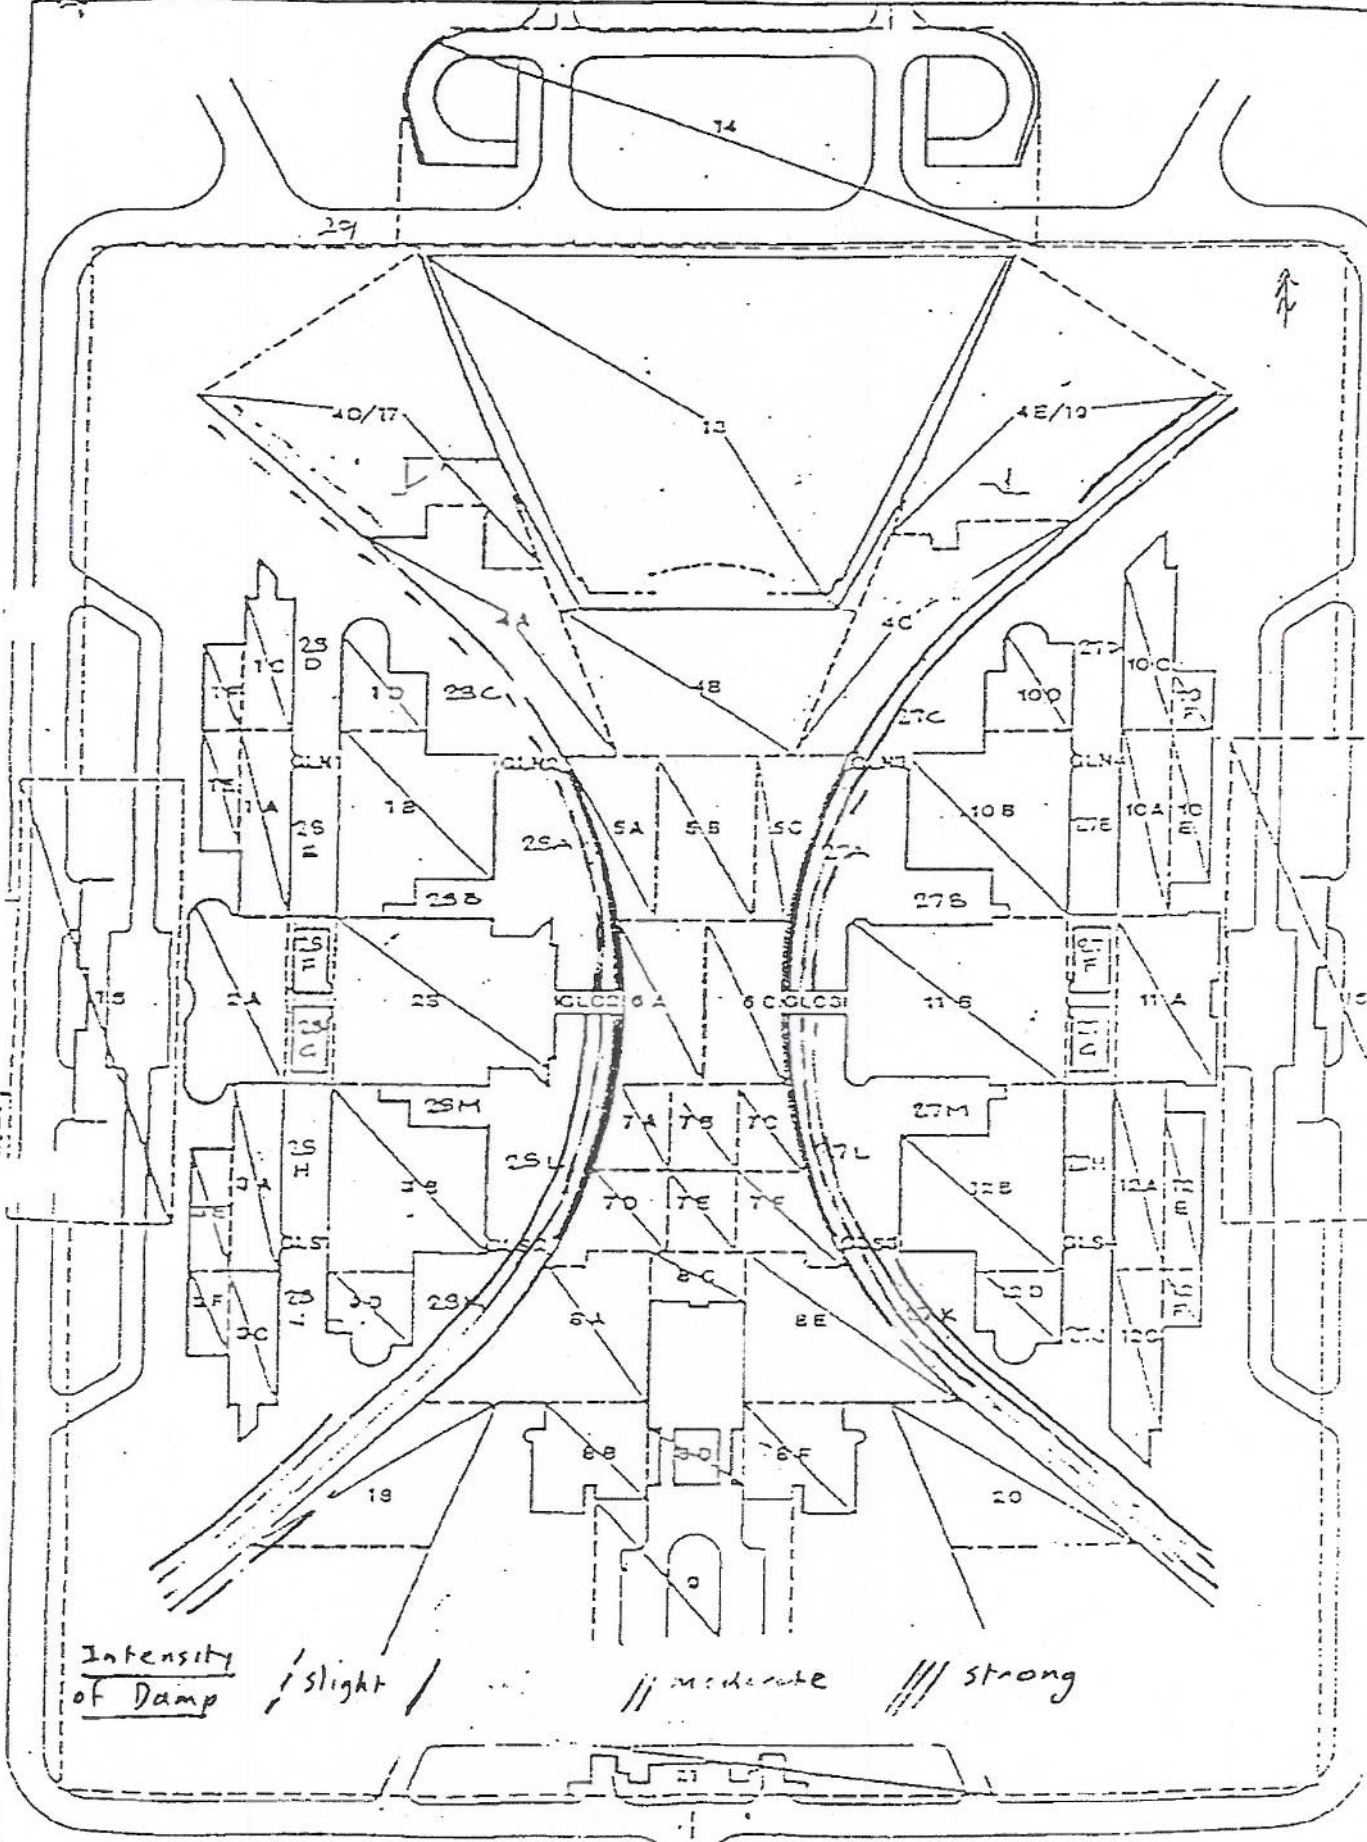
- (1) It is not evenly developed throughout both surfaces of both curved walls: It is uncommon on the inner surfaces and most strongly developed at the southern ends of the outer surfaces of the walls. Distribution is shown in Figure 1.

Intensity of Damp / slight // moderate /// strong

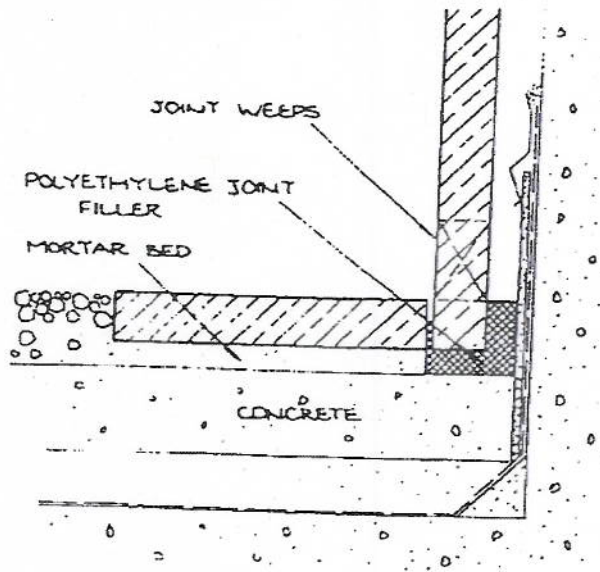
1. Outer base of marble columns

The marble of the forecourt is sound and not decayed but the damp at the base of the panels, recorded in 1988 is not only still present (Plates 6 and 7), but has matured to the stage where yellow iron staining is developing at the upper margin (Plate 7, No. 2).

- (1) The damp appears on all columns and wing walls.
- (2) The upper level of damp ranges from 0 to 800 mm above the base but is variable both across the whole structure, around each column and even on an individual panel.

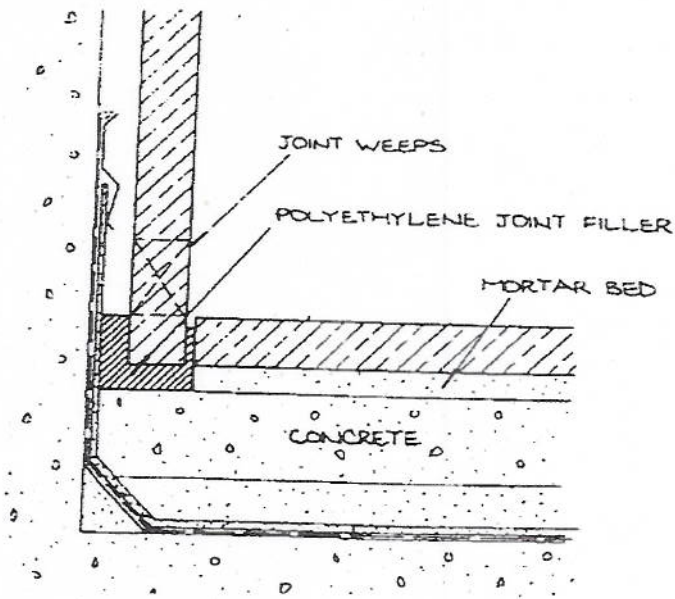
2. Inner base of marble columns

- (3) The intensity of darkening due to the damp is variable within each column, the damp on rear (inner) panels appearing fainter in darkening but commonly greater in height.

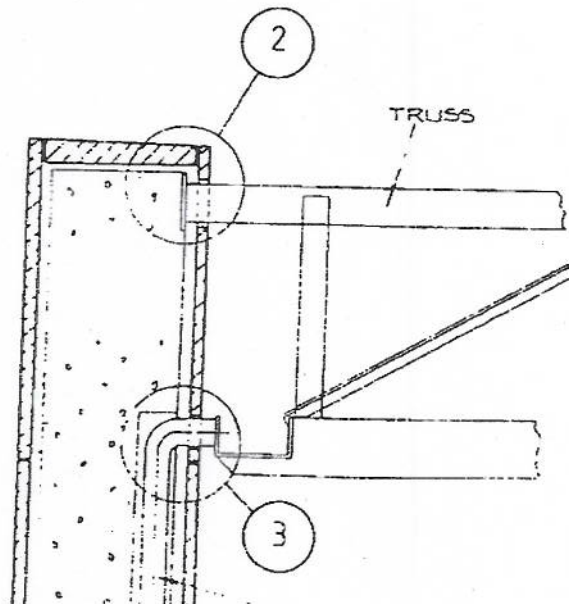
3. Down pipe at top of marble columns, passes down through columns

- (a) Moisture penetrating beneath the base of the lower-most panel from rainwater run-off or hosing of the paved area.
- (b) The structure of the base, as originally designed (drawing W32-044271-310 of 17.3.86, hence not necessarily the final design or the actual construction) is shown in Figure 2. The area marked 'polyethylene joint' is critical as it is a potential leak path. The supposedly open joint above is also important as moisture could be held behind the panel if the cavity has been filled, intentionally with mortar as 'solid-fix' or accidentally with rubbish.
- (c) Falling damp from open joints above or leakage from the rainwater draining downpipe (Figure 2) which passes down many columns.

The damp has been present for at least 2 years and is not improving, in fact, it is now developing unsightly brown staining which will increase with time. Actual deterioration of the marble will follow. The yellow staining should be removable (see Section 2.5.2.) but would probably return. It is essential to determine the source of the moisture so that this can be corrected. This should first involve an examination of the uppermost parts of the structure, looking for possible entry points for rain, of the joint, gaskets and of any seals around the base, plus any plumbing. Further investigation should be similar to that proposed in Section 2.2.2 for the similar problem of the granite on the curved walls. Removal of a panel may be necessary.

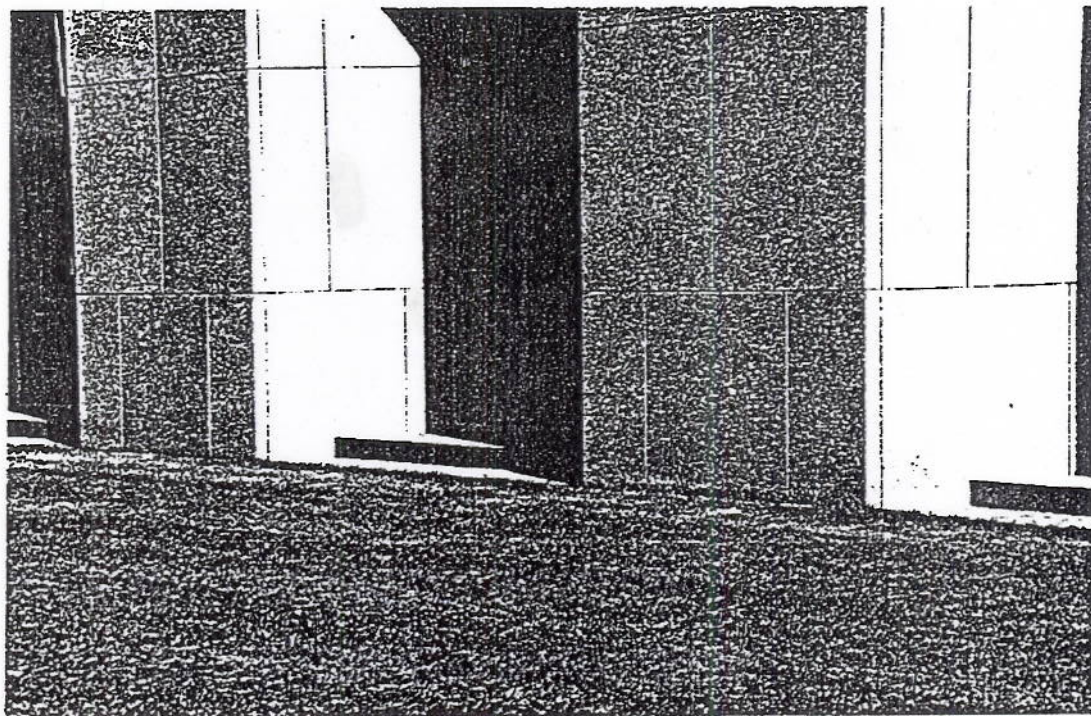
NO 1 The damp is visible as the irregular dark band at the base
of these columns on the outer surface, southern end,
eastern wall, area 27K. The lighter grey panels are on the
reveals to the columns.

It is essential to determine the cause of the problem in order to devise a cure, therefore it is necessary to investigate the construction of the rear of the base of the panels. This will require some penetration of the panel. The simplest method would be to core-drill (say 50 mm) several holes through the base and insert a light and a mirror to view. The core plugs could be re-fixed to repair the holes. Alternatively the whole base could be removed by sawing a strip, say 200 mm high across the base. This could be repaired easily.

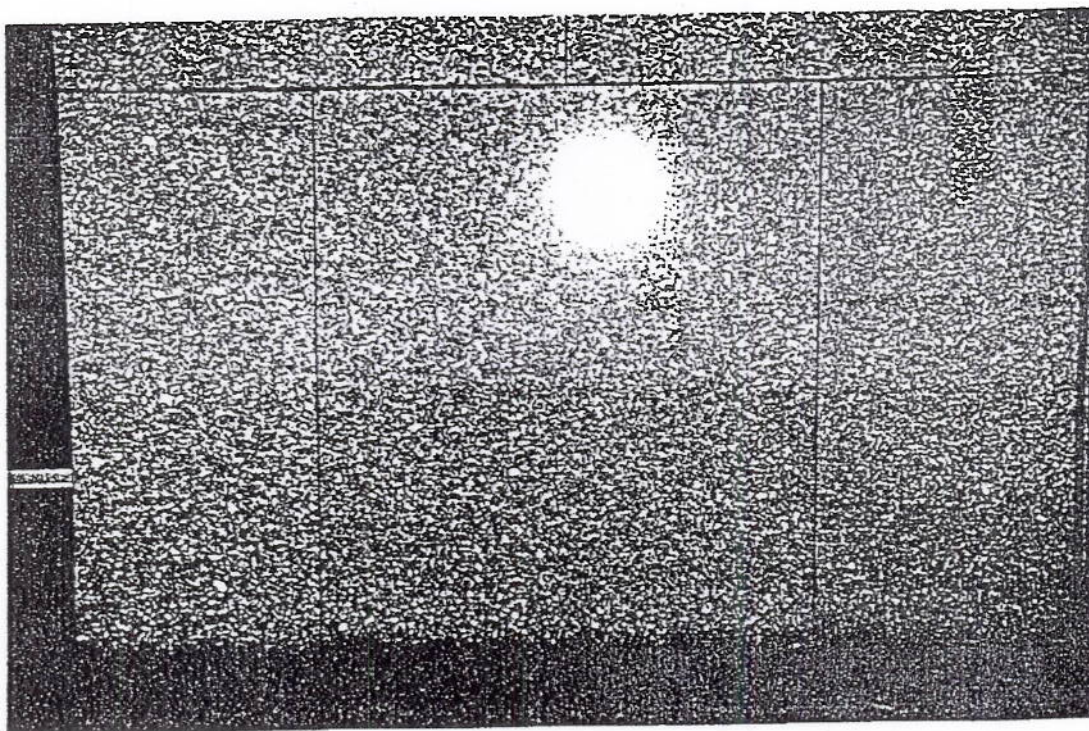
NO 2 The upper limit of damp differs from panel to panel, here
being higher in the central panel; location as for 1 above.
