Project  
Water Fountain Waterproofing Scoping  
Study

Client  
High Court of Australia,  
Parkes Place, Parkes ACT

Prepared by  
Hoadley Budge Olphert & Edwards  
Madigan Torzillio Briggs Pty Ltd  
ABN: 41 091 139 972

# High Court of Australia Water Fountain Waterproofing Scoping Study

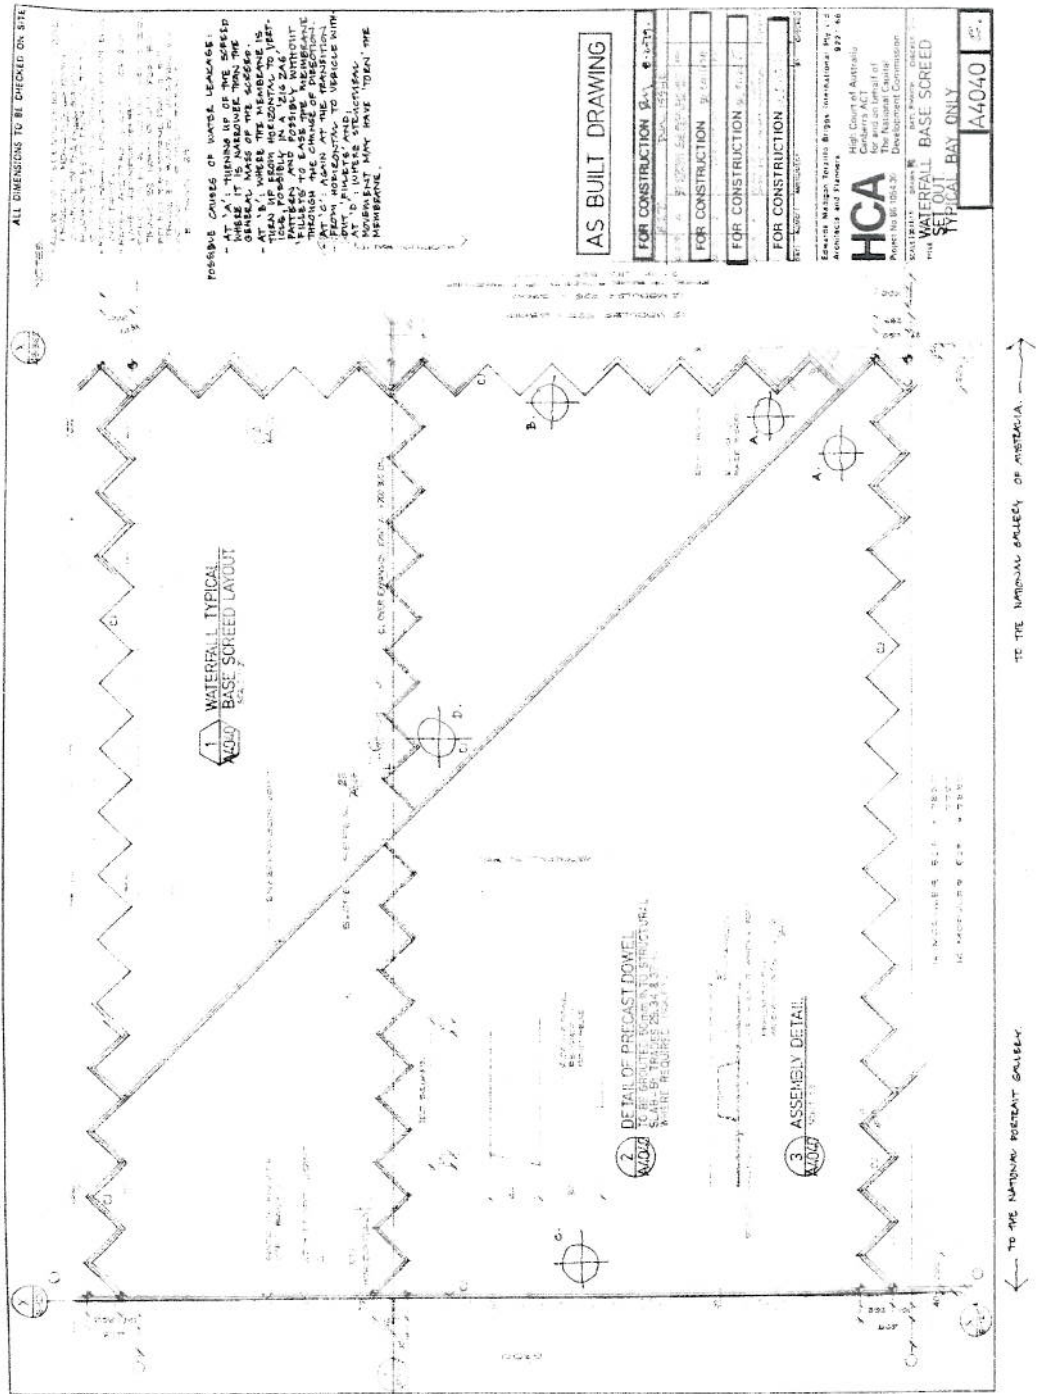
HCA Water Fall – Base Screened Set Out Typical Bay

HBO+EMTB and Cardno Young have identified, and indicated on "HCA Water Fall – Base Screed Set out Typical Bay" on page 13, the following possible causes of water leakage:

- \_ At position `A,' we consider that there has occurred the 'turning up' of the screed where it is narrower than the general mass of the screed, possibly causing a fracture of the membrane beneath,
- \_ At `B,': where the membrane is turned up from horizontal to vertical, possibly in a `zig zag' pattern and possibly without `fillets' to ease the membrane through the change of direction. The `zig zag' pattern, if covered with membrane with multiple joints, would be a potential area of water penetration due to the multiple seams in the membrane,
- \_ At `C': again at the transition from horizontal to vertical without `fillets' to ease the transition of the membrane and,
- \_ At `D': where structural movement may have `torn' the membrane

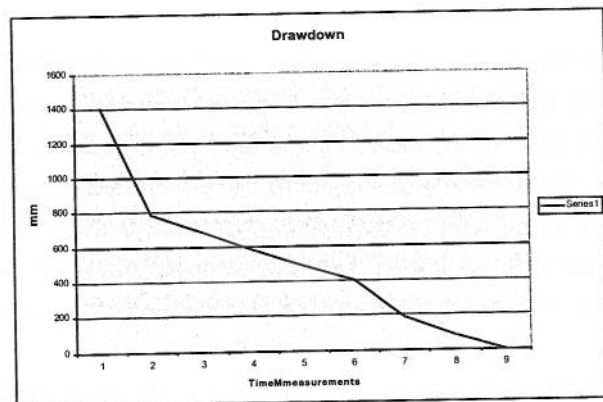
Further inspection of the feature on 24 June 2008 showed the cascade pools had continued to leak towards the Holding Pool, and then into the Holding Tank. A pump drawdown test was conducted to determine drawdown and tank capacity with respect to the feature's water volume requirements. A simple measure of drawdown against time was recorded until the pump cut out by activation of the low water level switch in the Holding Tank. There was some water retained in the cascade pools prior to the commencement of the pump test. As no volume was available from the original drawings for the Holding Tank the calculations are based on basic field measurements of distance from the top of the Holding Tank against time from when the pump was started. The results are below.

Time (Min)	Drawdown (mm)
Zero	380
6.00	1000
7.00	1100
8.00	1200
9.00	1290
10.00	1380
12.00	1600
13.00	1700
13.45	1780.

Note: the pump stopped at 13.45 minutes . The tank depth is 1780 mm, except for the sump well to the west, which is deeper and drains to the internal pump below.

This simple drawdown test demonstrated the Holding Tank capacity at the time was less than that required to fill the pools and have sufficient water remaining in the tank to allow reticulation. This makes no allowance for potential long term leakage from the pools. It was noted prior to the pump start up that the water level in the Holding tank and the Holding Pool was at the same level, ie 380 mm below the Holding Tank top level. It is considered that the amount of water retained in the cascade pools, together with the Holding Tank capacity would be of an approximate sufficient volume for the feature to
