ATSB TRANSPORT SAFETY REPORT  
Aviation Short Investigations  
AB-2011-128  
Final

# Aviation Short Investigation Bulletin: Third Quarter 2011

Issue 7

Report No.	Publication date	ISBN
AB-2011-128	December 2011	978-1-74251-232-7

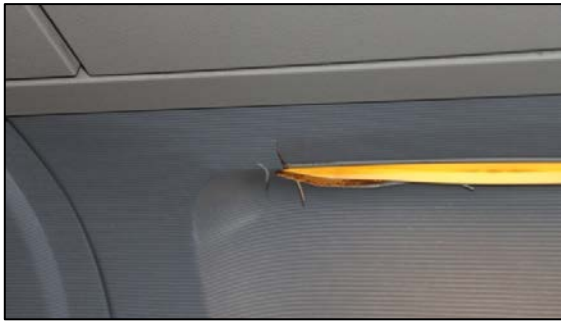
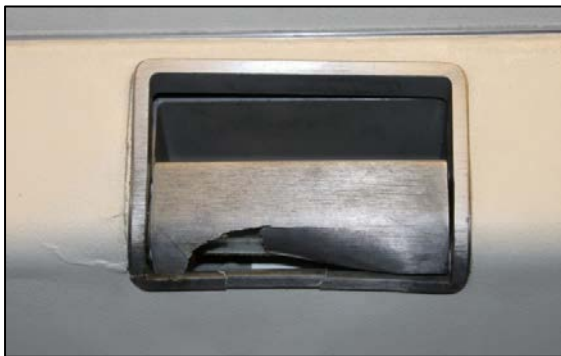
**Figure 1: Damage to window reveal and overhead locker**

Further turbulence was experienced and the flight crew elected to conduct a go-around. The aircraft was levelled off at 3,000 ft and the PIC made an announcement to reassure the passengers and cabin crew. The cabin crew then contacted the flight crew and advised that two passengers, who were reportedly not wearing their seat belts at the time, had sustained injuries from coming into contact with a window reveal and an overhead locker (Figure 1). The two passengers were seated separately.

As a result of the turbulence, one passenger sustained a head injury and received medical treatment on arrival at Perth. A second passenger sustained a deep cut to his head; spinal pain; and soft tissue damage to his neck, back, leg and arm, and was subsequently transported to hospital for treatment.

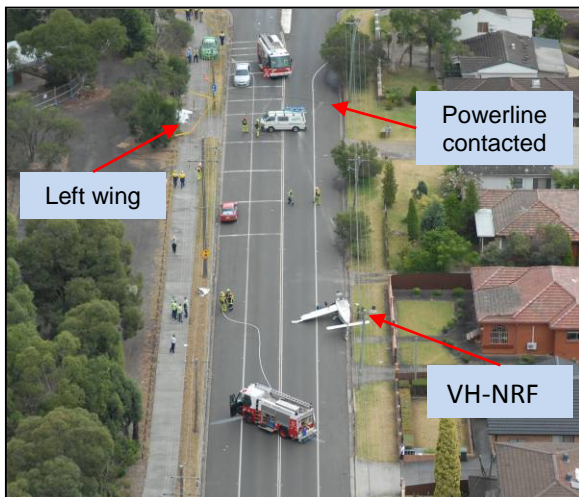
**Figure 1: Accident site**

About 1 minute later, in preparation for the landing, the pilot attempted to turn the fuel selector off and positioned the aircraft to fly between powerlines that ran across the street, but due to vehicles in the area he had to slow the aircraft. He determined he had insufficient height to fly over the powerlines so attempted to fly between two powerlines that were about 2.5 m apart. During the manoeuvre, the left wing contacted the lower powerline and became separated from the aircraft. The aircraft then rolled to the left and became inverted. It continued airborne along the street before the right wing collided with a power pole. The aircraft spun around and impacted the ground at about 1232 Eastern Standard Time<sup>6</sup> (Figure 1).

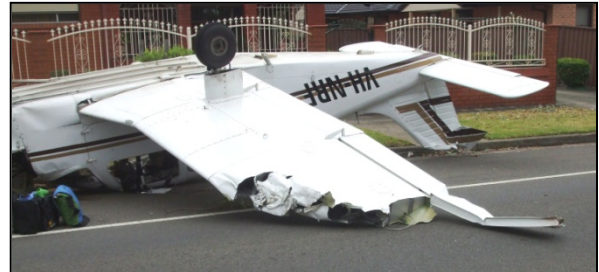
**Figure 2: Aircraft wreckage**

The pilot and passenger released their seatbelts. The door could not be opened, so the pilot kicked the door window out and both egressed. The pilot and passenger sustained minor injuries, the aircraft sustained serious damage (Figure 2).

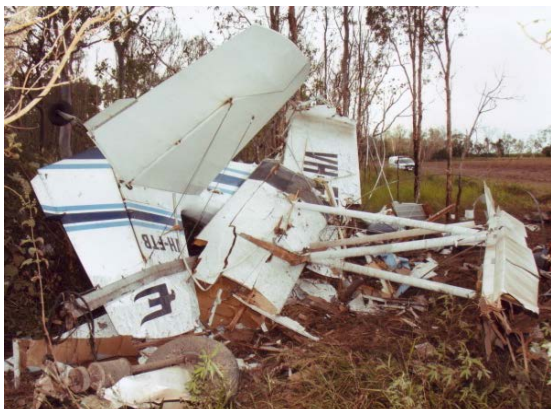
**Figure 2: Wreckage**

Although the pilot's injuries were serious, his being securely restrained and wearing a helmet significantly reduced the potential level of injury.

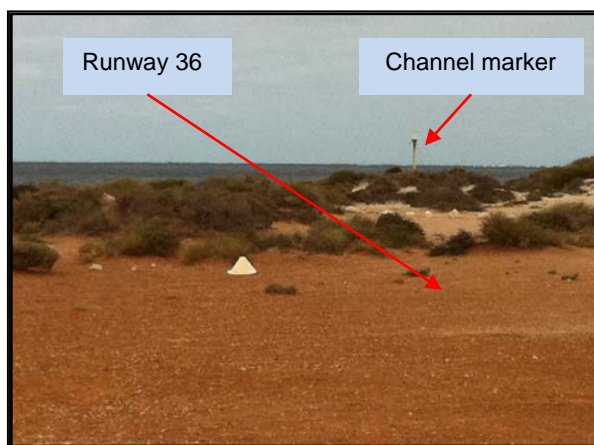
**Figure 2: Channel marker**

The channel marker provided navigational guidance for vessels operating into the anchorage and jetty area located on the eastern side of the Island. The marker, which was about 2.8 m in height, was located to the south-west of the runway<sup>3</sup> (Figure 2). The pilot stated that, while the marker was positioned to the left of the runway centreline, it was reasonably visible when on final approach.

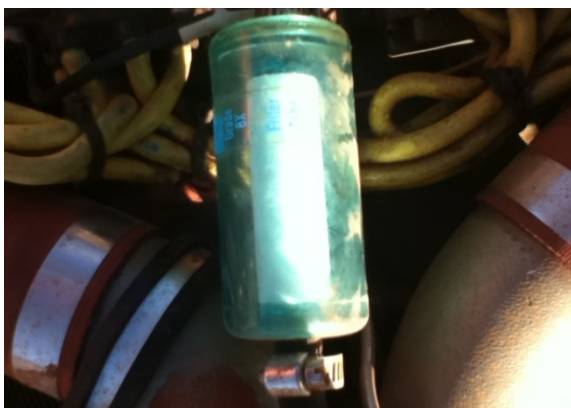
The fuel from both wings was found to be clean, bright and free of visible contaminants. The aircraft fuel filter, contained within the engine bay, was found intact but empty of any fuel (Figure 2).

**Figure 2: Empty fuel filter in engine bay.**

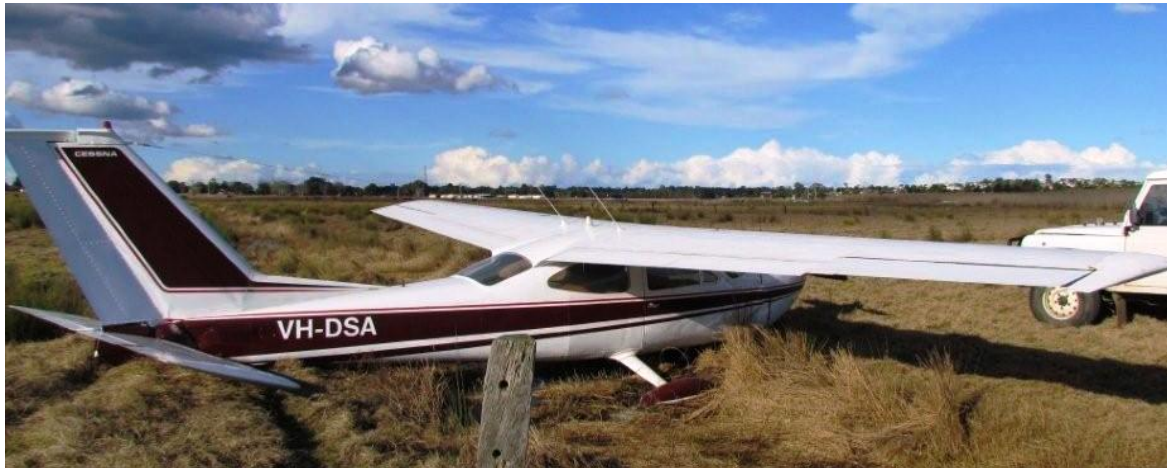
Figure 3: VH-DSA in the shallow earth drain.

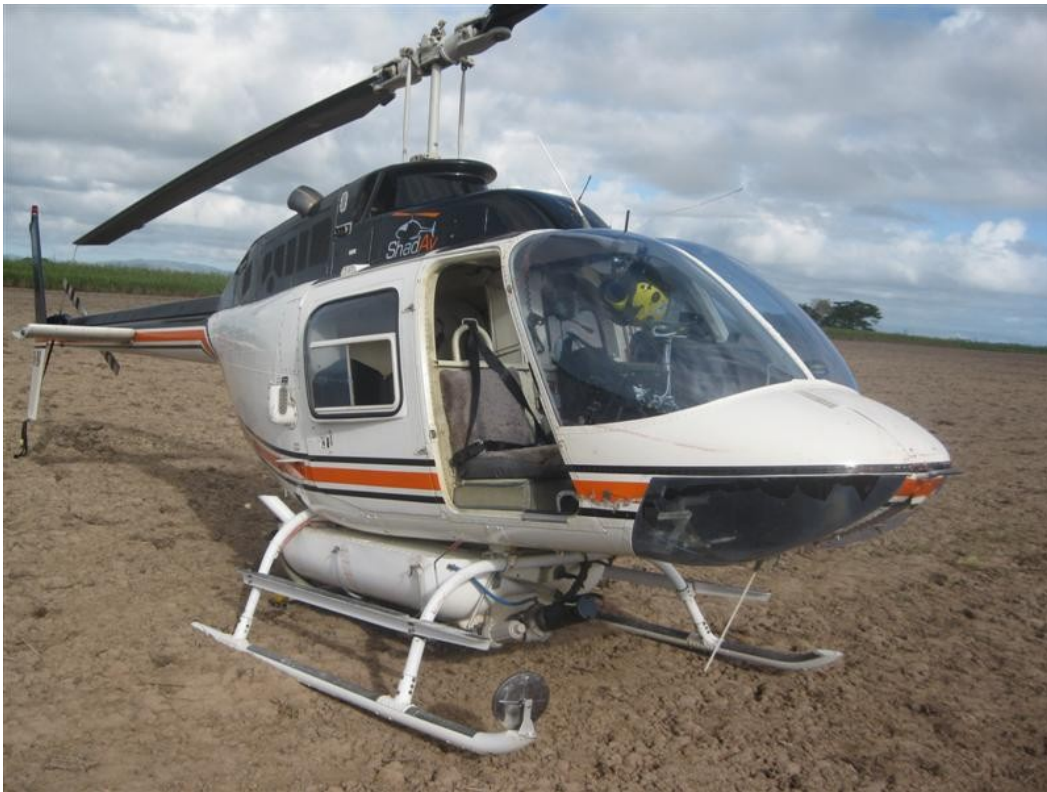
Figure 4: VH-BNG after wirestrike.

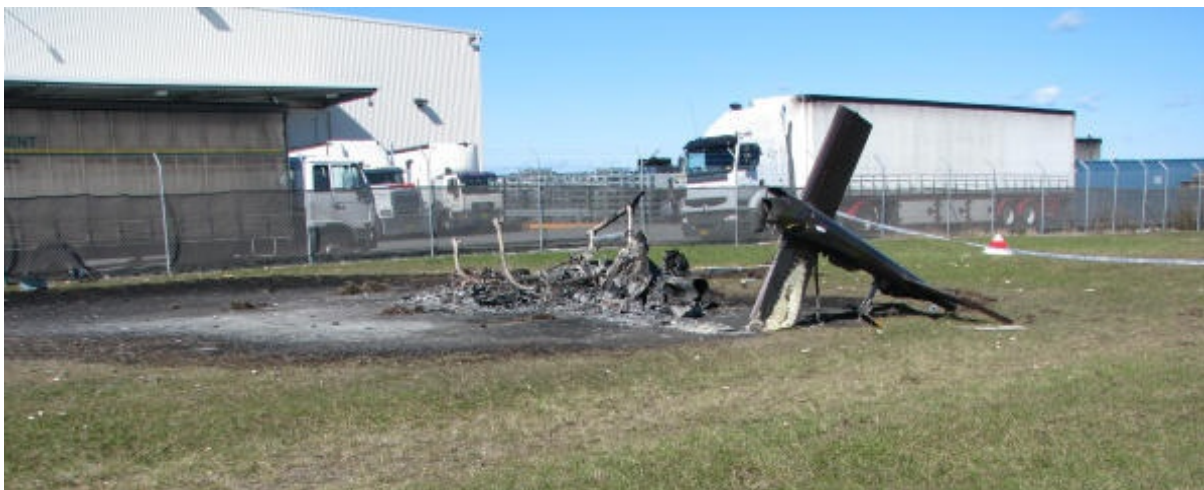
Figure 5: VH-XXW Wreckage

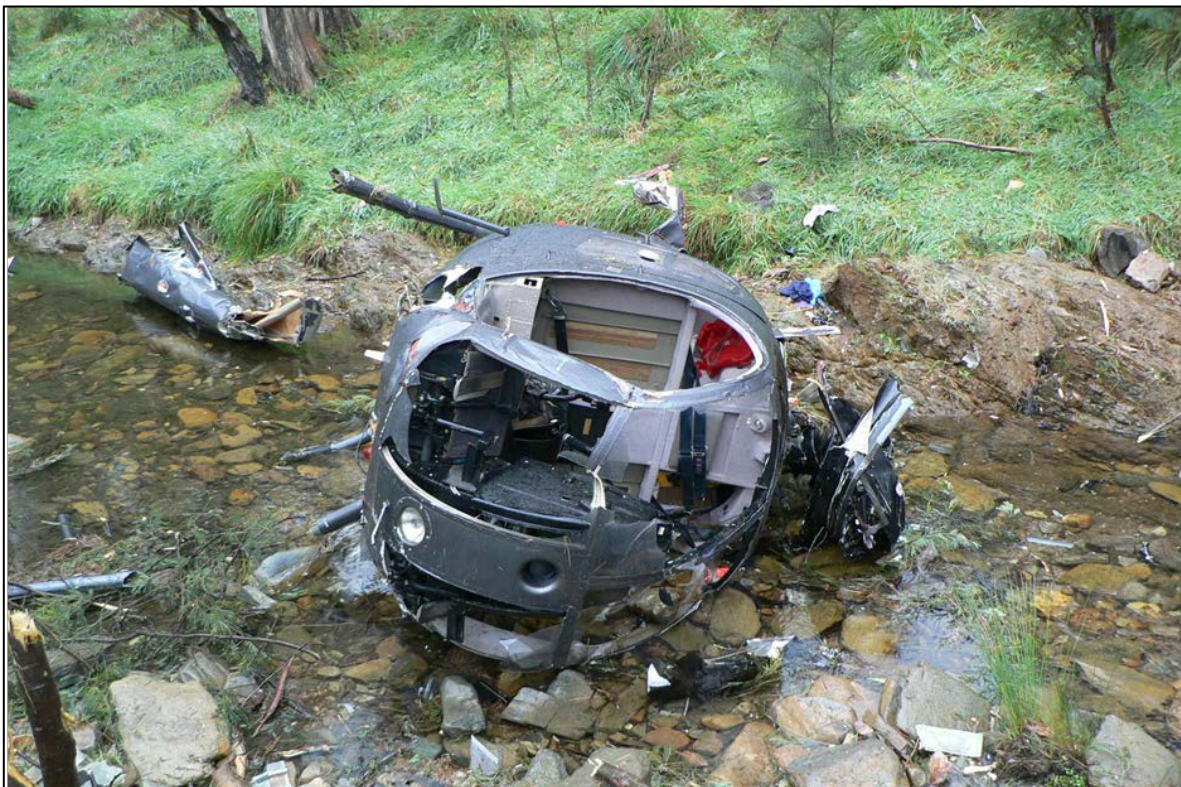
The ATSB did determine that the increased power required for hovering OGE, coupled with a right pedal turn, increased the risk of LTE.

Figure 1: Wreckage of VH-XAA

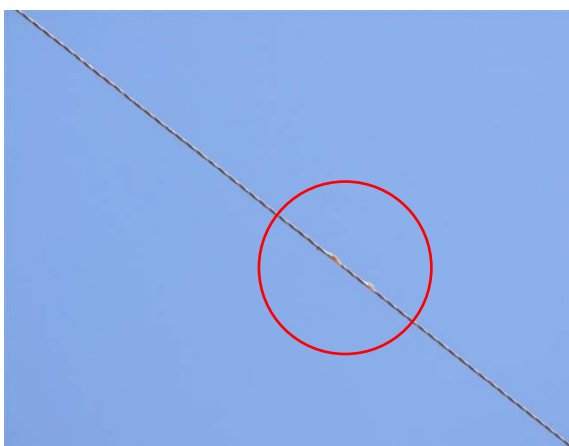
The police also noted impact marks on the power line (Figure 4). An inspection of the helicopter revealed suspected wirestrike markings on the upper surface of the right side skid and the main rotor blades.

Figure 4: Contact point with powerline
