ATSB TRANSPORT SAFETY REPORT
Aviation Short Investigations
AB-2011-128
Final

Aviation Short Investigation Bulletin: Third Quarter 2011

Issue 7

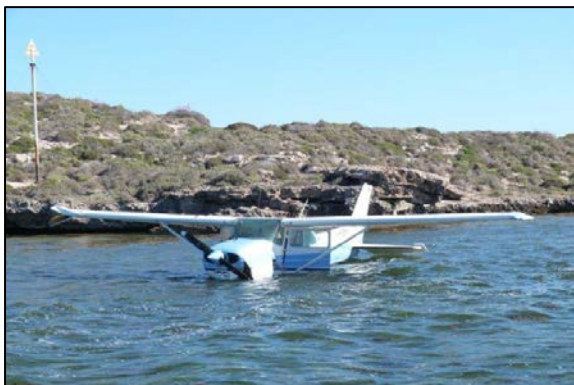
Figure 2: VH-SMY

The reason for the degraded engine performance was not determined.

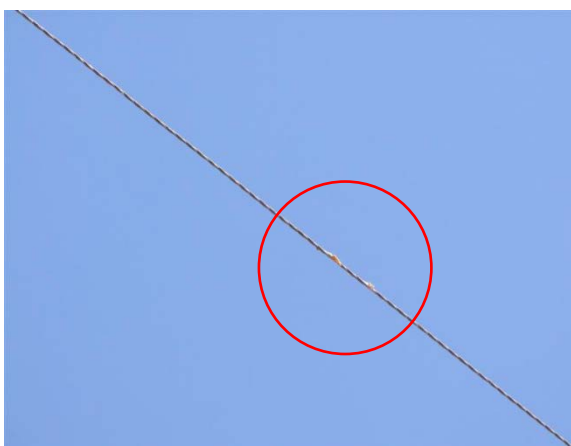
Figure 4: Contact point with powerline

The police also noted impact marks on the power line (Figure 4). An inspection of the helicopter revealed suspected wirestrike markings on the upper surface of the right side skid and the main rotor blades.
