Report of Investigation

**Flying Fish Cove
Christmas Island**

Failure of Favelle Favco Tower Crane

8 April 2005

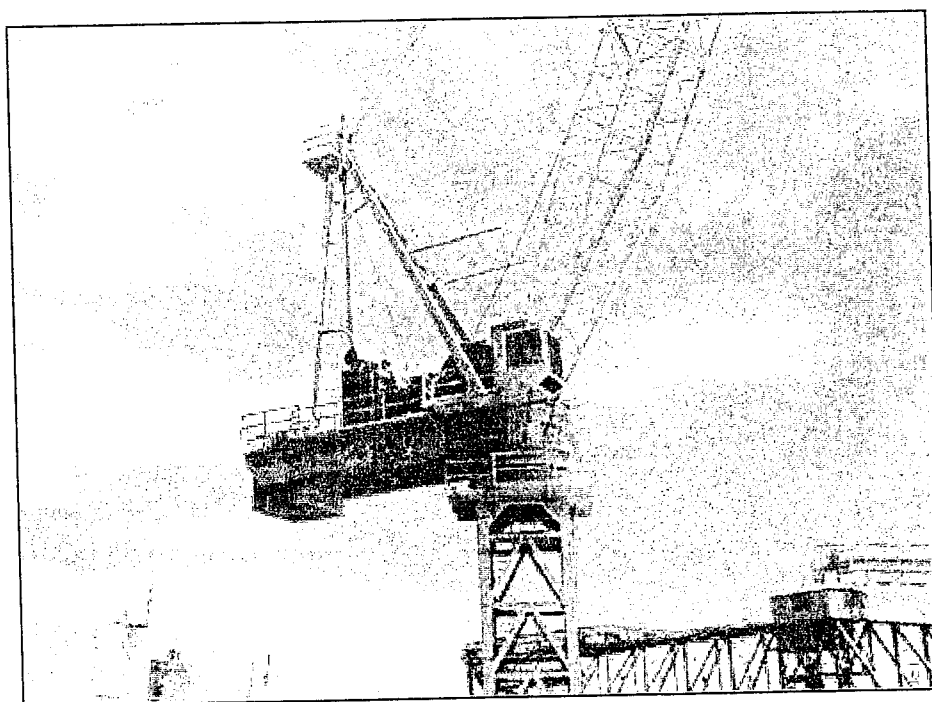
Photograph 1: Favelle Favco Tower Crane.

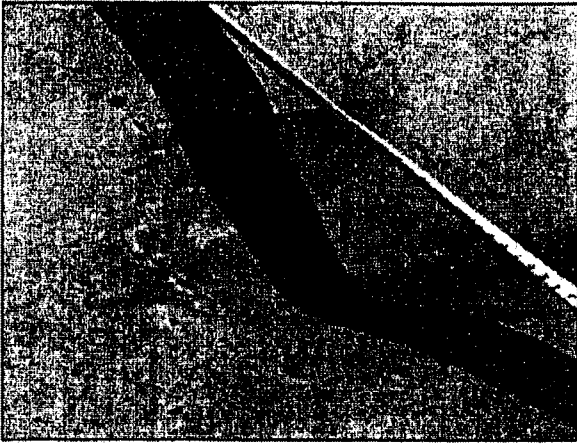
13. The speed of the boom lowering was reported to be similar to that of being under power, not a "free fall speed". The load hit the deck with considerable force, however this was probably accentuated by the fact that the ship was rolling and pitching. See photograph 2. in Attachment D.

Photograph 2 Showing Indentation on ships deck.

The ship was rolling and pitching and the inshore side of the bottom container hit the deck with force, leaving an indentation into the steel deck. When the container had fully landed it slid a few metres across the deck away from the crane. The boom was still lowering, it caused the lifting arrangement to go slack, the spreader bar with slings landed on the seaward side of the container. At that point the crane boom stopped lowering and the whole structure shook, my assumption was that this occurred due to the brakes being applied.

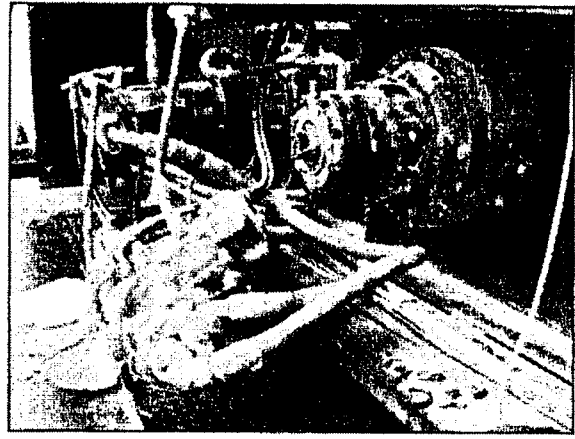
15. When Hassin left the crane cabin to survey the machinery deck he found that one of the luffing motor assemblies had broken into two pieces see photograph 3 in Attachment D. Hassin ascertained that the crane hoist and slewing motions were still operable and proceeded to stow the crane in a safe manner.

Photograph 3 Showing Failed luffing motor assembly.

I arrived at the crane site and carried out a visual inspection of the crane tower whilst climbing to the crane upper. On arrival at the crane machinery deck I saw the Rexroth hydraulic drive motor detached from the brake unit and realised that there was an adaptor failure between the Rexroth motor and Brevini brake unit.

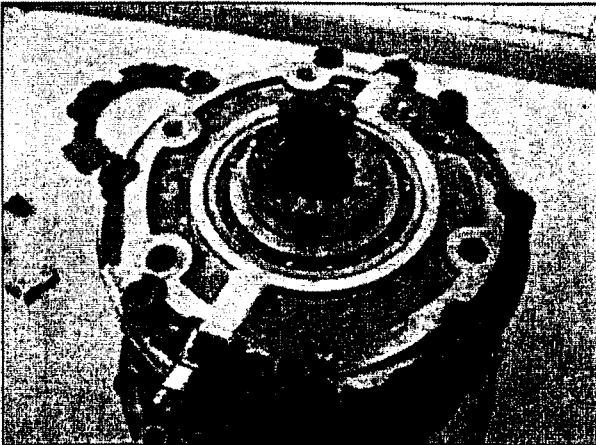
19. The motor is secured to the adaptor unit by four M12 hex bolts, removal of these bolts gave access to the connection of the motor adaptor to the brake unit. This is where the failure had occurred. The adaptor is secured to the brake unit by six M12 cap bolts. These bolts are not visible unless the adaptor is unbolted from the drive motor. Of these six, four were found to be loose inside the adaptor. Two had stripped threads on the threaded section and two were clean. The casing surrounding the brake unit had two sections broken away, with the cap bolts still attached to the threaded sections. See photographs 4 to 9 Attachment D

20. It appears that during operation of the crane two of the cap bolts had worked loose from the casing, leaving four bolts to secure the assembly. Continued operation of the crane had put stress on the four remaining cap bolts causing two to strip the threads from the casing. This then left only two bolts securing the assembly. The added stress caused two sections of the brake unit casing to break away allowing the hydraulic drive motor with the adaptor to detach.

Photograph 4 Showing damaged brake unit casing.

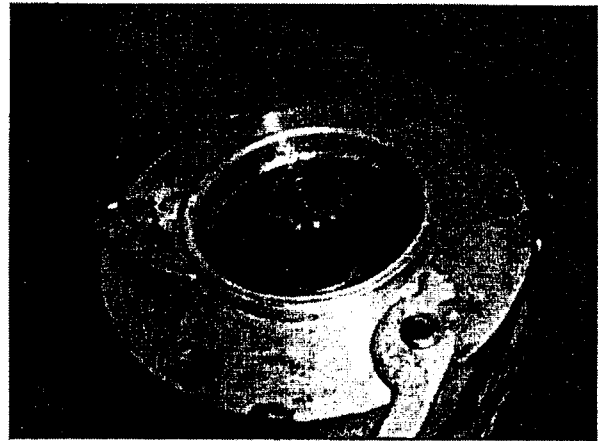
Photograph 5 Showing motor adaptor with sections of brake unit casing.

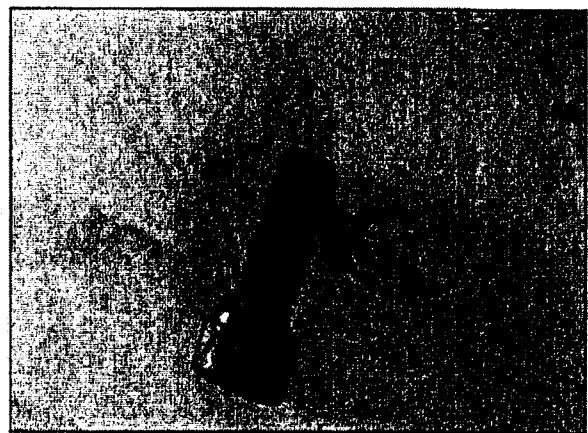
27. The ultimate cause of the incident was the failure of the cap bolts securing the motor adaptor to the brake assembly.
28. There are no positive means provided to ensure that the cap bolts cannot come loose.
29. There are no maintenance procedures that include checking the tightness of the six cap bolts.
30. If the crane driver had returned the luffing motion lever to neutral or let go of the lever the brakes would have been applied and the downward motion of the boom would have stopped.
31. Servicing and maintenance of the crane had been carried out as required by the manufacturer. Operators had completed the required daily checks. There was no evidence that the Department of Transport and Regional Services had breached the Act.

Photograph 7 Showing cap bolt with threads stripped from casing.

- 33.2. FFC implements a system to reduce the possibility of the cap bolts working loose.
- 33.3. DOTARS amends maintenance procedures for the Favelle Favco Tower Crane Model M760DW at Flying Fish Cove to include checking on a regular basis tightness of bolting for all major components such as drive assemblies to the luffing winch and hoisting winch frames.

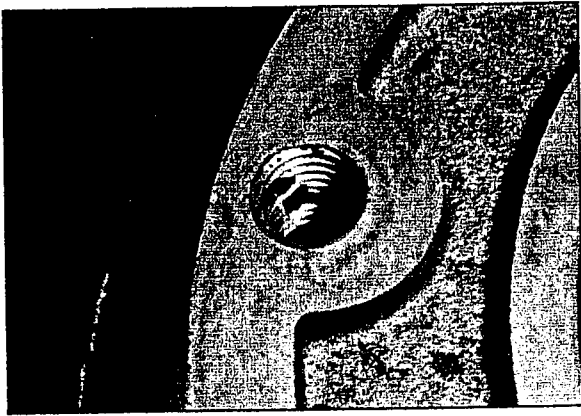
Photograph 8 Showing intact threaded bolt hole in brake unit casing.

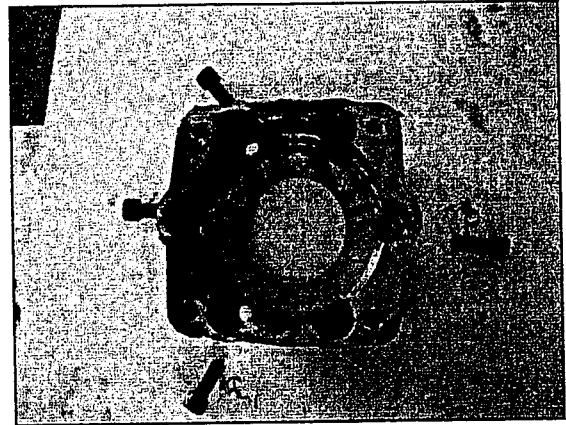
Photograph 9 Showing motor adaptor after removal from motor.

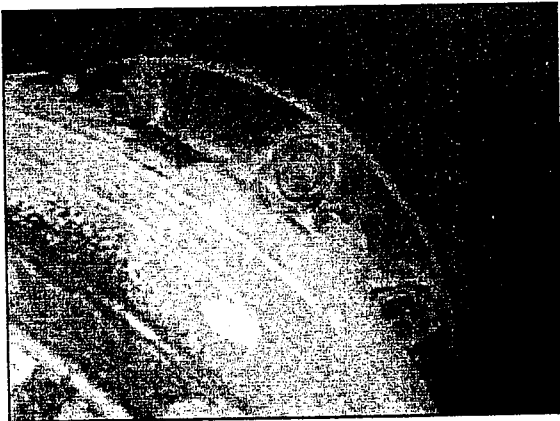
22. It was noted during the disassembly of the units that some the M19 nuts and bolts shown as item 8 & 9 Attachment I, which secure the whole drive assembly to the luffing winch frame were loose. One of the nuts had actually disengaged from the bolt (see photograph 10 Attachment D). The new drive assembly attached to the luffing winch frame is shown in photograph 11 Attachment D.

Photograph 10 Showing loose bolt on drive assembly to luffing winch frame.

On further inspection I found the main retaining bolts from the gearbox to the main winch frame were loose. I removed the drive pinions, replaced eight out of the ten bolts, applied Loctite to the nuts and then re torqued them.

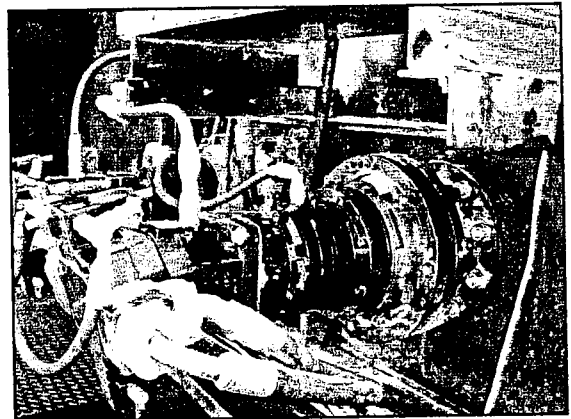
Photograph 11 Showing new drive assembly attached to luffing winch frame.

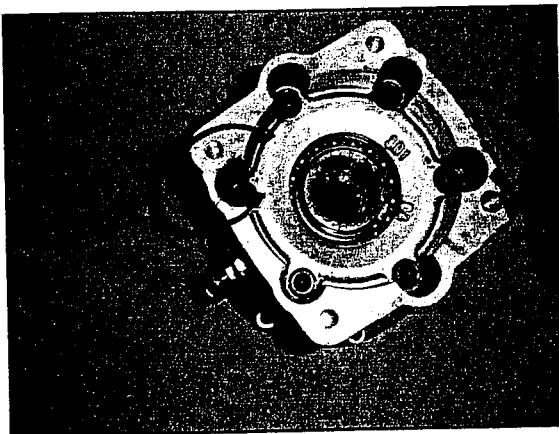
23. The second drive assembly was also dismantled for inspection at my request. It was found that a circlip, which retains the drive spline, had failed, see photograph 12 Attachment D. The failure of this circlip could lead to incorrect positioning of the spline drive causing additional stresses on the drive. This also could cause vibration in the drive assembly.

Photograph 12 Showing damaged circlip in motor adaptor on winch assembly 2.

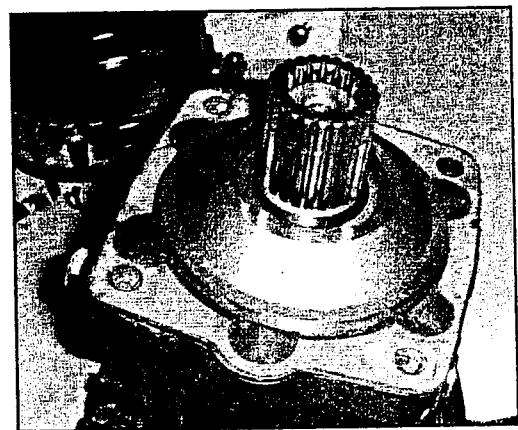
Photograph 13 Showing circlip locating groove on drive spline winch assembly 2.
