ATSB TRANSPORT SAFETY INVESTIGATION REPORT  
Marine Occurrence Investigation No. 263  
Preliminary

# Loss of containers from *Pacific Adventurer* off Cape Moreton, Queensland 11 March 2009

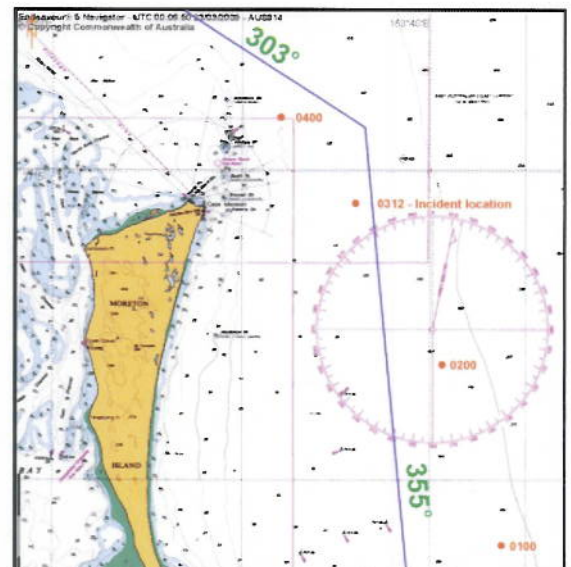
**Figure 2:** Section of navigational chart Aus 814 showing the ship's planned track and actual positions as it approached Cape Moreton
