Reference: Plantations forests industry

FURTHER SUBMISSION FOLLOWING COMMITTEE'S VISIT

COUP LA028A

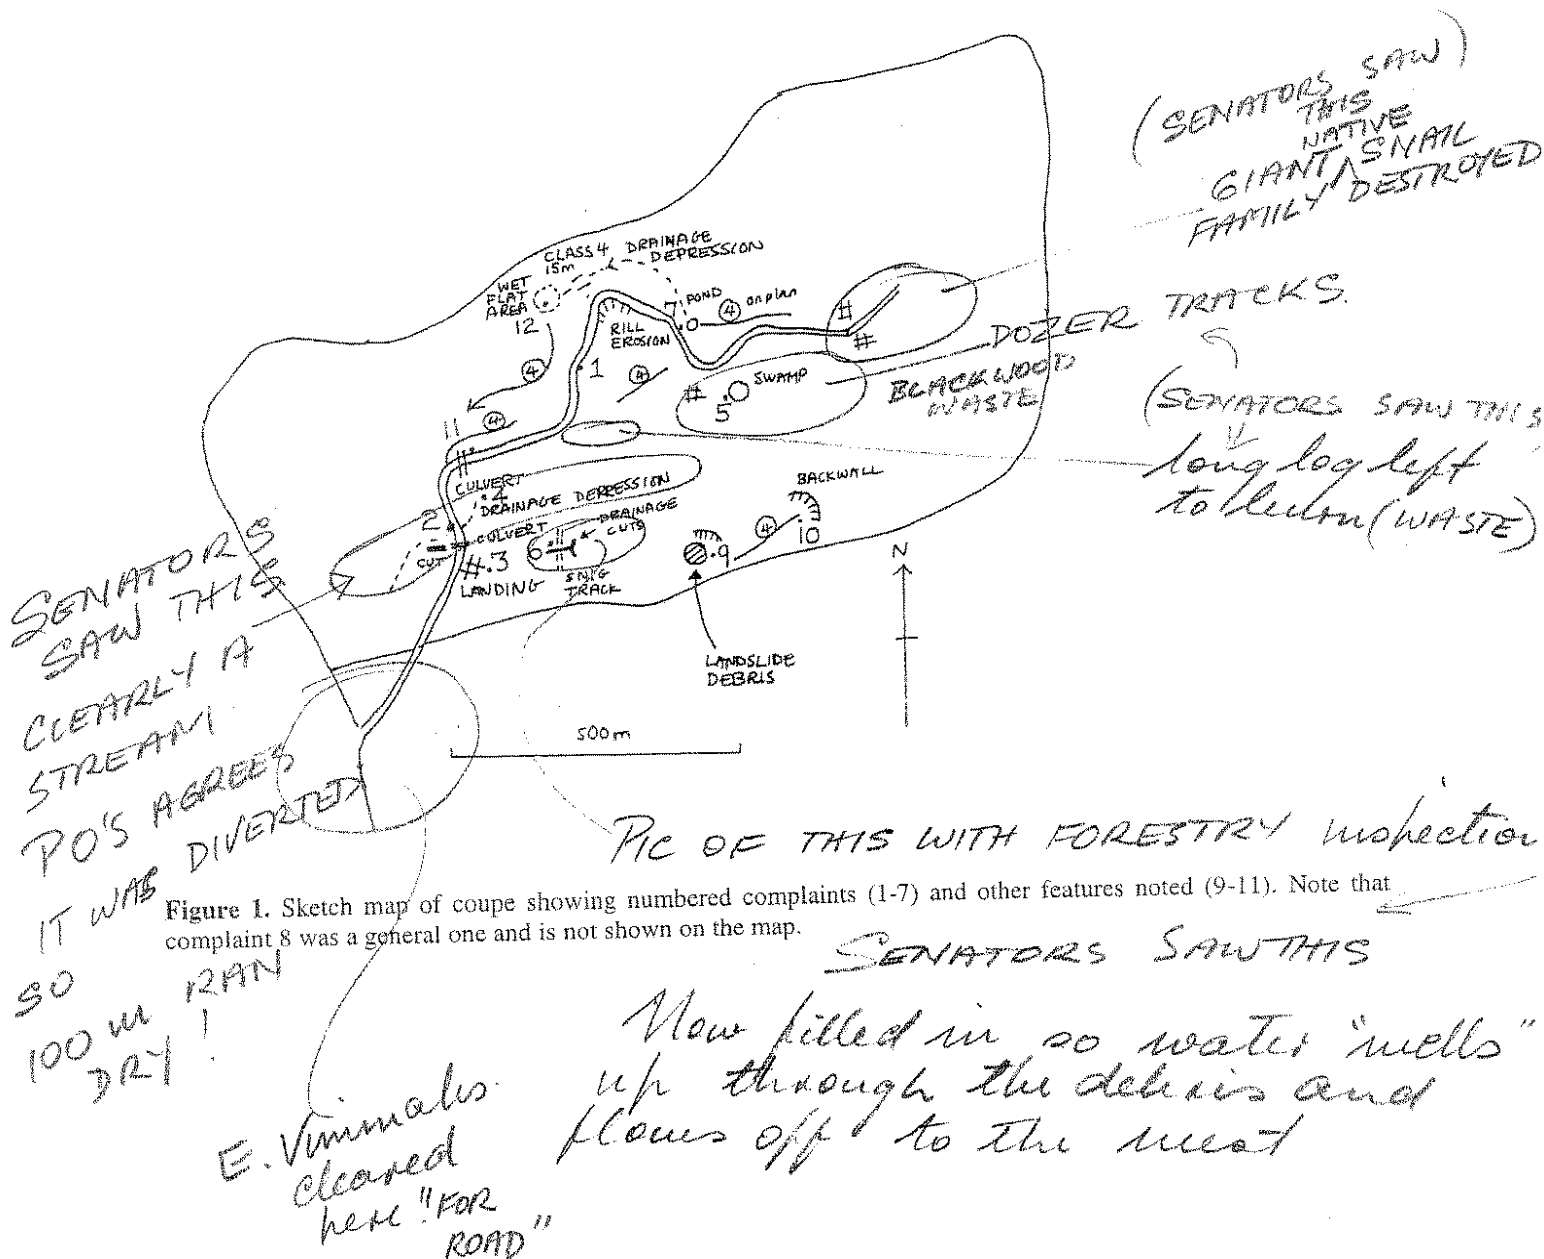
Figure 1. Sketch map of coupe showing numbered complaints (1-7) and other features noted (9-11). Note that complaint 8 was a general one and is not shown on the map.

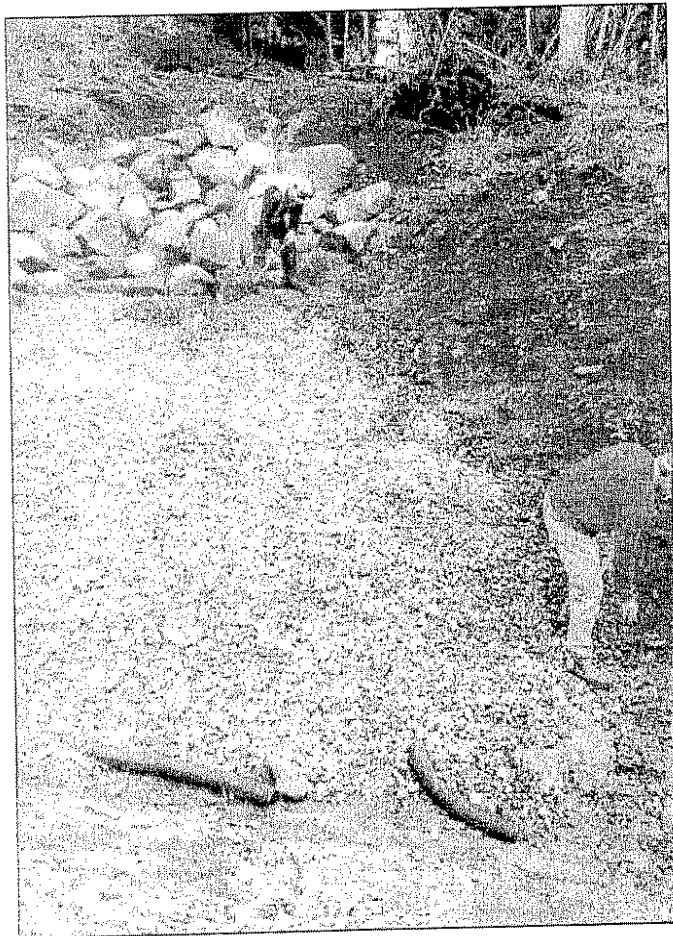
The roadside batter collapse was the subject of a report by P.D. McIntosh on 20 February 2002. The remedial measures taken broadly follow the recommendations of the report and have been successful in stabilising the land behind the small landslide, through a combination of drainage and armouring the landslide face with boulders (Figure 2). The minor divergences from the recommendations of the report are immaterial.

Figure 2. The small landslide (roadside batter collapse) at complaint site 2 has been successfully stabilised by installing drainage and armouring the backwall of the collapse with boulders.

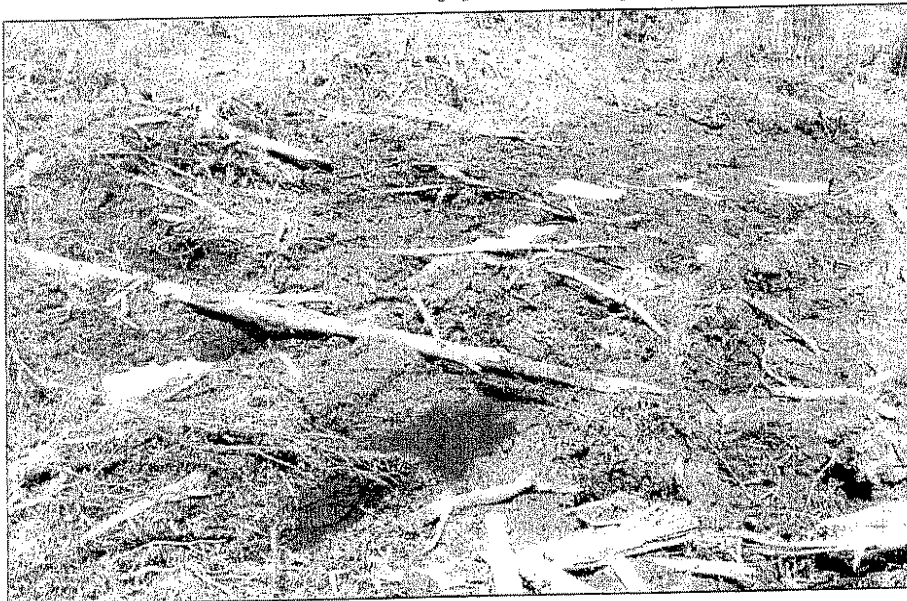
Rutting through drainage depressions was not observed to be deep (Figure 3). The Code requires (page 33) that rutting be minimized. The Code also requires (page 41) that snig tracks rutted to a depth of more than 300 mm over a 20 m section be restored by infilling. Other areas observed had been restored to this standard (although it may be that no rutting occurred to a level that required restoration under the Code).

These are NOT drainage lines they are class 4 streams !!

Figure 3. Partly corded snig track either side of an excavated channel (following log in centre of photo).

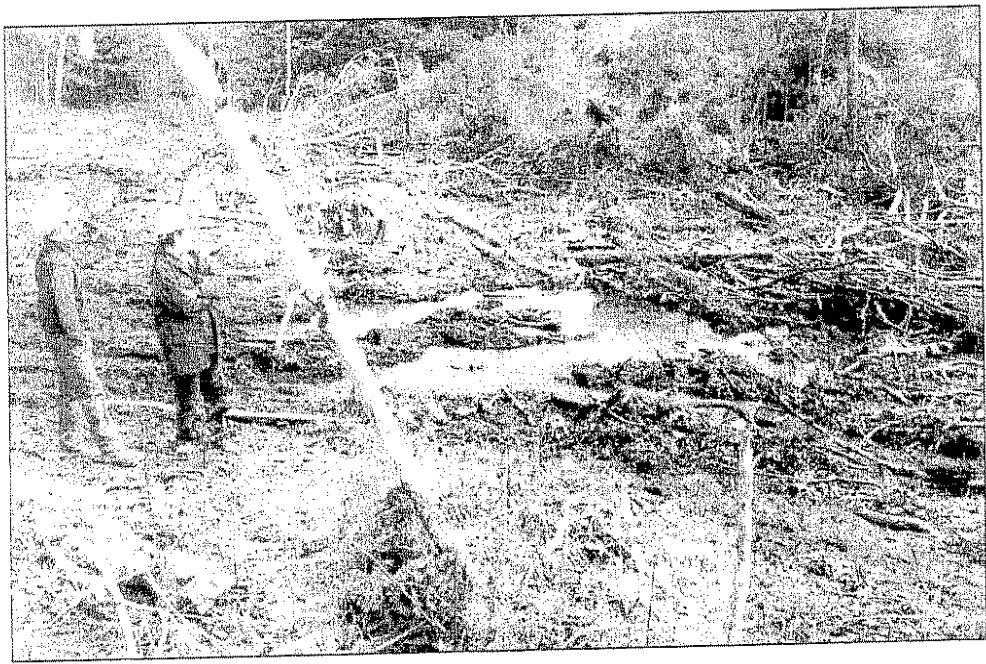
Water from the drainage depression in the north of the coupe discharges water onto a broad flat area. Light logging debris impedes drainage (Figure 4). This logging debris needs to be removed with an excavator so that natural drainage is restored.

Figure 4. Wet flat area at site 12. The drainage of this area would be improved by removing the light logging debris.

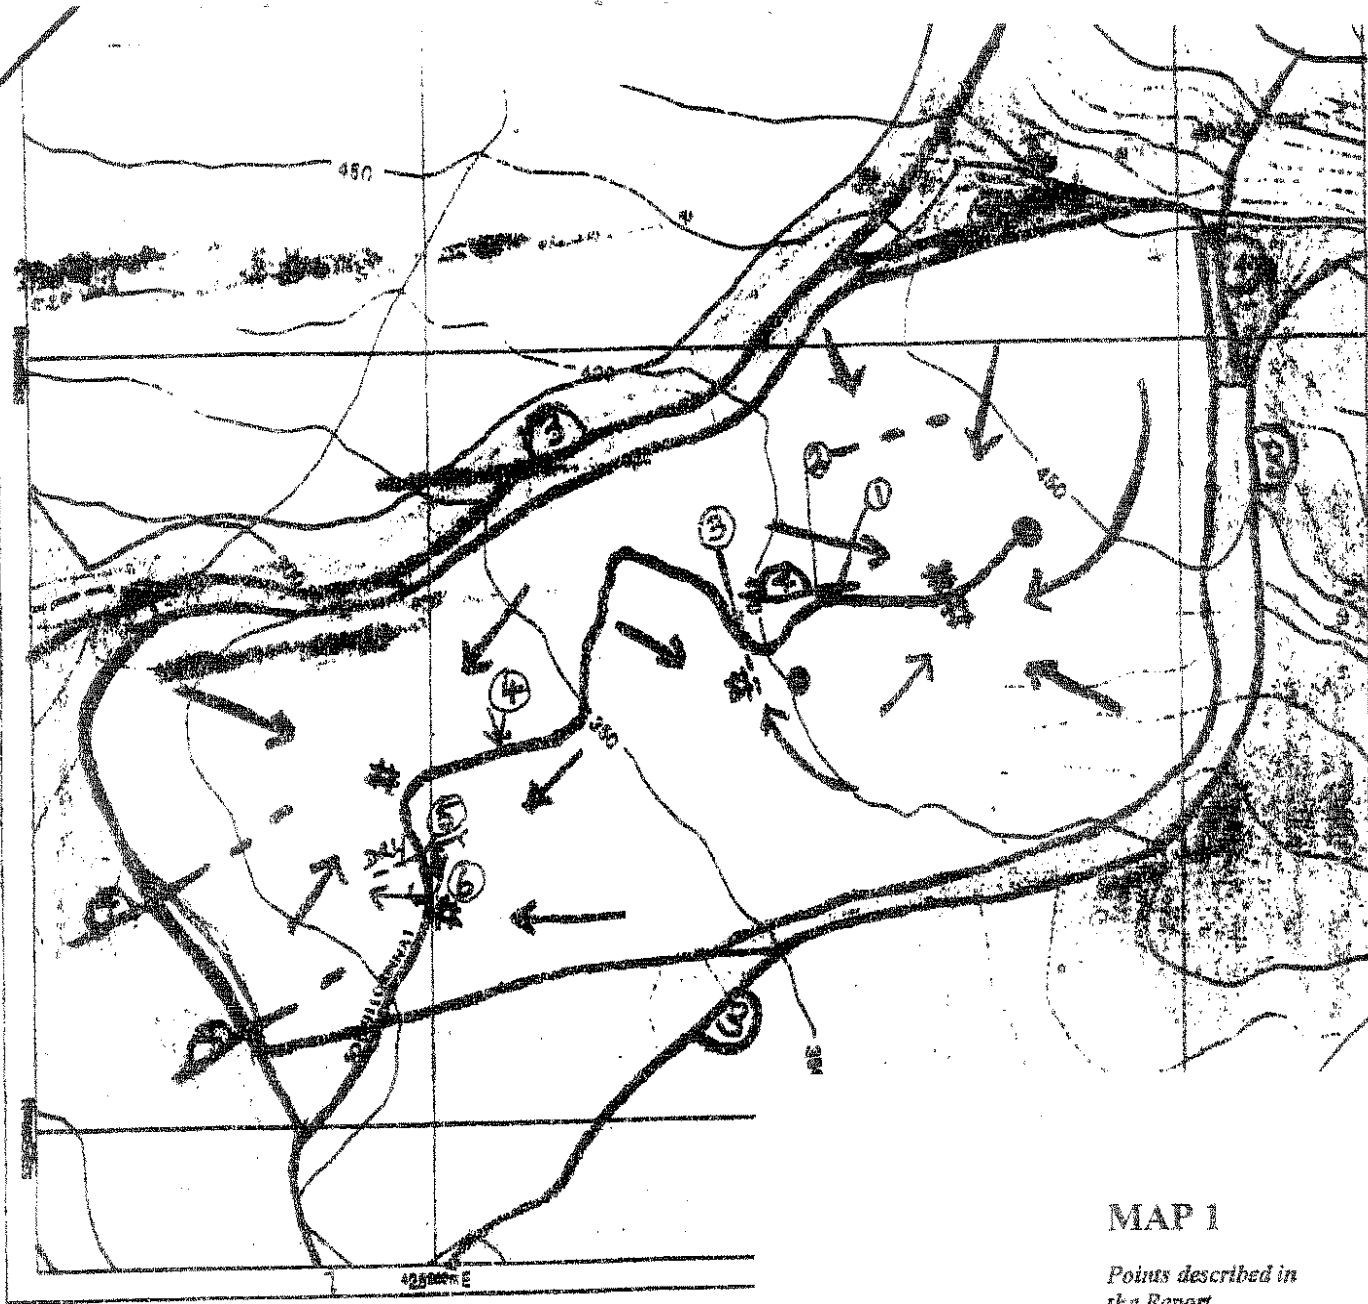
MAP 1

2.3.1 From the uppermost location at a landing site in the north west of the coupe it was 167m distance to the first culvert, at point 1 on the map, which drained the road out to the north. This distance exceeded the Code minimum distance of 112m. Before this outlet it was observed that the road was set into the soil profile making provision of outlet drains difficult.

2.3.2 At a point 27m from the culvert noted in 2.3.1 it was observed that an enclosed soakage was marked on the map at point 2 as a class 4 stream. In contrast many class 4 streams on the coupe had not been marked on the plan.

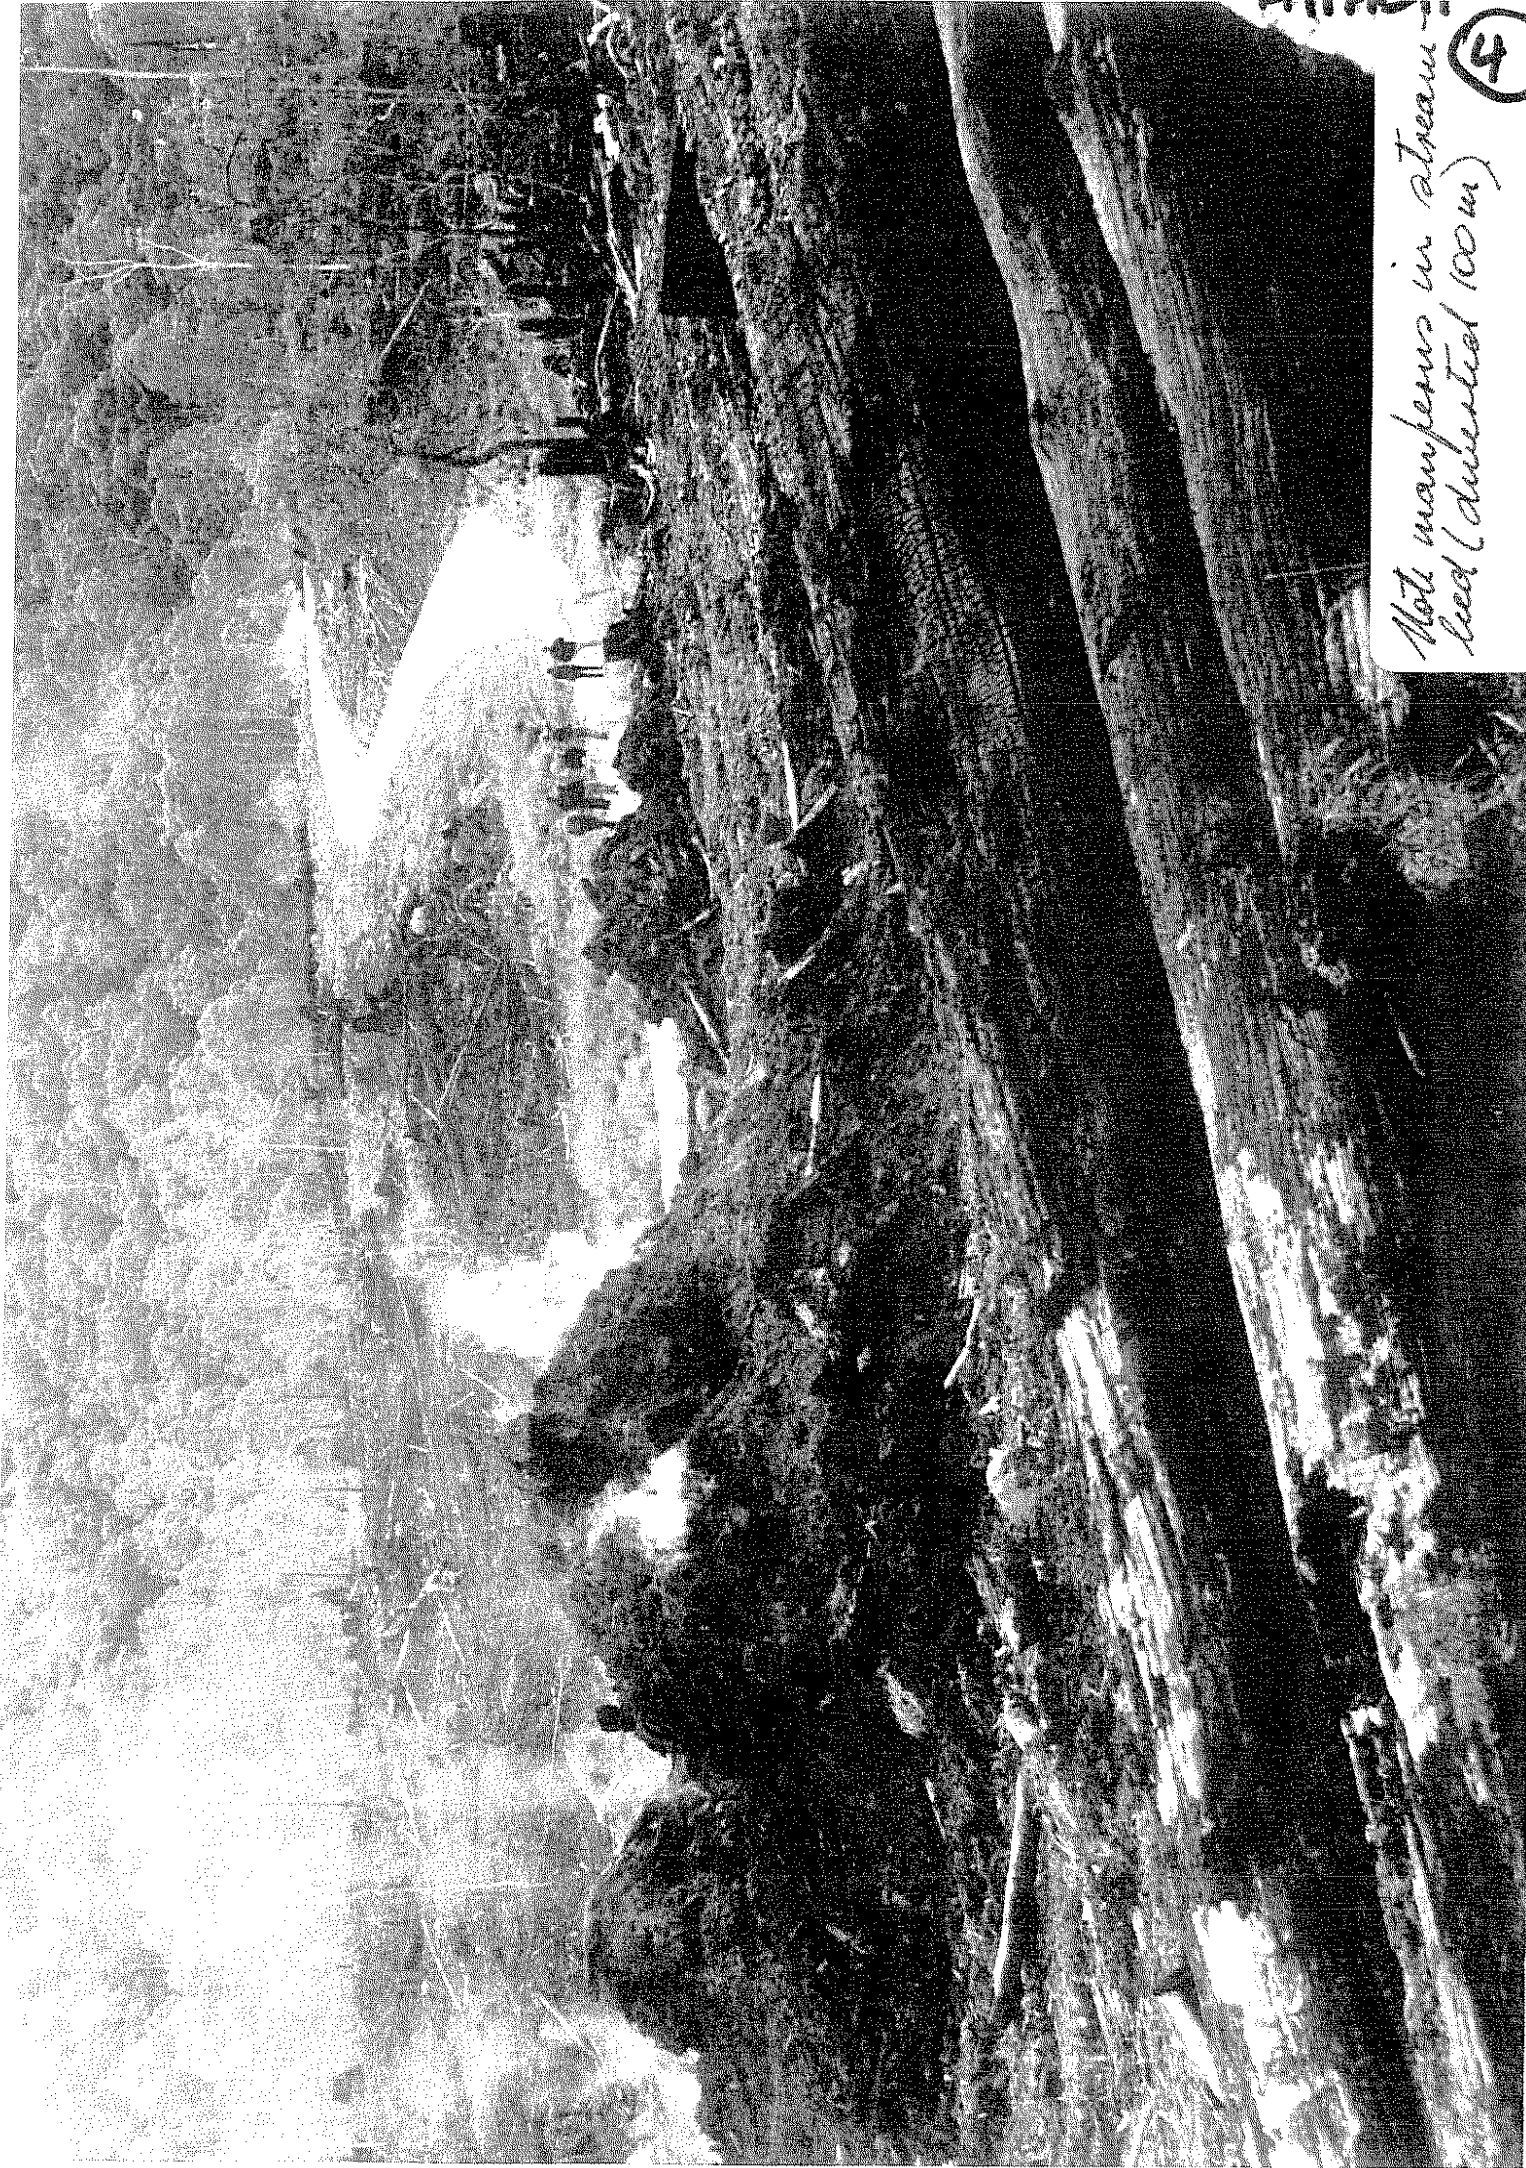
Note mangroves in stream bed (distorted 100m) (4)

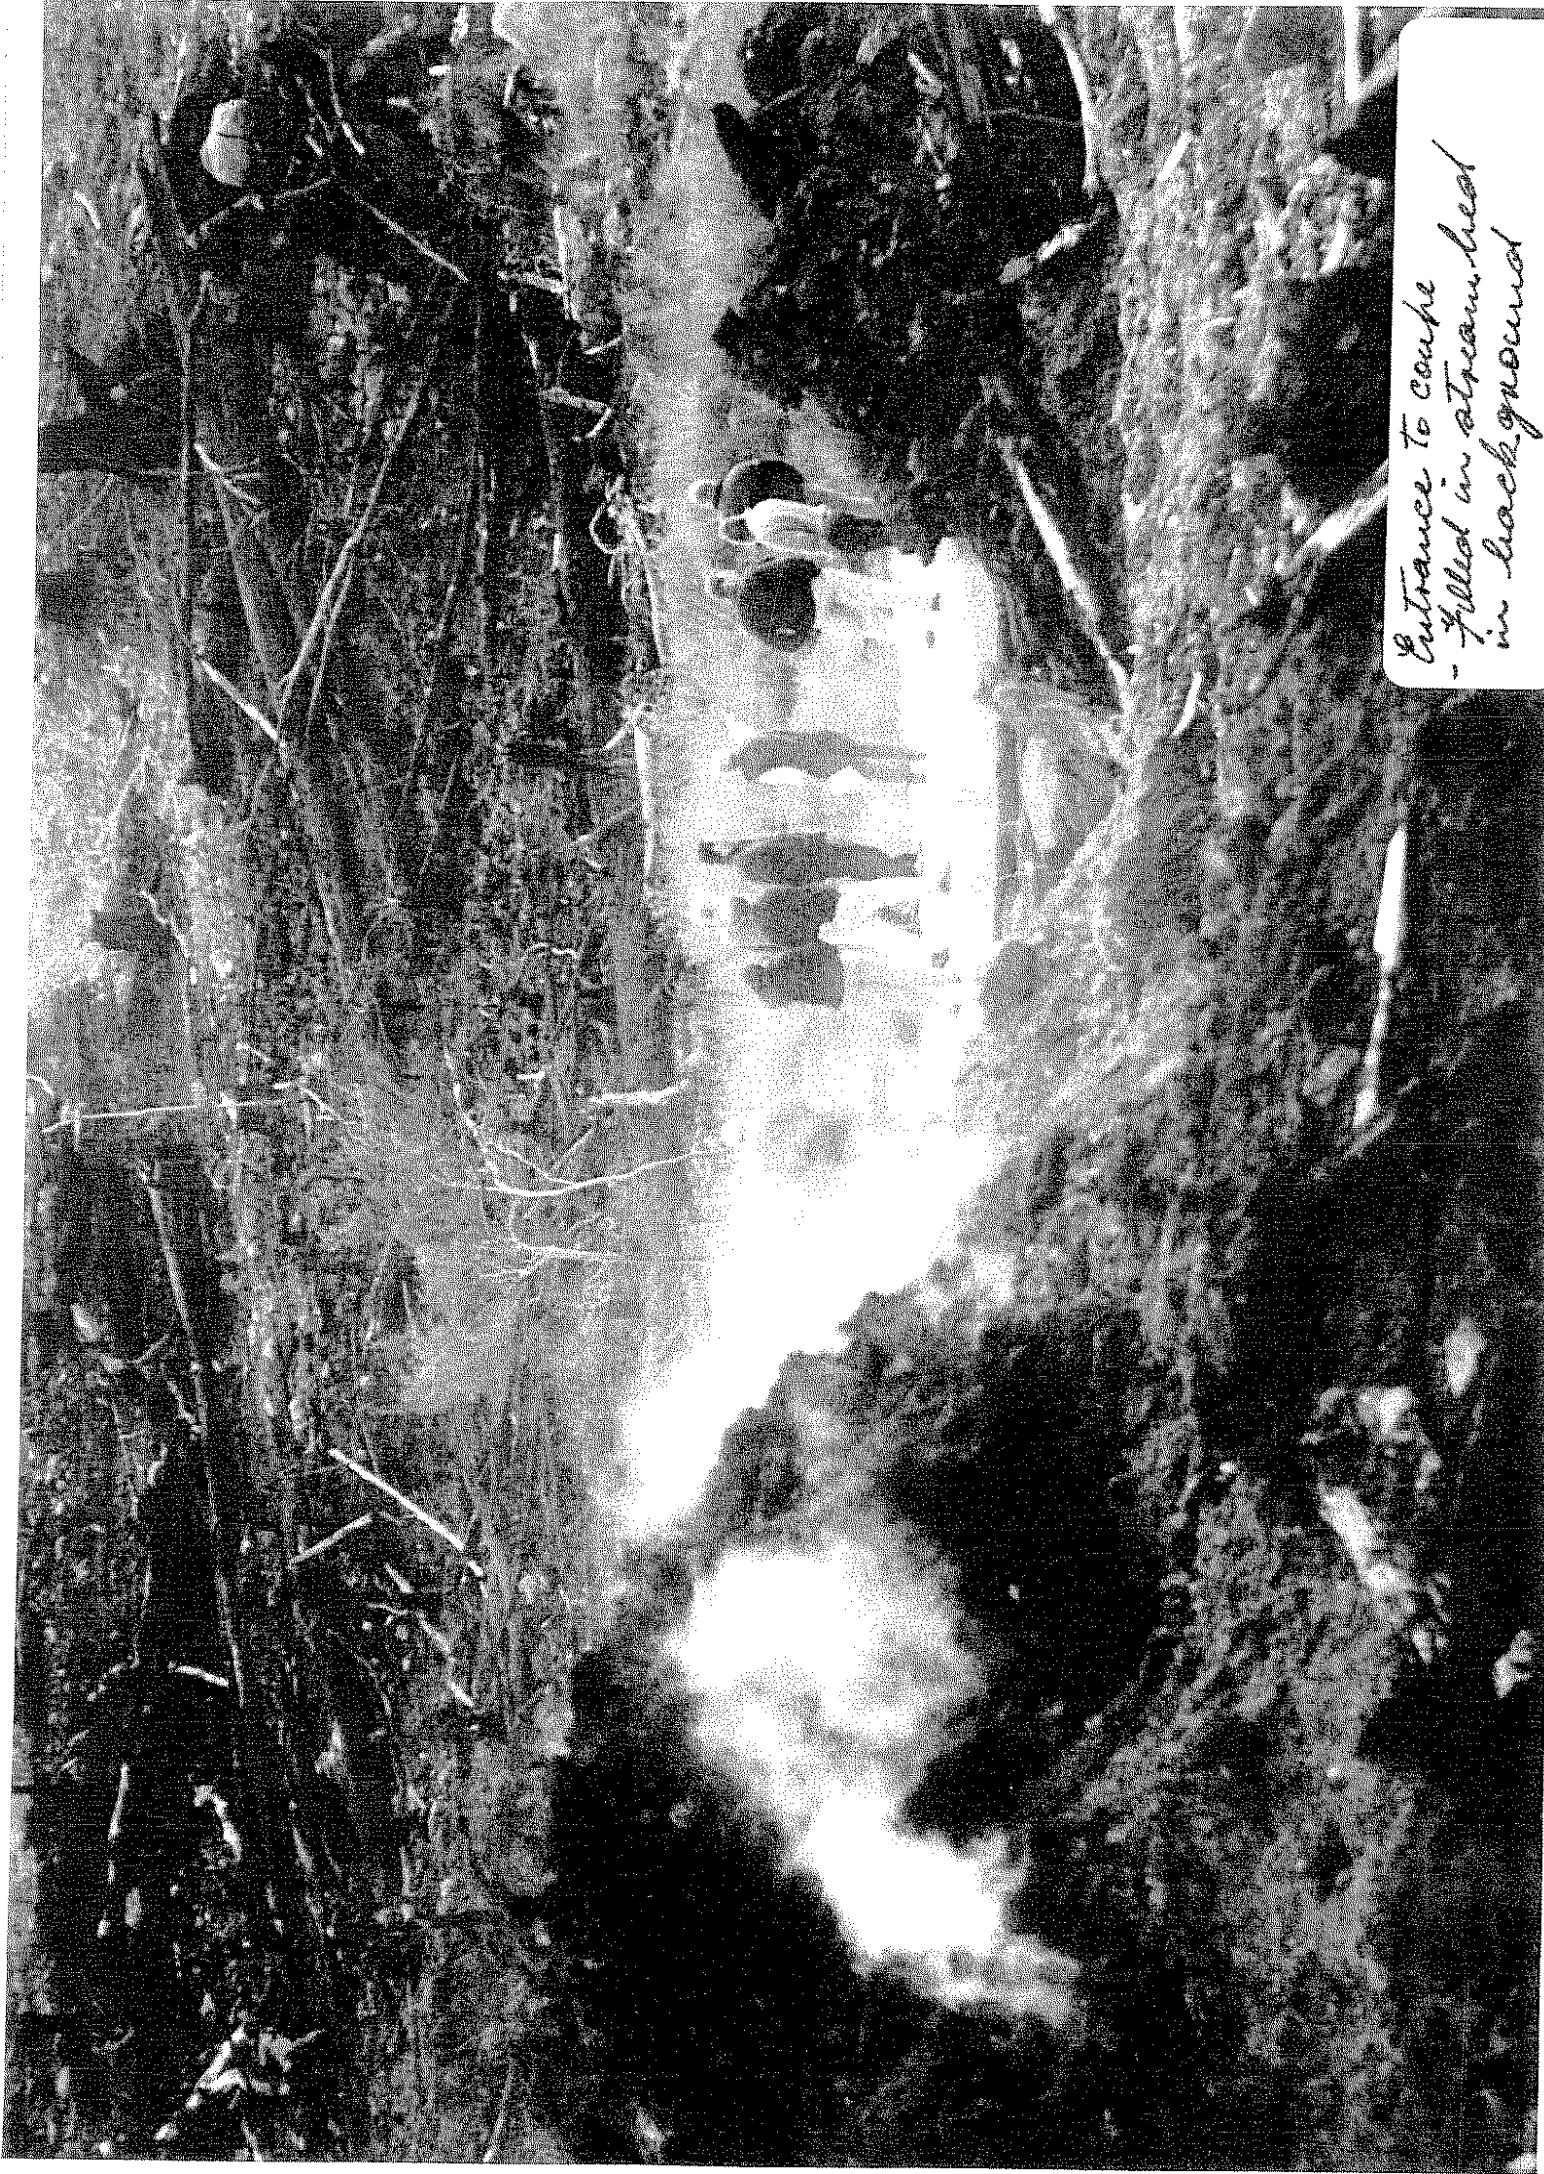
Entrance to coupe
- filled in streambed
in background

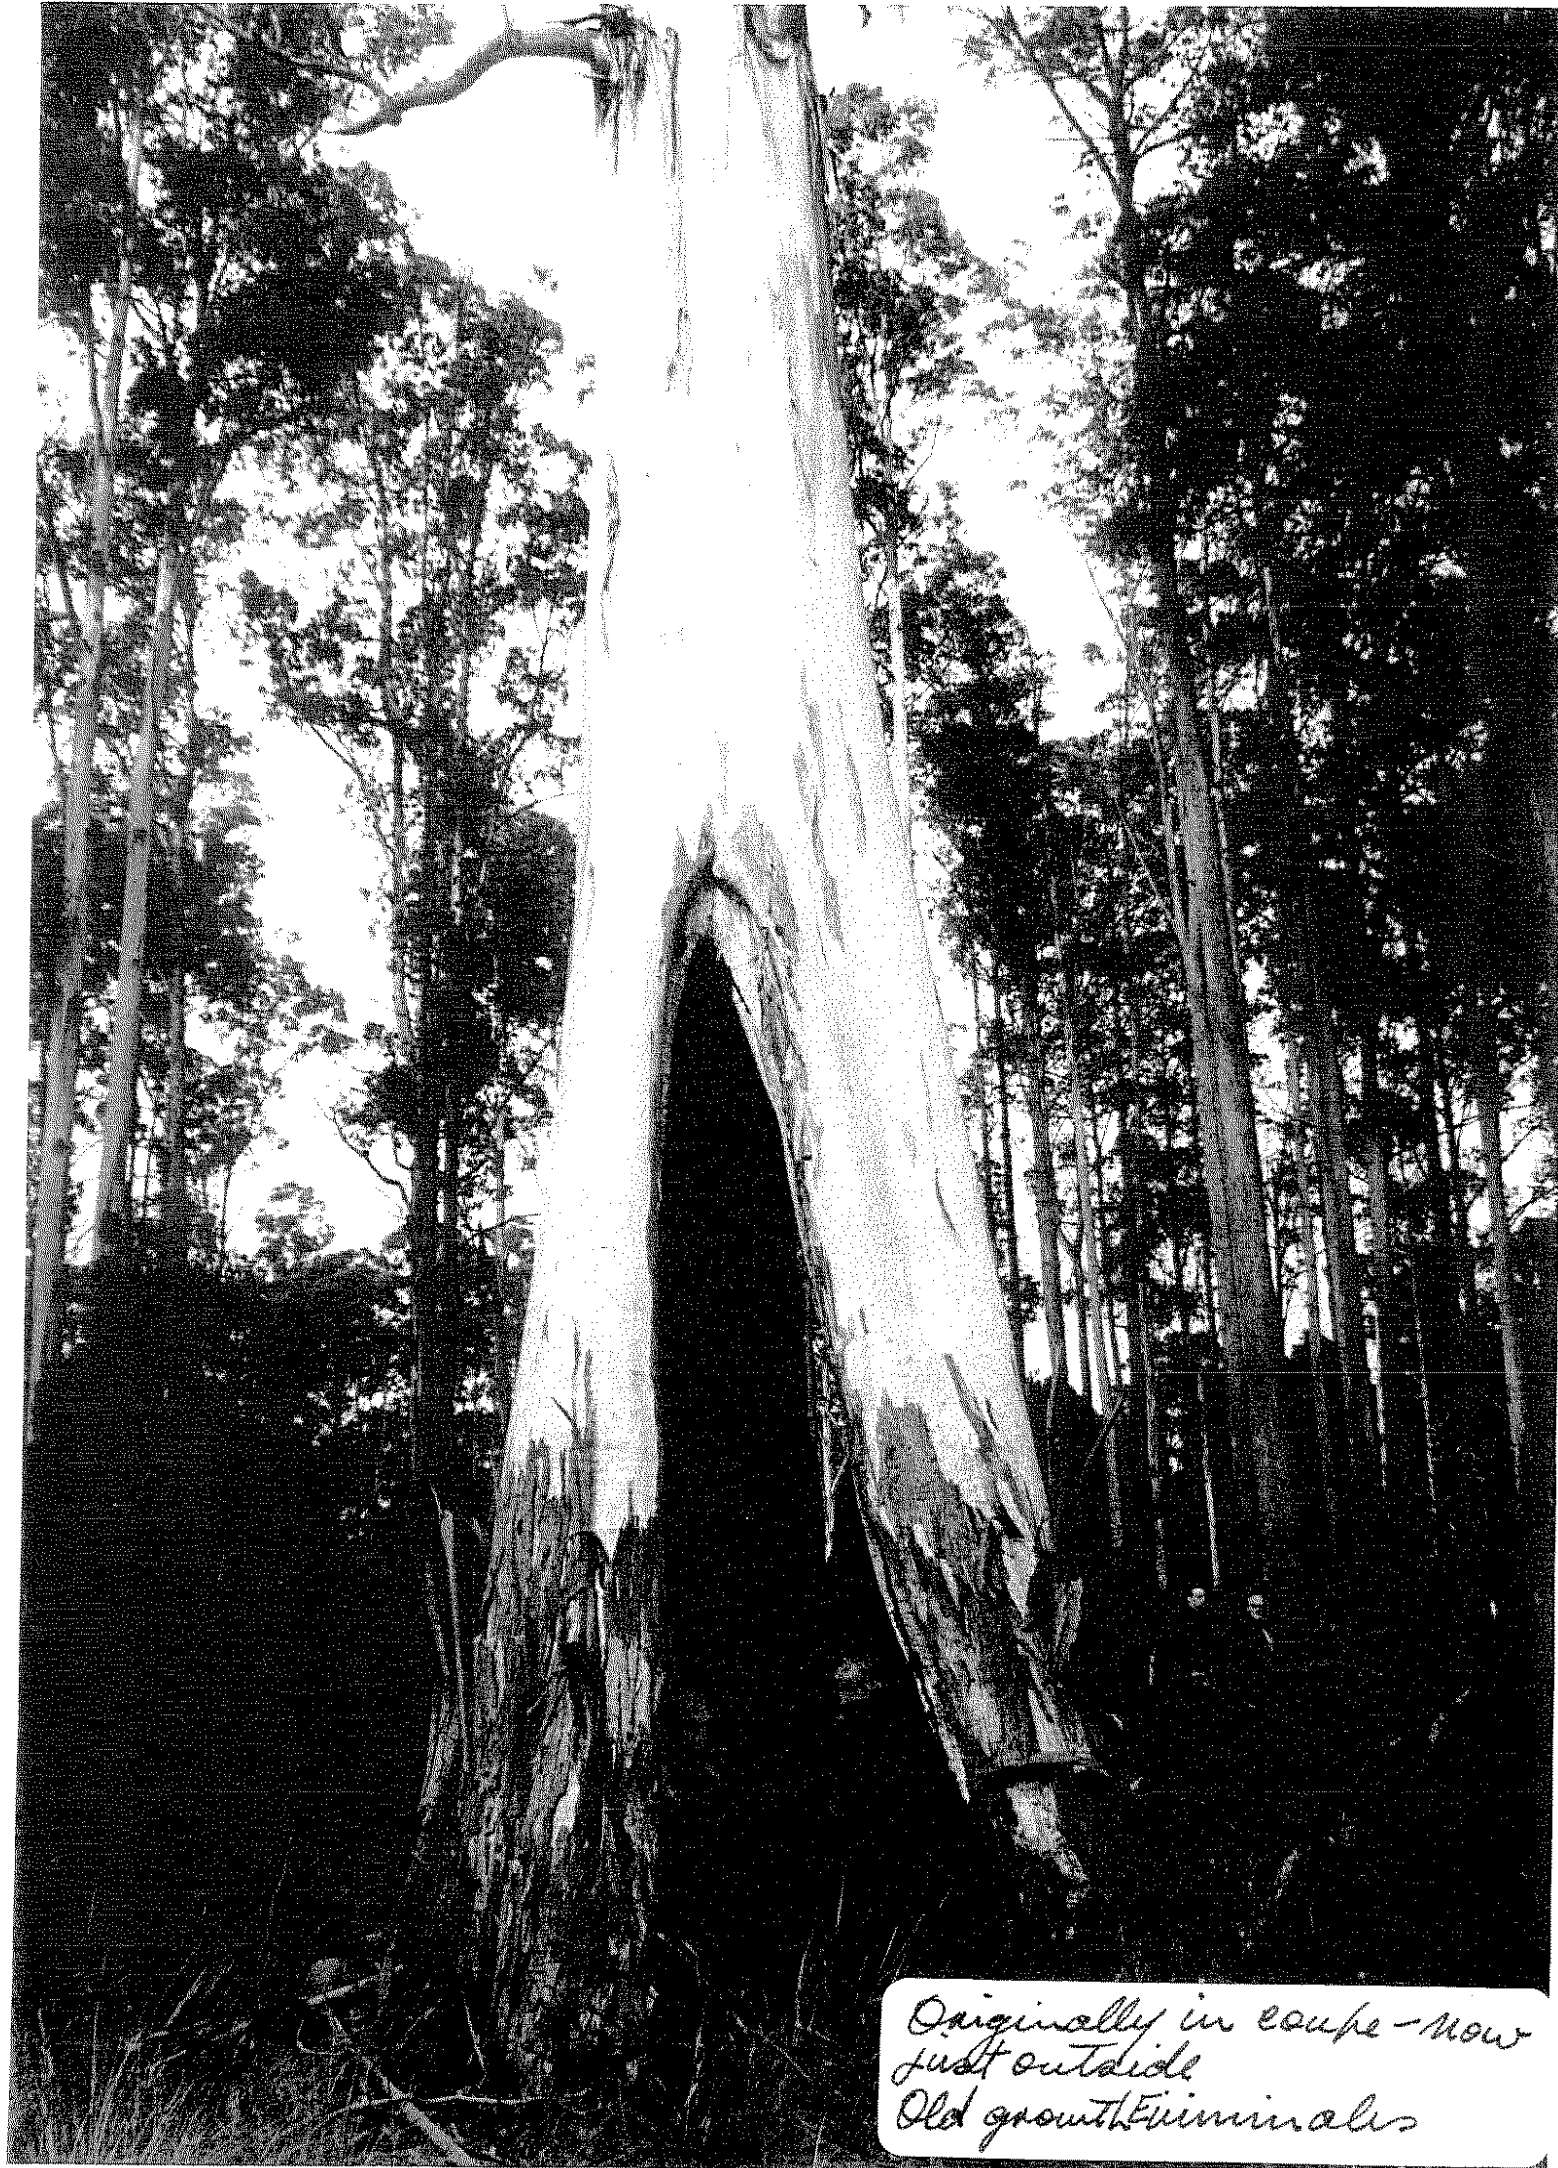
Originally in coupe - now
just outside
Old growth *Fraxinus*

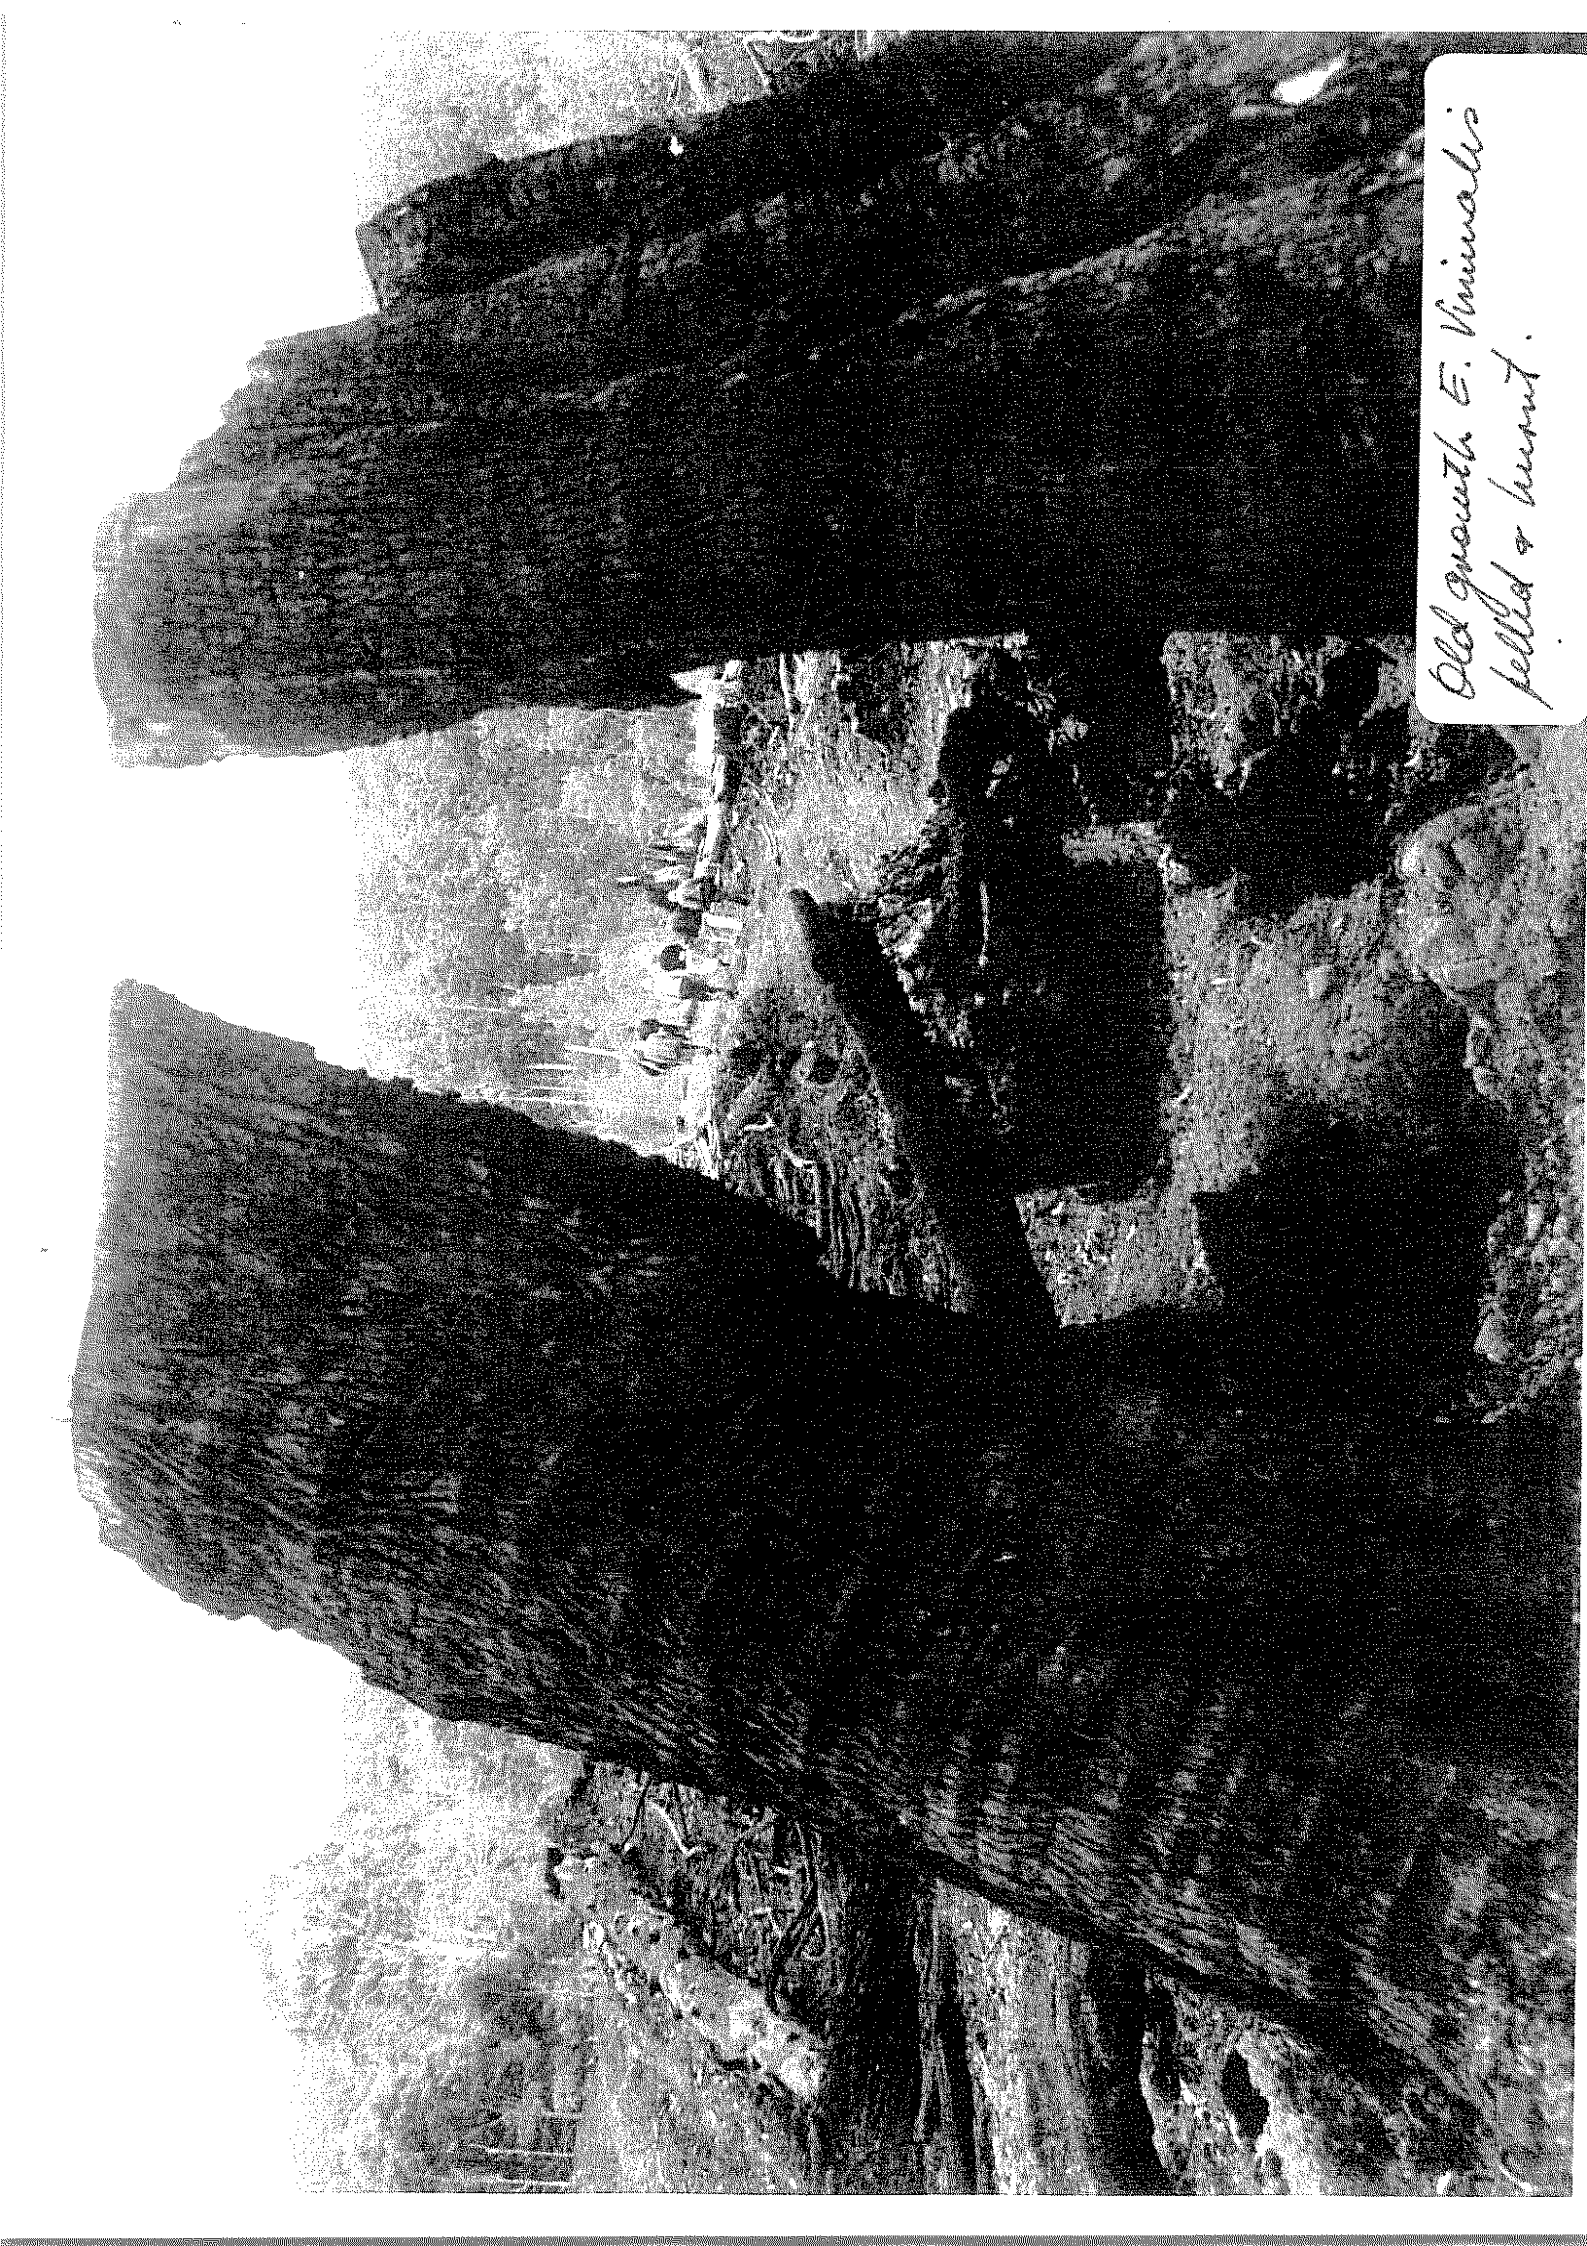
Old growth E. Viminalis
felled & burnt.

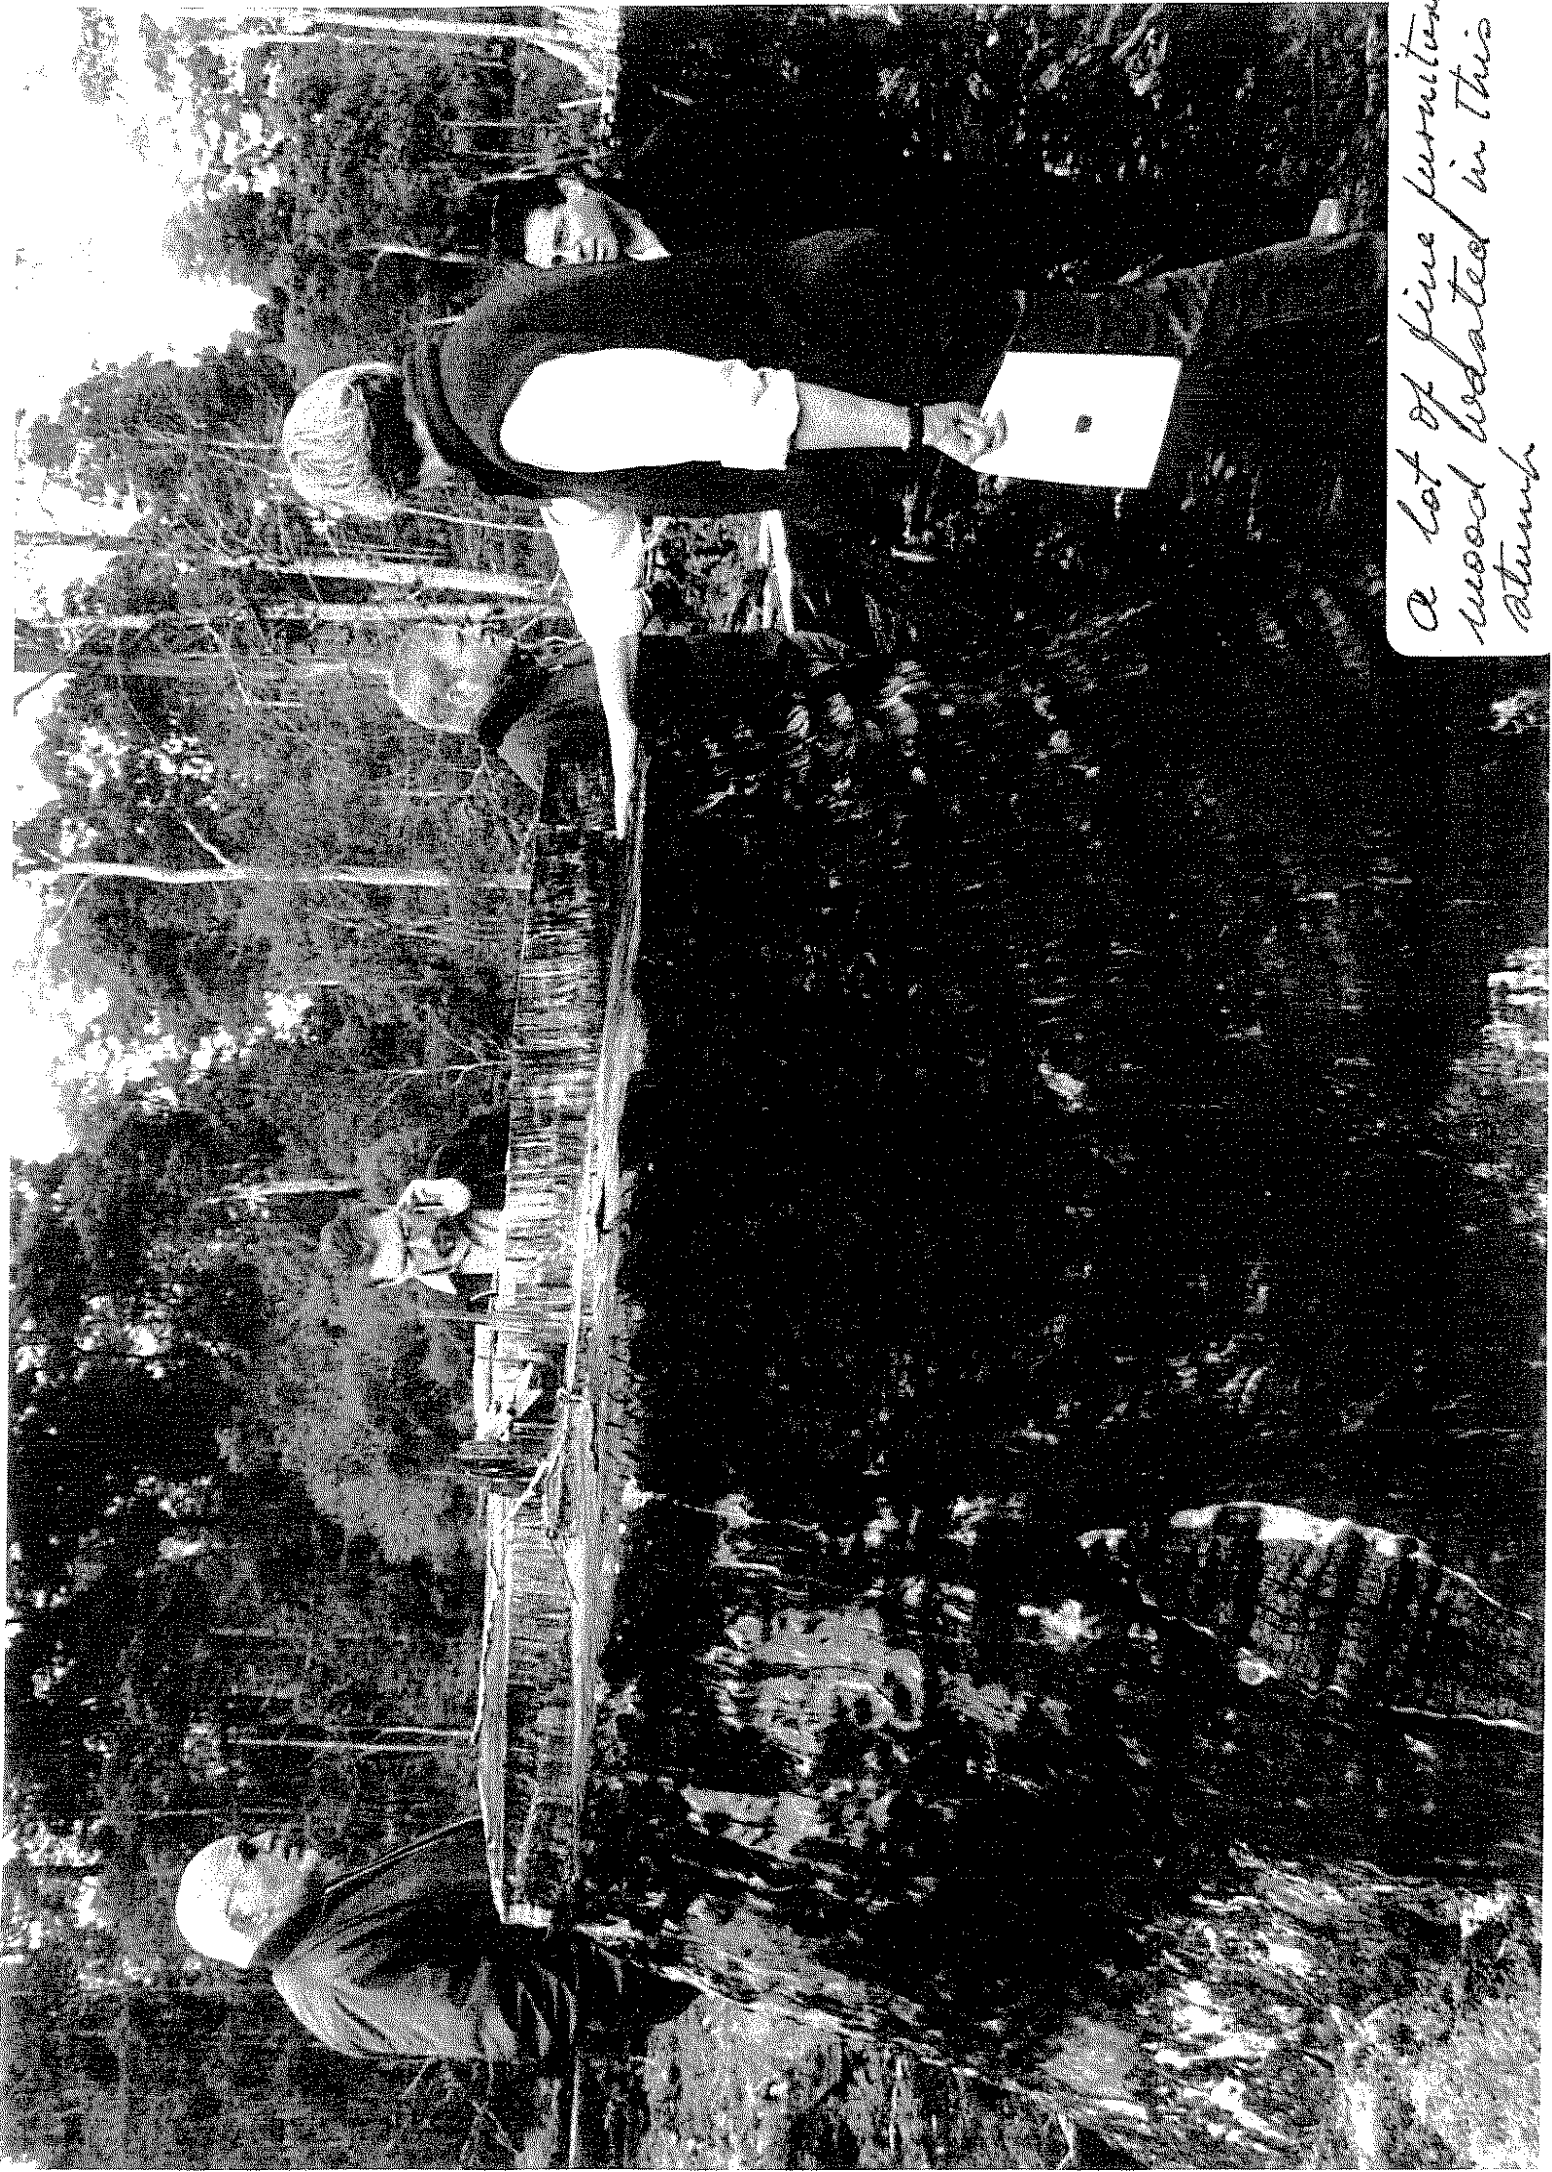
*A lot of pine sawtimber
wood located in this
stump*
