Reference: Plantations forests industry

FURTHER SUBMISSION FOLLOWING COMMITTEE'S VISIT

COUP LA028A

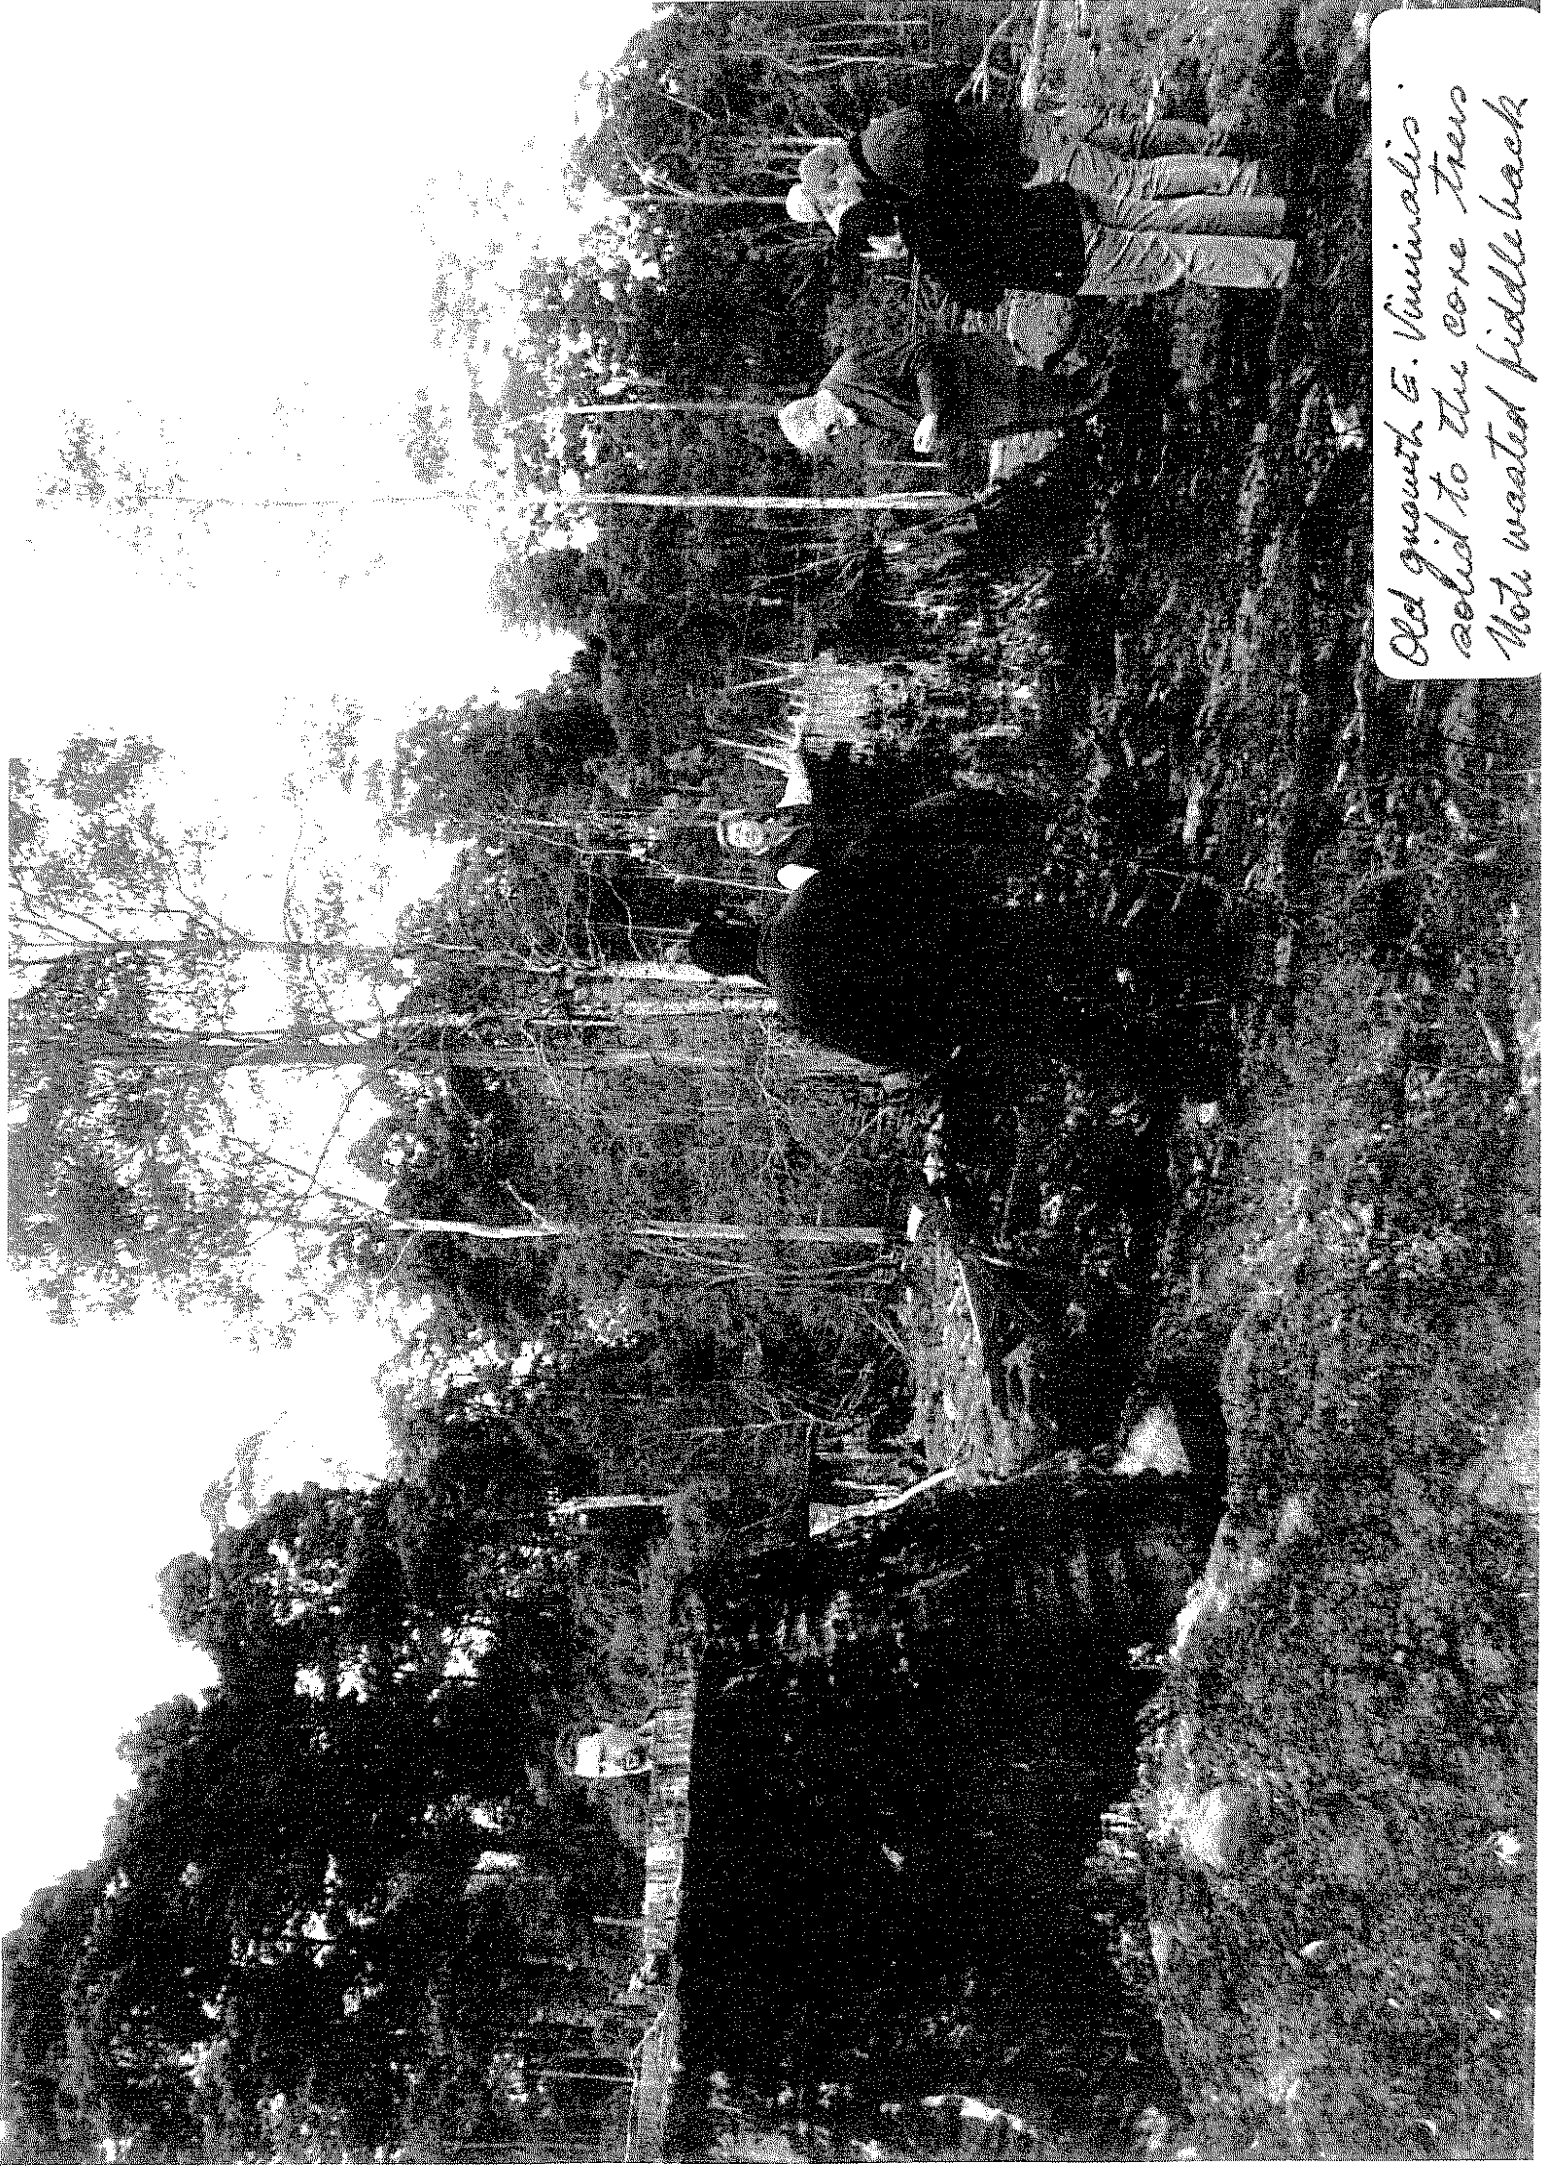
Old growth *E. Virginialis*.
solid to the core trees
Not wasted fiddle back

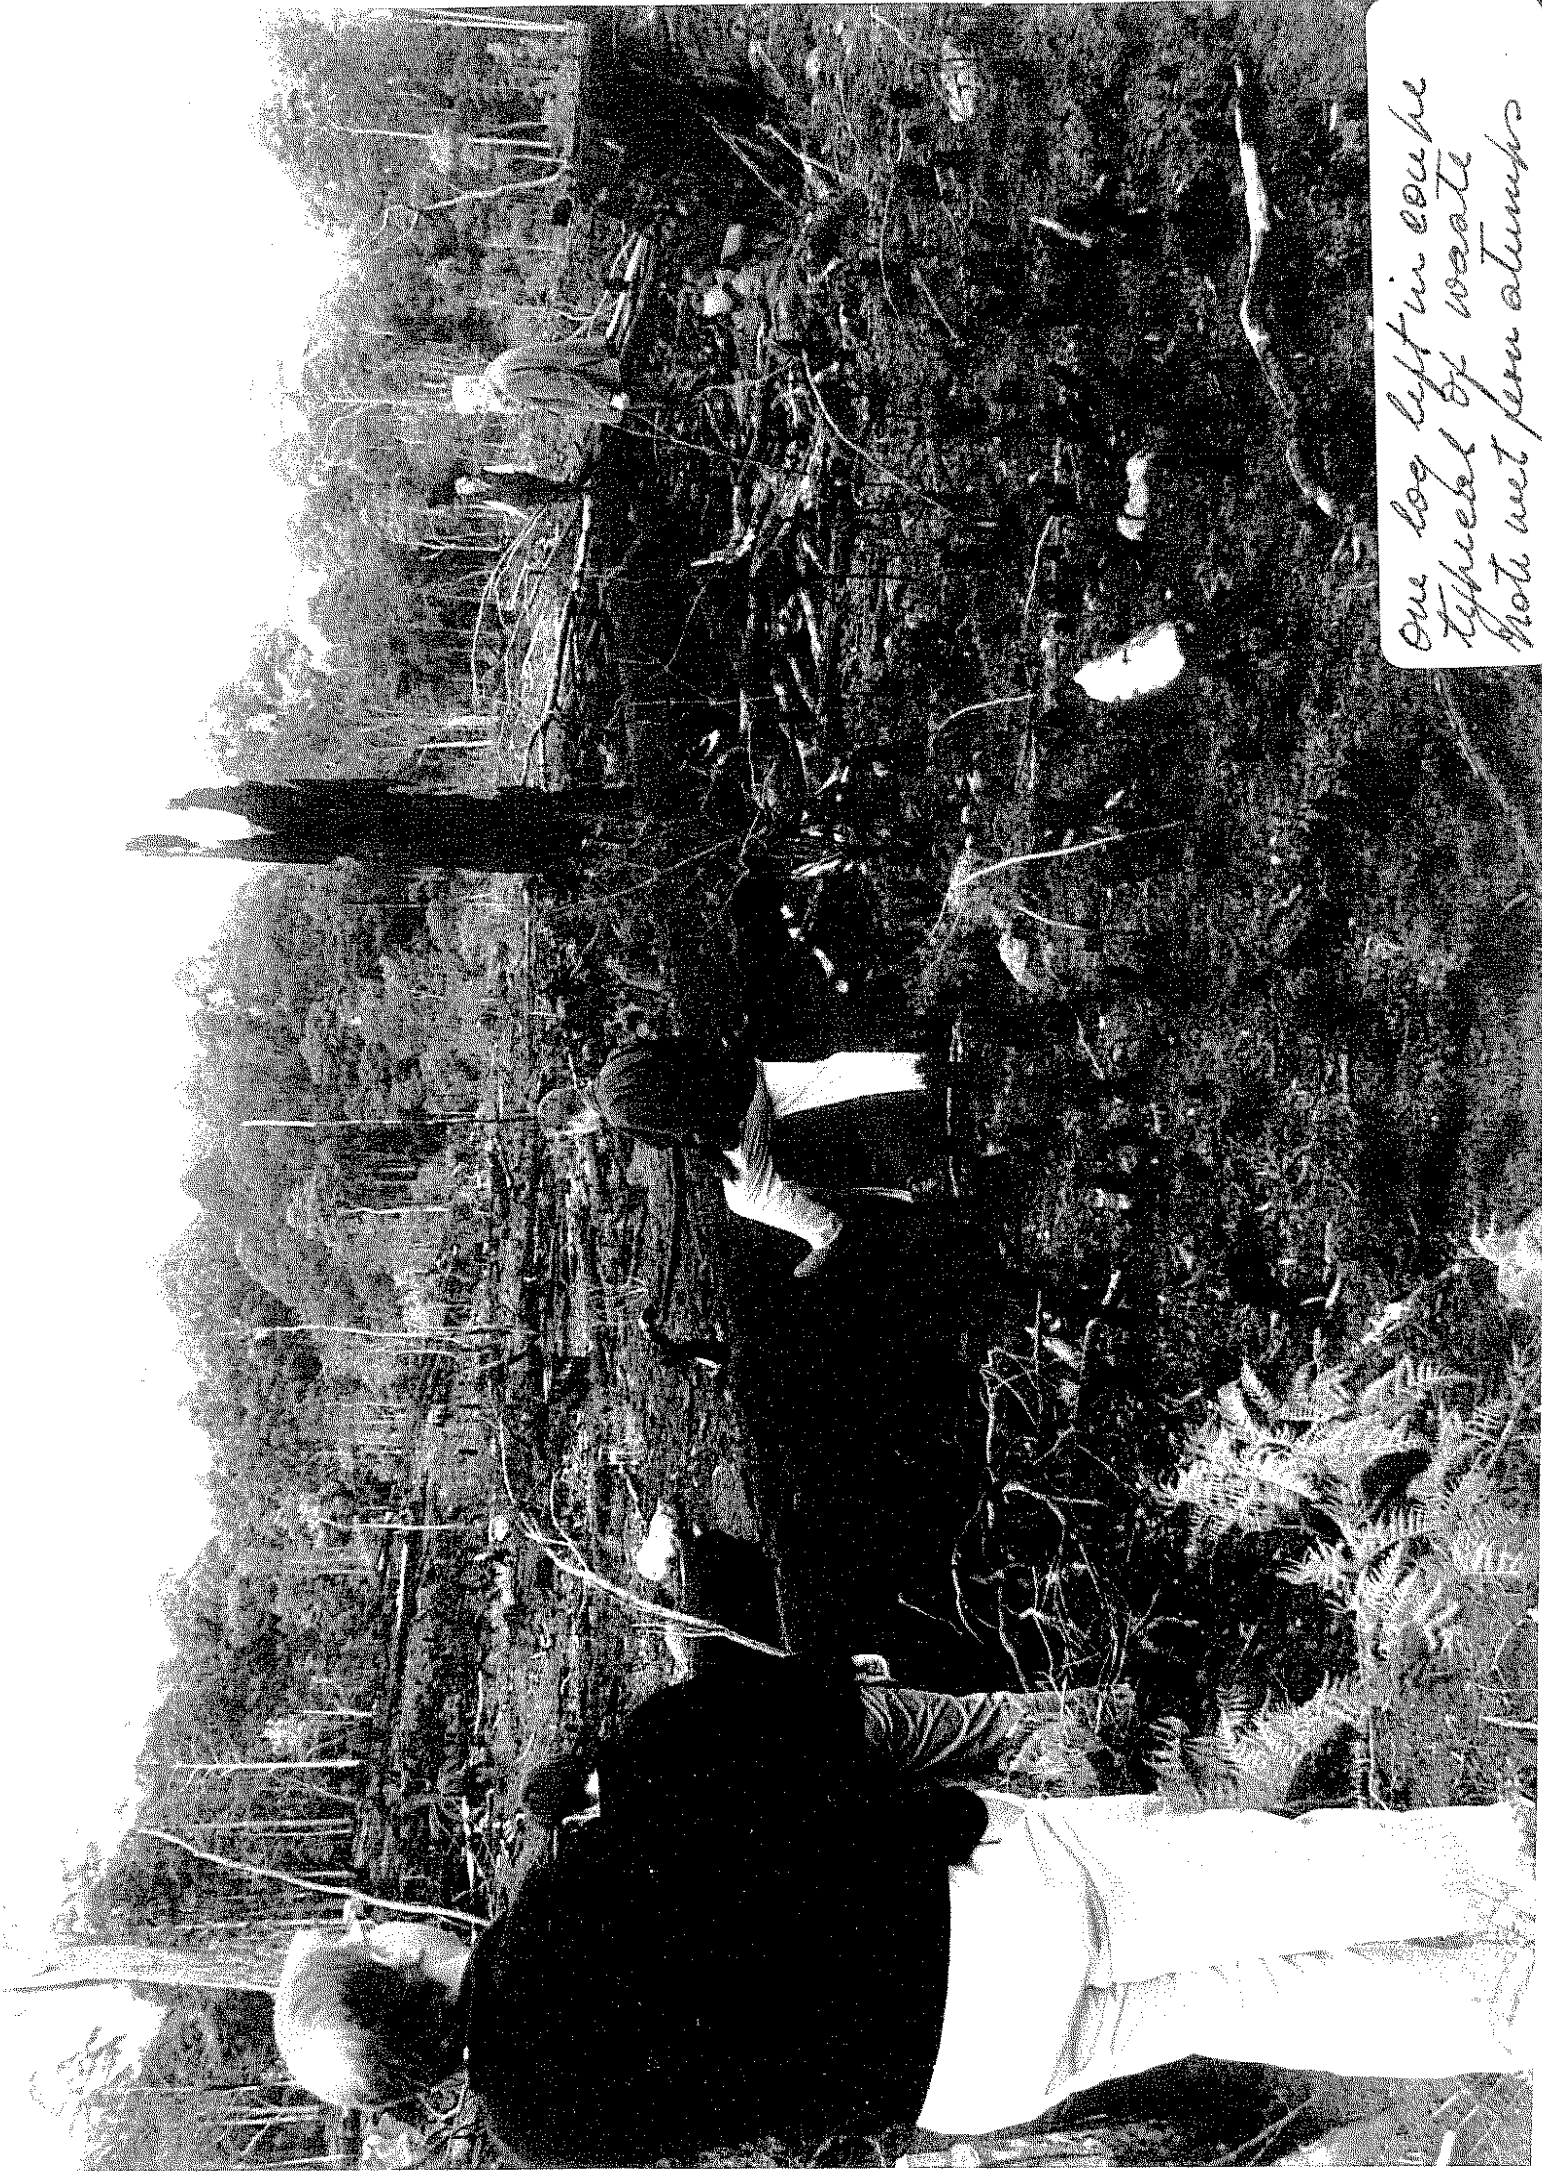
One log left in coupe
tipped of waste
Note wet fern stumps

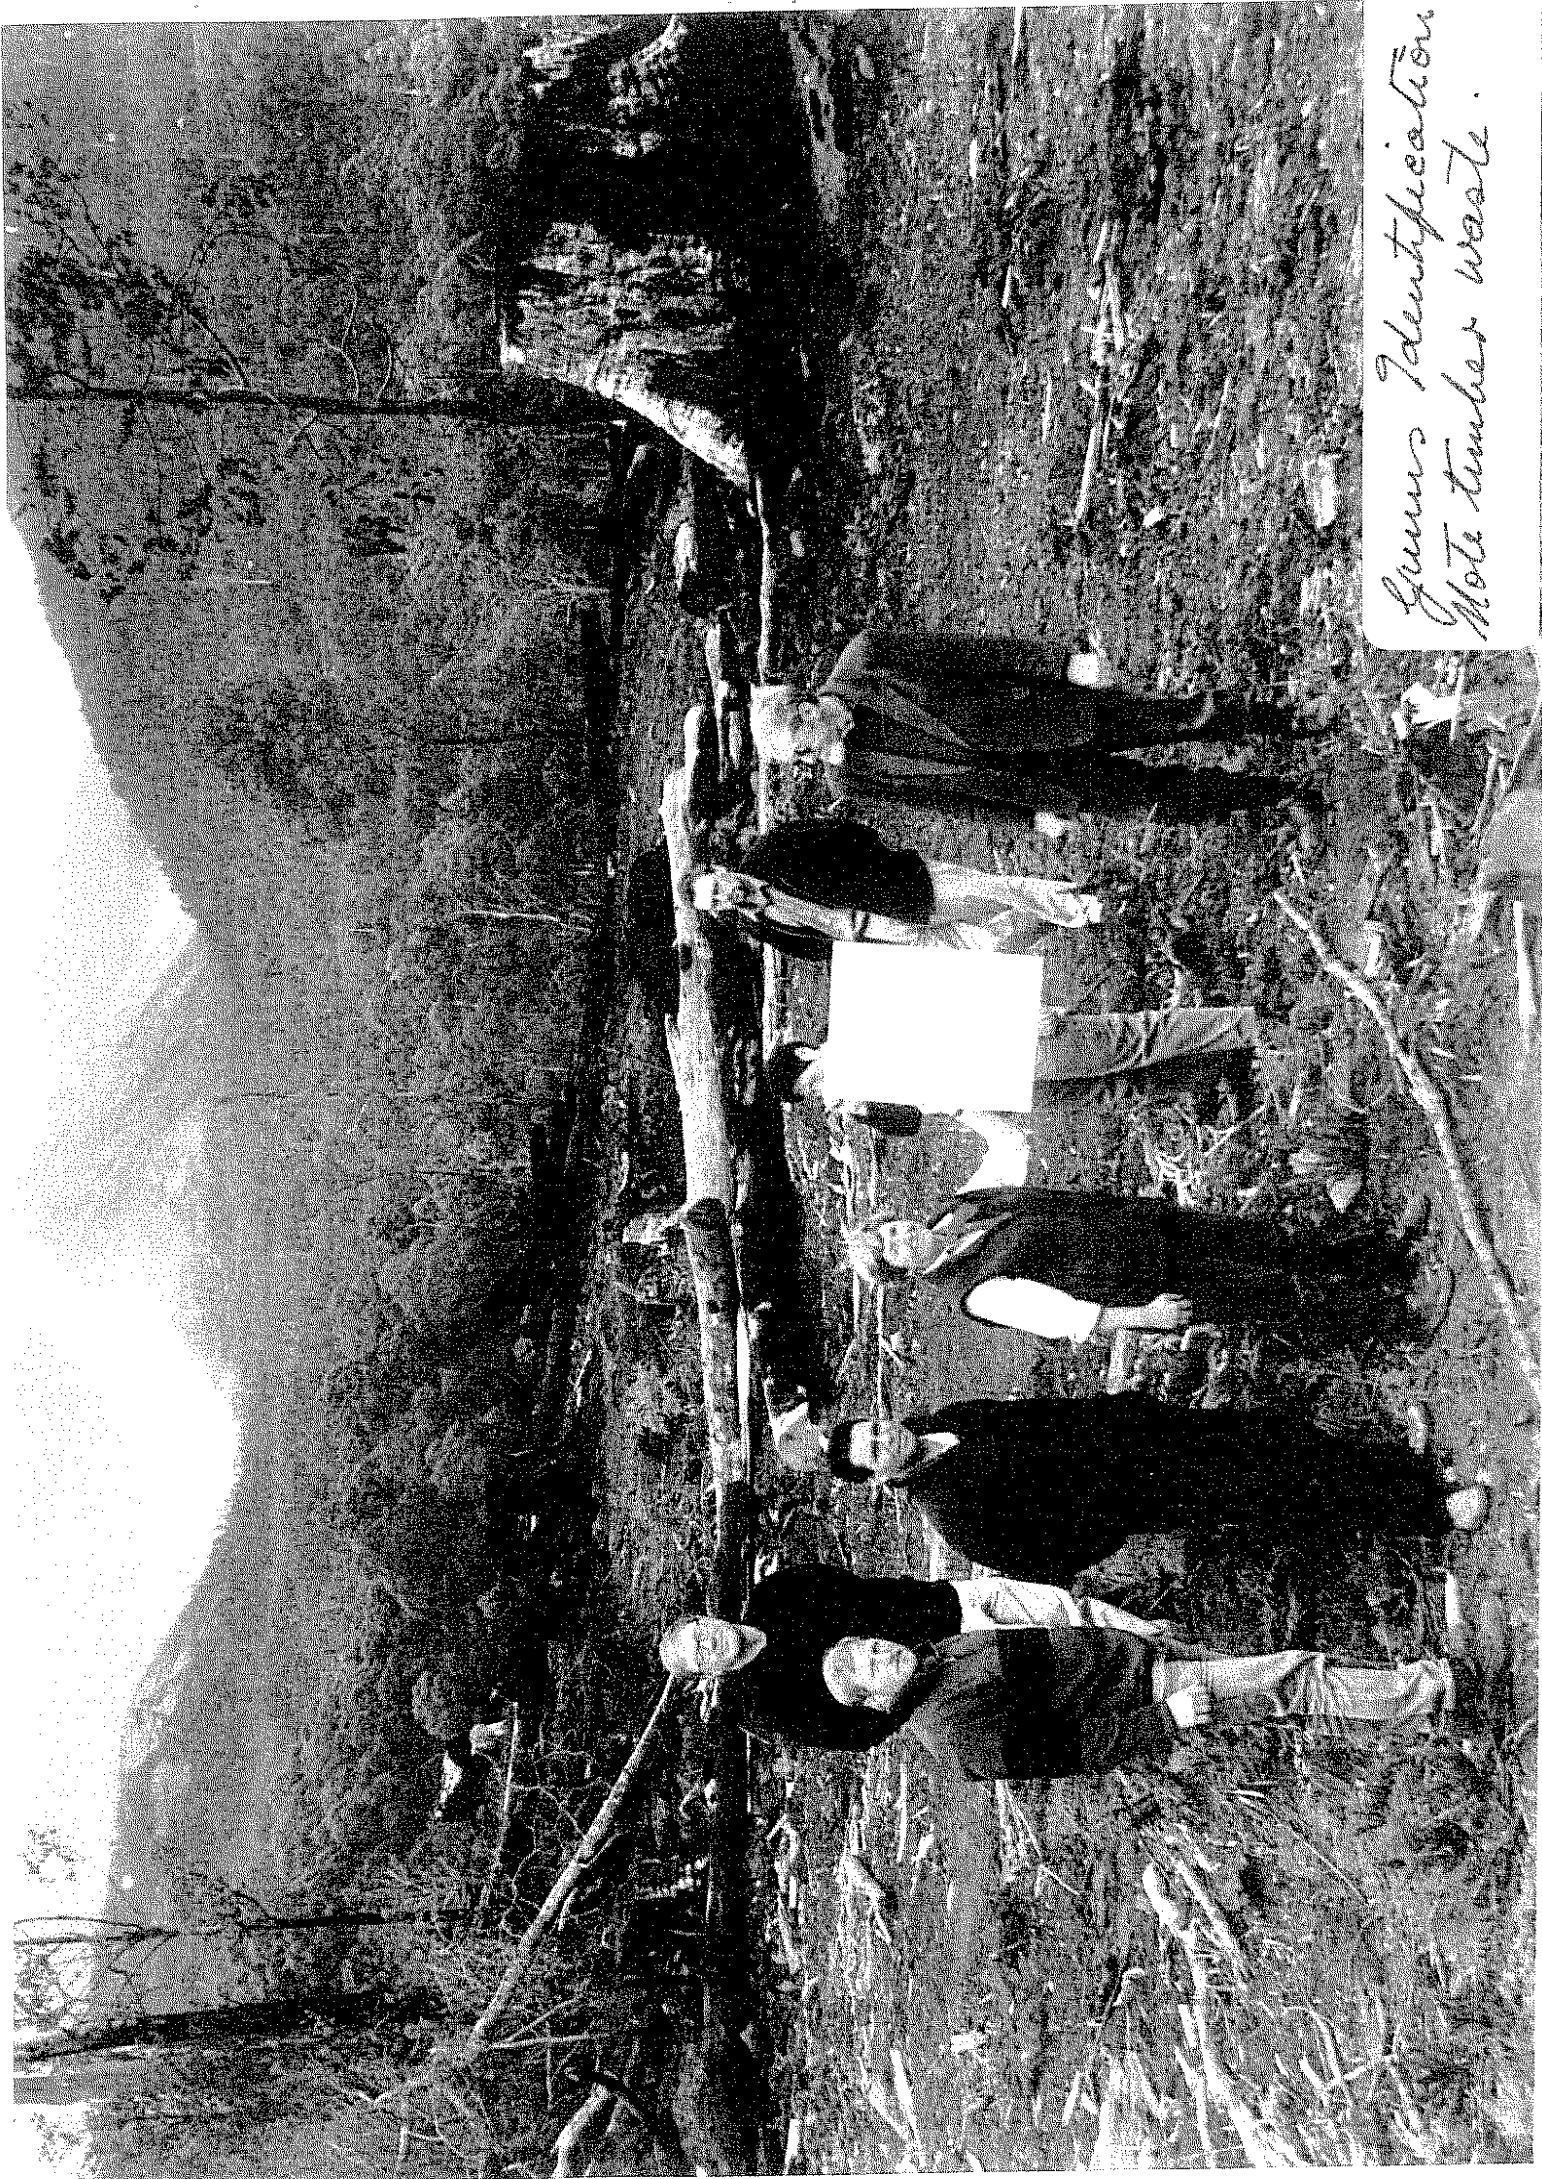
*Gum Identification
Note timber waste.*

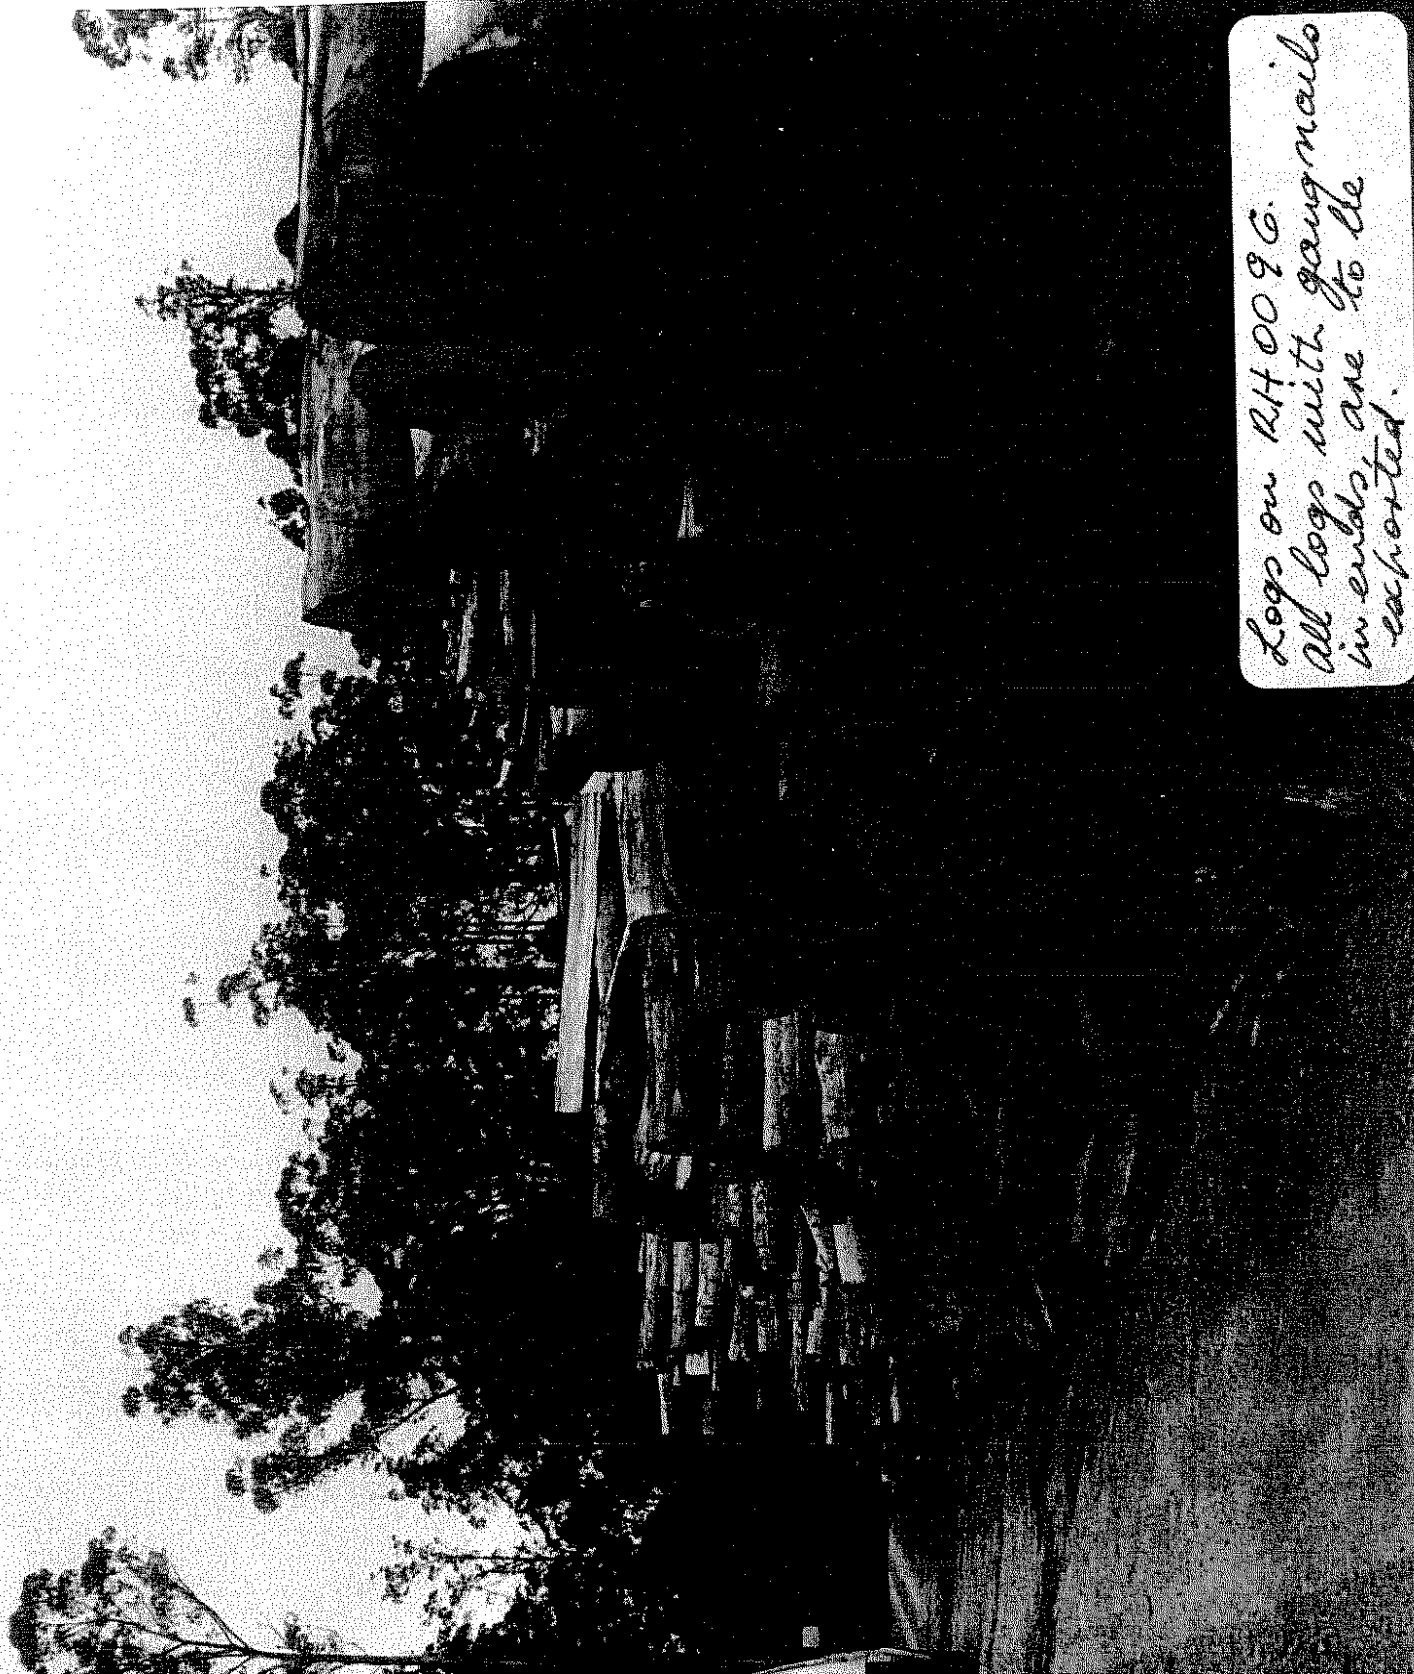
Logs on R40096.
All logs with gang nails
in ends, are to be
exported.
