**Submission of the Civil Aviation Safety Authority
to the Senate Standing Committee
on Rural and Regional Affairs and Transport
Inquiry into Aviation Accident Investigations (Pel-Air)**

**CASA Accident Liaison and Investigation Unit
Accident Investigation Report 09/3 Israel Aircraft Industries Westwind VH-NGA
Operated by Pel-Air Aviation Pty Ltd - Norfolk Island – 18 November 2009
(21 July 2010)**

AIRCRAFT ACCIDENT REPORT No. 09/3

Aircraft Type, Westwind Series 2
Serial Number and Registration: Serial No:387
VH-NGA

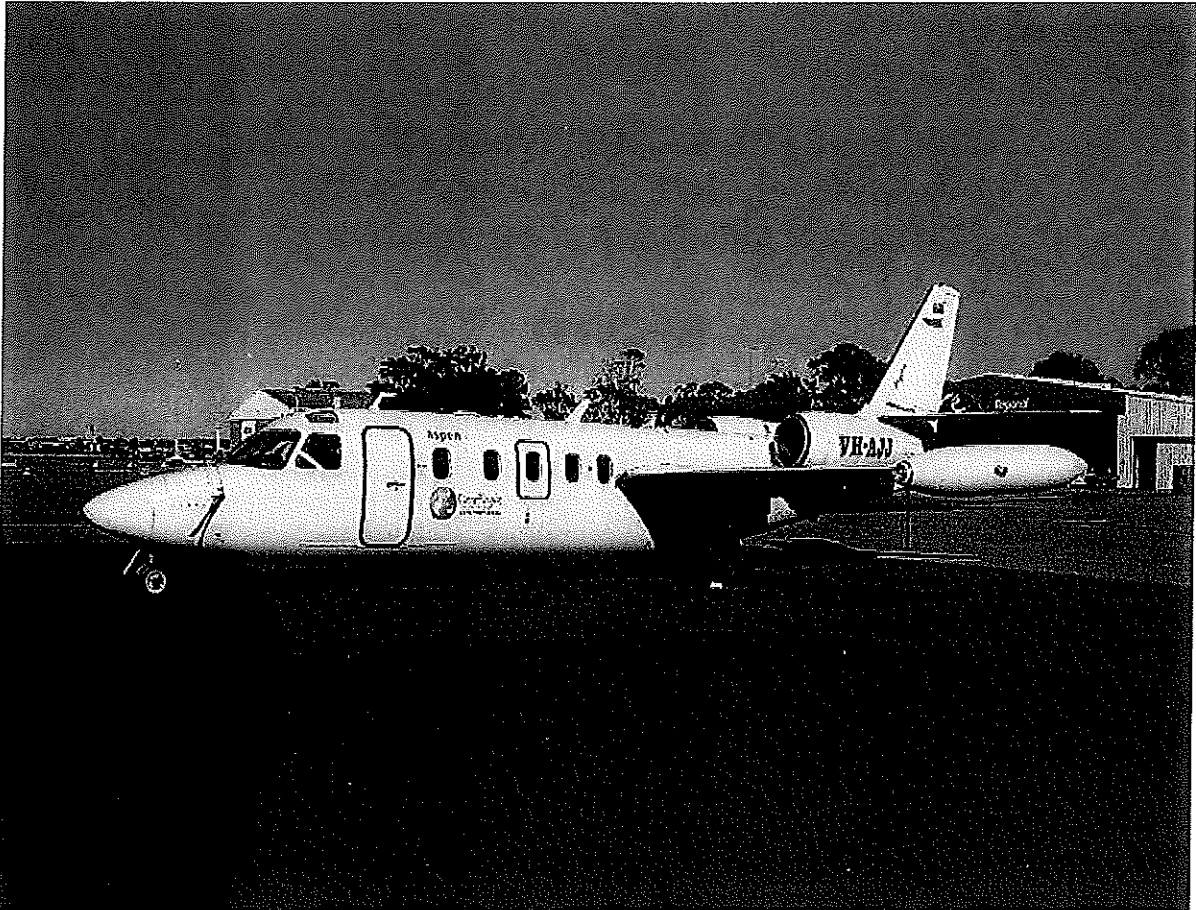
Westwind Series 1 Showing Door and Window Exit same as Series 2 VH-NGA
