Further information from Graeme Sawyer relating to my previous evidence.

Summary

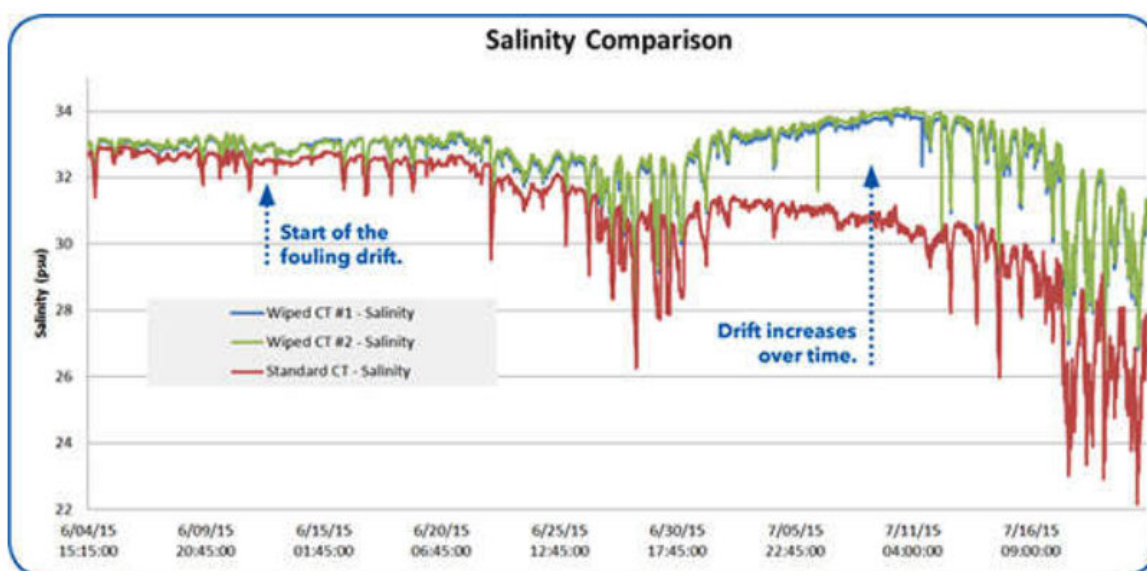
Figure 1 - Sensor fouling research data plot from salinity research.

1 Sensors using an electrical current to measure micro siemens as a salinity or dissolved ions measurement typically show reduced readings when they suffer from fouling not sudden increases⁵.

2 Even when they are suffering from fouling the sensor will still show the up and down movement changes in salinity readings as can be seen from the image below where the red line, the fouling sensor plot, is still showing the peaks and troughs in synch with the green and blue plots from the self-cleaning sensors. This is clear in Figure 1 below. The 28 August 2019 EC spike looks more likely to be real when this evidence is considered.

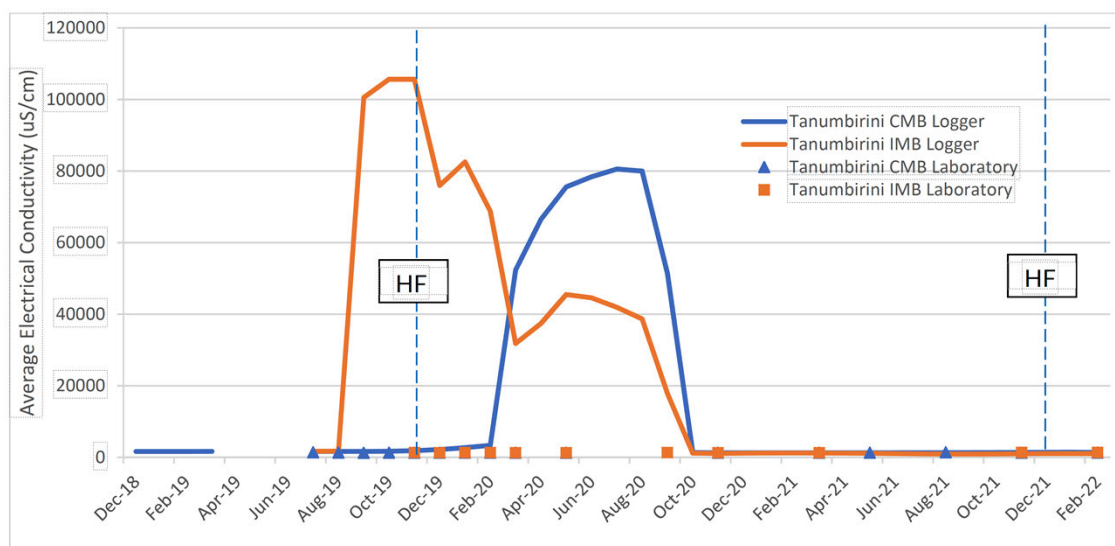
Figure 2 Data inconsistency plot from NTG Regulatory Statement- Electrical Conductivity

There is a clear and unexplained discrepancy with the manual data, which has been collected in a different manner. The regulator needs to take control of this process and use independent sources for this work to meet transparency requirements and use multiple sensors as specified to develop a clear understanding of these issues relating to the water column and bores. This must be transparent. There is no manual data from RN040936 in the period leading up to the EC reading spike in Aug 2019 that I am aware of. It is strange that this graph shows no manual data (Blue triangles) from RN040930 at the time of the EC spike in that bore's data. This needs investigation.

This idea that the data from the Control bore RN040930 refutes the data from RN040936 is not supportable. The Control bore RN040930 was specifically designed and located “upstream” so as to not be influenced by the wells. So why is it claimed this data refutes the sensor data?

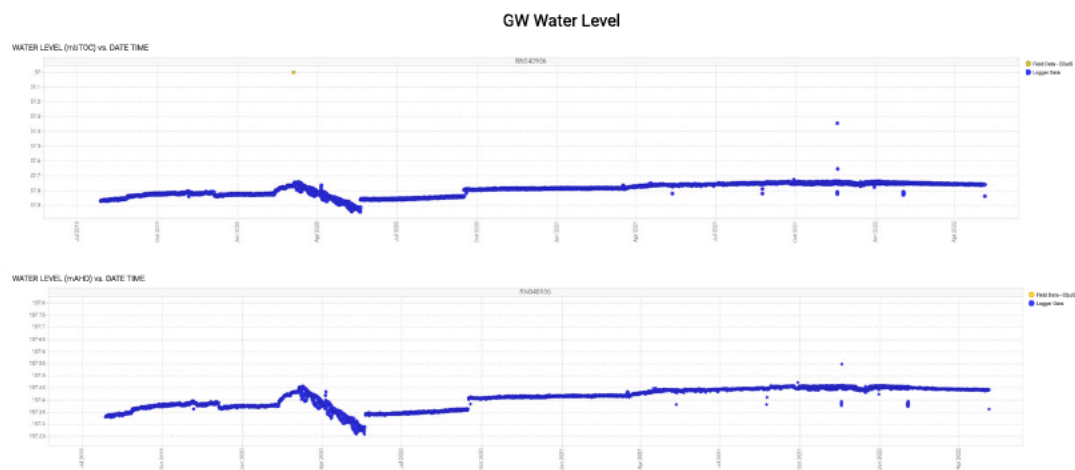
Figure 3 Water elevation data RN040936

Further there are concerns with other water elevation data that appears to roughly coincide with the salinity spikes in the bores. Figure 3 below shows a major change in the water elevation around the time the spike in RN040930 occurred. This indicates that there was fracking activity at the time of salinity spikes suggesting that the vibrations of operation at one well on a pad could be impacting the bonding on nearby wells perhaps calling into question the multi well wellpad concept. I do not have access to the Well Operations management plan WOMP to analyze this and would ask the senate inquiry to facilitate this.

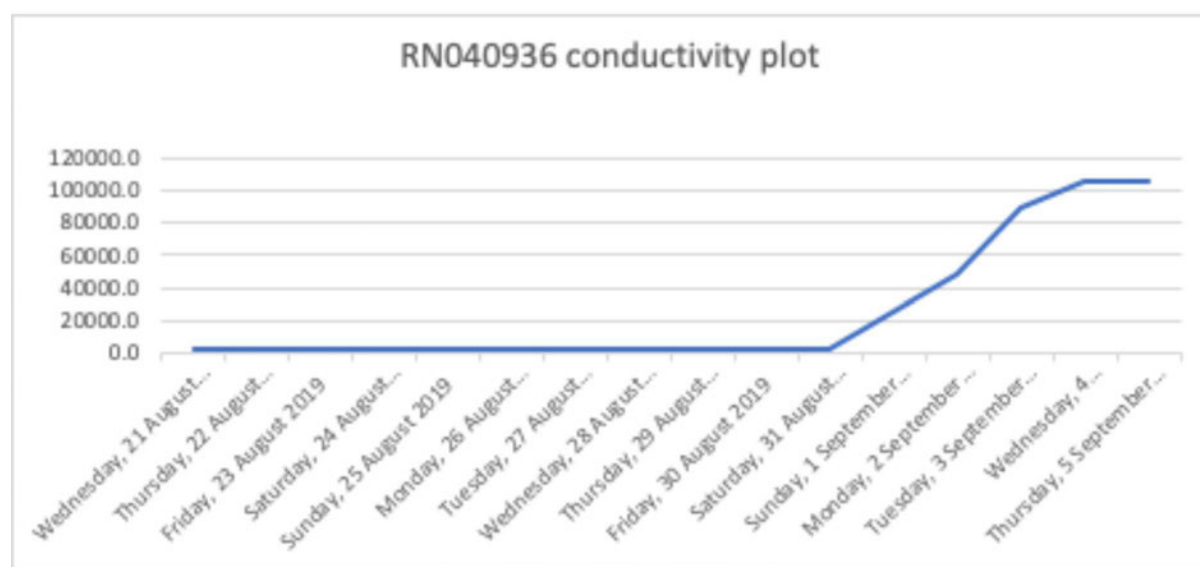
Figure 1 - Daily Average EC plot ($\mu\text{S}/\text{cm}$) from IMB RN040936 around the time of the initial increase in EC

The raw data from RN090936, also known as the impact monitoring bore, reveals an approximately 50-fold increase change in the conductivity reading microsiemens/cm ($\mu\text{S}/\text{cm}$) which is a standard measure of total dissolved ion load/salinity in water, commonly used to track the salinity of freshwater.

The conductivity $\mu\text{S}/\text{cm}$ measurements began in bore RN 040936 on the 27th July 2018 with a value of 1714.8 $\mu\text{S}/\text{cm}$. For the next 13 months, until Thursday 27th August 2019 EC readings were between 1670 $\mu\text{S}/\text{cm}$ and 1730 $\mu\text{S}/\text{cm}$.

The raw data shows that the conductivity measure went above 1800 ($\mu\text{S}/\text{cm}$) for the first time on Thursday 29th August with the early morning (0:00 hrs) reading of 1804.1 $\mu\text{S}/\text{cm}$. By that evening the reading was 1861.9 $\mu\text{S}/\text{cm}$. By Friday night, the reading was 2027.1 $\mu\text{S}/\text{cm}$, by Saturday night 5895 $\mu\text{S}/\text{cm}$, By Sunday night 34,473.8 $\mu\text{S}/\text{cm}$. By Monday night the reading was 62092.6 $\mu\text{S}/\text{cm}$ and by Tuesday night it had reached 105651 $\mu\text{S}/\text{cm}$ which is around the maximum the sensor was able to measure.
