Further information from Graeme Sawyer relating to my previous evidence.

Summary

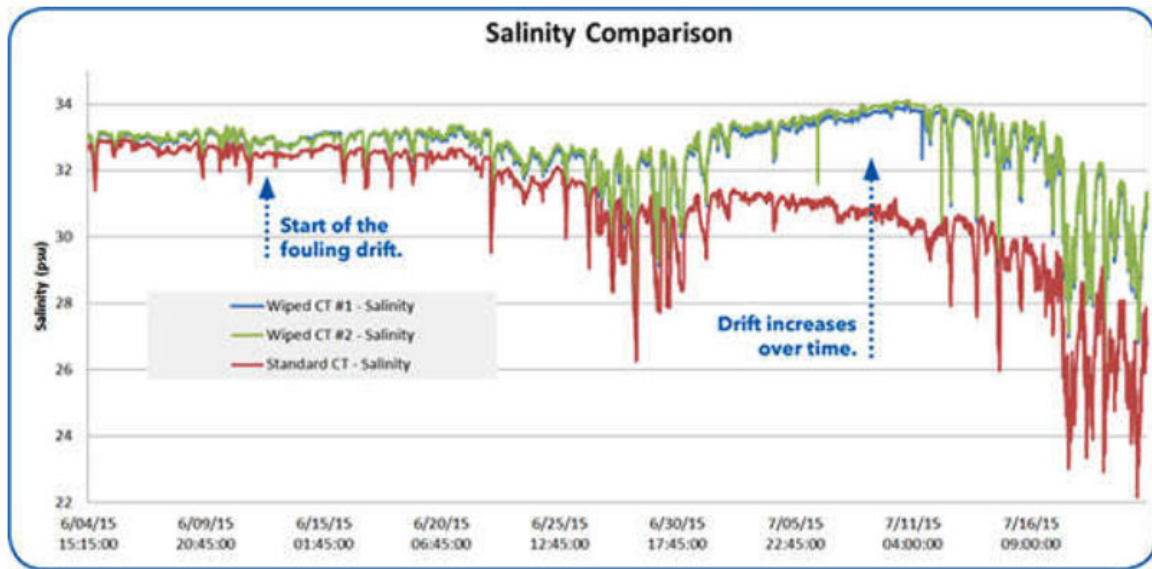
Figure 1 - Sensor fouling research data plot from salinity research.

The statement shows no evidence to support these claims and available evidence refutes them. As an example, the raw data from RN040936 shows very little drift in the readings and a slight increase if anything. This notion of fouling causing the rapid increase in EC readings does not fit with the science of the types of sensors used as fouling normally leads to a lowering of readings. It also does not fit with the significant drift claim. Fouling is a slow process and is cumulative. It doesn't usually cause sudden dramatic increases. This is because the fouling slows the electrical current flow used as the key sensor function. See figure 1 below for details

1 Sensors using an electrical current to measure micro siemens as a salinity or dissolved ions measurement typically show reduced readings when they suffer from fouling not sudden increases⁵.

2 Even when they are suffering from fouling the sensor will still show the up and down movement changes in salinity readings as can be seen from the image below where the red line, the fouling sensor plot, is still showing the peaks and troughs in synch with the green and blue plots from the self-cleaning sensors. This is clear in Figure 1 below. The 28 August 2019 EC spike looks more likely to be real when this evidence is considered.

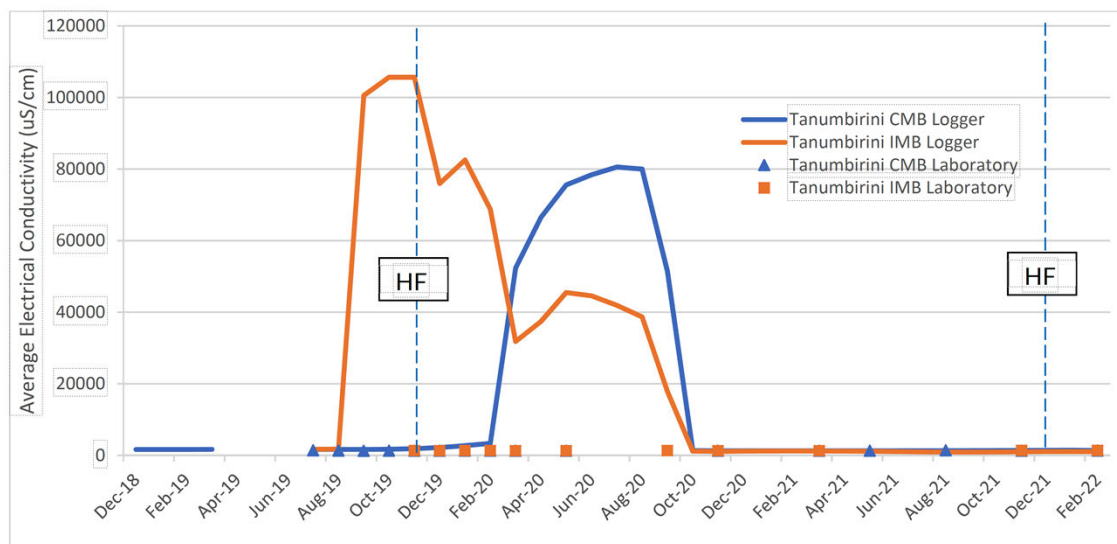
Figure 2 Data inconsistency plot from NTG Regulatory Statement- Electrical Conductivity

There is a clear and unexplained discrepancy with the manual data, which has been collected in a different manner. The regulator needs to take control of this process and use independent sources for this work to meet transparency requirements and use multiple sensors as specified to develop a clear understanding of these issues relating to the water column and bores. This must be transparent. There is no manual data from RN040936 in the period leading up to the EC reading spike in Aug 2019 that I am aware of. It is strange that this graph shows no manual data (Blue triangles) from RN040930 at the time of the EC spike in that bore's data. This needs investigation.

This idea that the data from the Control bore RN040930 refutes the data from RN040936 is not supportable. The Control bore RN040930 was specifically designed and located “upstream” so as to not be influenced by the wells. So why is it claimed this data refutes the sensor data?

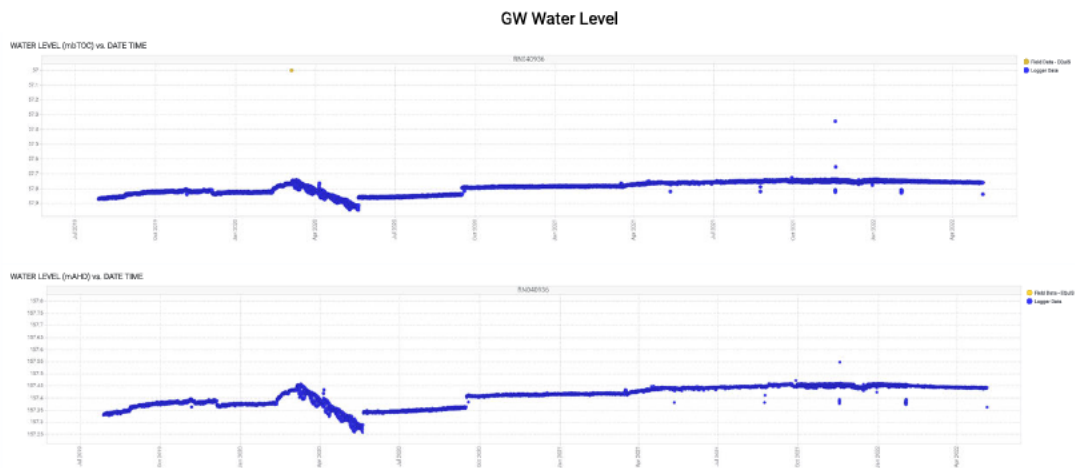
Figure 3 Water elevation data RN040936

Further there are concerns with other water elevation data that appears to roughly coincide with the salinity spikes in the bores. Figure 3 below shows a major change in the water elevation around the time the spike in RN040930 occurred. This indicates that there was fracking activity at the time of salinity spikes suggesting that the vibrations of operation at one well on a pad could be impacting the bonding on nearby wells perhaps calling into question the multi well wellpad concept. I do not have access to the Well Operations management plan WOMP to analyze this and would ask the senate inquiry to facilitate this.
