Submission 40 - Welding Technology Institute of Australia

SUPPLEMENTARY SUBMISSION TO THE SENATE INQUIRY INTO: THE FUTURE OF AUSTRALIA'S STEEL INDUSTRY

POLICY PROPOSAL: SAFETY OF FABRICATED STRUCTURAL STEEL

Bussellton Pedestrian Bridges Visual Examination and Commentary Regarding Weld Quality >

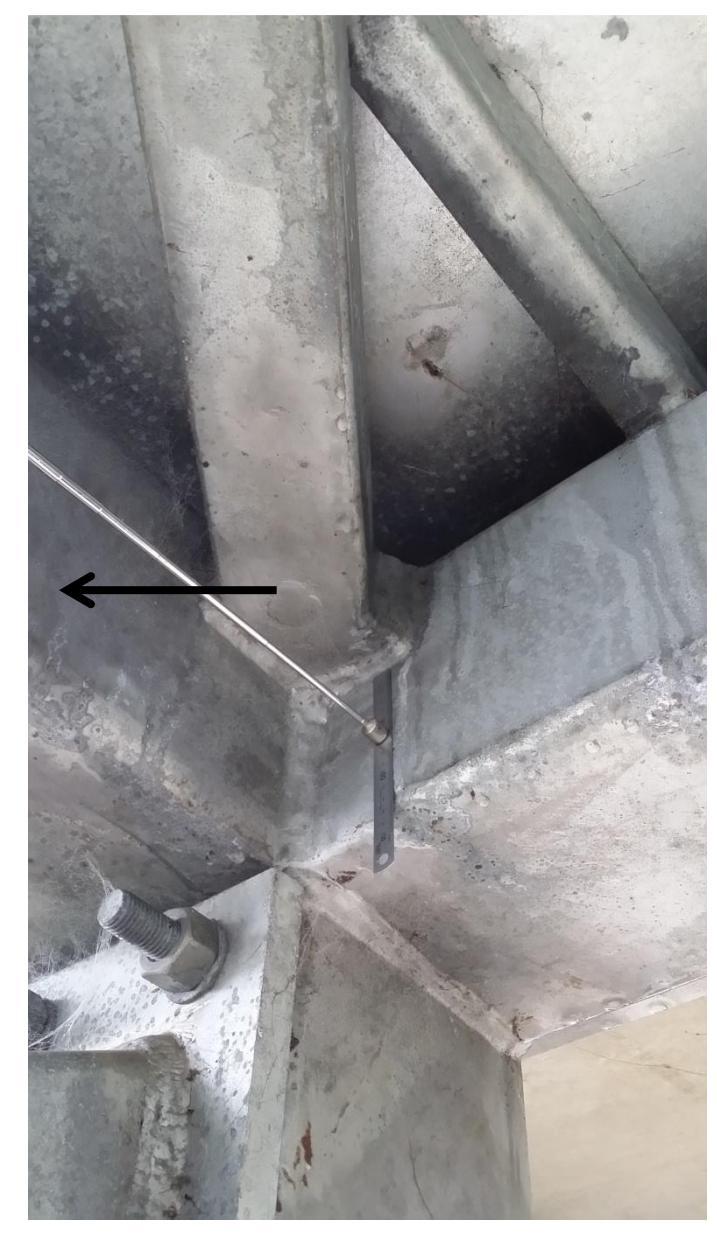
1.1 Toby Inlet Bridge

- Weld Imperfections Evident
 - Weld is excessive in size and a round bar approximately 16mm in diameter appears to have been used as filler within the weld.
 - ٠

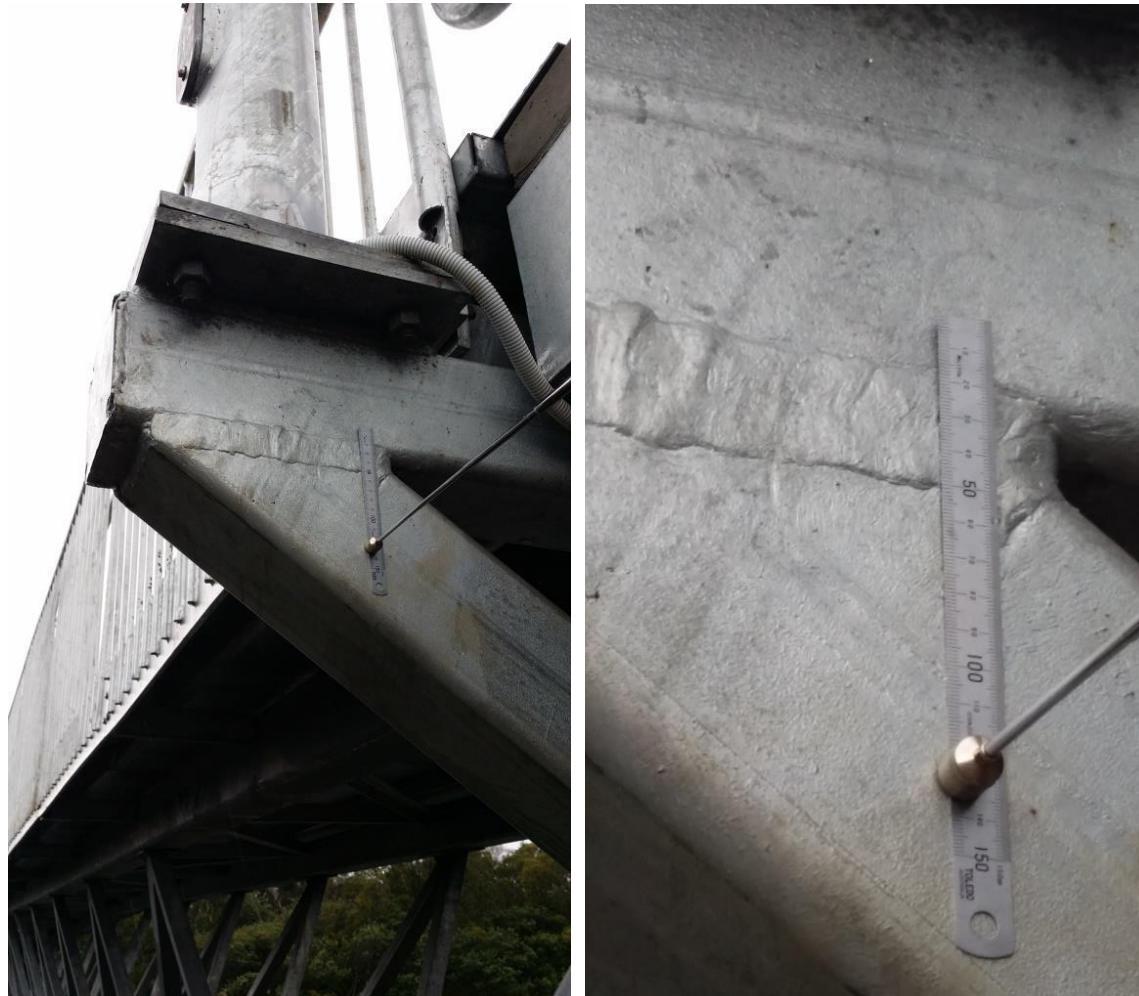
Weld imperfections evident

• Weld size is excessive – cap is over 30mm wide indicating that fit up may not have been in accordance with the standard.

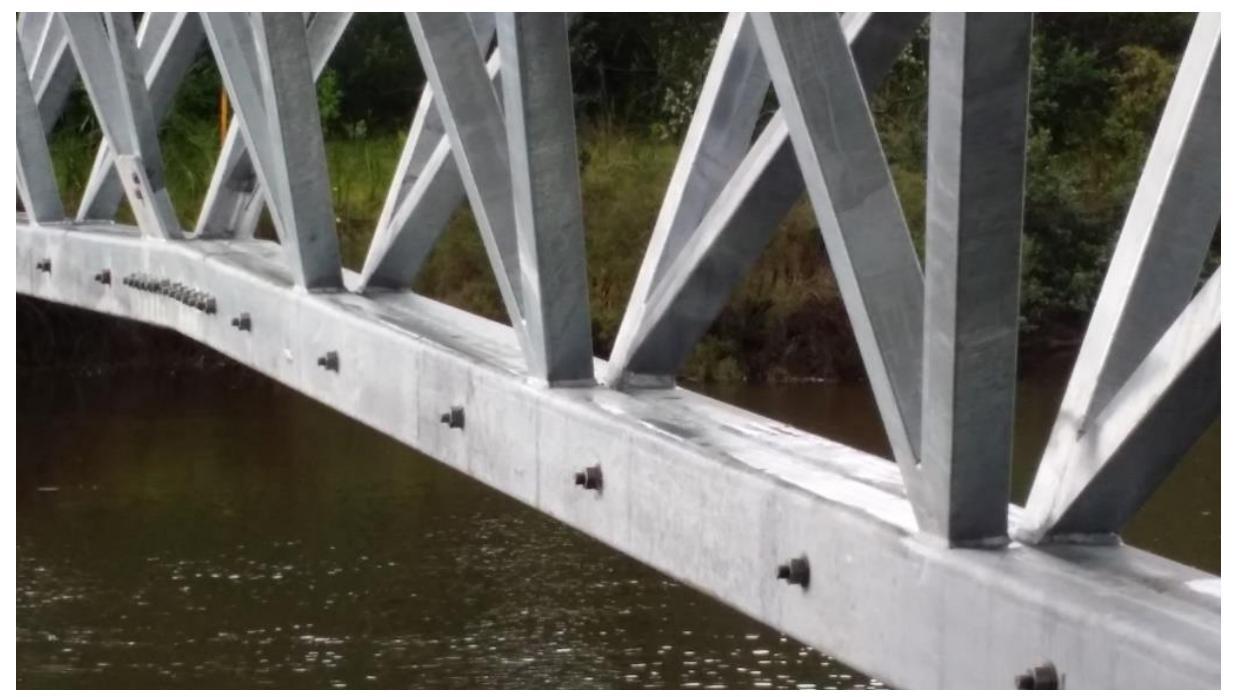
Welds joining similar joints varied substantially in size and quality. Overroll, Undercut, Incorrect bead shape, Excessive size and porosity were evident.

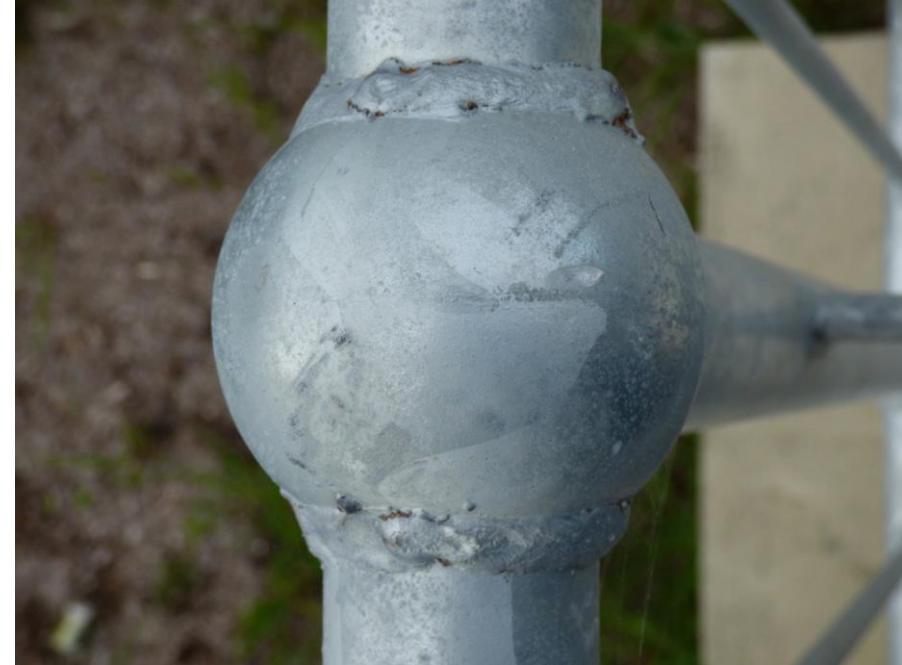
P1010070

Weld imperfections evident

- Lack of fusion
- Overroll
- Porosity
- Incorrect bead shape

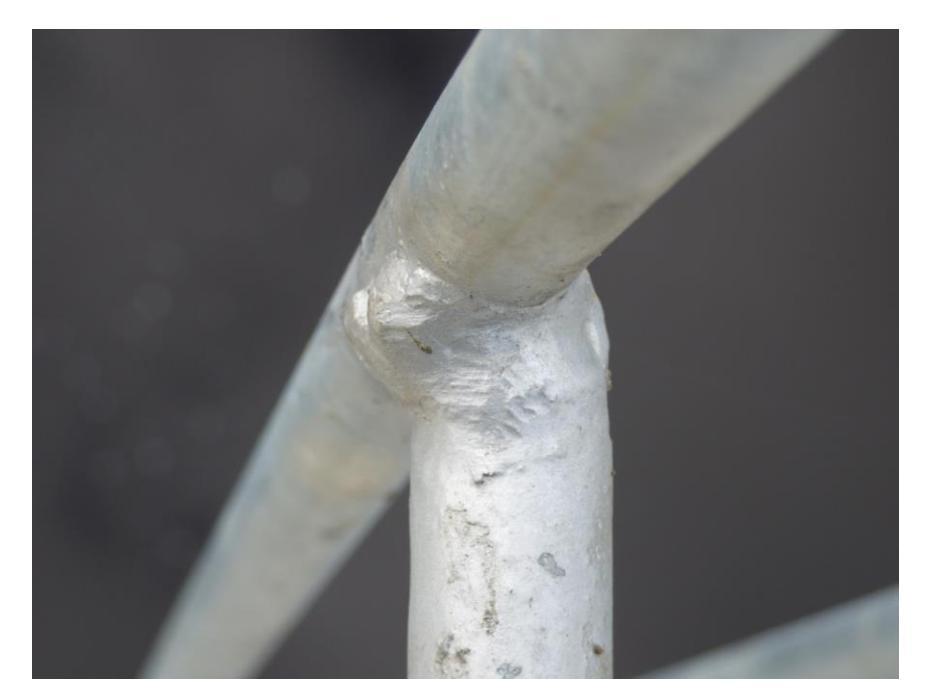
P1010070

Weld imperfections evident

The weld has been excessively ground and the extent of the welded zone is not clear. The weld shape is consistent with a joint that had very poor fit up.

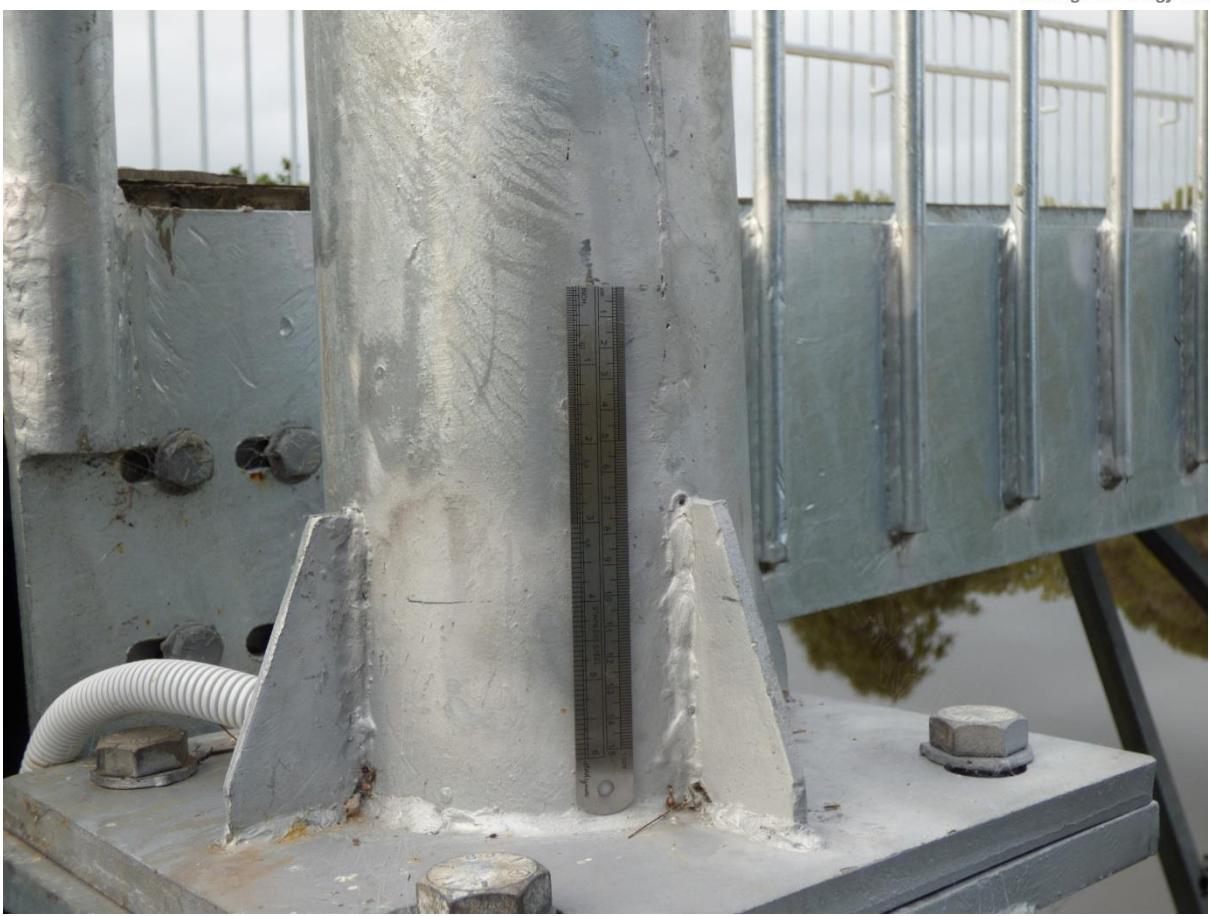
P1010117

- Porosity
- Incorrect bead shape
- Plate edges on the gusset plates have been poorly profiled and have a poor surface finish

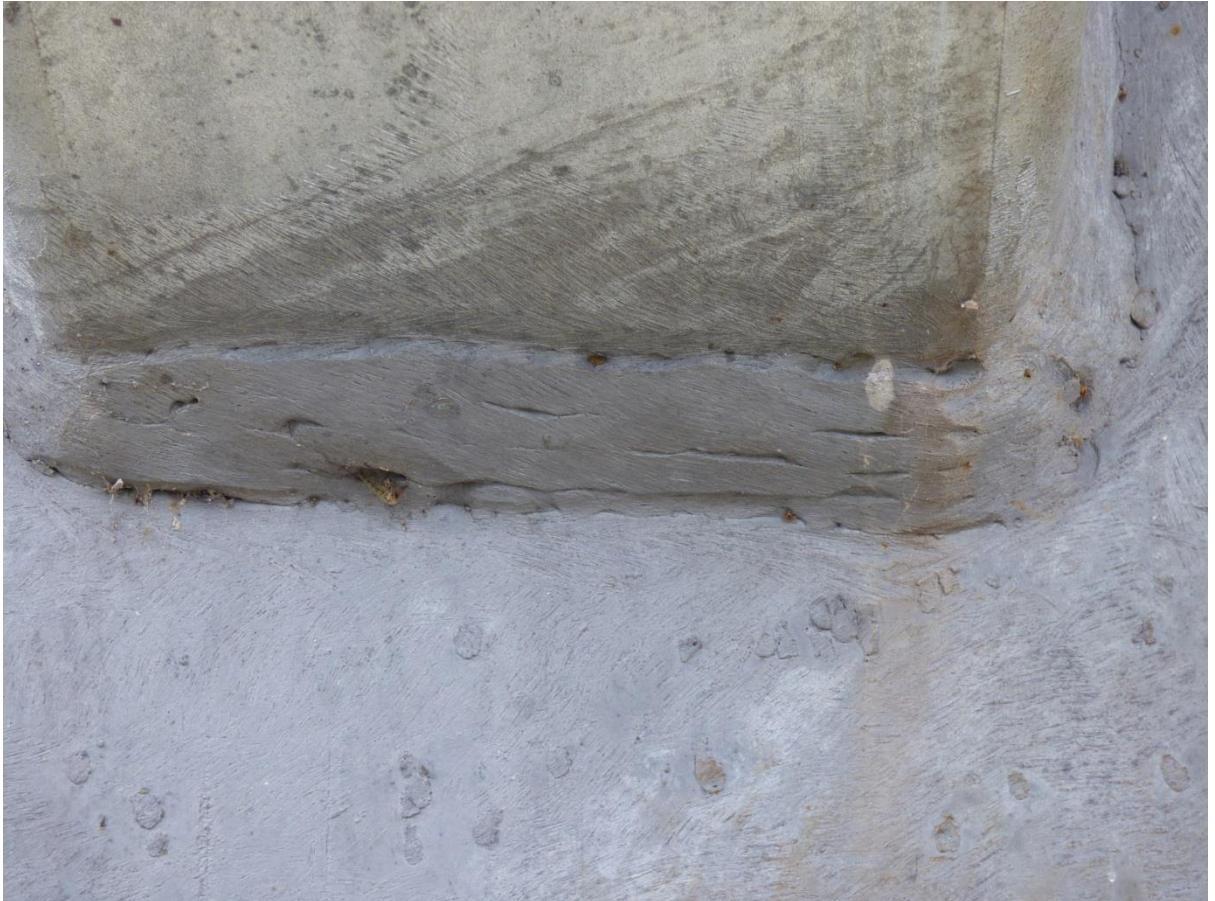
- Lack of fusion
- Overroll
- Undercut
- Excessive spatter not removed before galvanizing

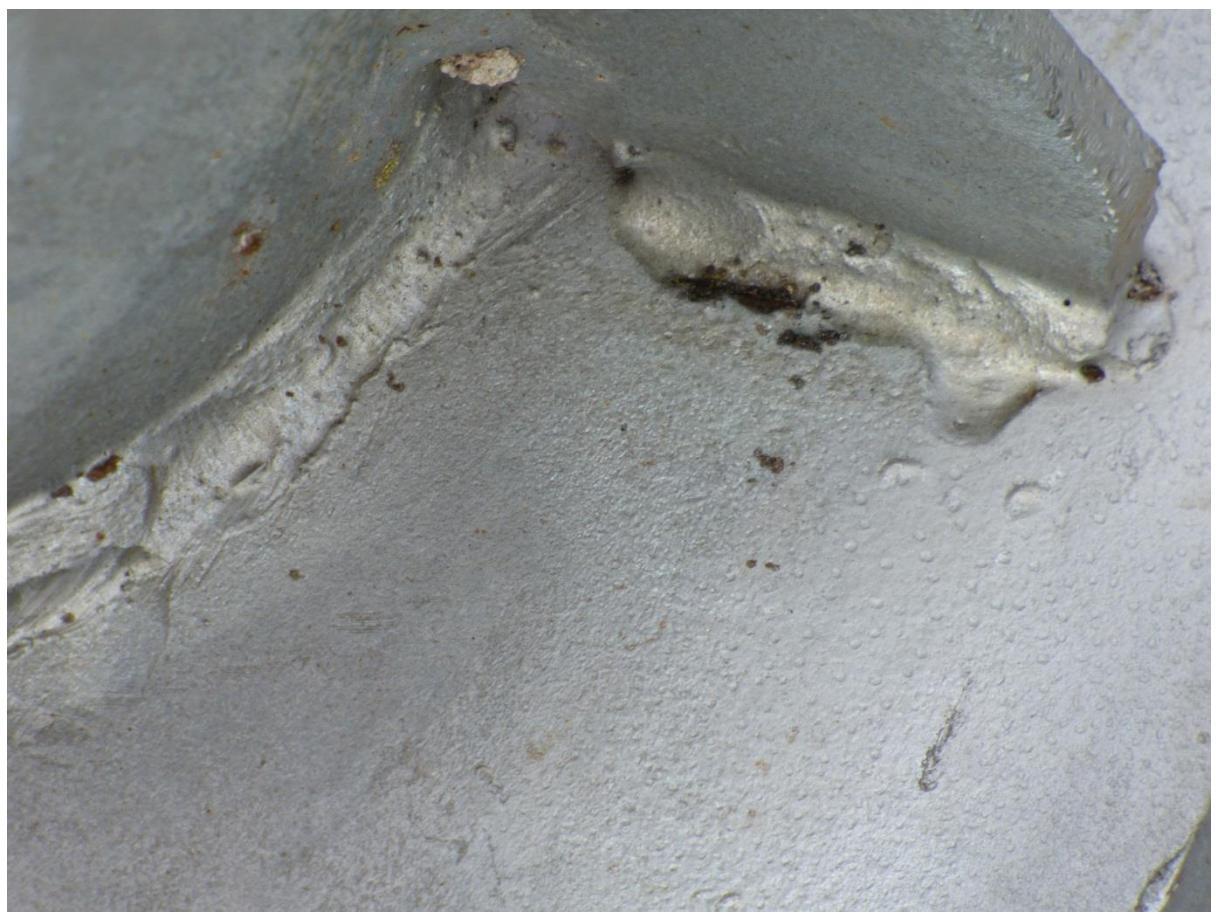
P1010020

- Incomplete welding at the gusset corner and around the end of the gusset
- Overroll
- Porosity
- Incorrect bead shape

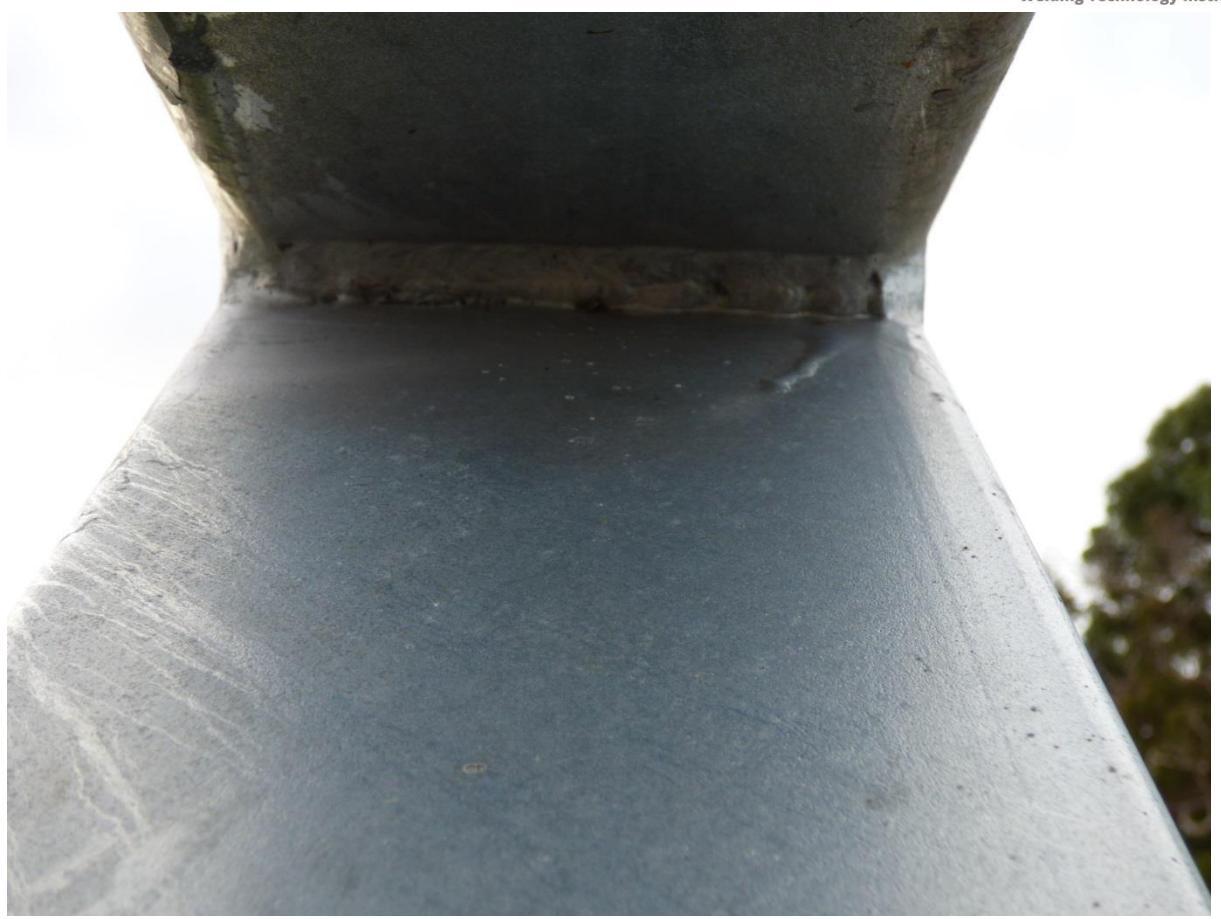
- Weld imperfections evident
 - Overroll

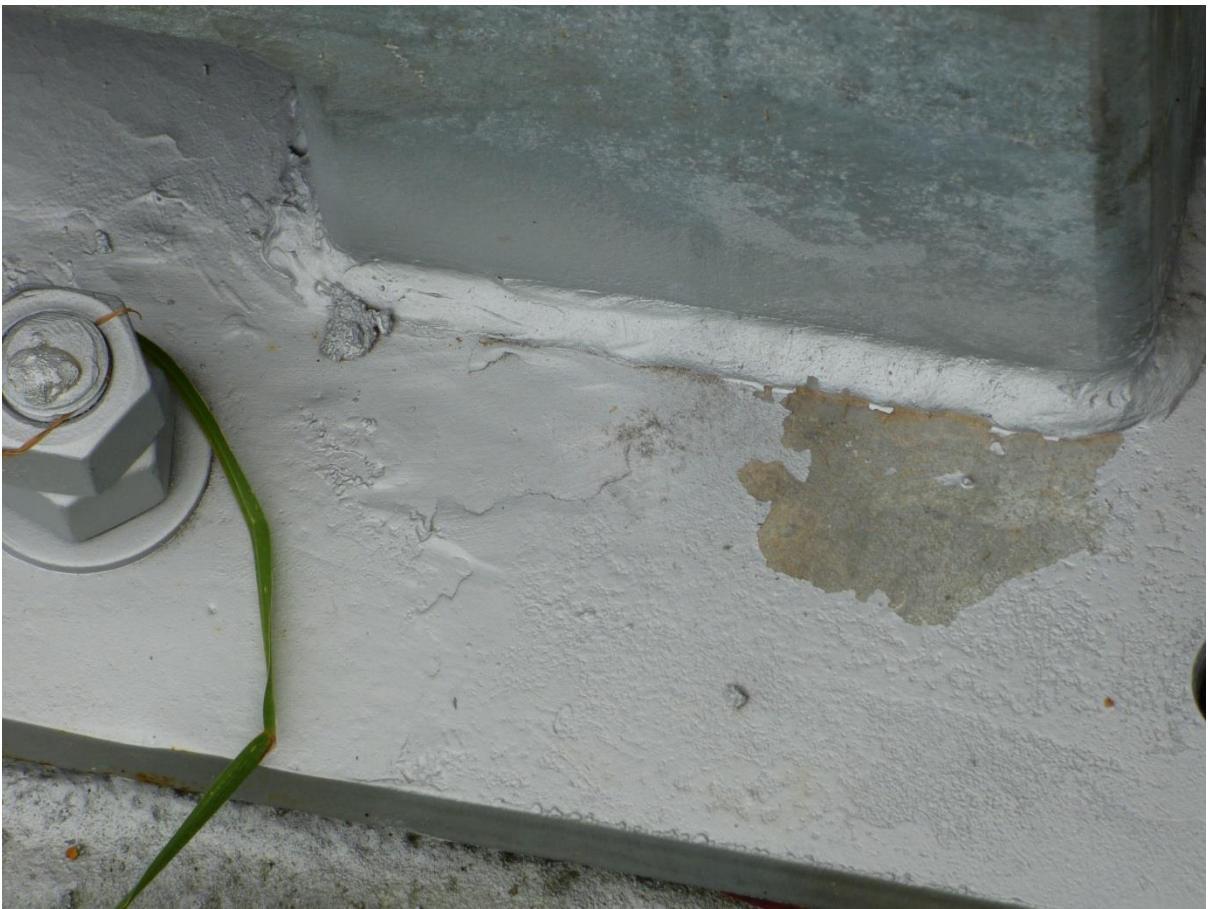
- Weld imperfections evident
 - Overroll
 - Porosity and wormholes

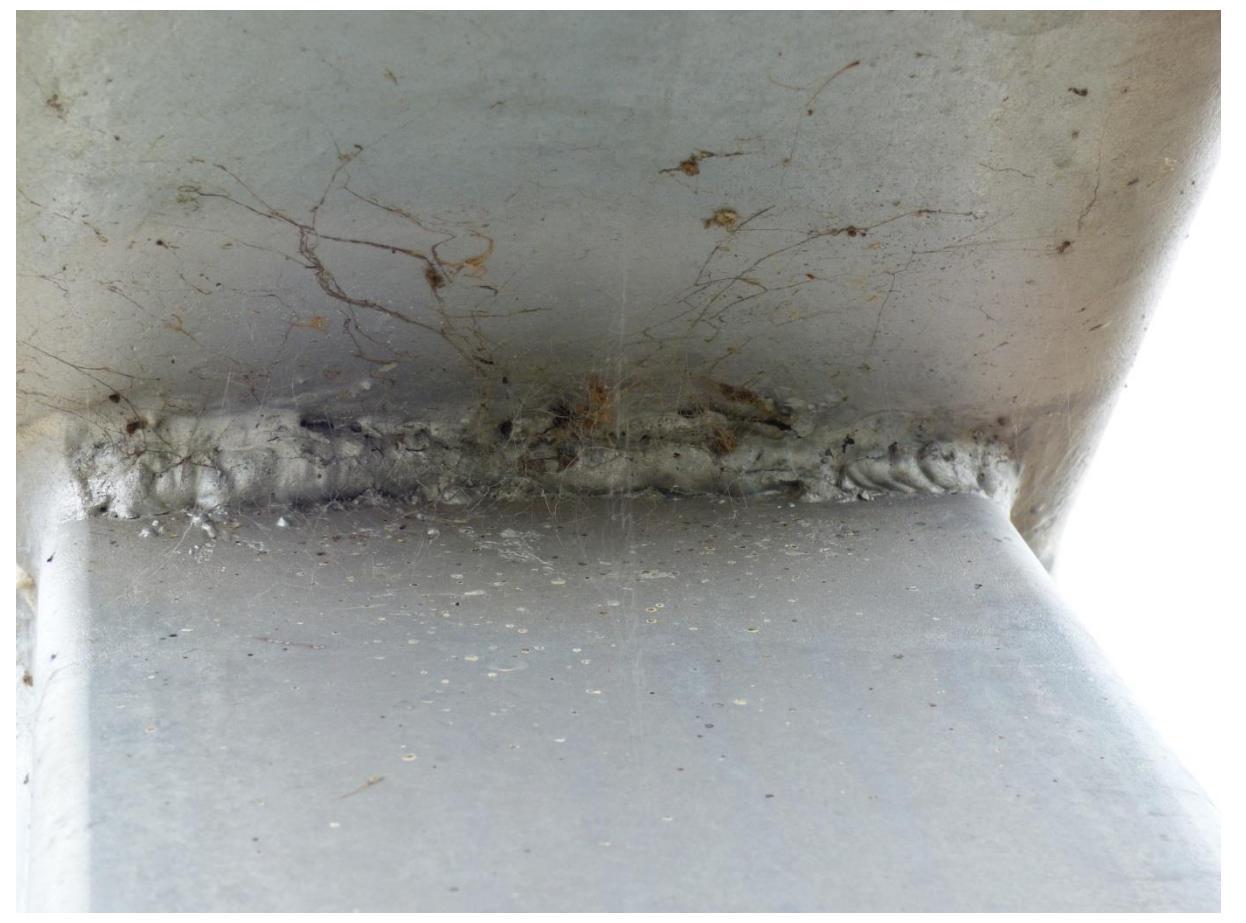
- Weld imperfections evident
 - Lack of fusion
 - Overroll
 - Porosity
 - Incorrect bead shape

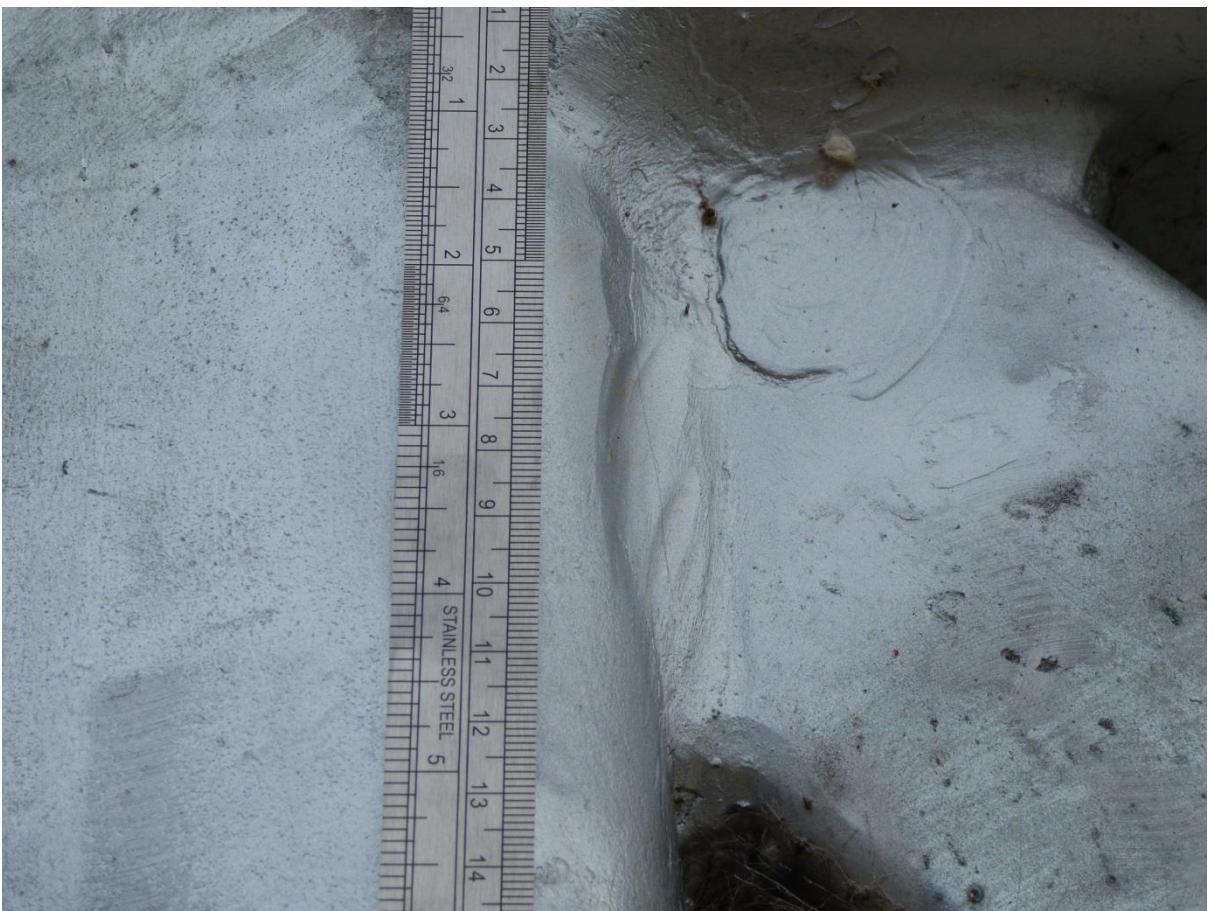
- Weld imperfections evident
 - Excessive grinding
 - Incorrect bead shape

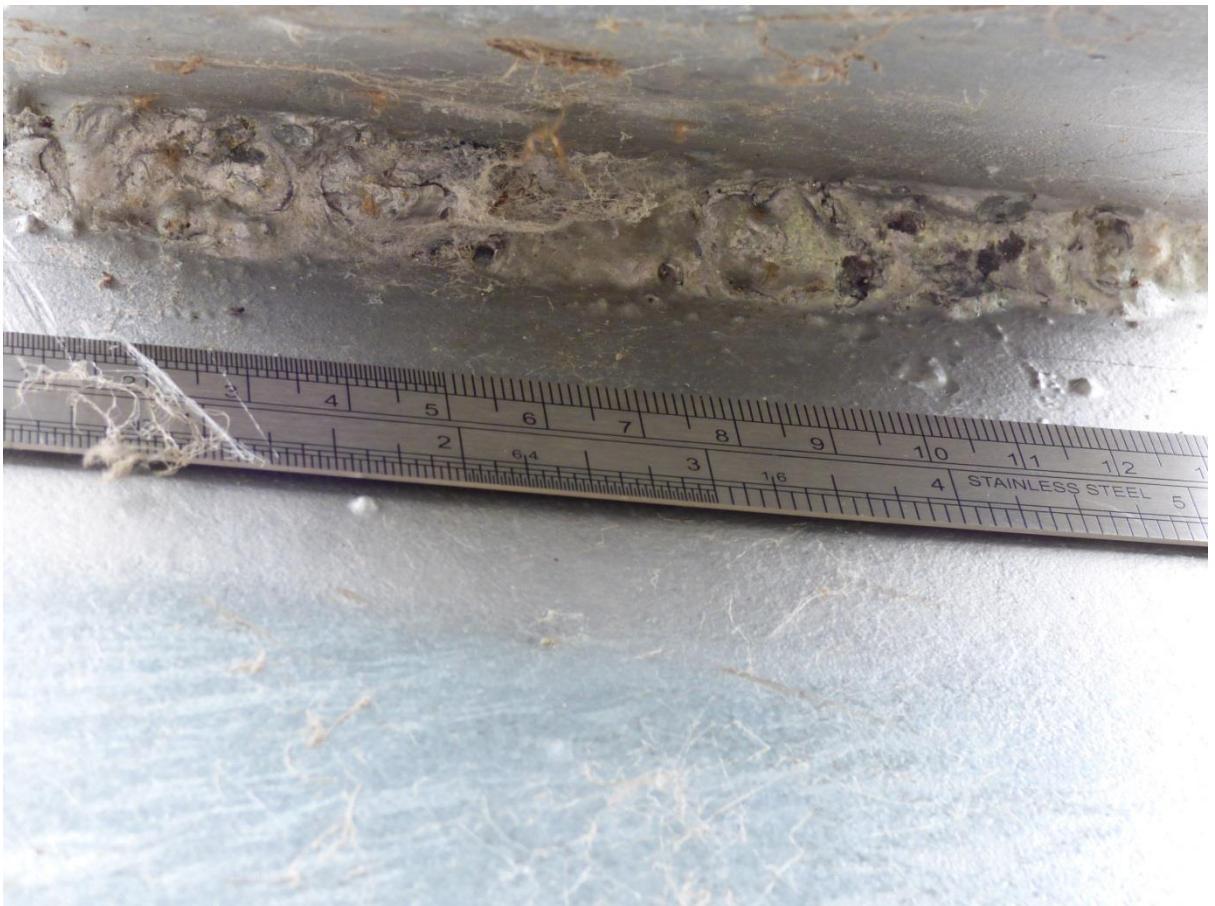
- Slag inclusions
- Lack of fusion
- Overroll
- Porosity
- Slag not removed
- Incorrect bead shape

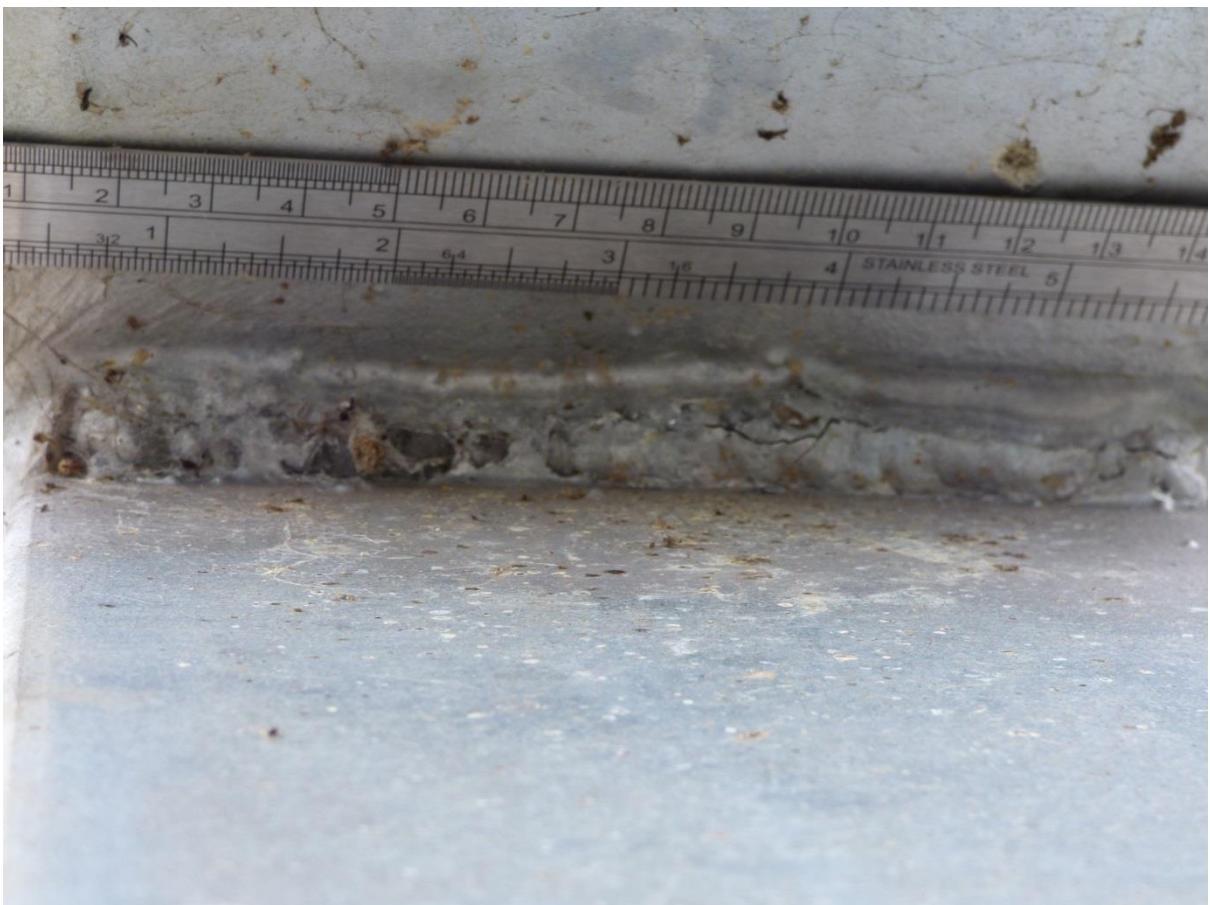
- Weld imperfections evident
 - Slag inclusions
 - Lack of fusion
 - Overroll
 - Porosity
 - Slag not removed
 - Incorrect bead shape

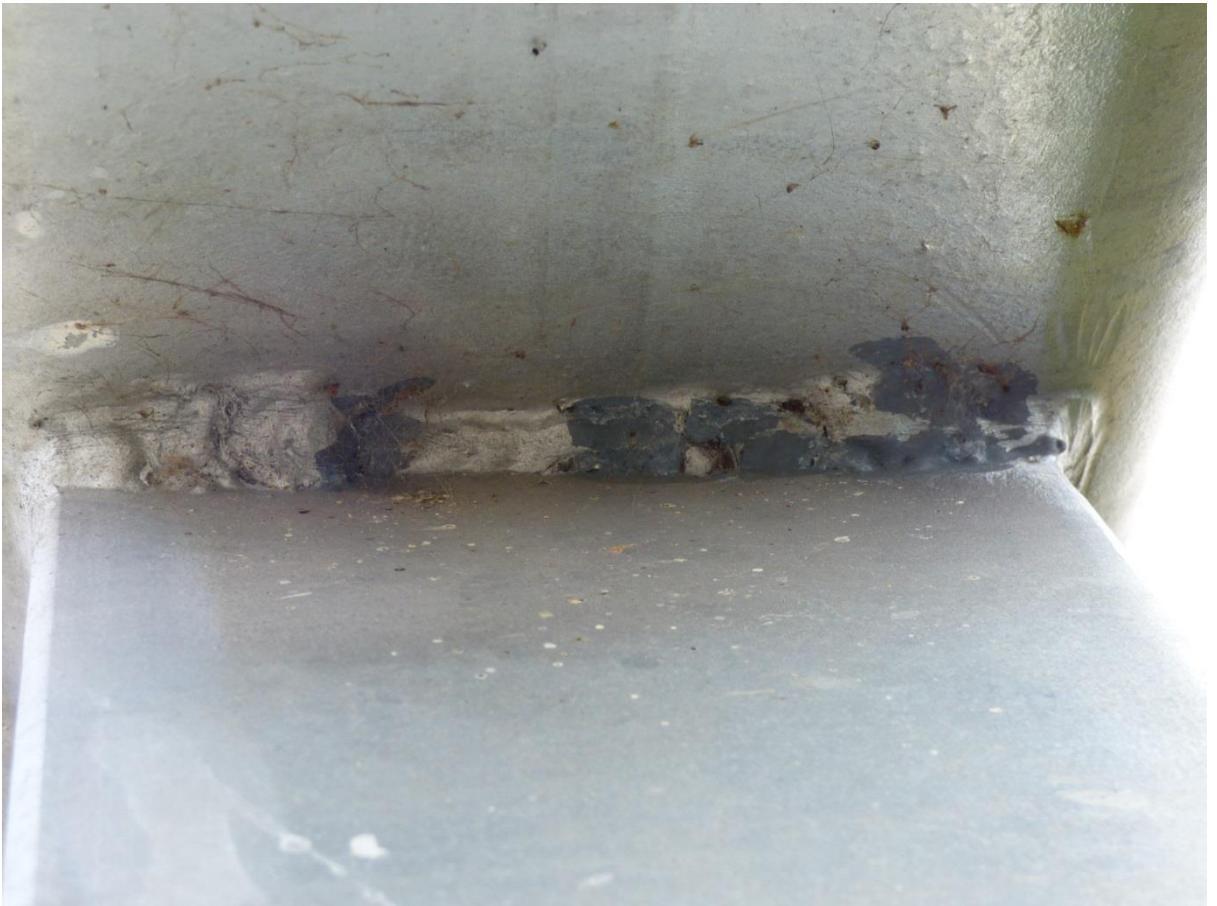
- Weld imperfections evident
 - Slag inclusions
 - Lack of fusion
 - Overroll
 - Slag not removed
 - Porosity
 - Incorrect bead shape

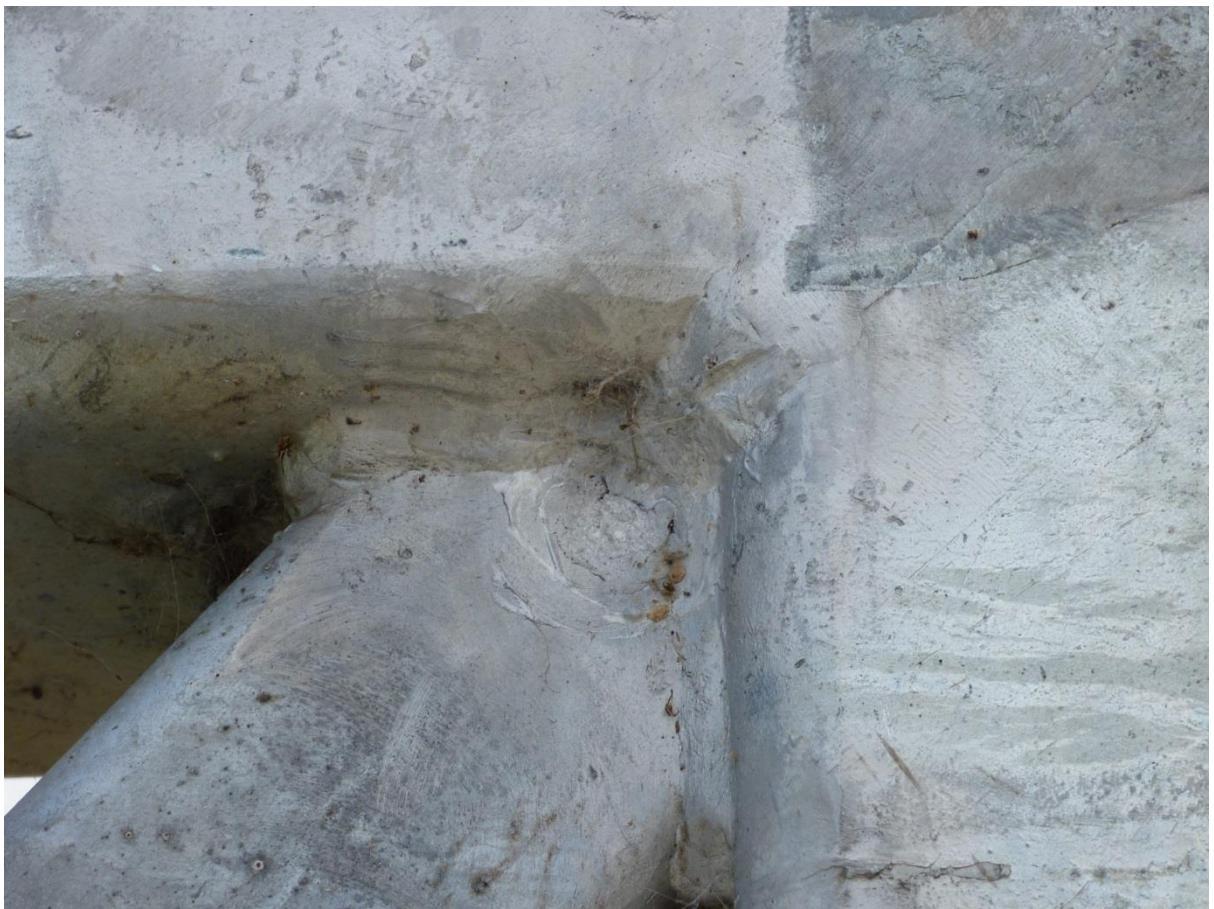
- Weld imperfections evident
 - Lack of fusion
 - Overroll
 - Porosity
 - Incorrect bead shape

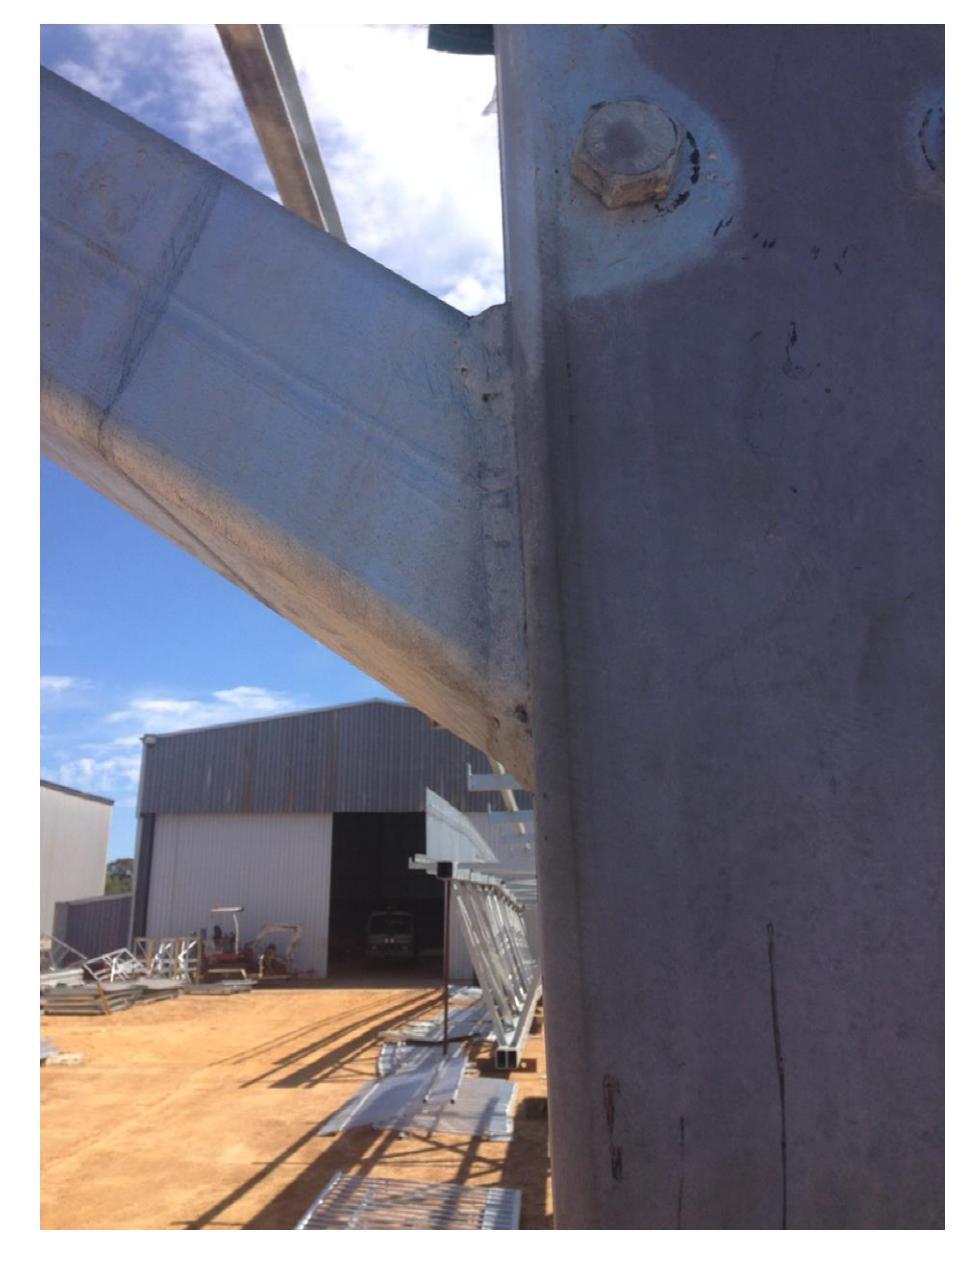
IMG_005

- Weld imperfections evident
 - Slag inclusion
 - Porosity

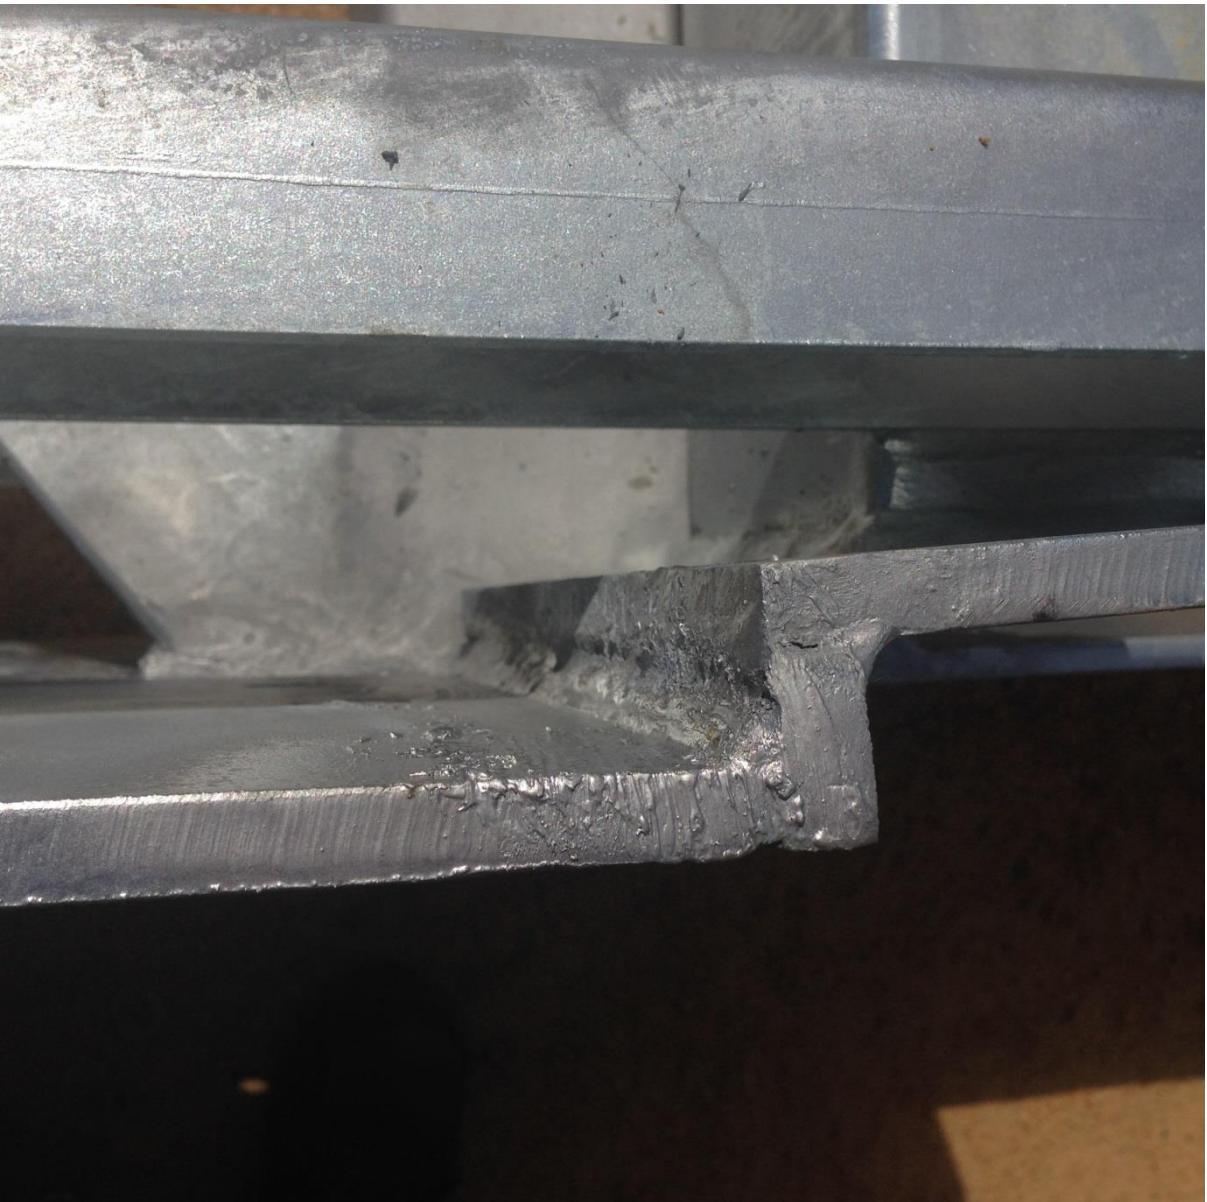
IMG_0029

- Weld imperfections evident
- Incorrect bead shape
- Poorly finished flame cut edge

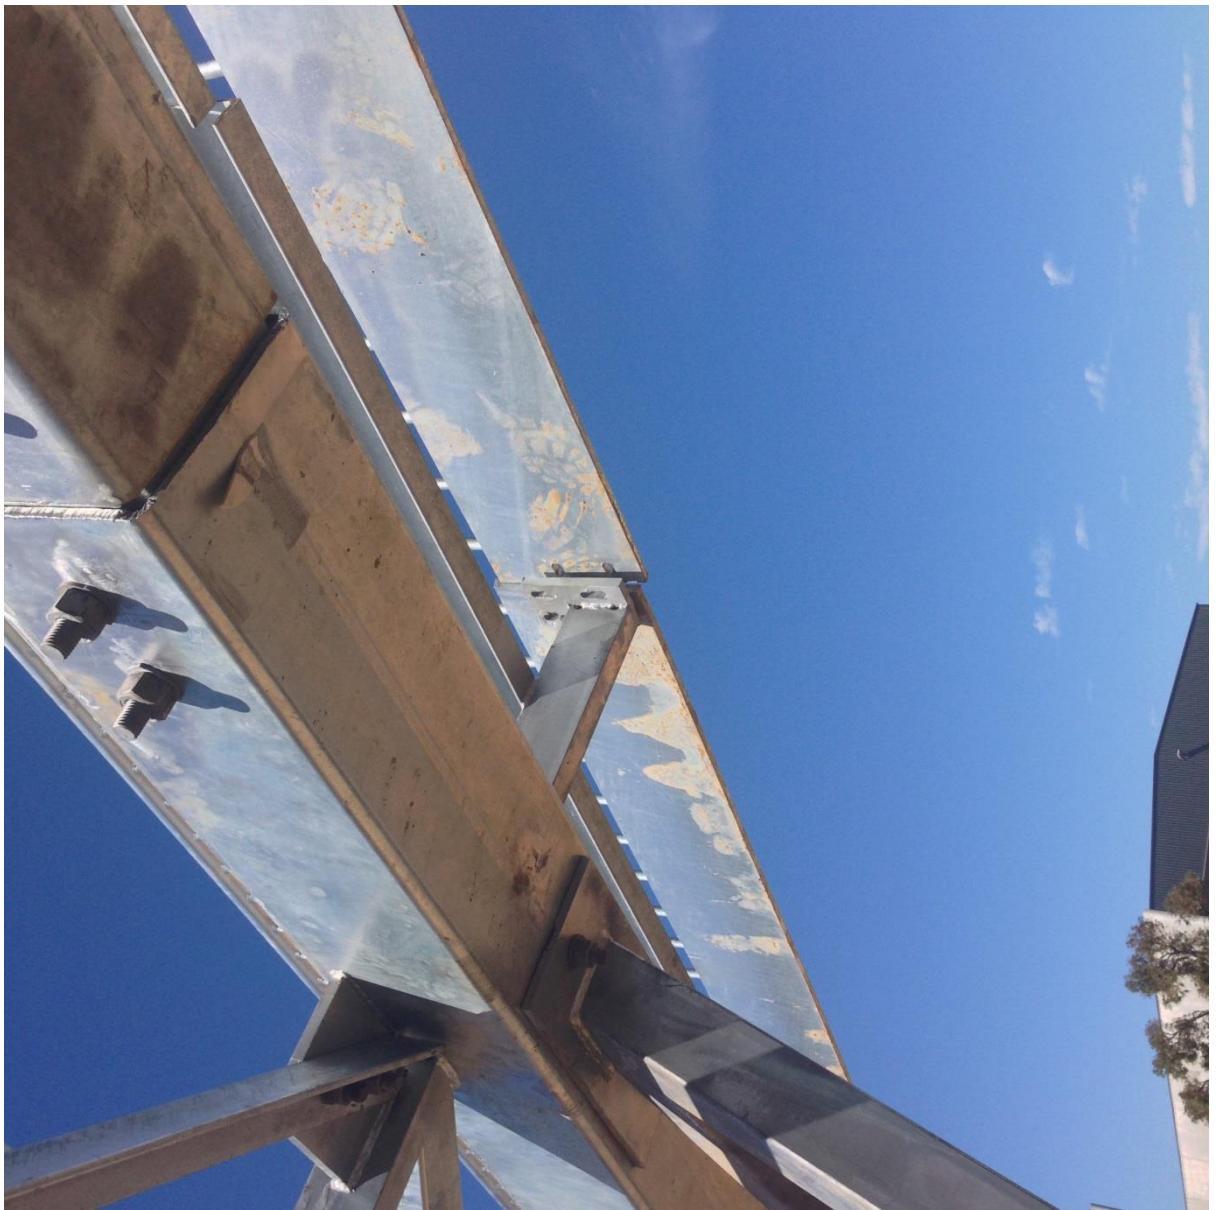
IMG_0060

- Incorrect bead shape
- Vent holes located incorrectly intersecting weld zone
- 4th bolt hole?

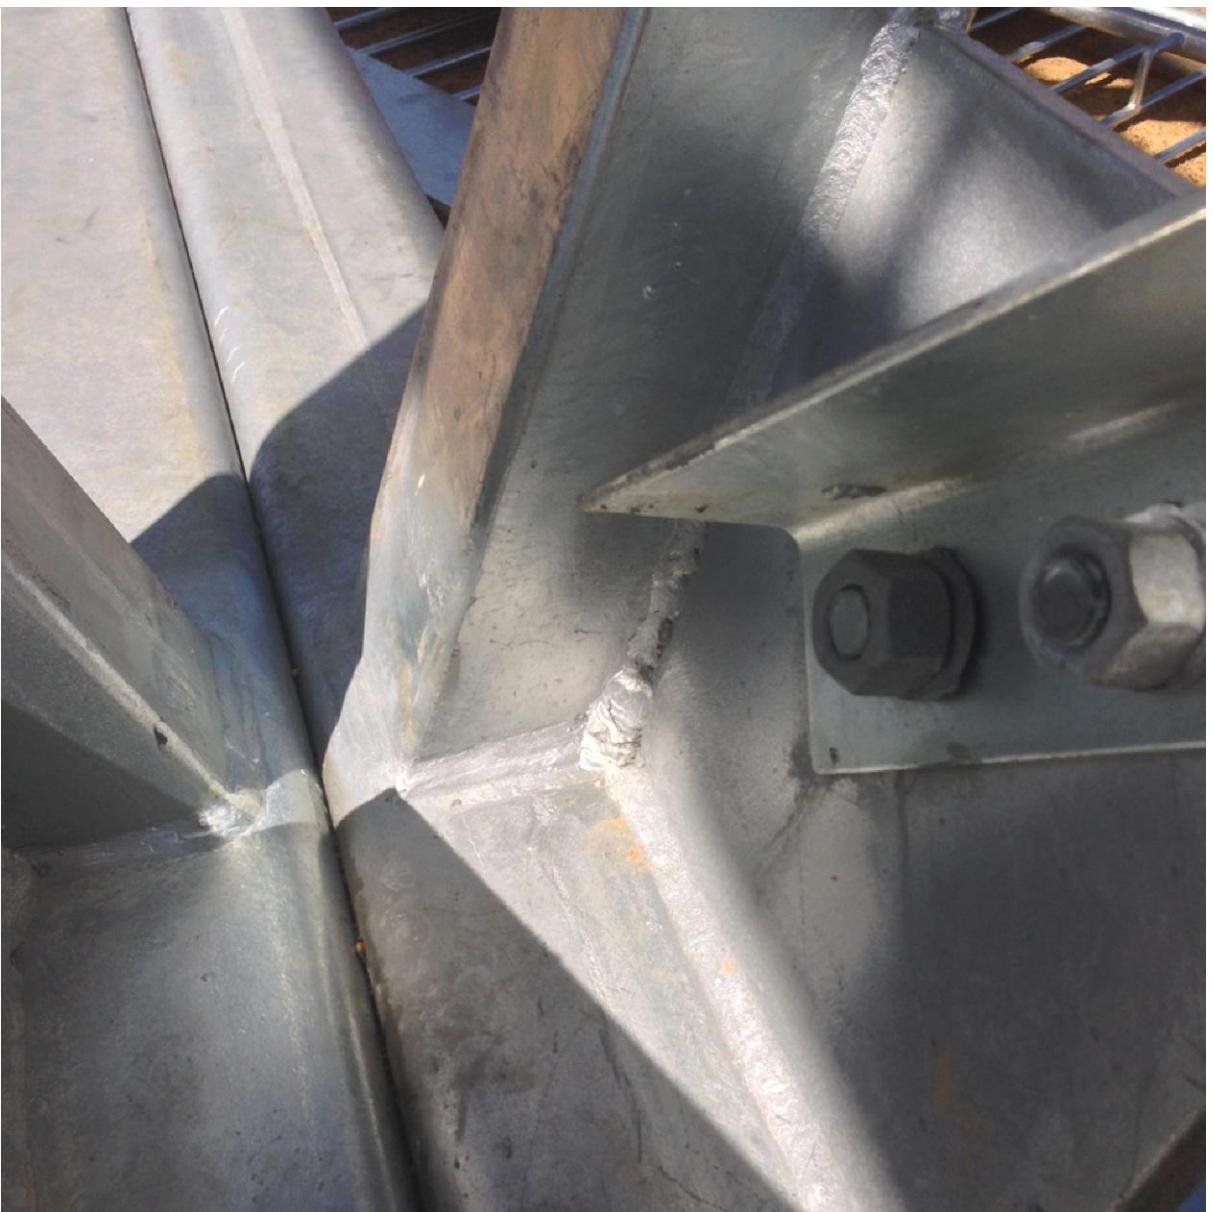
IMG_0064

- Lack of fusion
- Overroll
- Porosity
- Incorrect bead shape
