Submission 40 - Welding Technology Institute of Australia

SUPPLEMENTARY SUBMISSION TO THE SENATE INQUIRY INTO: THE FUTURE OF AUSTRALIA'S STEEL INDUSTRY

POLICY PROPOSAL: SAFETY OF FABRICATED STRUCTURAL STEEL

Bussellton Pedestrian Bridges Visual Examination and Commentary Regarding Weld Quality >

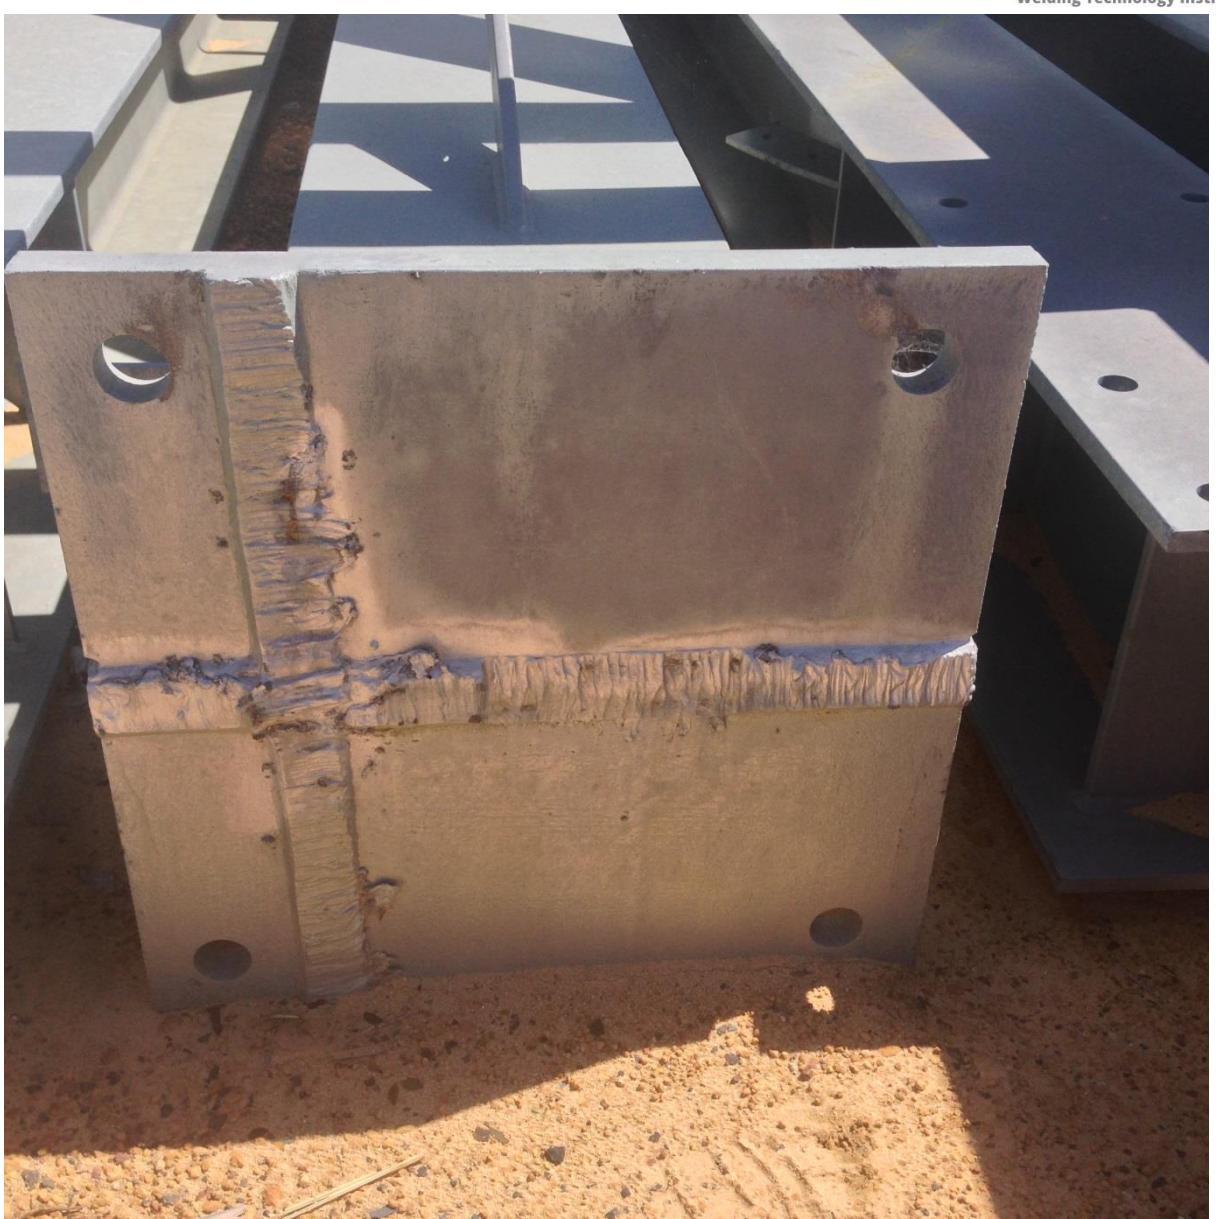
IMG_0070

- Bottom of baseplate has had material removed by oxy-fuel gas cutting
- The surfaces are as cut and undressed
- Surfaces are unsuitable for galvanizing

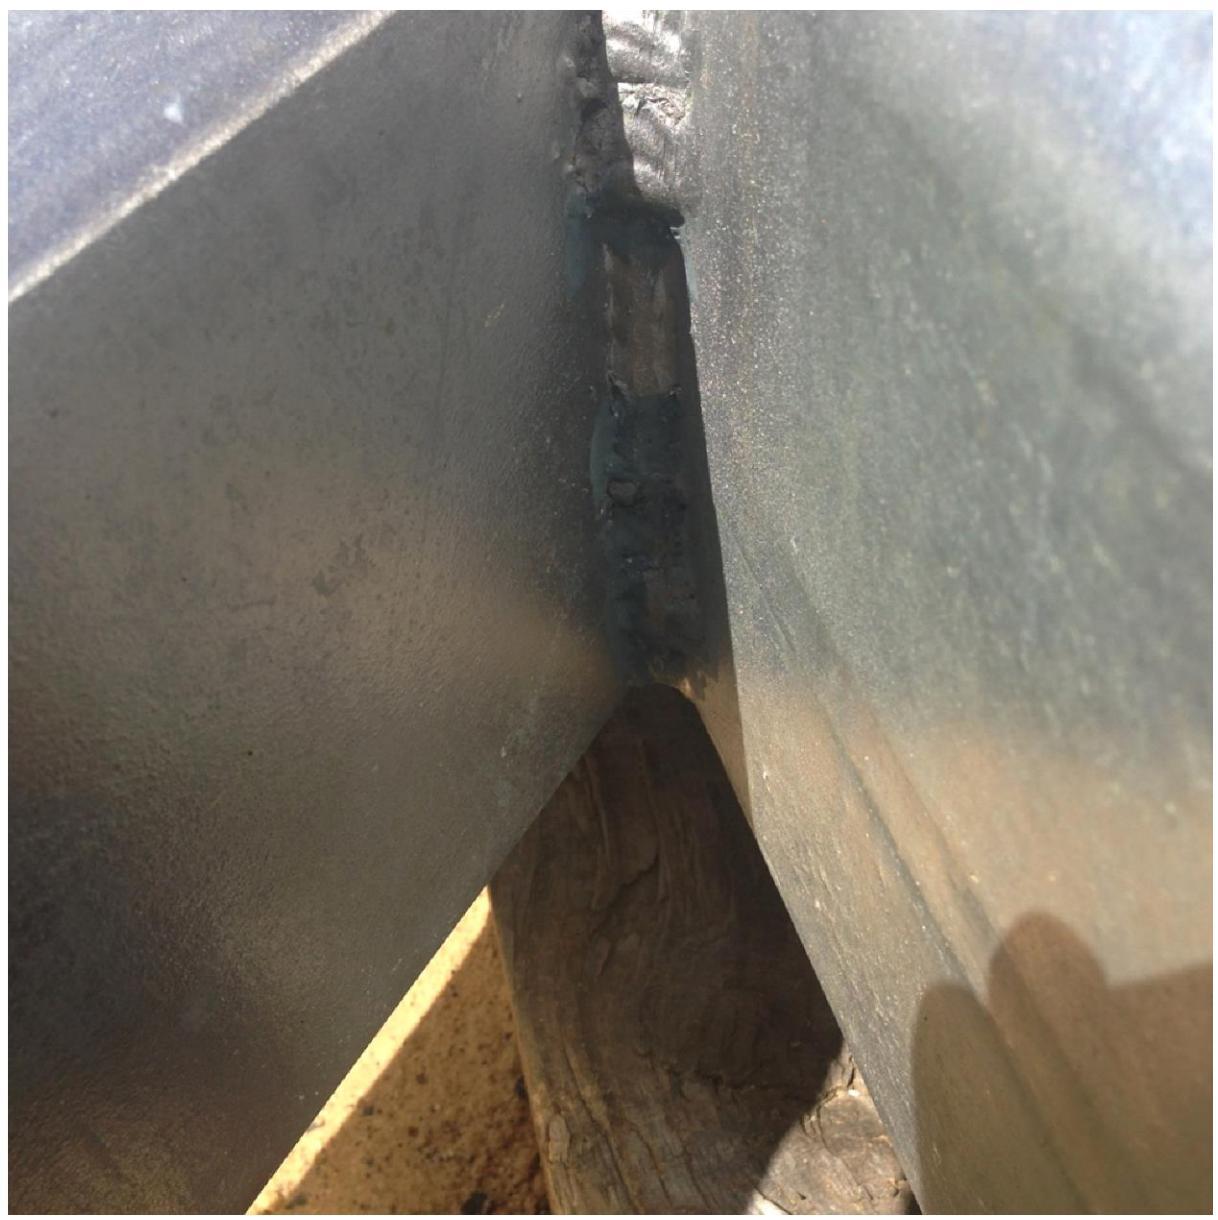
IMG_0077

- Weld imperfections evident
 - Variable fillet sizes

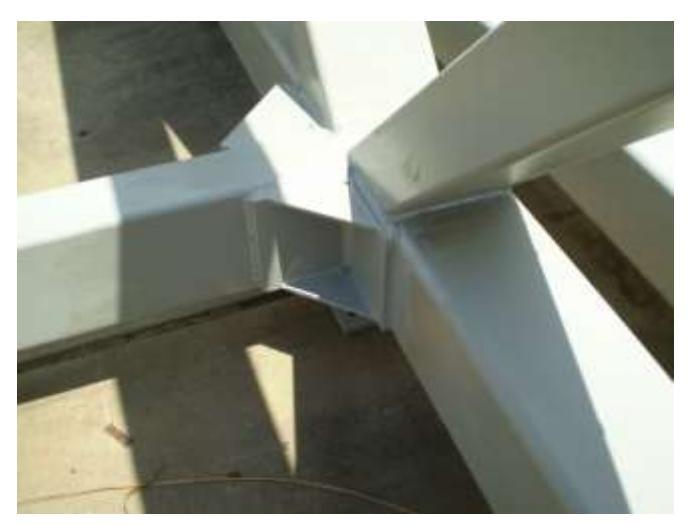
Photo 1 Showing site rectification of split join of main and cross cords of the truss

This rectification work was deemed insufficient to stabilise the structure and as a result one of the local tenderers was engaged to rebuild the structure.

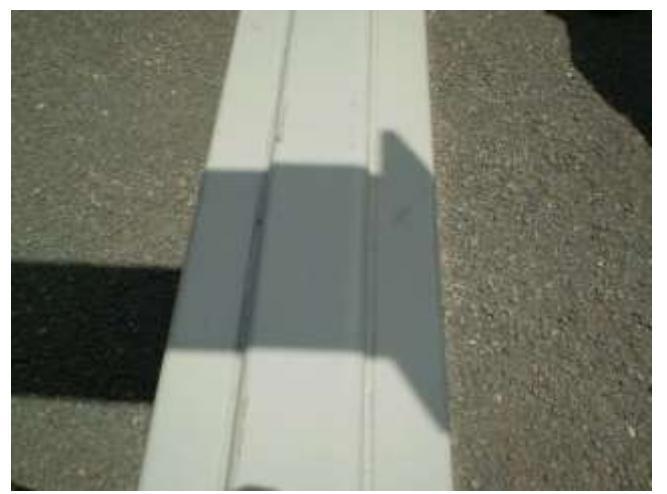
Photo 2 Showing site rectification of the split cross cord of the truss. Tubing was welded each side of the split section.

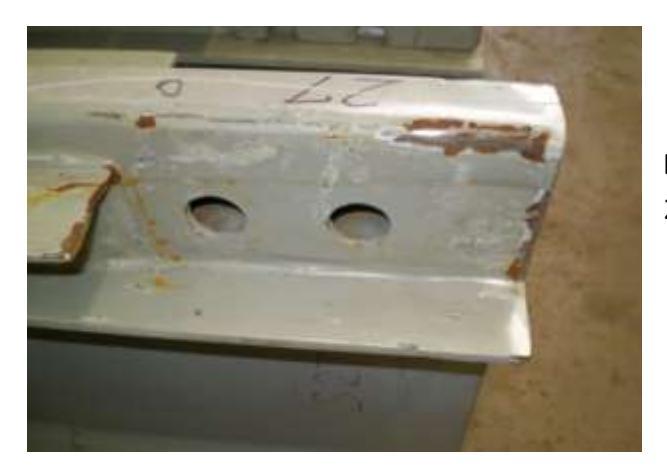
Photo 3 30mm holes were drilled to take 20 mm bolts. This is non-compliant

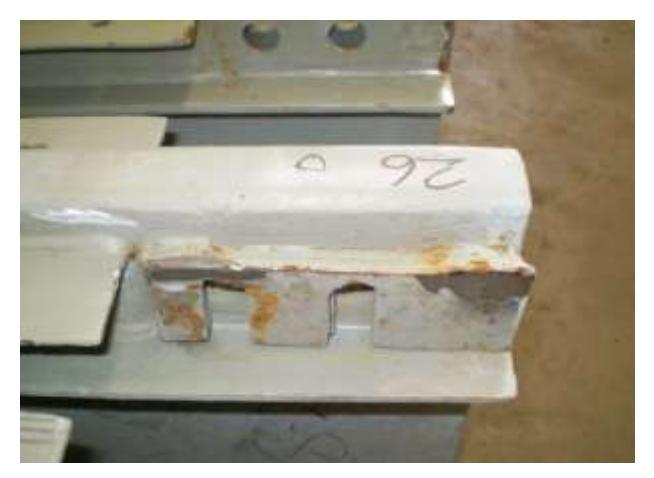
Photo 4 It is thought that the connecting chords to this beam were cut too short, requiring spacers to be inserted at each join – poor workmanship

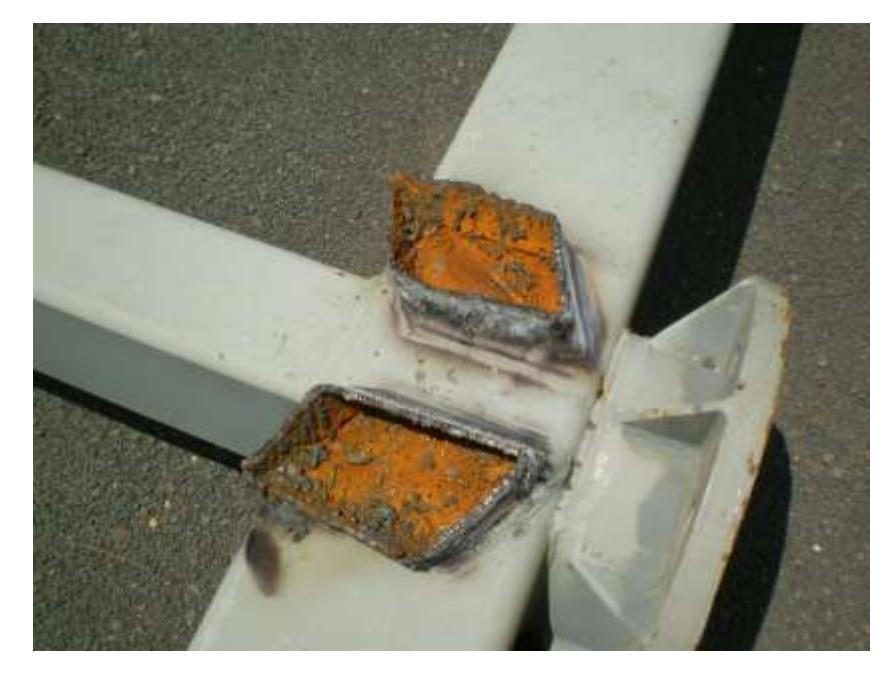
Photo 5 The diagonal chords when cut were found to be filled with water. This is extremely unusual and is thought possibly to have been deliberate to build up the weight of the structure to have a mass within overall specification.

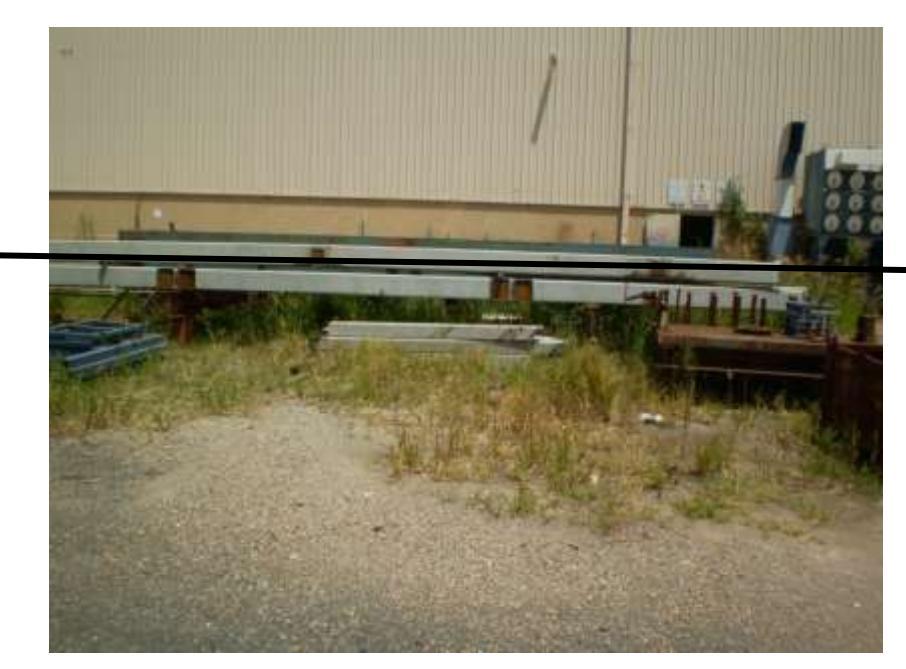
Photo 6 Bottom chords showing bending

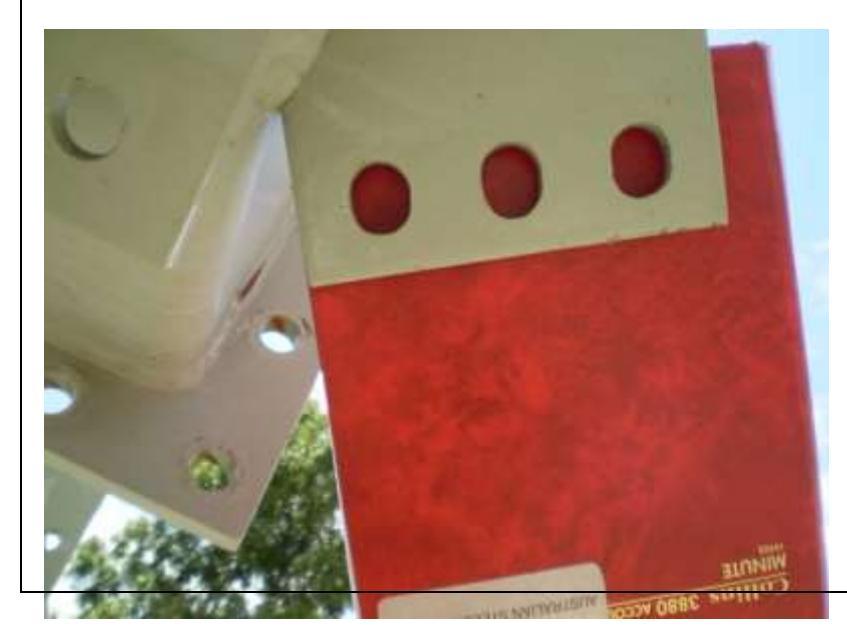
Photo 7 Elongated holes to allow fit up and create potential for movement and slop.

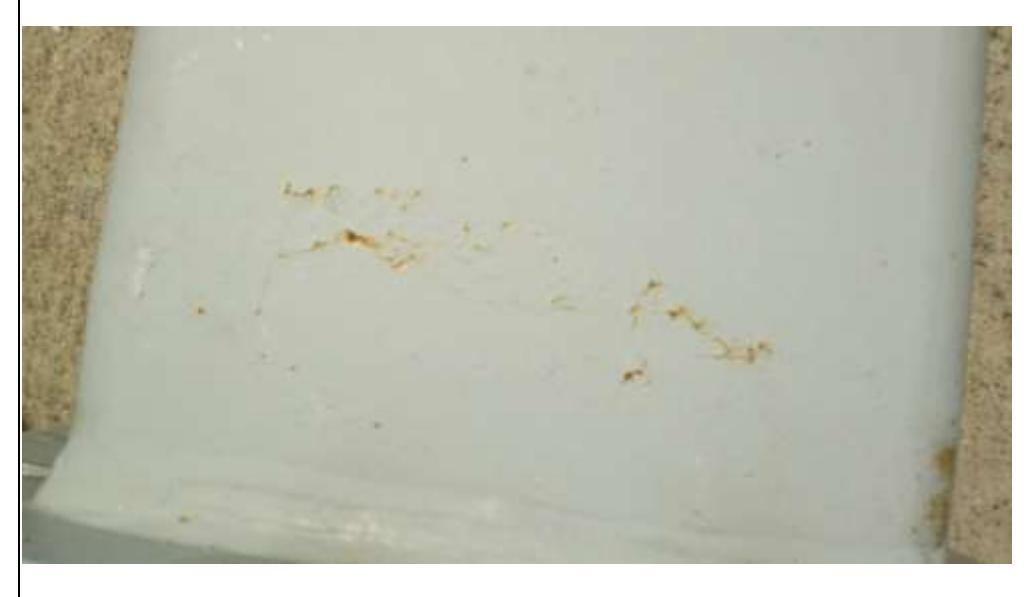
Holes are approx. 28mm diameter for 20mm bolts

Photo 8 Poor paint finish against a specification of 75um inorganic zinc silicate, 125um Epoxy and 75um urethane

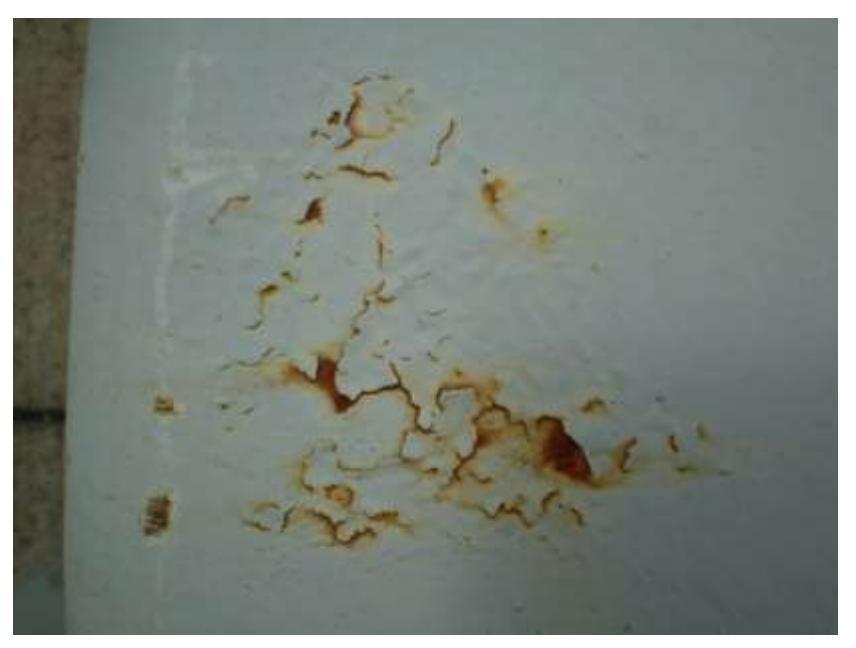
Photos 9 and 10 Poor paint finish

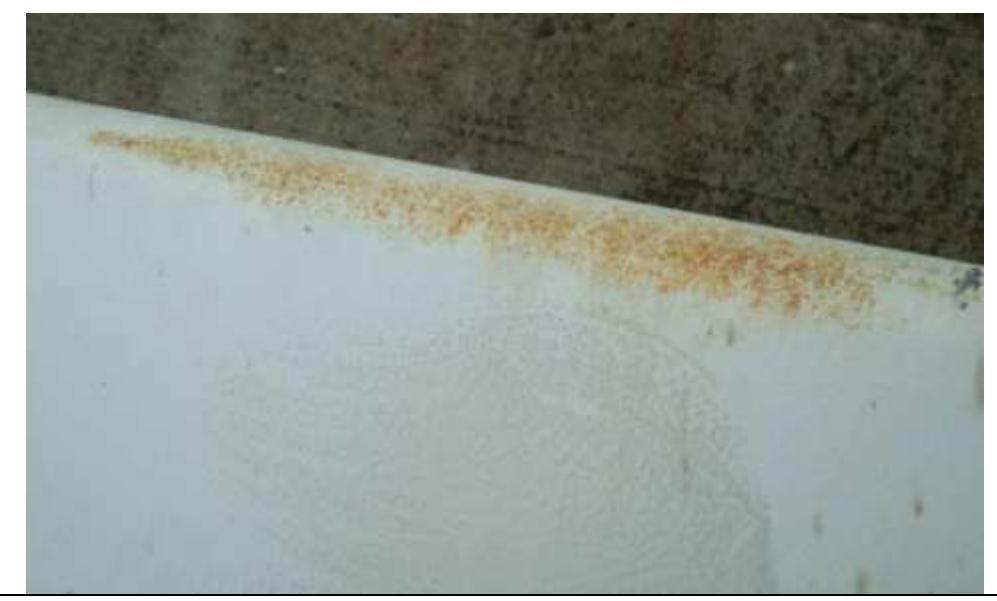
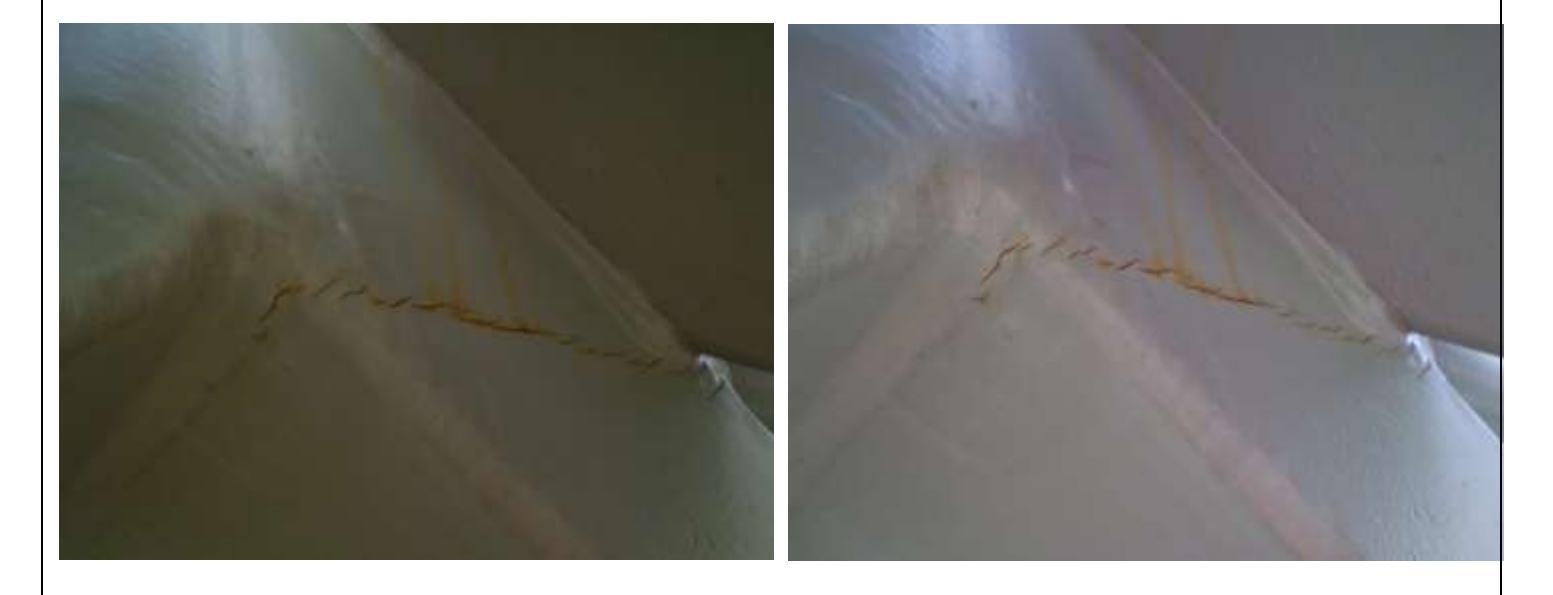
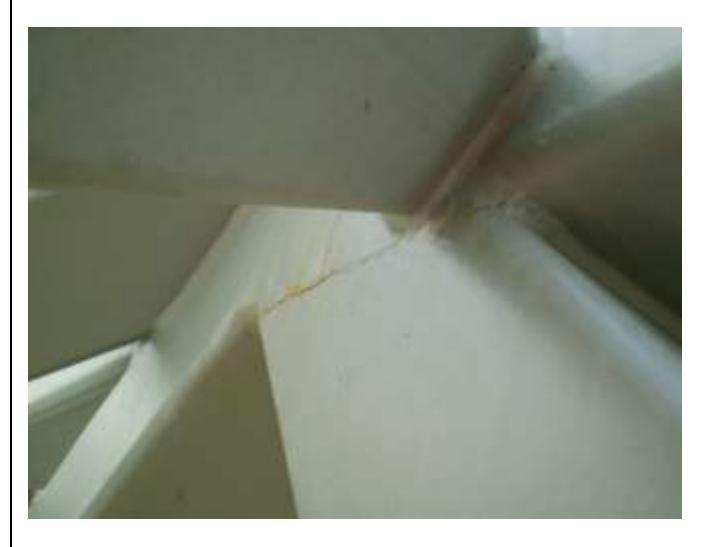
Photos 11-14 Cracking across the section

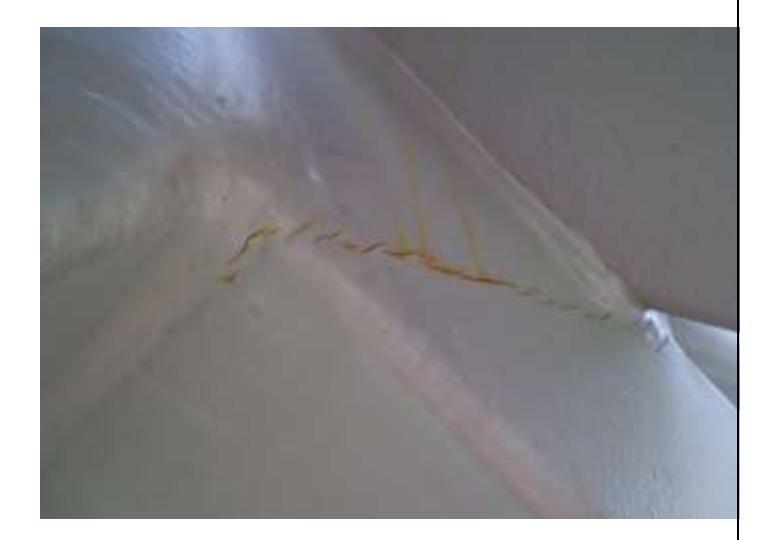
Photo 15 Very poor seam welding or rectification of an unwelded section

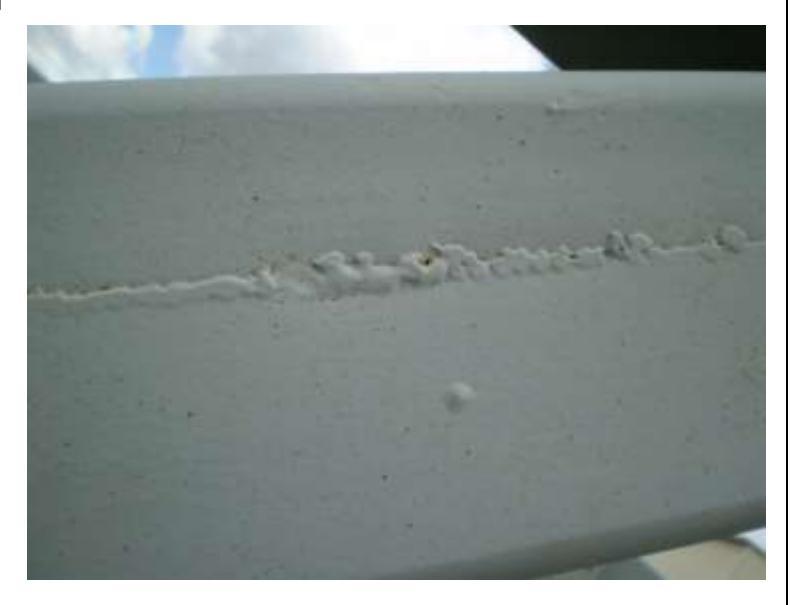
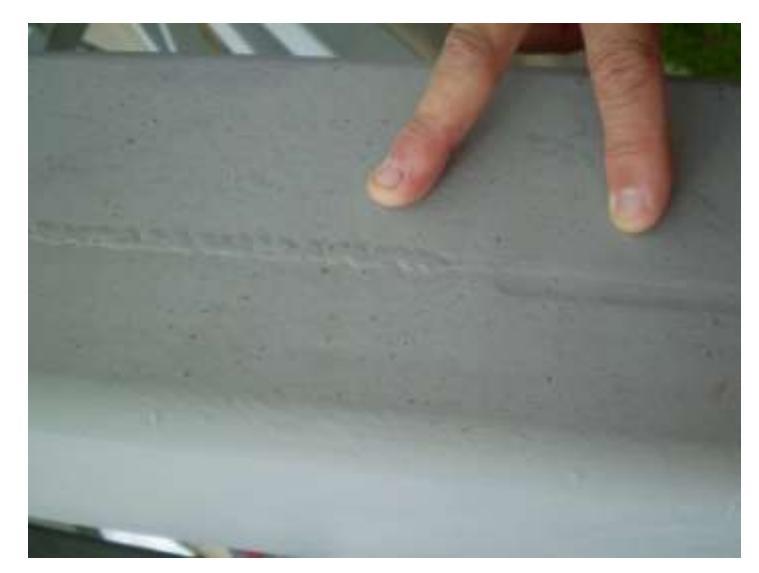
Photo 16 and 17 Poor scarfing of the weld including undercut with potential to be below the wall thickness specification.

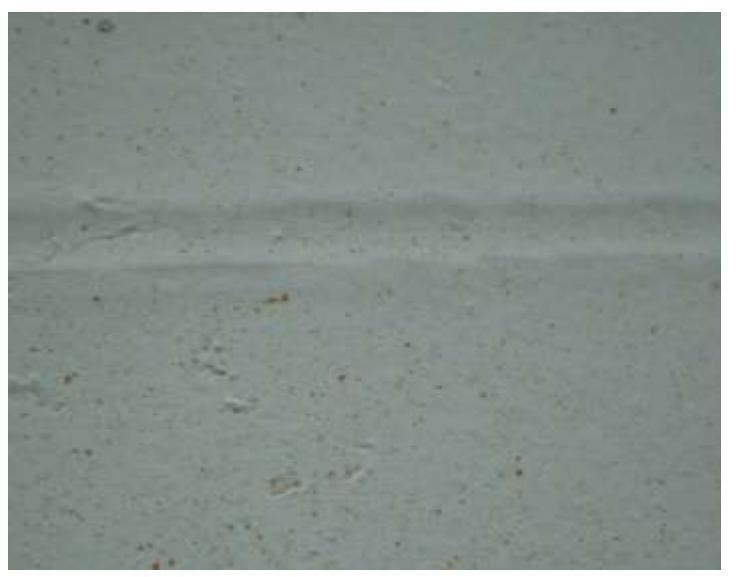
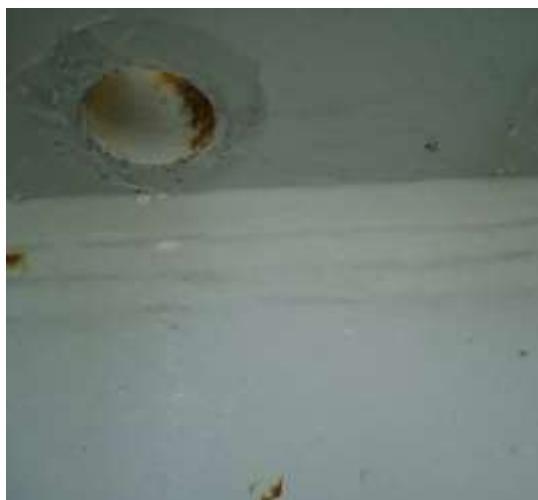
Photo 18 Fillet welds instead of full penetration butt weld

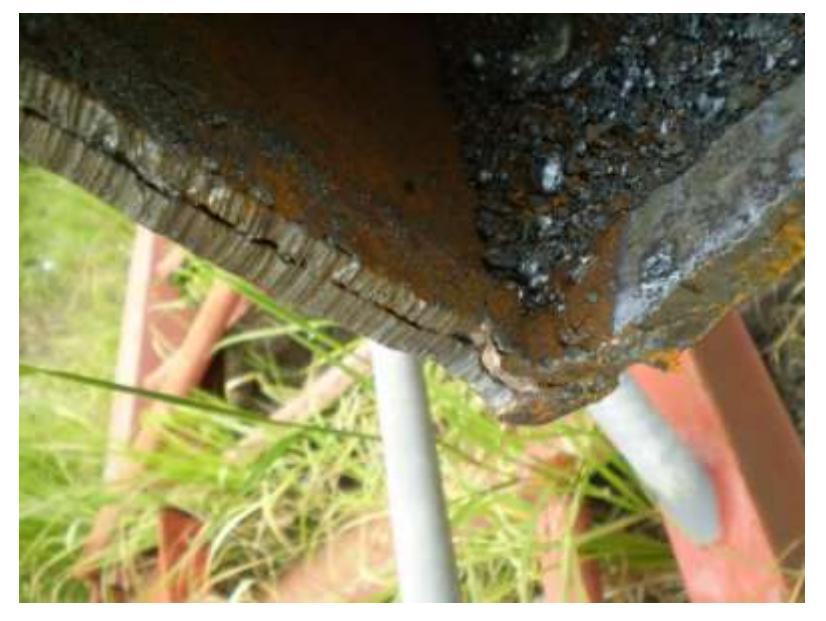
Photo 19 Use of a sleeve instead of a full penetration butt weld as specified

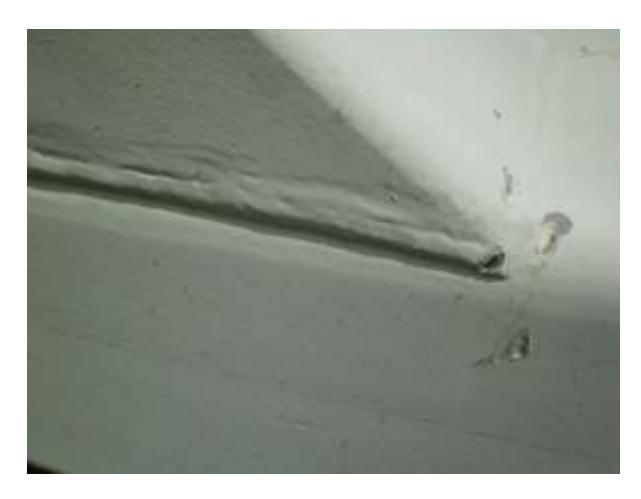
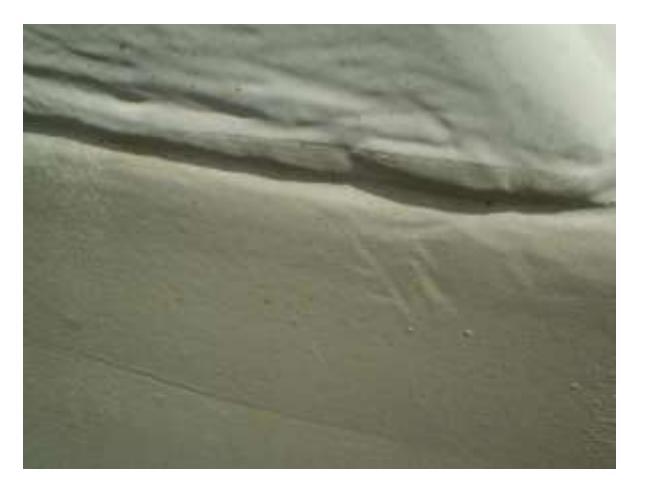
Photo 20 – 23 Under cut on weld profiles
