MAP1: PETROLEUM EXPLORATION LICENCES IN NSW

MAP 1: COAL SEAM GAS IN THE PILLIGA FOREST

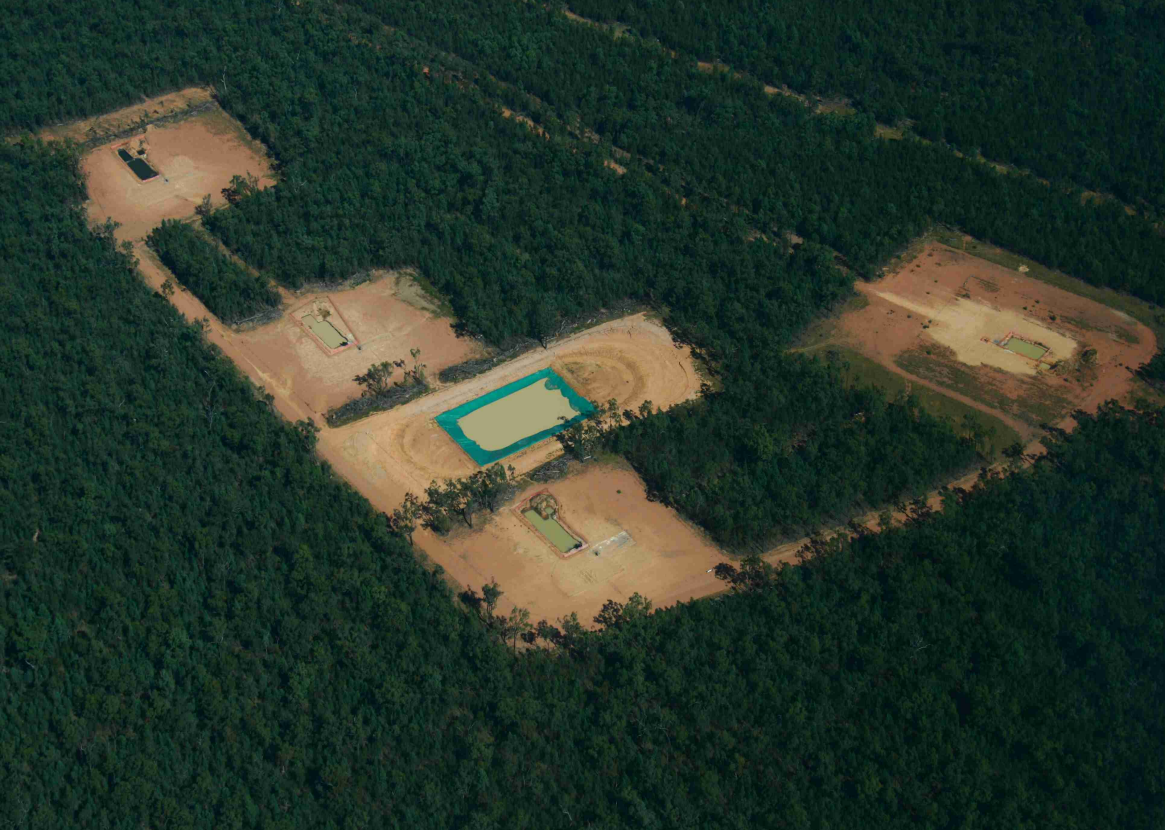
Photo 1: 'Pilot production' well drilled under exploration licence. Dewhurst 8 complex, located on private property in the Pilliga. Photo May 2010.

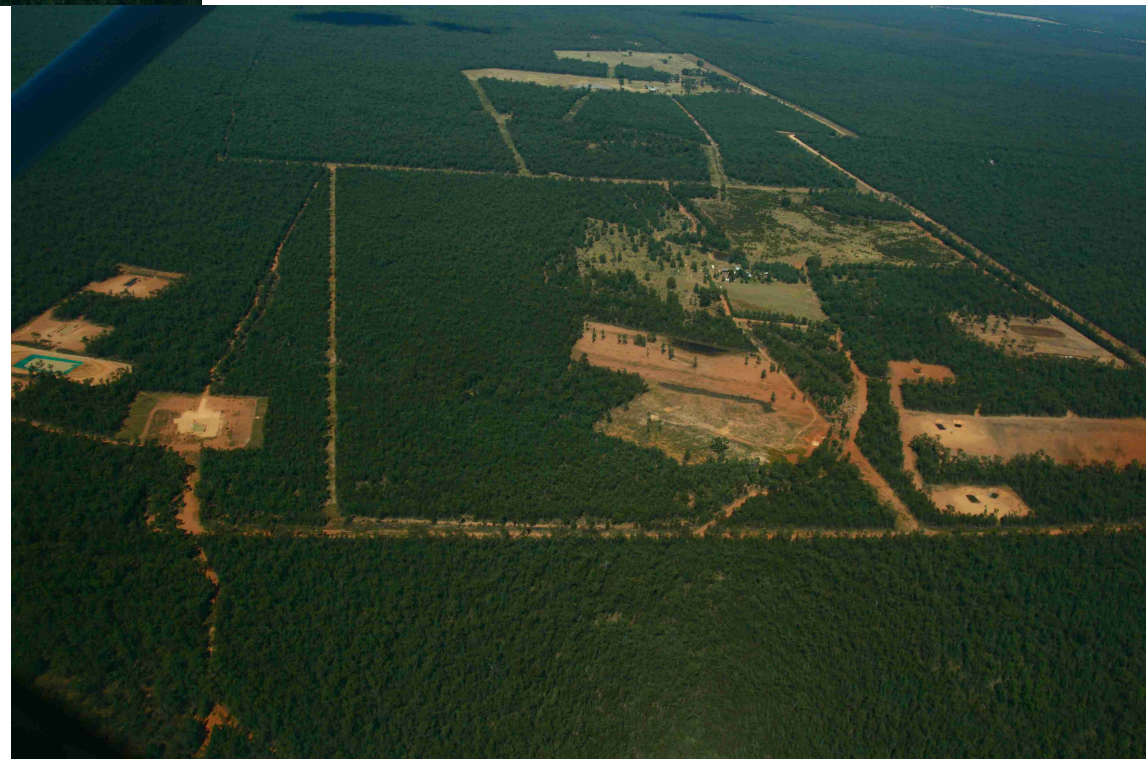
Photo 2: 'Pilot production' wells drilled under exploration licence. Dewhurst 8 complex, located on private property in the Pilliga. May 2010.

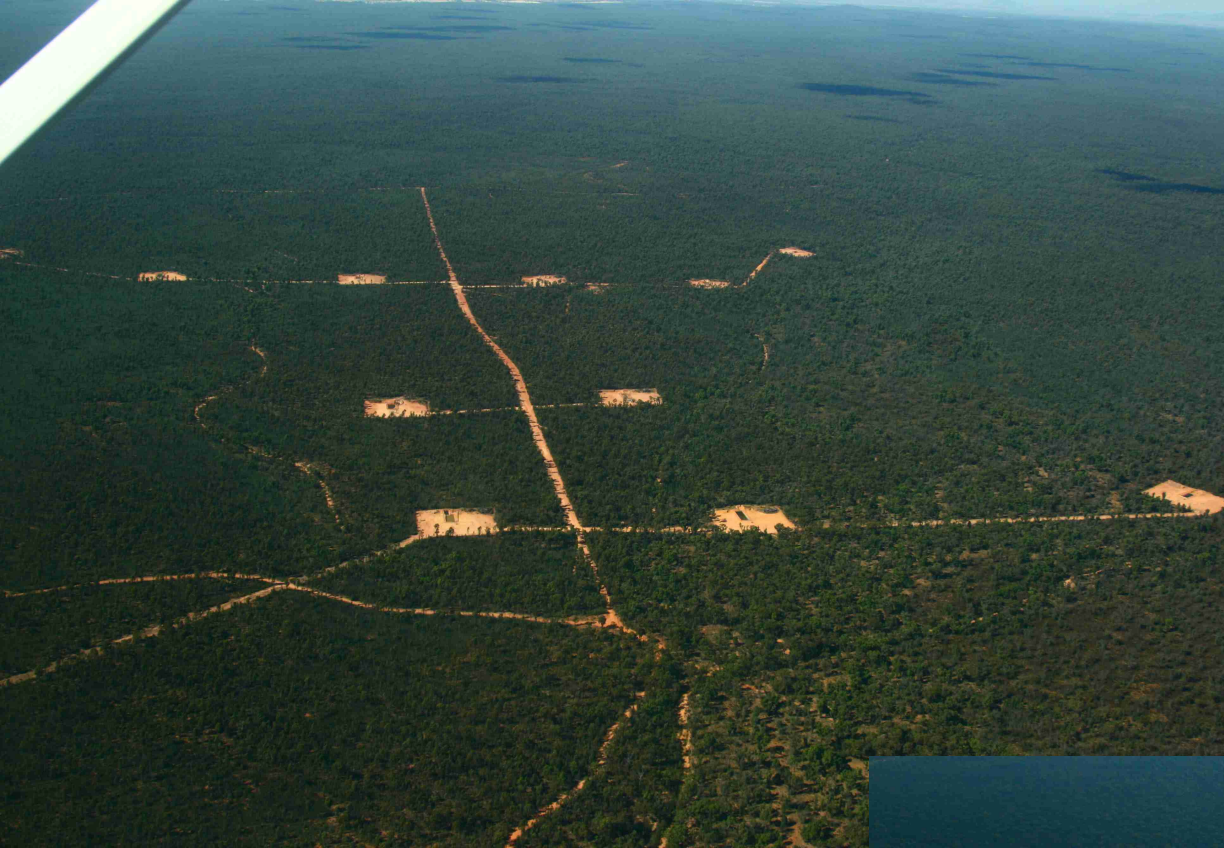
Photo 3: 'Pilot production' wells in Bibblewindi State Forest. Photo May 2010.

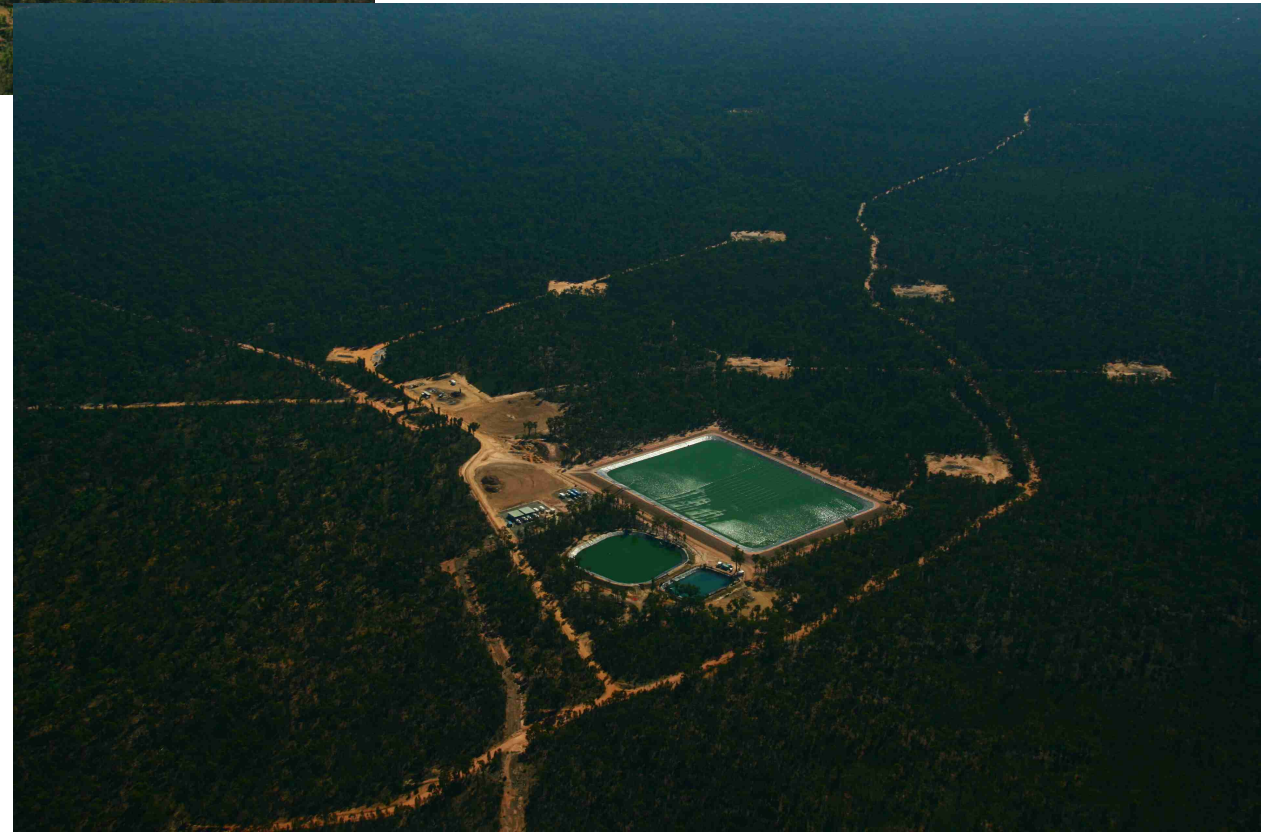
Photo 4: 'Pilot production' wells and water treatment dams in Bibblewindi State Forest. Photo May 2010.

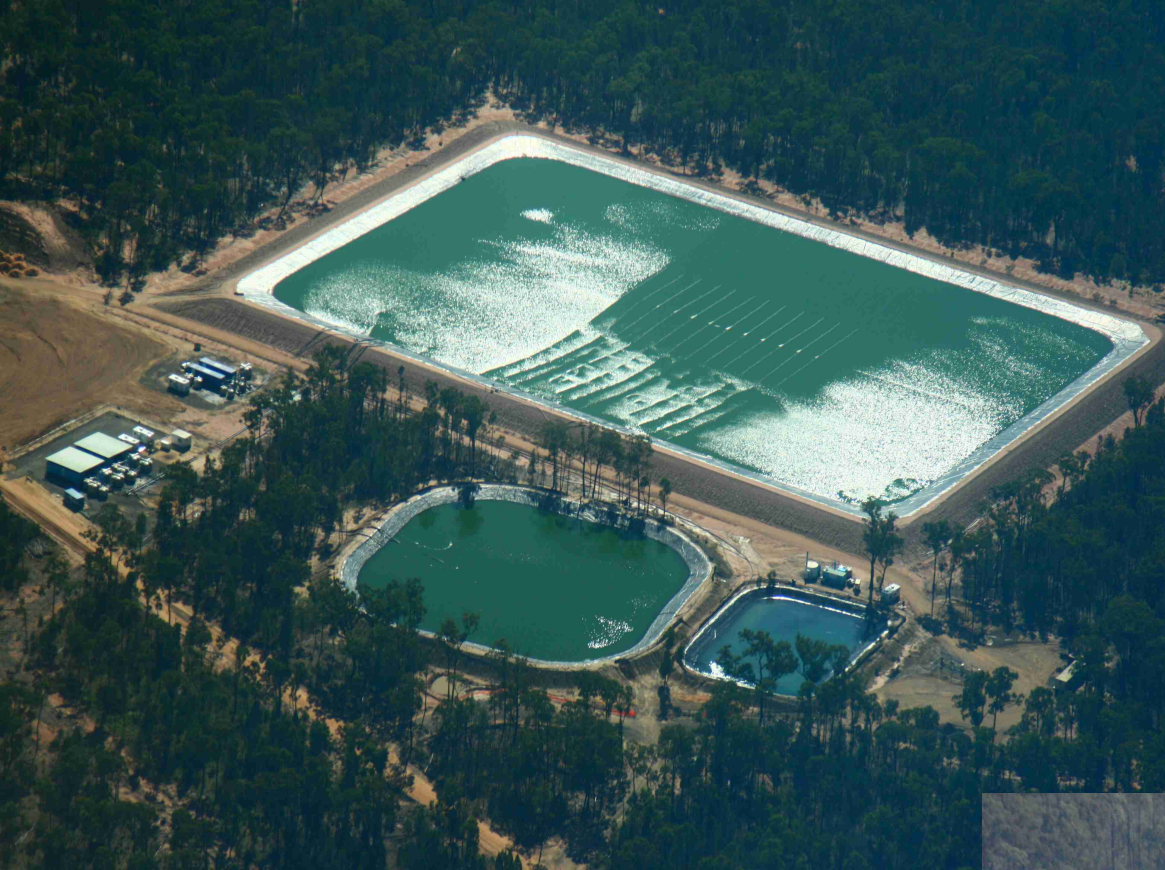
Photo 5: Bibblewindi West Water Treatment works in Bibblewindi State Forest. Photo May 2010.

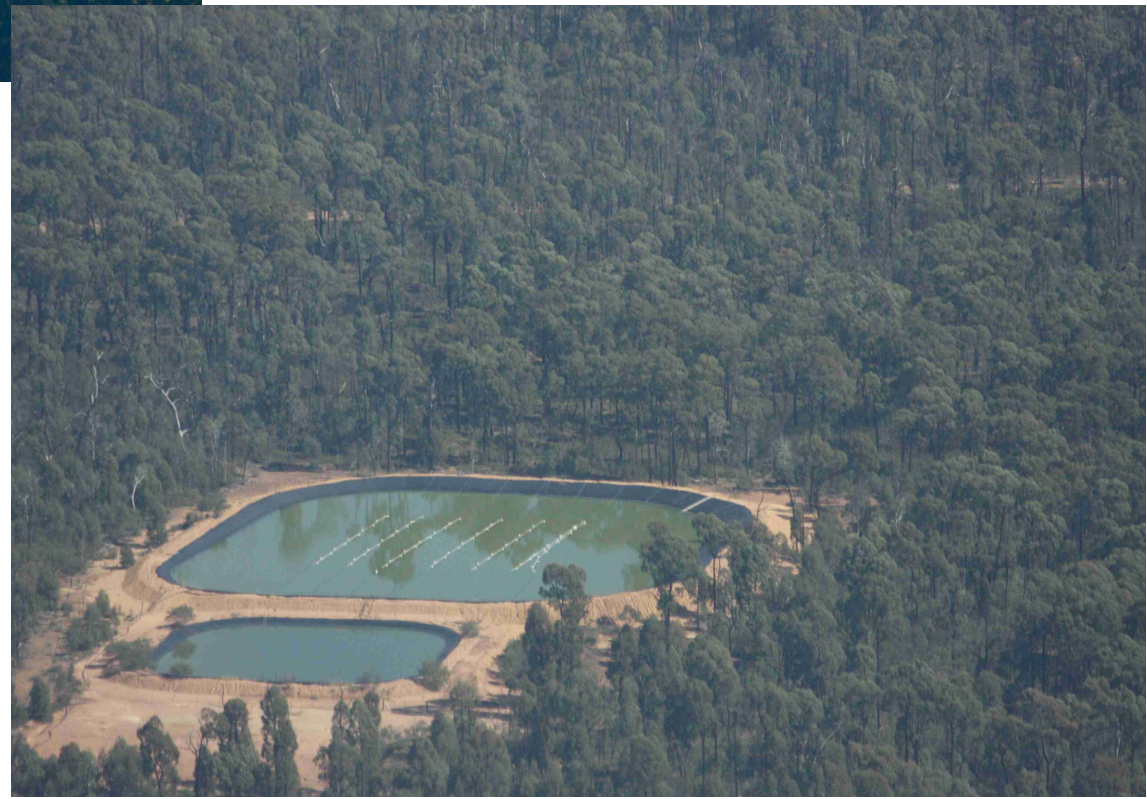
Photo 6: Bohena Evaporation ponds in Pilliga East State Forest. Photo May 2010.

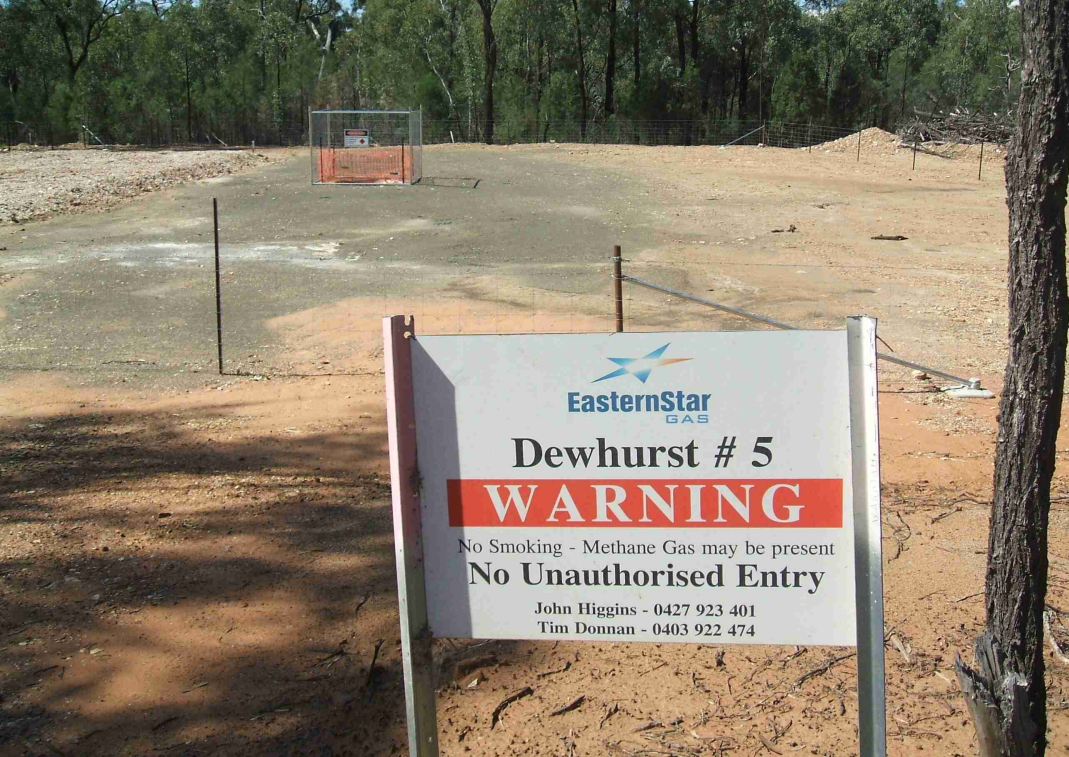
Photo 7. Dewhurst 5 exploratory corehole. Pilliga East State Forest. Abandoned, not rehabilitated. Photo 2011.

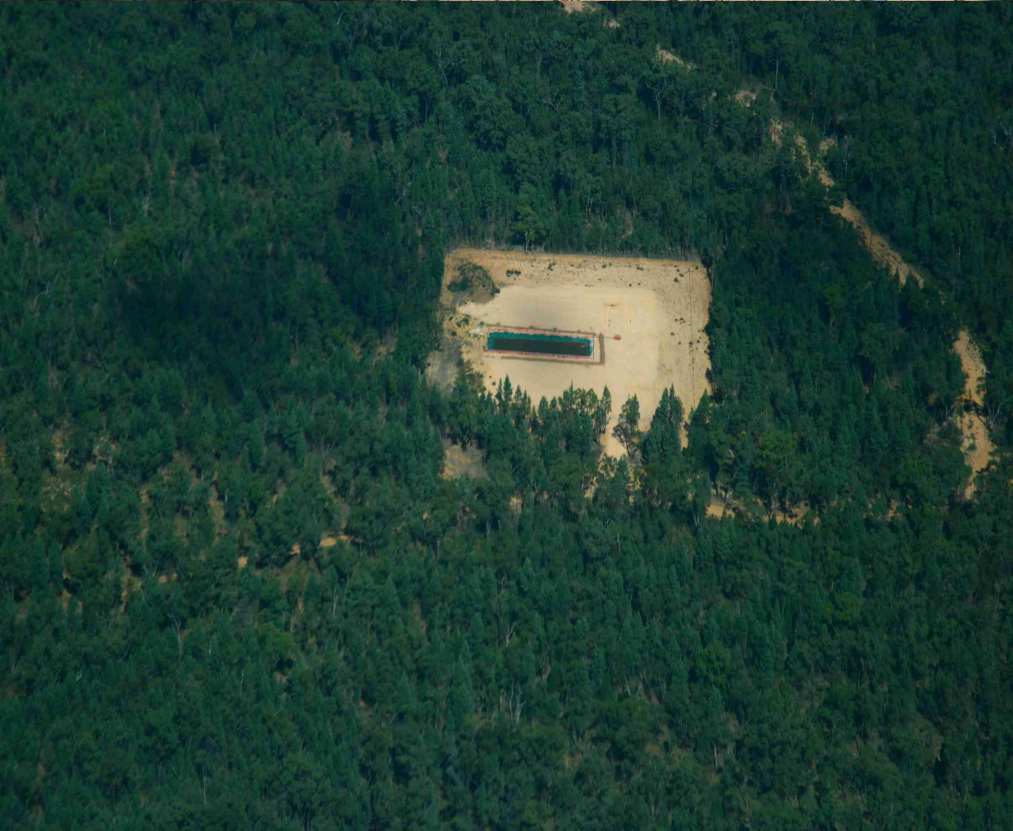
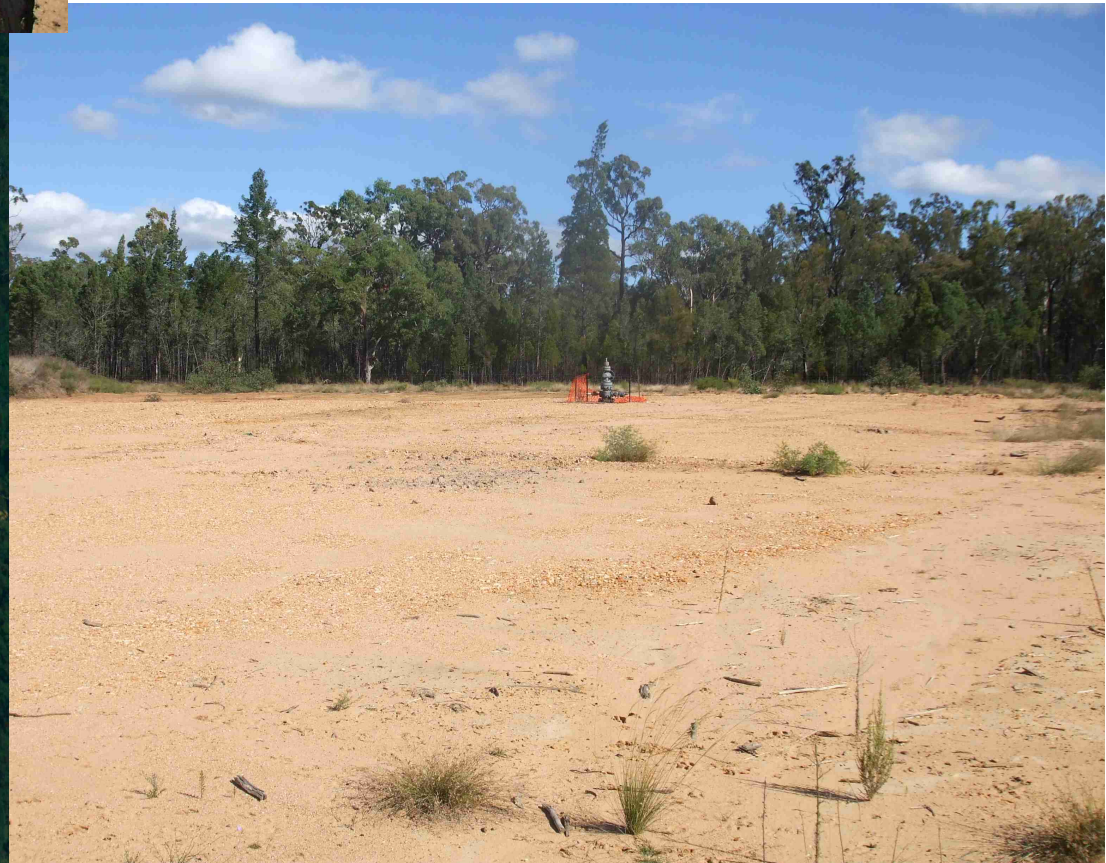
Photo 8 & 9 (below). Dewhurst 6c, exploratory corehole, Pilliga East State Forest. Abandoned, not rehabilitated. Photo 2011.

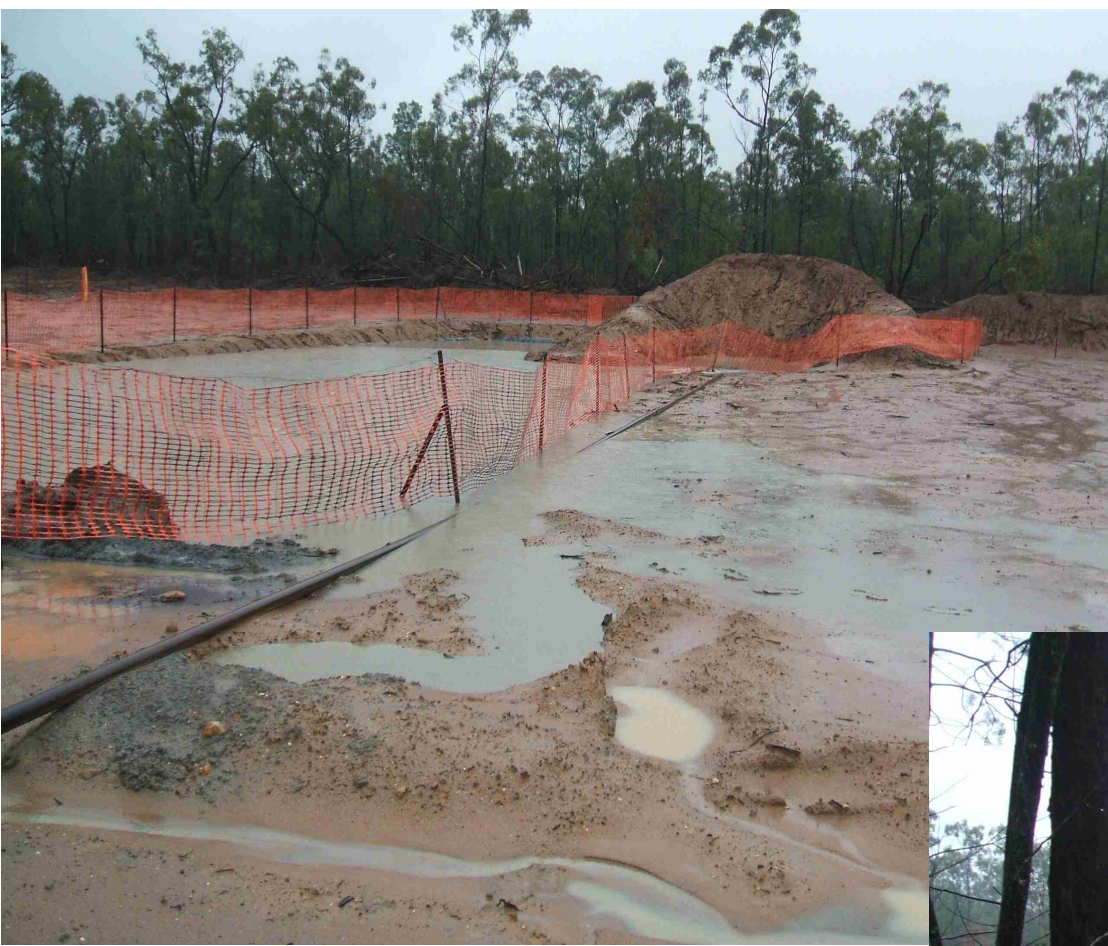
Photo 10. Dewhurst 16H,
exploratory corehole. Unlined drill
pond overflowing on private land
during rain event in the Pilliga.
Taken 2010.

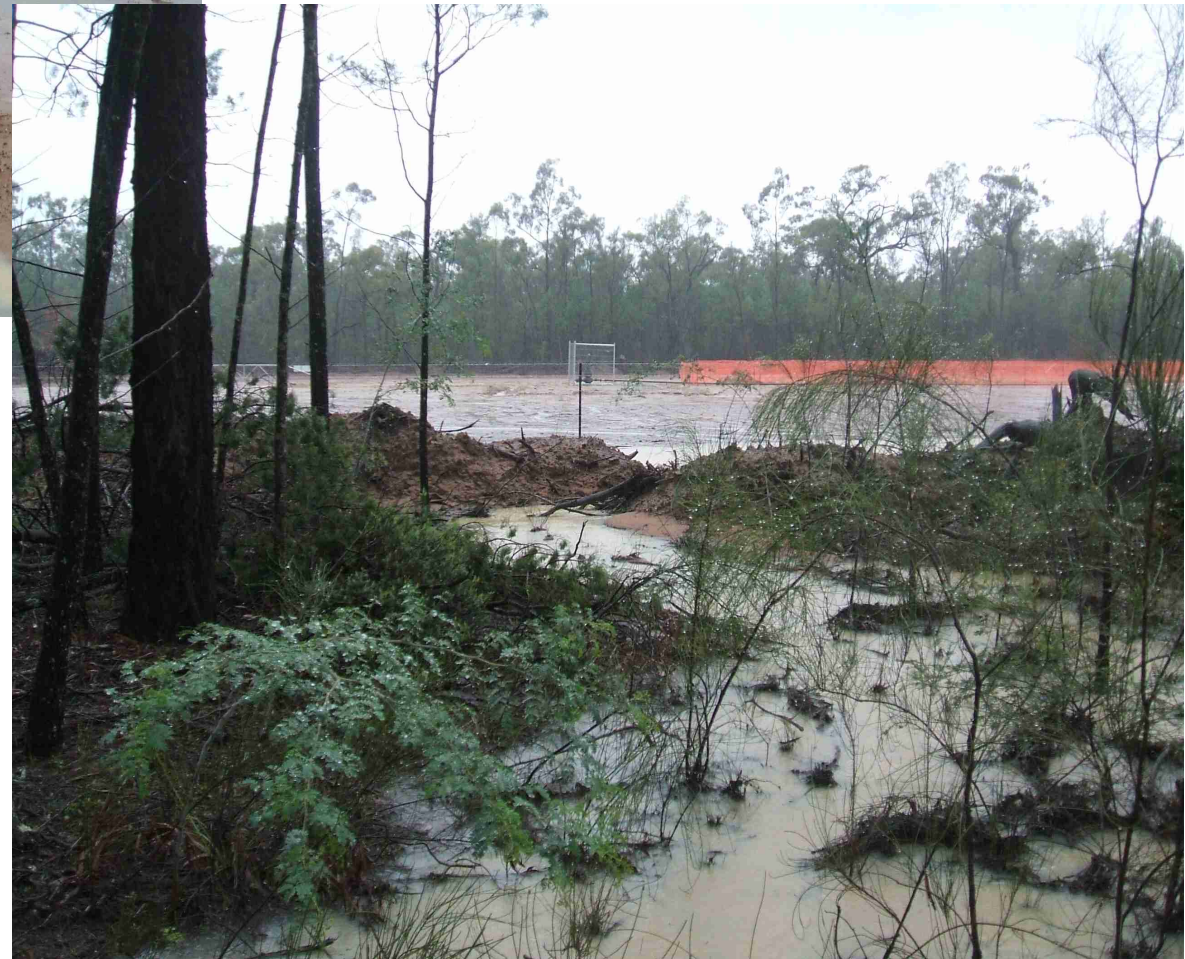
Photo 11. Dewhurst 16H exploratory
corehole. Drill pond and wellpad
flooding on private land during rain
event in the Pilliga. Taken 2010.

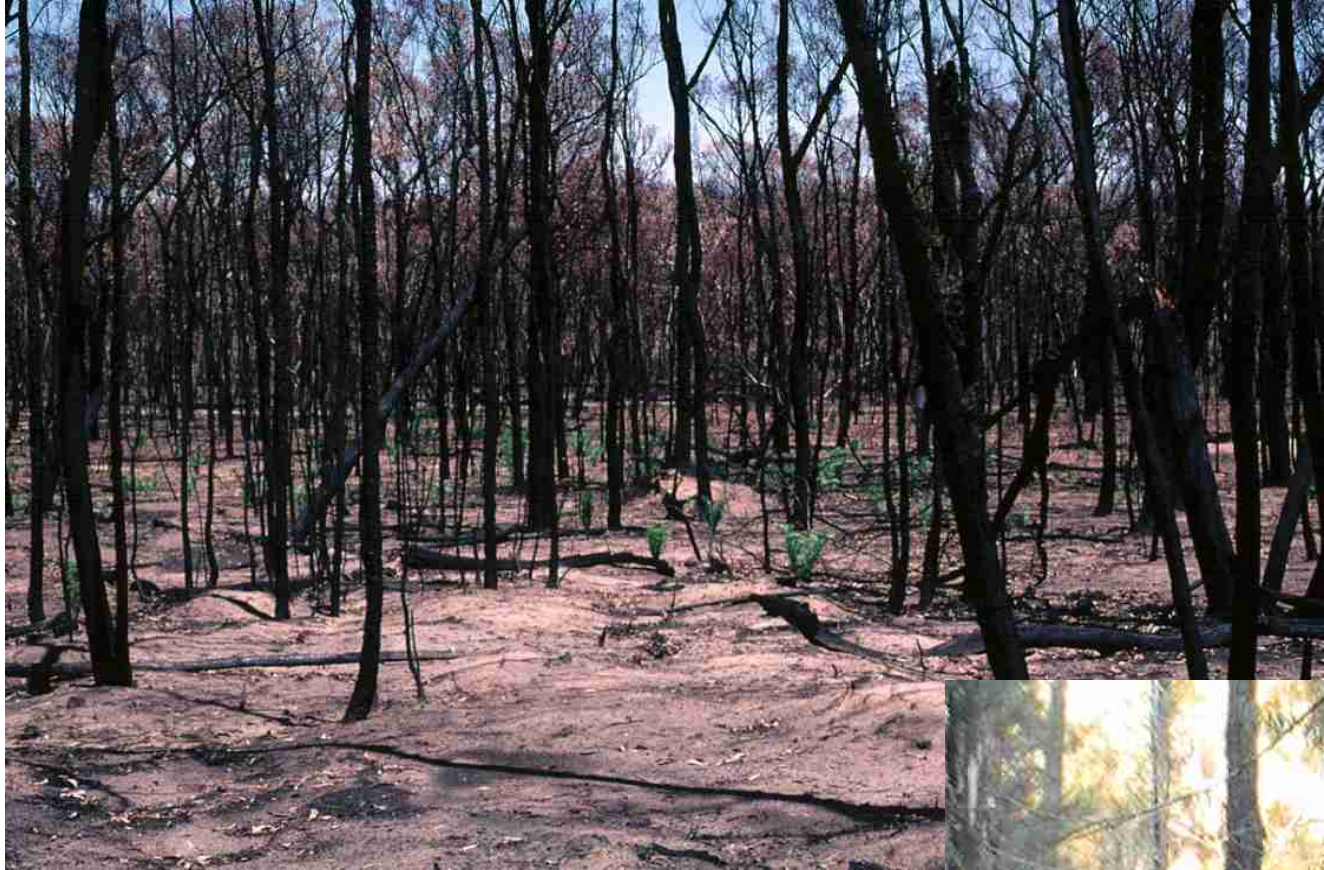
Photo 12. Bohena 2D exploratory corehole. Tree deaths from saline water spill, Pilliga East State Forest. Photo taken 2002.

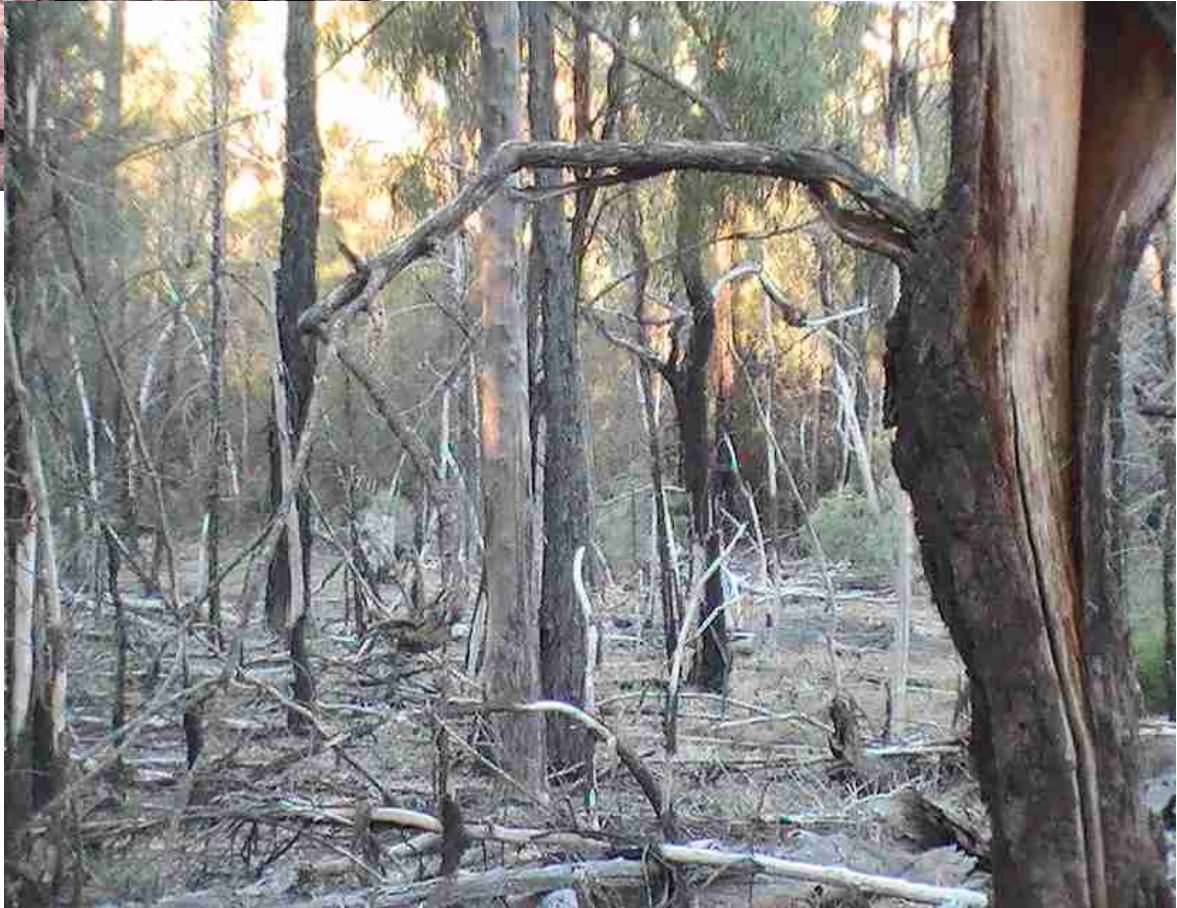
Photo 13. Bohena 2D exploratory corehole. Tree deaths from earlier saline water spill. Photo 2011. Pilliga East State Forest.

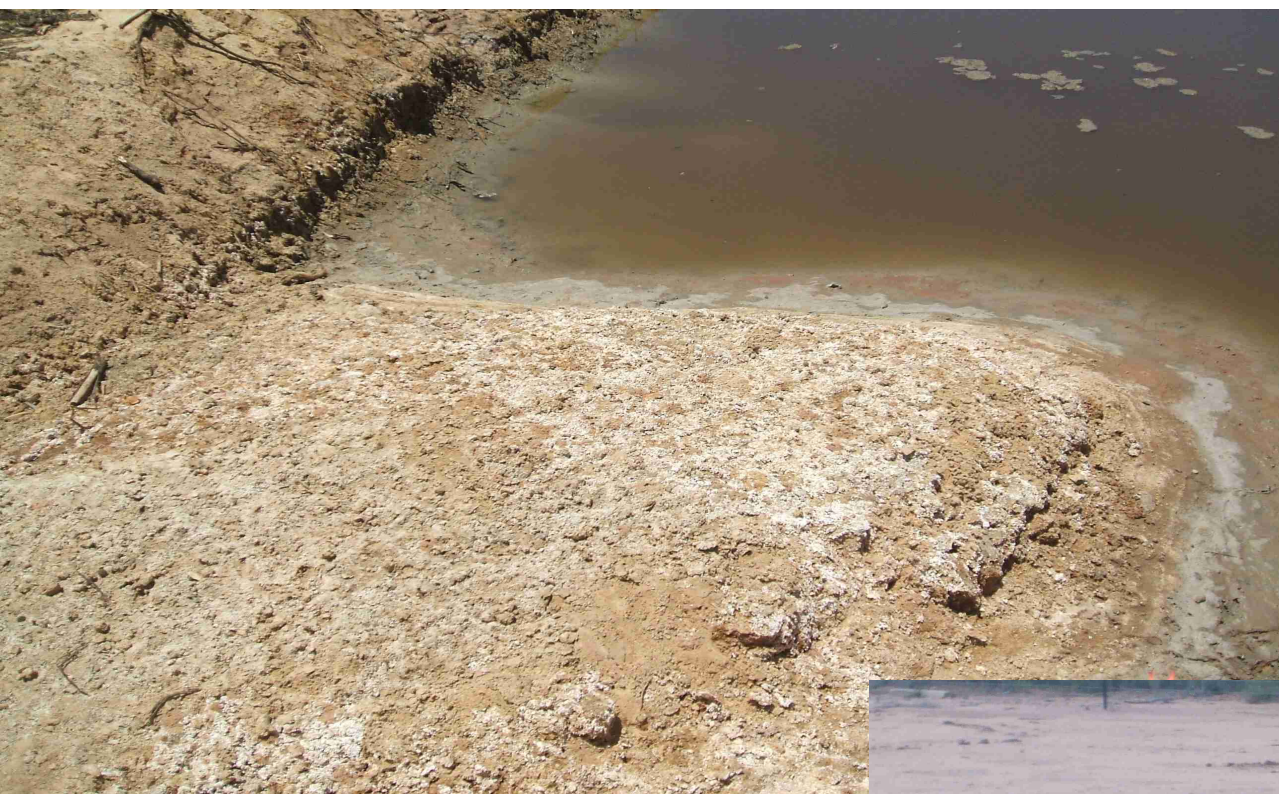
Photo 14. Bibblewindi 22 pilot production well. Salt scald next to unlined drill pond, Pilliga East SF. Photo taken May 2009.

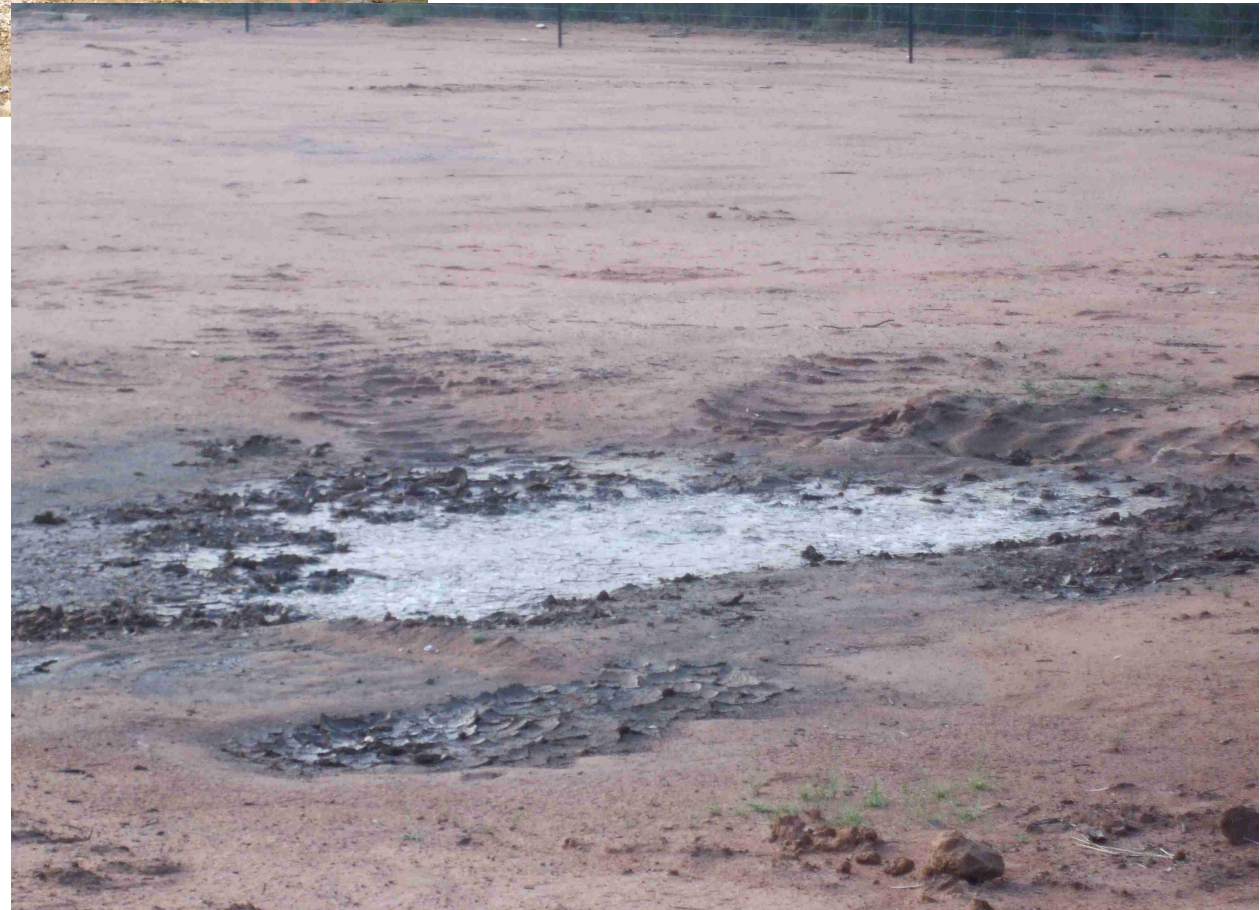
Photo 15. Bibblewindi 16 pilot production well. Salt scald adjacent to unlined drill pond, Bibblewindi SF. Photo 2011.

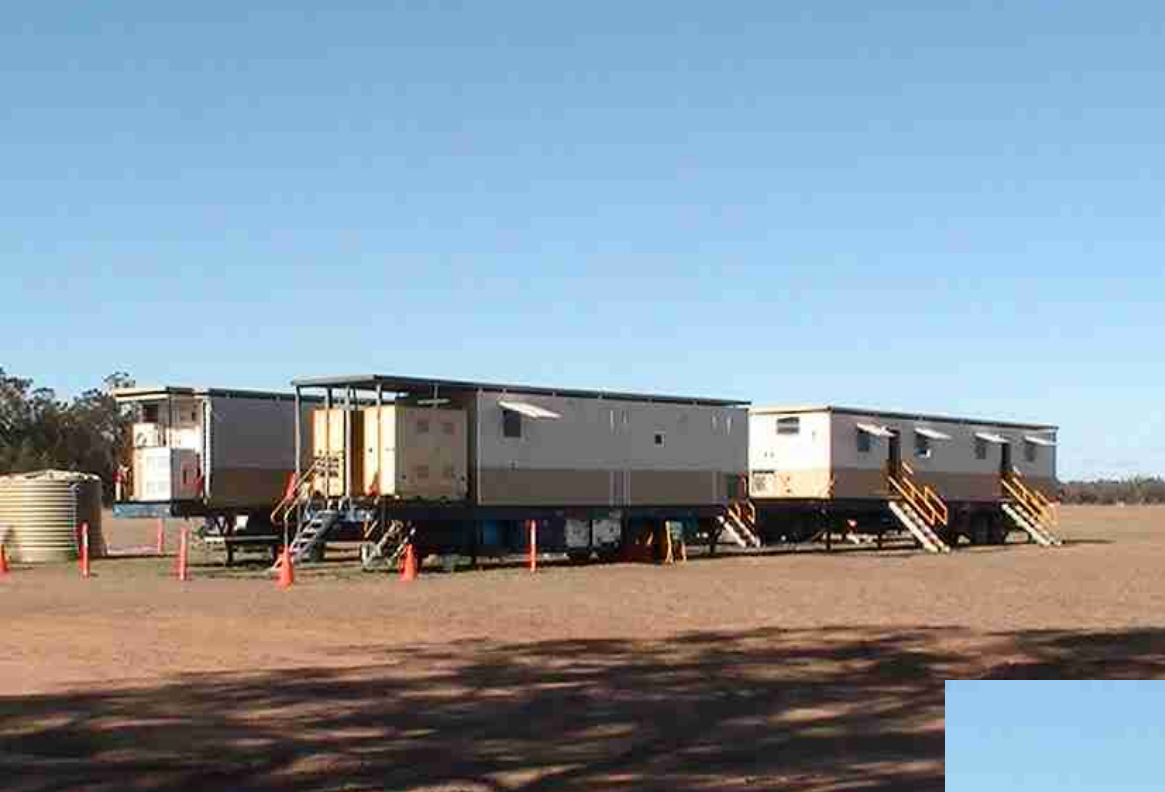
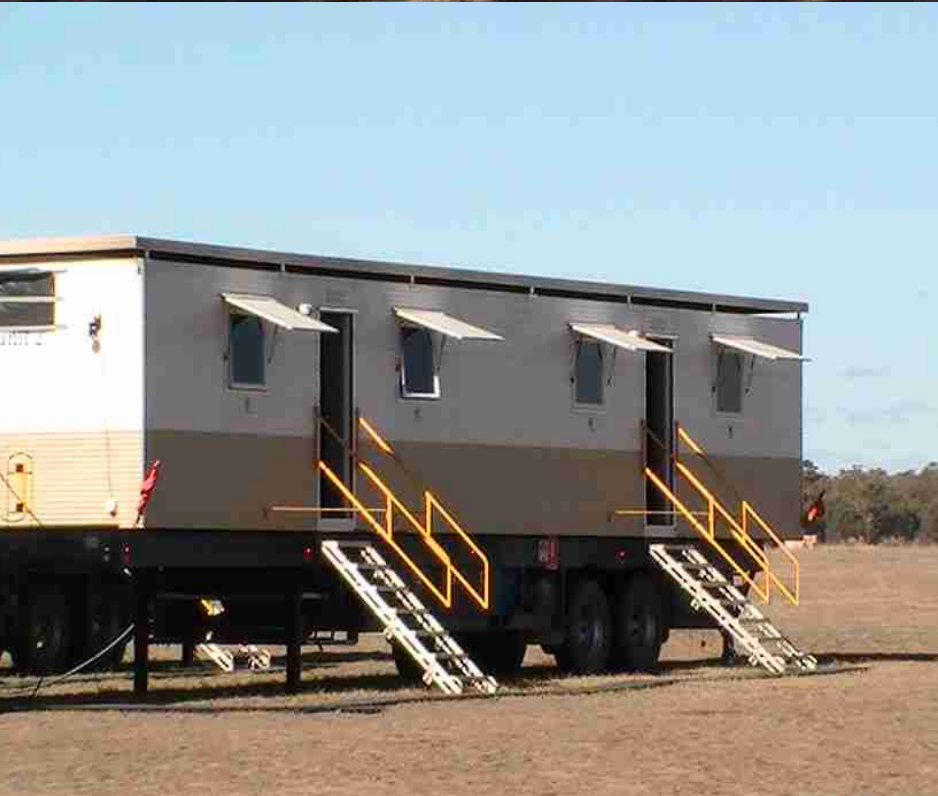
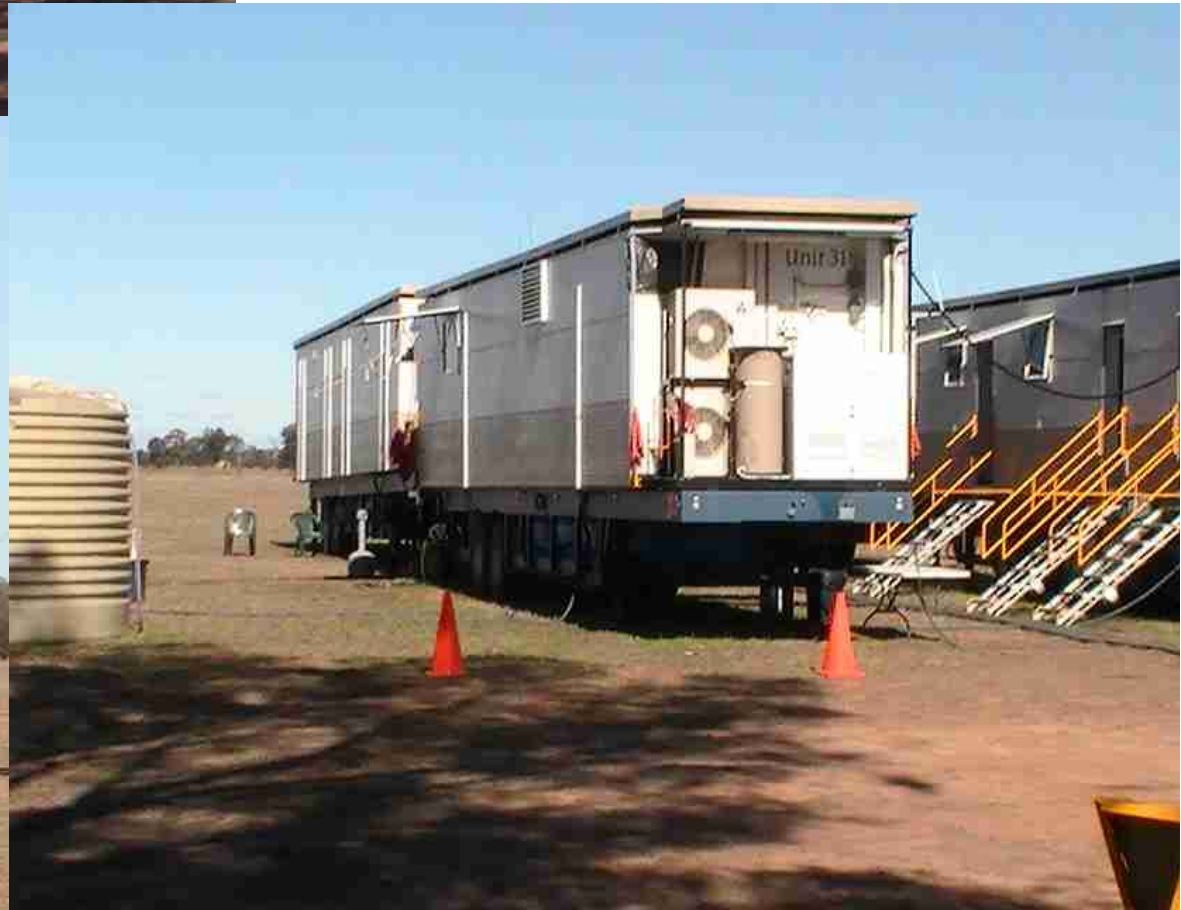
Photos 16-18. Miners drilling camp on Claredon, at Cains Crossing, Yarrie Lake Road. Photo taken in July 2011.
