**NATIONAL
RADIOACTIVE
WASTE MANAGEMENT
FACILITY**

Site Characterisation Technical Report - Lyndhurst

Client: Commonwealth Department of Industry, Innovation and Science

AECOM Australia Pty Ltd

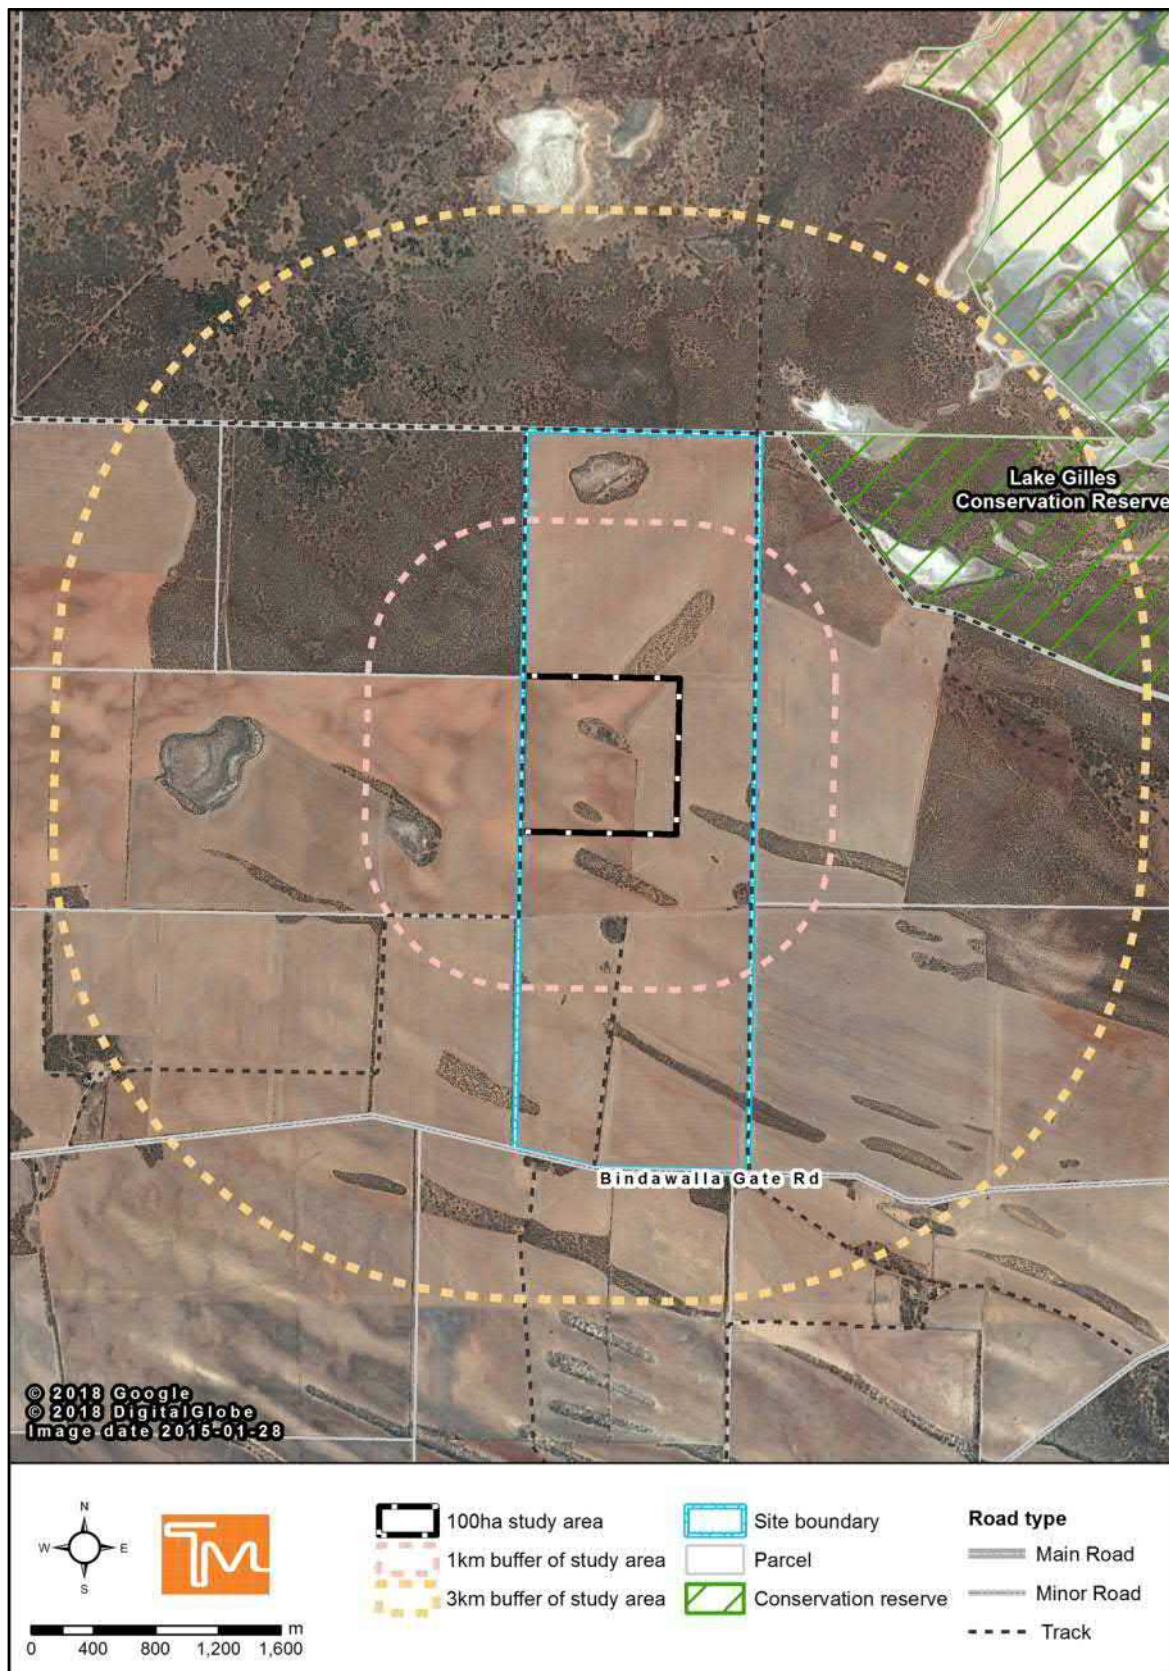
Figure 8 Lyndhurst landscape assessment to 3km.

The South Australian prescribed burning guide identifies that semi-arid Mallee vegetation occurs across large areas of the central to northern Eyre Peninsula and describes this vegetation as '*Low open eucalypt dominated vegetation with an understorey of smaller shrubs, grasses and herbs. The fuel array is typically highly discontinuous*' (DENR, 2011). AECOM provided photos and descriptions of vegetation on and round the site (MacDonnell, 2018; AECOM, 2018a) that match this descriptor and accord best with a Mallee-Mulga classification under AS 3959-2009.

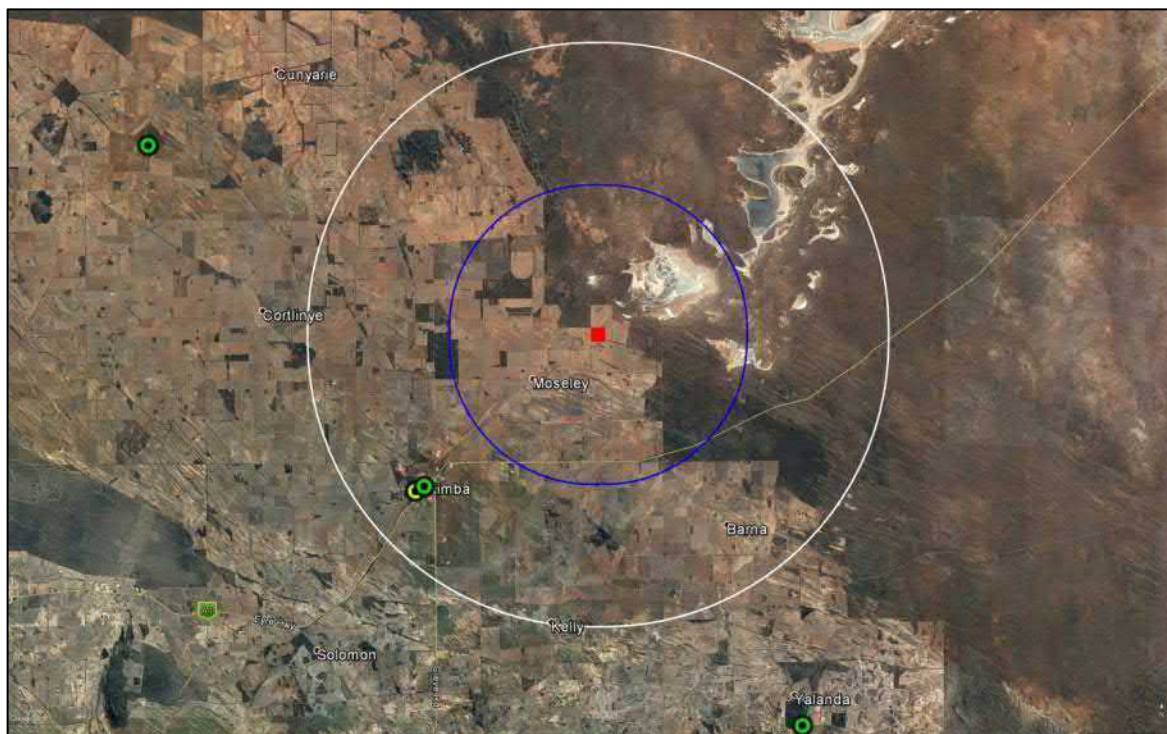
Figure 9 The landscape surrounding the Lyndhurst 100ha site and expanded Study Area (show in red fill)

A 10km buffer of the site is shown in blue outline and a 20km buffer is shown in white outline. The yellow circle shows the location of the BOM weather station from which weather data was obtained and analysed (see Section 2.4.2.3). Green circles identify the locations of the nearest CFS brigades (see Section 2.4.2.4.4).

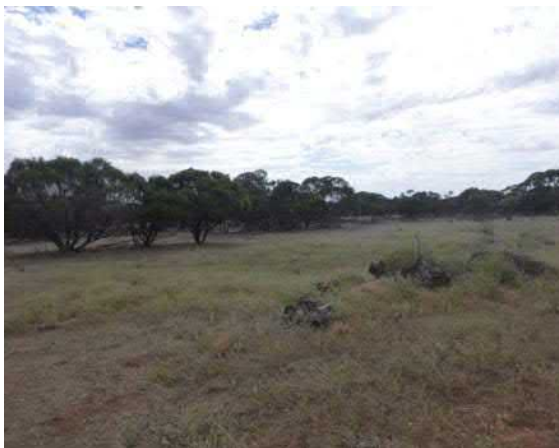
Low lying area to the south of the site (mapped as H2 soil subgroup) where ponded water has previously been observed.

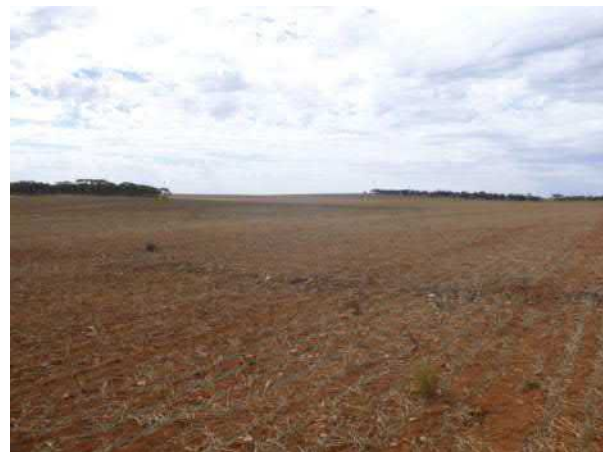
Majority of site showing red-brown soils (D3 soil subgroup) with nodular calcrete. Vegetated dunes in the distance.

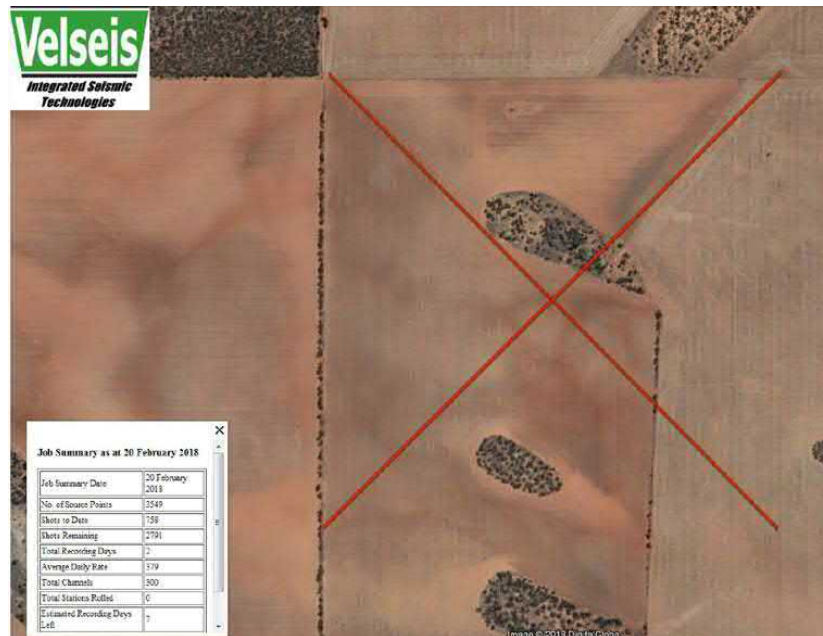
Figure 19 Job completion summary for Lyndhurst seismic data acquisition

Once the data was acquired Velseis output a refraction solution to provide an indication of the depth to the weathered / un-weathered boundary. Velseis then provided a preliminary interpretation of the processed data which is attached as Appendix C. It is noted that given the lack of borehole control available at the time of the survey, only more prominent potential structures have been inferred and given the complexity of the data smaller scale structures are also likely to be present.

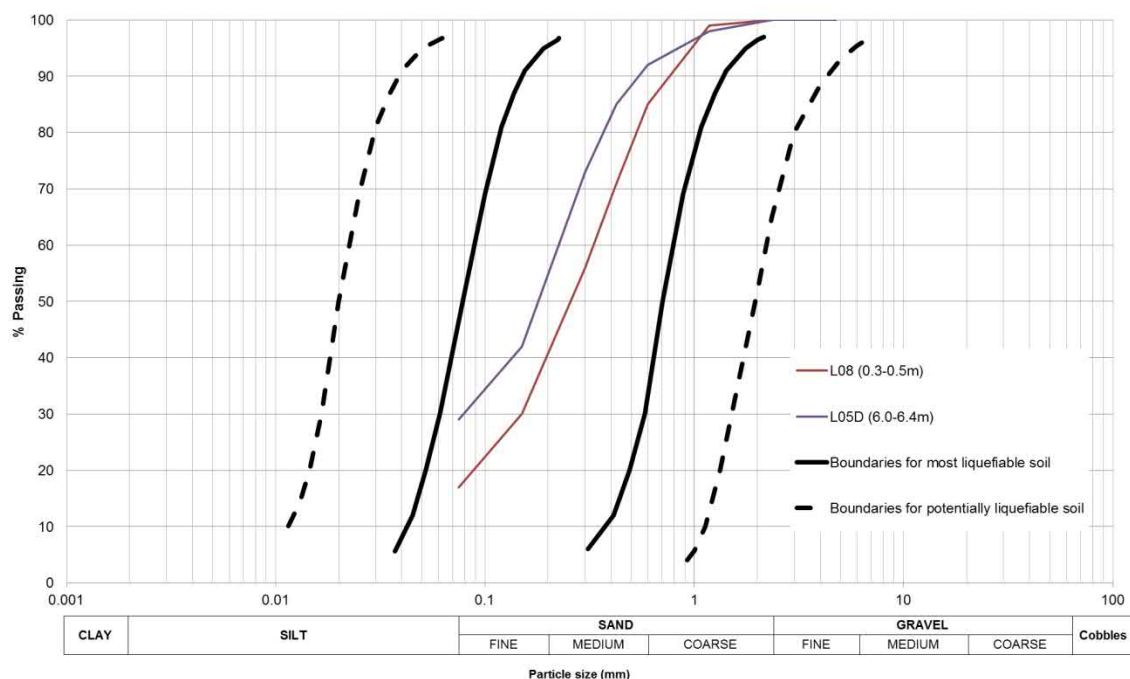
Figure 24 Particle Size Distribution of Tested Materials

Based on the above figure, the tested site materials can be characterised as liquefiable soil based on particle size distribution.
