**NATIONAL
RADIOACTIVE
WASTE MANAGEMENT
FACILITY**

Technical Report - Site Characterisation, Napandee

Client: Commonwealth Department of Industry, Innovation and Science

AECOM Australia Pty Ltd

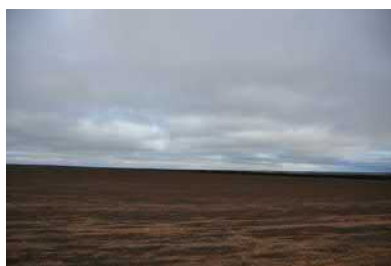
Open farmland

Open farmland was the dominant habitat type within the proposed site footprint and much of the adjoining paddocks. This area was almost entirely denuded of living vegetation and was dominated by a mixture of bare ground and crop stubble (dead organic matter). No current farming activities were identified. This area was not observed to support any fauna species, and in its observed condition, would be of negligible habitat value. Discussion with the landholder / managers revealed that, in recent times, the land had been subject to cropping, intense grazing (sheep) and finally spraying to kill off all vegetation and suppress weeds. This land use approach is understood to be used across cropped land within the farmers land holding.

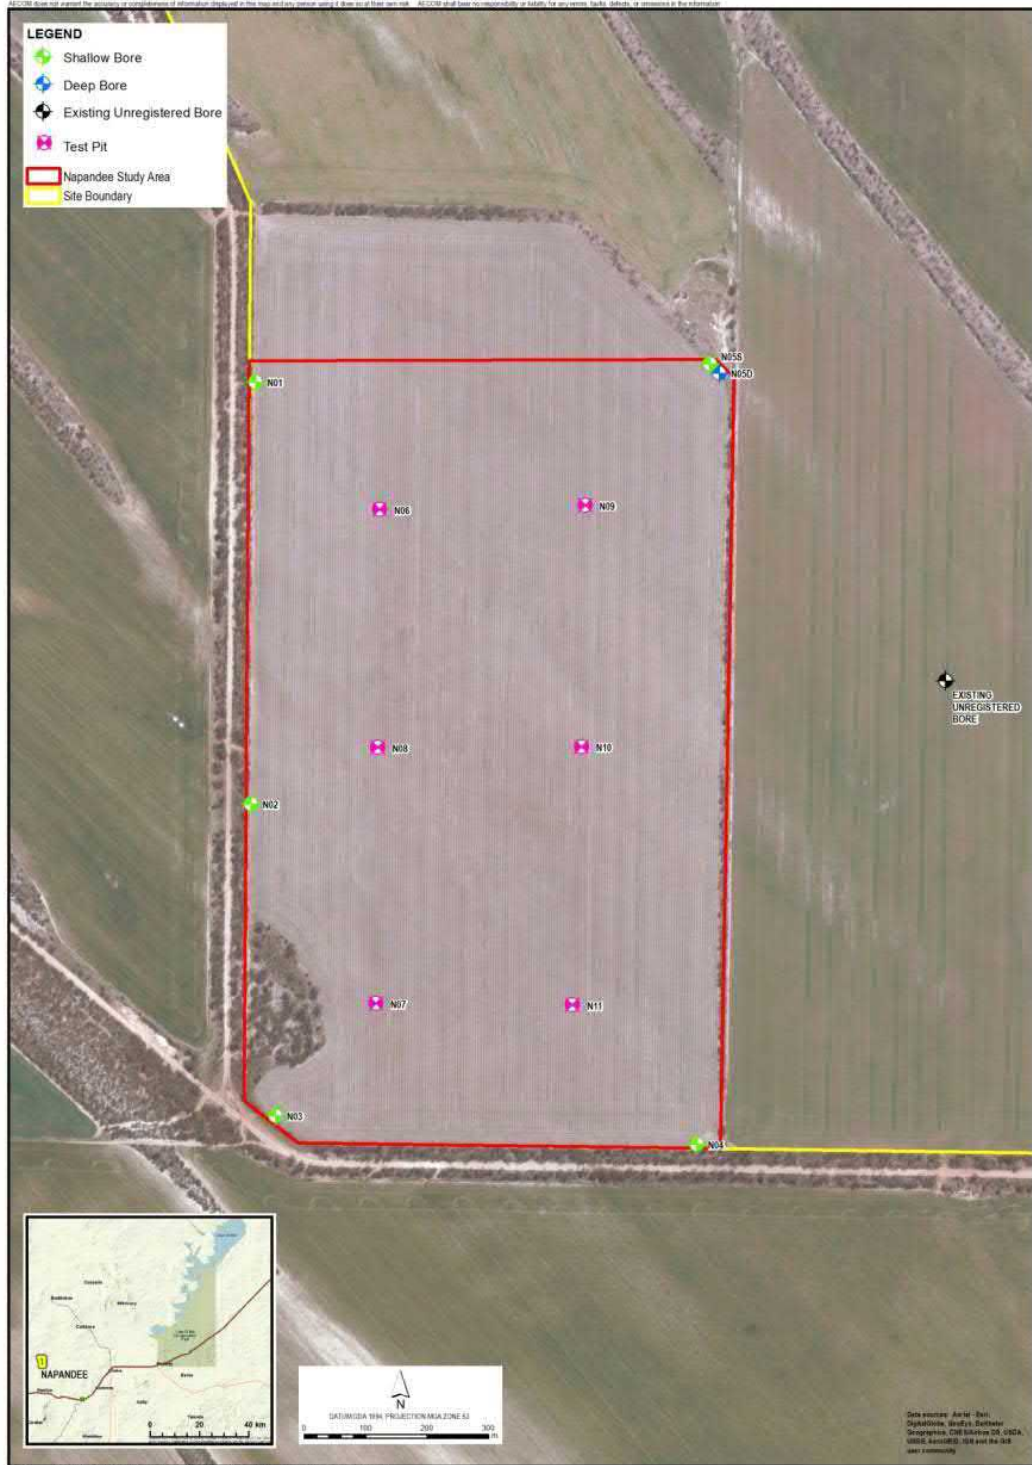
Figure 24 Location of investigation bores and test pits within Napandee site
