JOINT SELECT COMMITTEE ON THE CHRISTMAS ISLAND TRAGEDY
AUSTRALIAN CUSTOMS AND BORDER PROTECTION SERVICE

Question No. 2

Attached is a copy of the map made by the Customs and Border Protection officer who first reported the sighting of SIEV 221 on 15 December 2010.

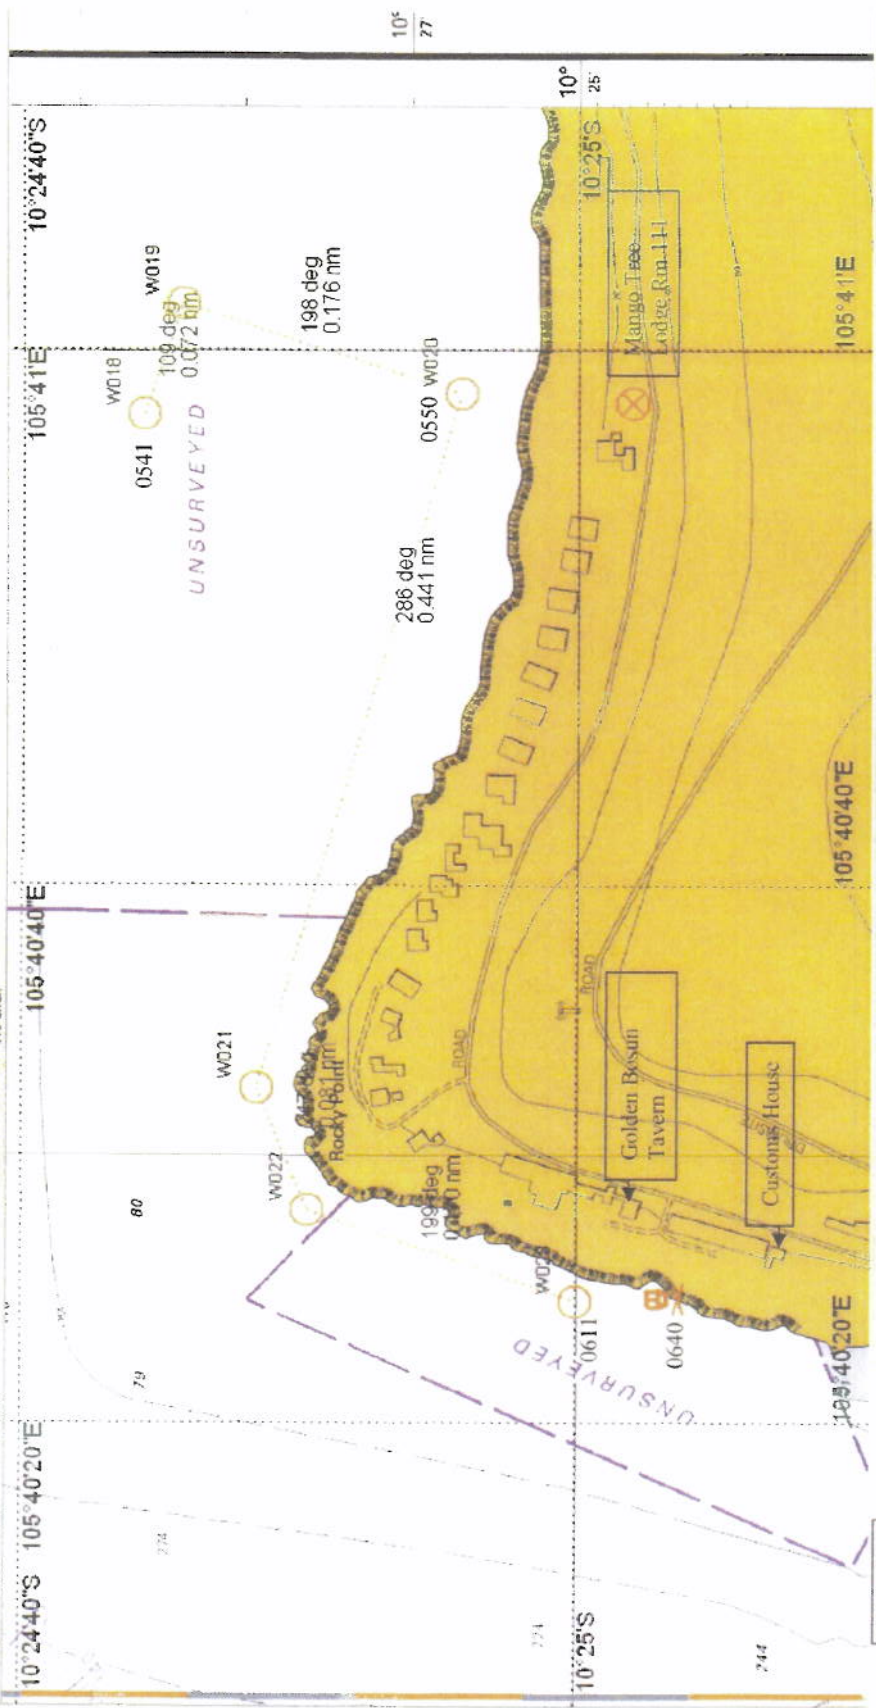
- This map shows the approximate path and approximate timing of the sightings of SIEV 221 as it travelled from where it was first sighted at approximately 0540 (Christmas Island time) from the Mango Tree Lodge, to its impact off Rocky Point.

- The orange dotted line indicates the approximate path of SIEV 221 from where it was first sighted at Waypoint (WO) 18, then travels in a south east direction to WO19, then travels in a south west direction to WO20, then north west to WO21, south west to WO22, then south south west to WO23 to where it finally impacted on rocks at Rocky Point, indicated by the cross and skull symbol to the south of WO23.

- Times (Christmas Island local time) are shown as 05:41 at WO18, 05:50 at WO20, 06:11 at WO23 and 06:40 for the place of impact.
- The circle with the cross in it indicates where the Officer was standing at the Mango Tree lodge when he first sighted SIEV 221. This position was obtained from the GPS in the Officer's phone.
