**These photos do not show any asbestos that is below the surface. It is unknown if or where this may occur. No visual observations of any asbestos being looked for by asbestos removal personnel at any location throughout the Roe 8 project was seen by the many observers present.**

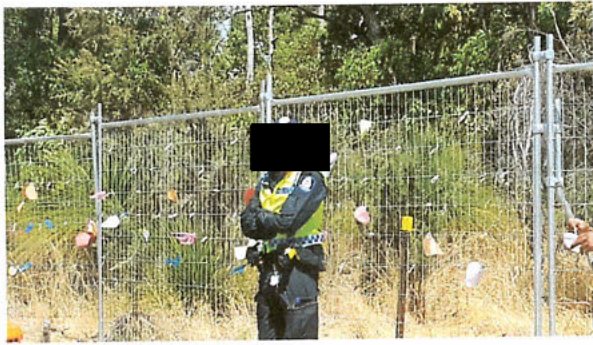
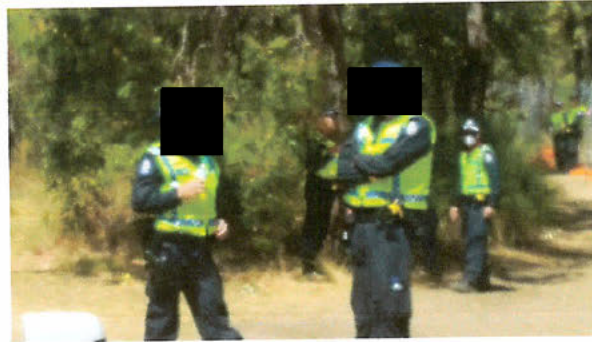
Police wearing ppe after residents advised them to at Mulvolio Road site.

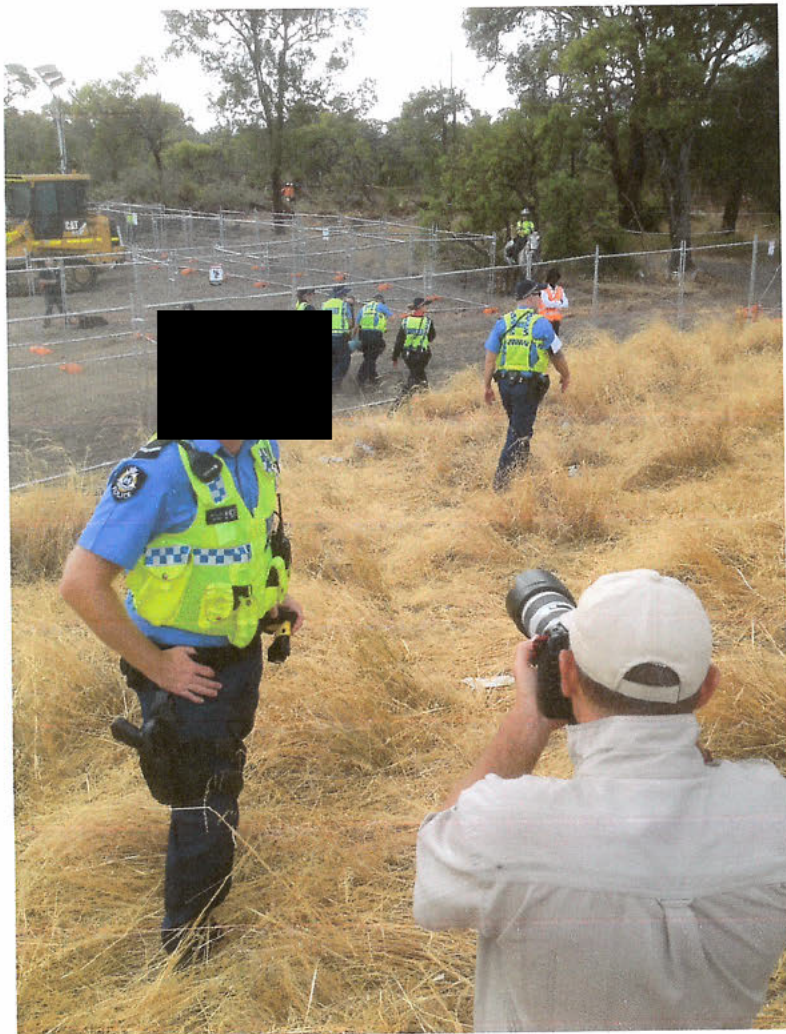
**Police inside the compound at Nth Lake Road, both on foot and on horseback, shown not wearing respirators. Also shows a security guard not wearing a respirator. This is contrary to Section 20 of the Occupational Safety and Health Act 1984 and shows a clear breach of the law.**

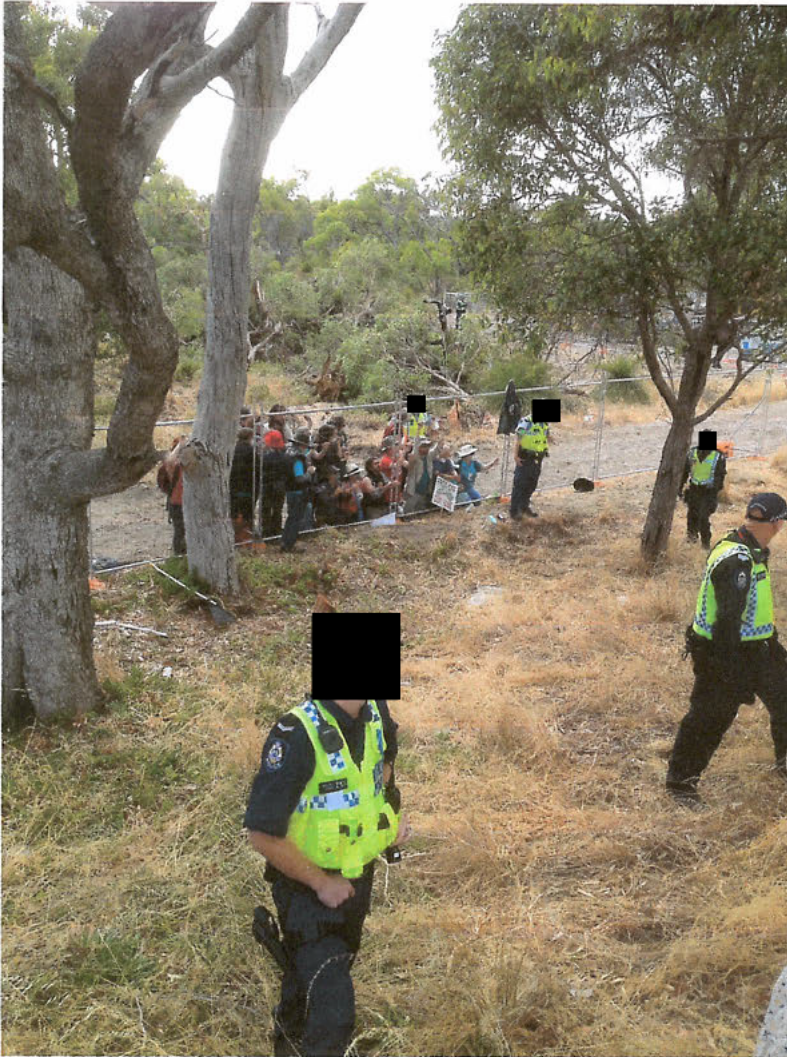
All police inside the fenced area where removal of asbestos was being conducted are not wearing ppe

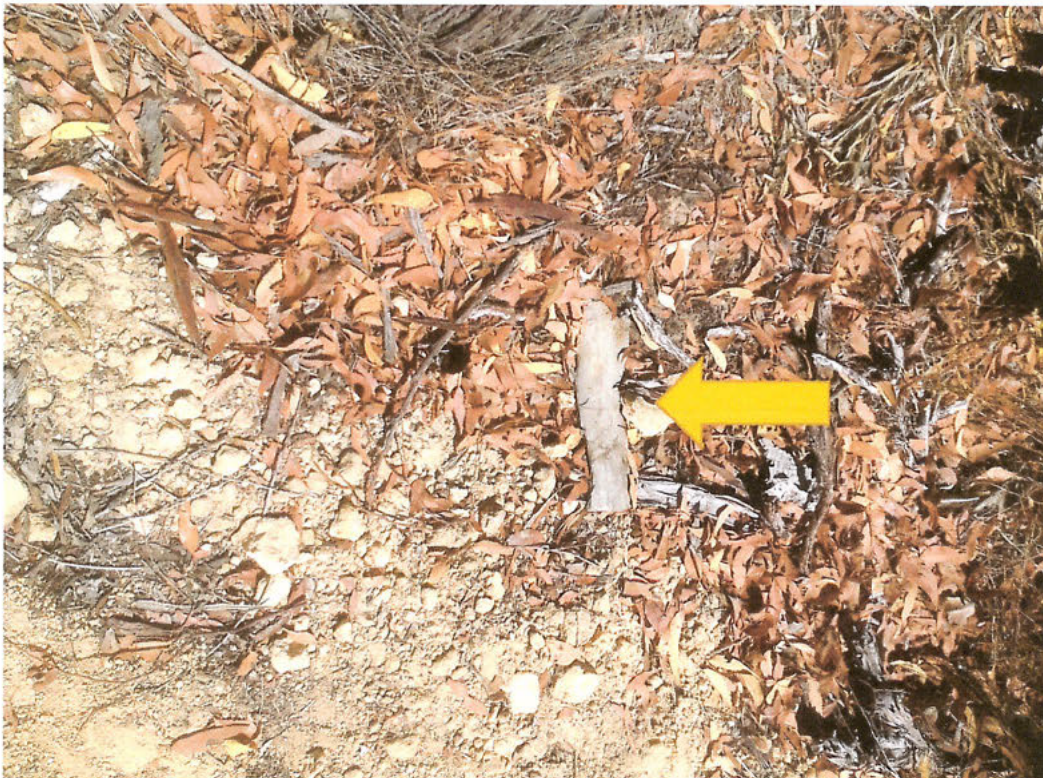
Asbestos piece inside the fenced area after the alleged clean-up of asbestos.

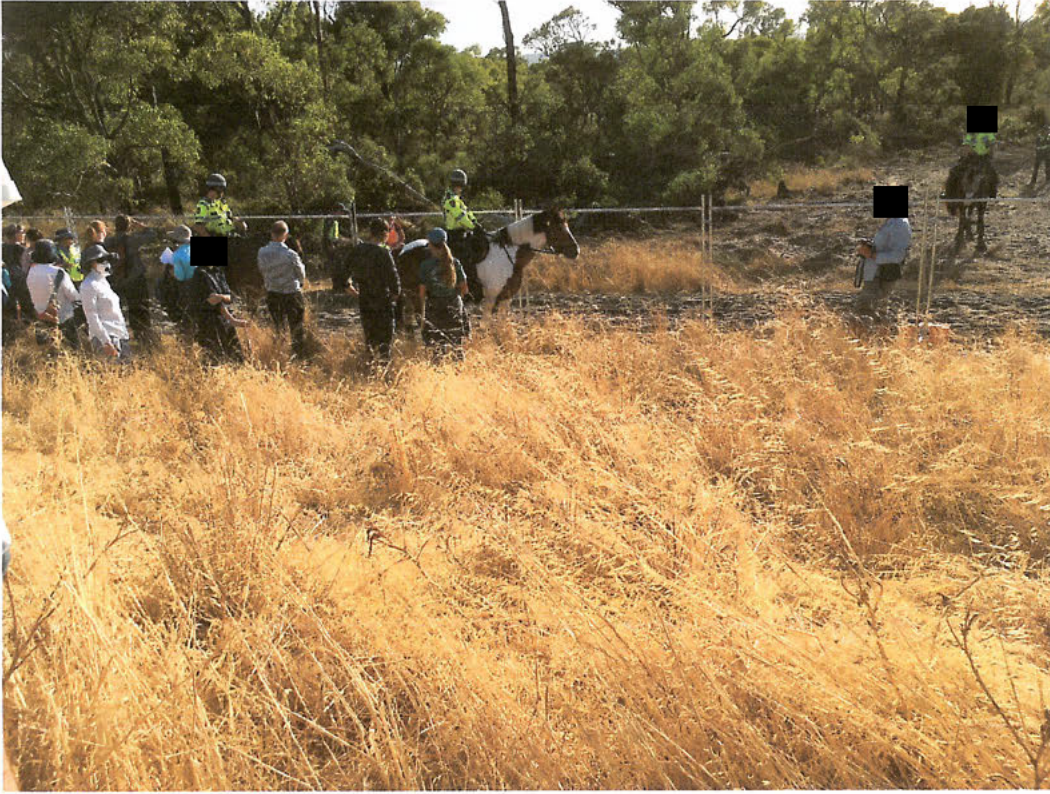
Police on horseback not wearing masks in a known contaminated area.

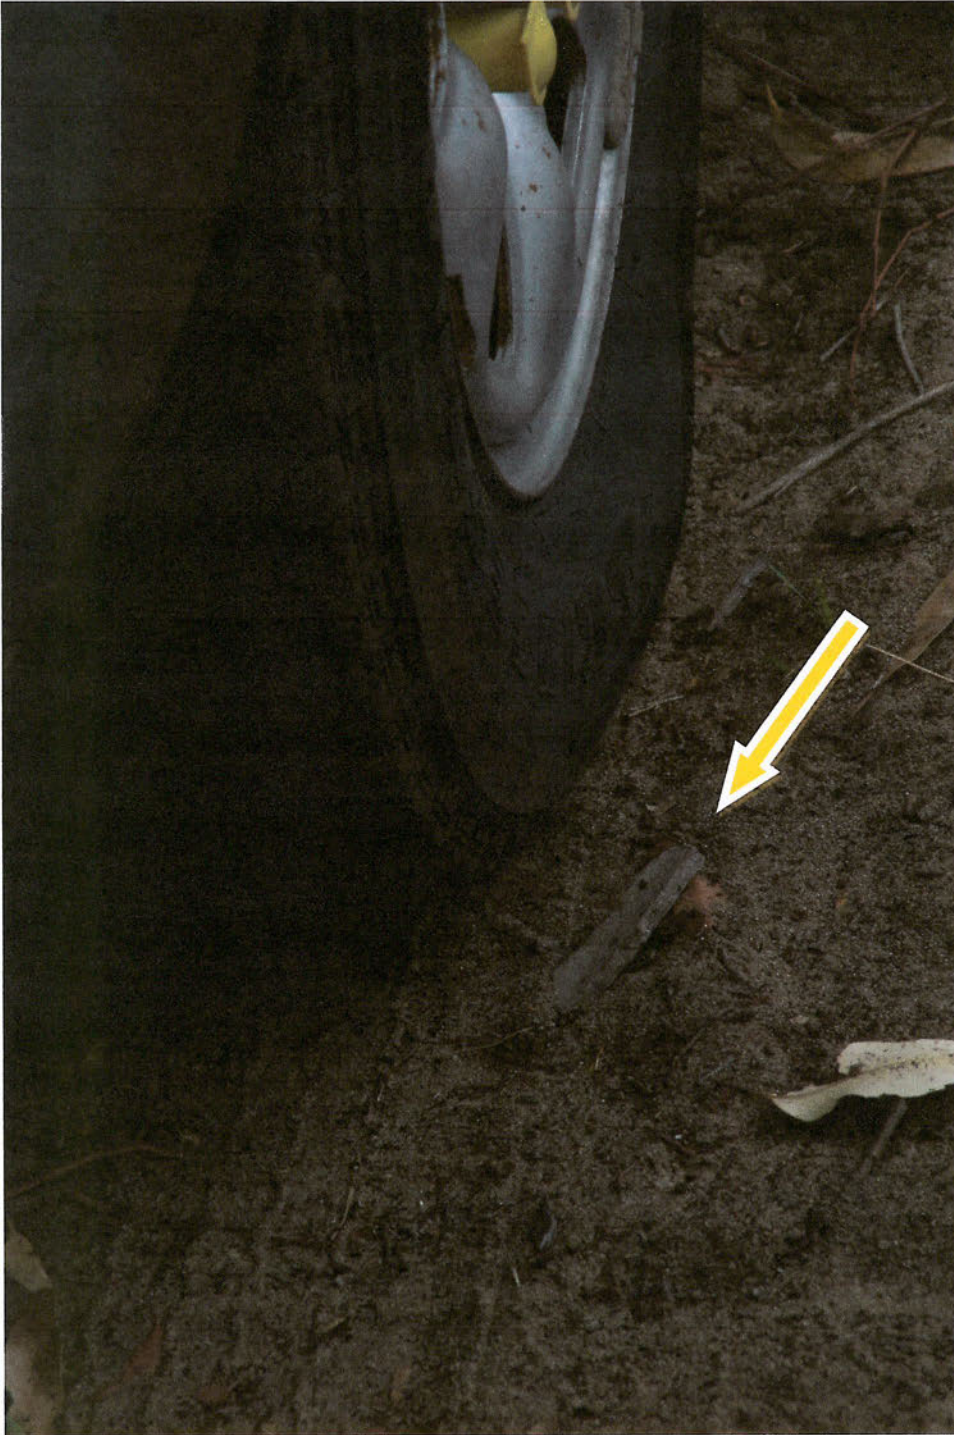
**Piece of broken asbestos beside a well - used track by the construction vehicles. As can be seen it has been run over by the vehicle.**

**The asbestos clean-up has not been conducted in a proper manner here, and maybe elsewhere in the bushland where it may be less obvious**

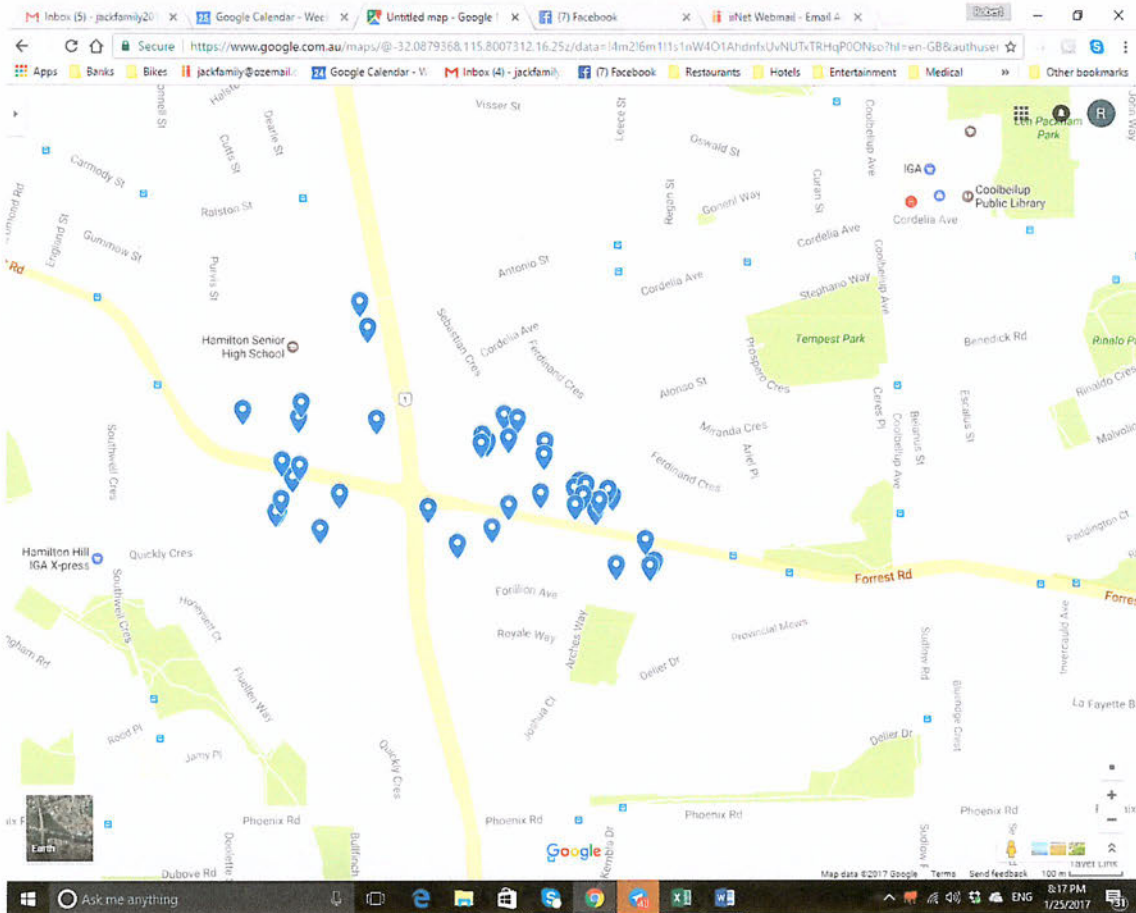
GPS plotting of tested samples along parts of the Roe 8 project.

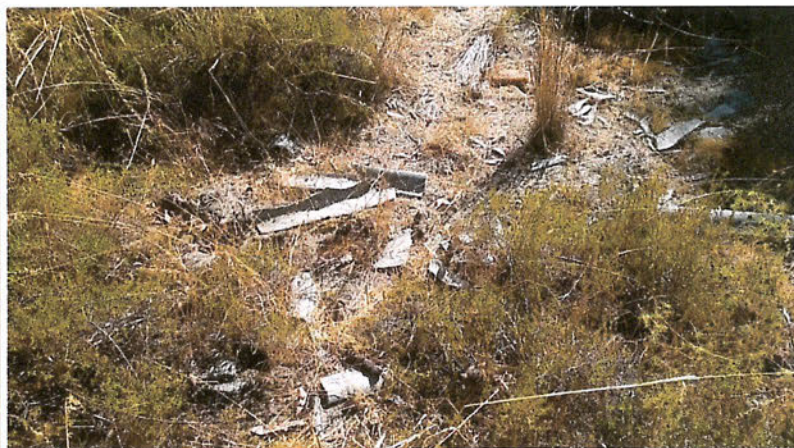
Asbestos laying intermittently on the ground surface. Photos taken by Phillip Eva JP of Cockburn Council on January 24, 2017, east of the Women's Army Camp. Much of the ground in the surrounding area was littered with broken asbestos. These photos were sent to Minister for the Environment on 25/01/2017.

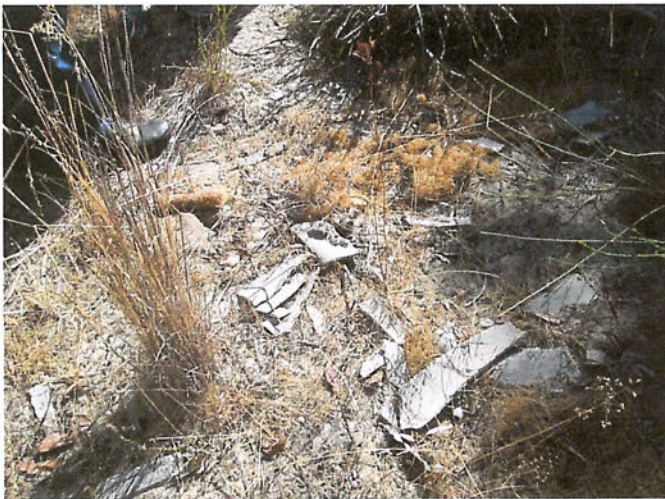
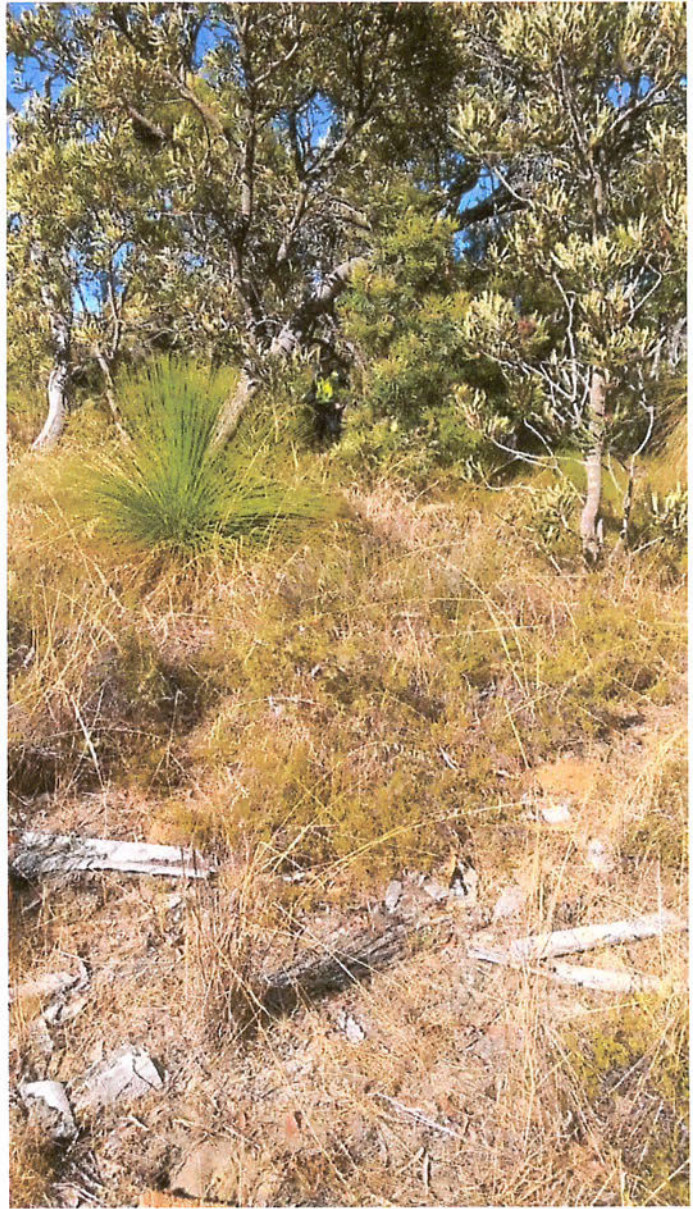
Photos taken by Phillip Eva JP of Cockburn Council on January 24, 2017, east of the Women's Army Camp. Much of the ground in the surrounding area was littered with broken asbestos. These photos were sent to Minister for the Environment on 25/01/2017.

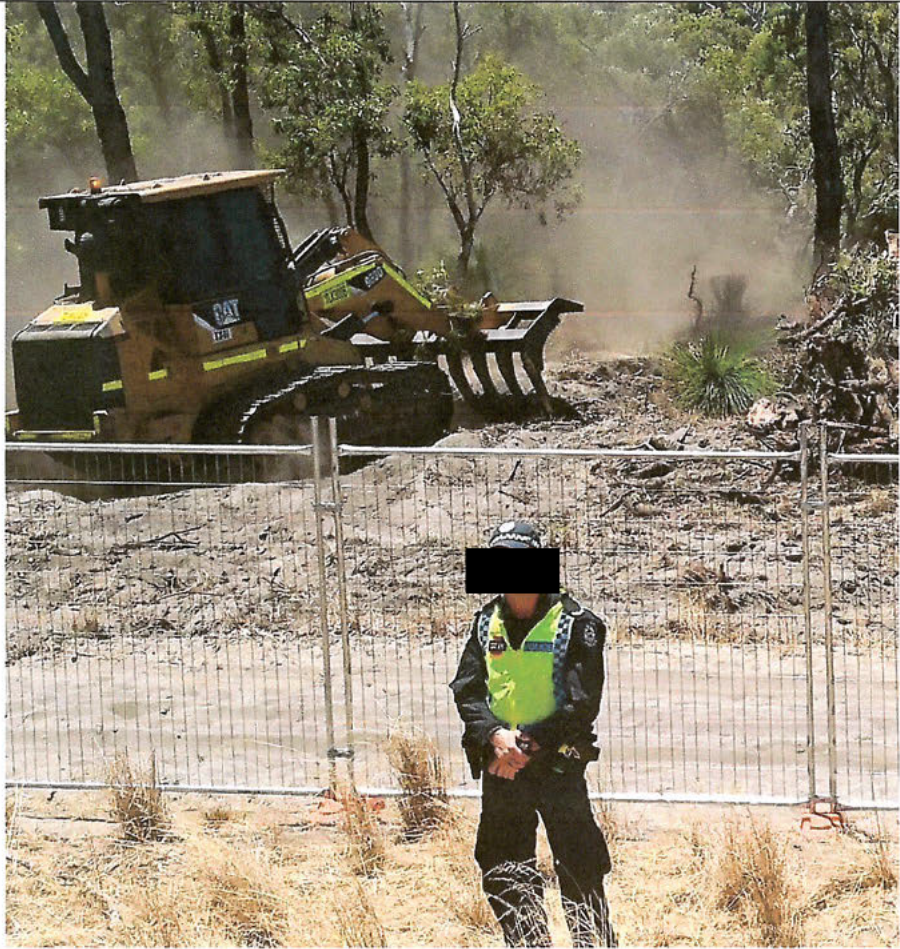
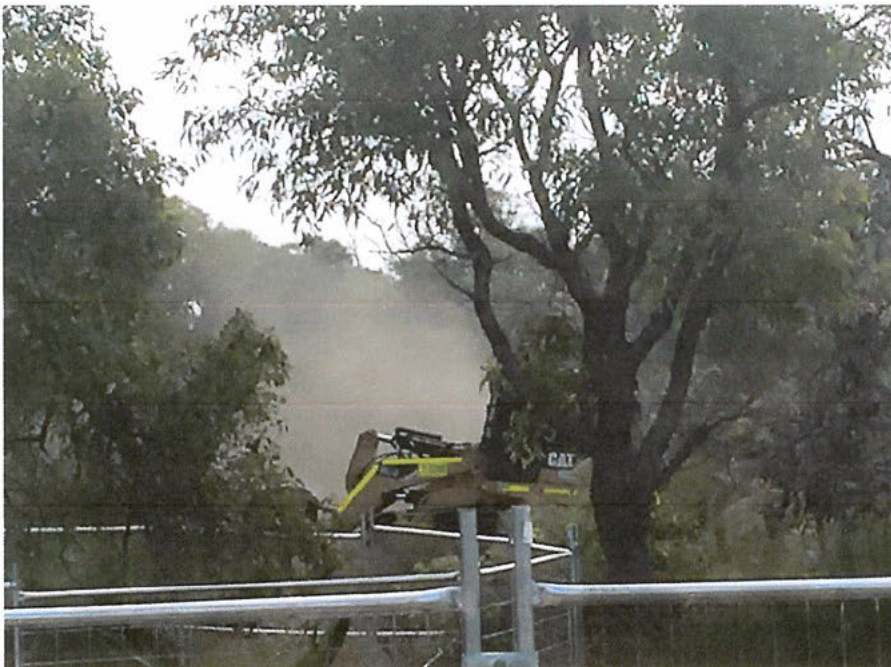
**These photos were taken by Shona Ann Hunter and show the dust being generated by the machines in light winds with NO watering of the area performed prior to this work commencing. Also shows a police officer in close proximity to this equipment not wearing any personal protective equipment to prevent asbestos exposure. Such behaviour is contrary to Section 20 of the Occupational Safety and Health Act 1984 to which the police are covered by the provisions of this Act.**

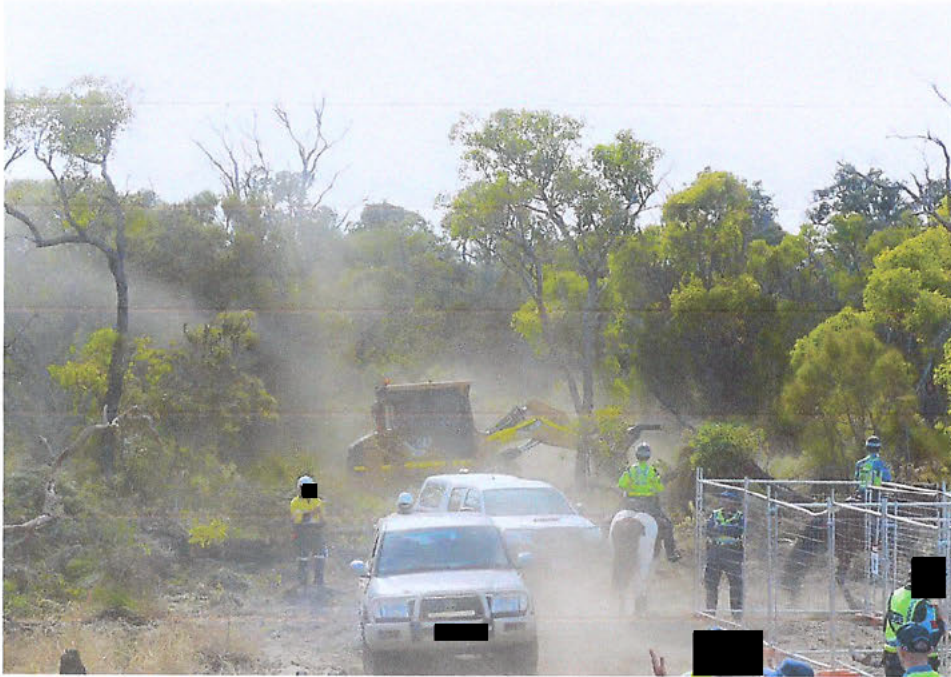
**Police, mounted police, workers and vehicles in the contaminated area. NO dust suppression and windy conditions carrying the dust plume through the bushland. Note that no one is wearing a respirator contrary to the OSH Act of 1984 Section 20 Duty of Care.**

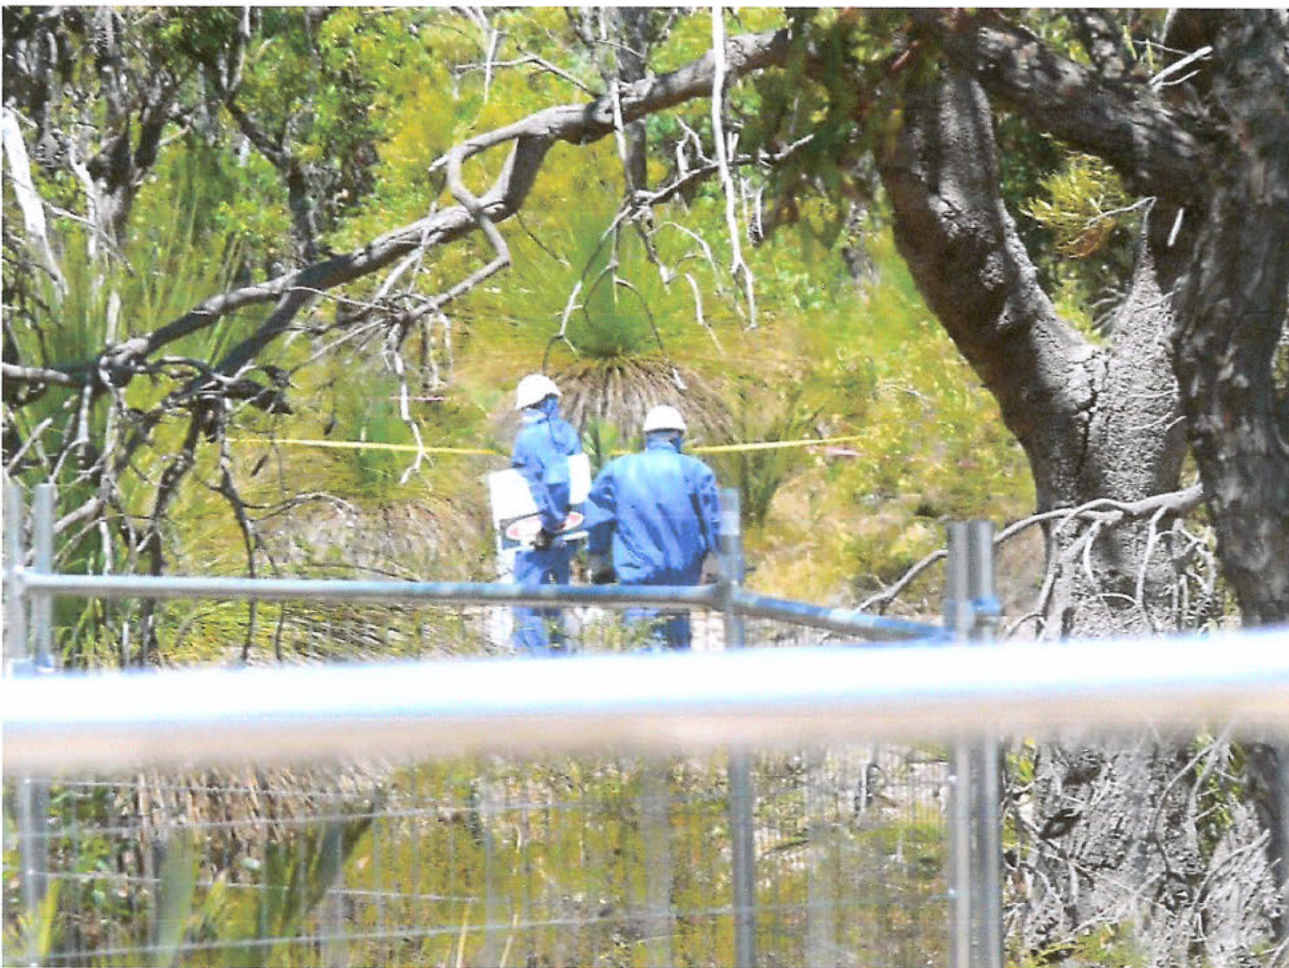
Asbestos removalists at a later stage of the Roe 8 project wearing their ppe.

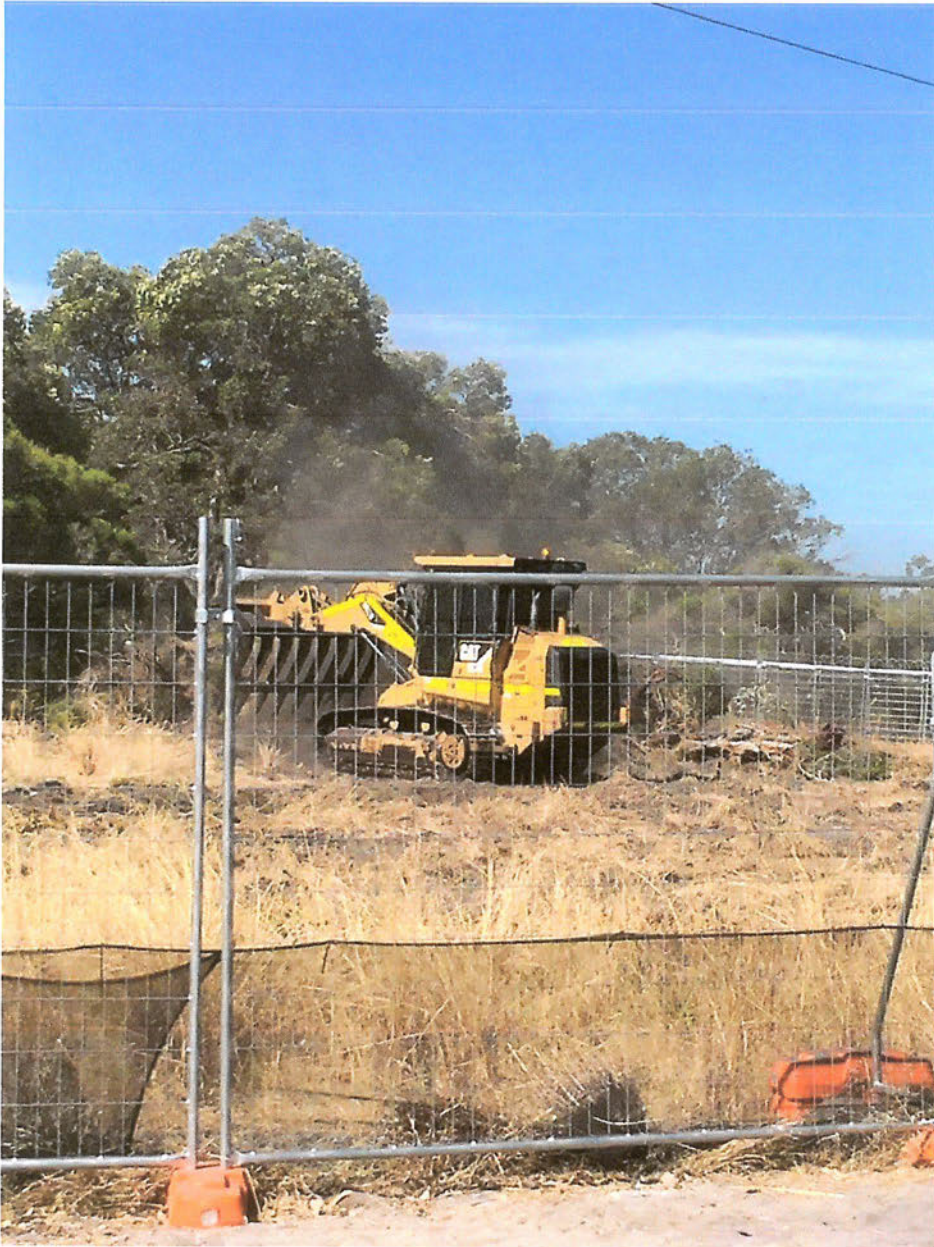
Dust being generated by this track mounted machine. NO wetting of the area prior to work being undertaken and this was done in light windy conditions.

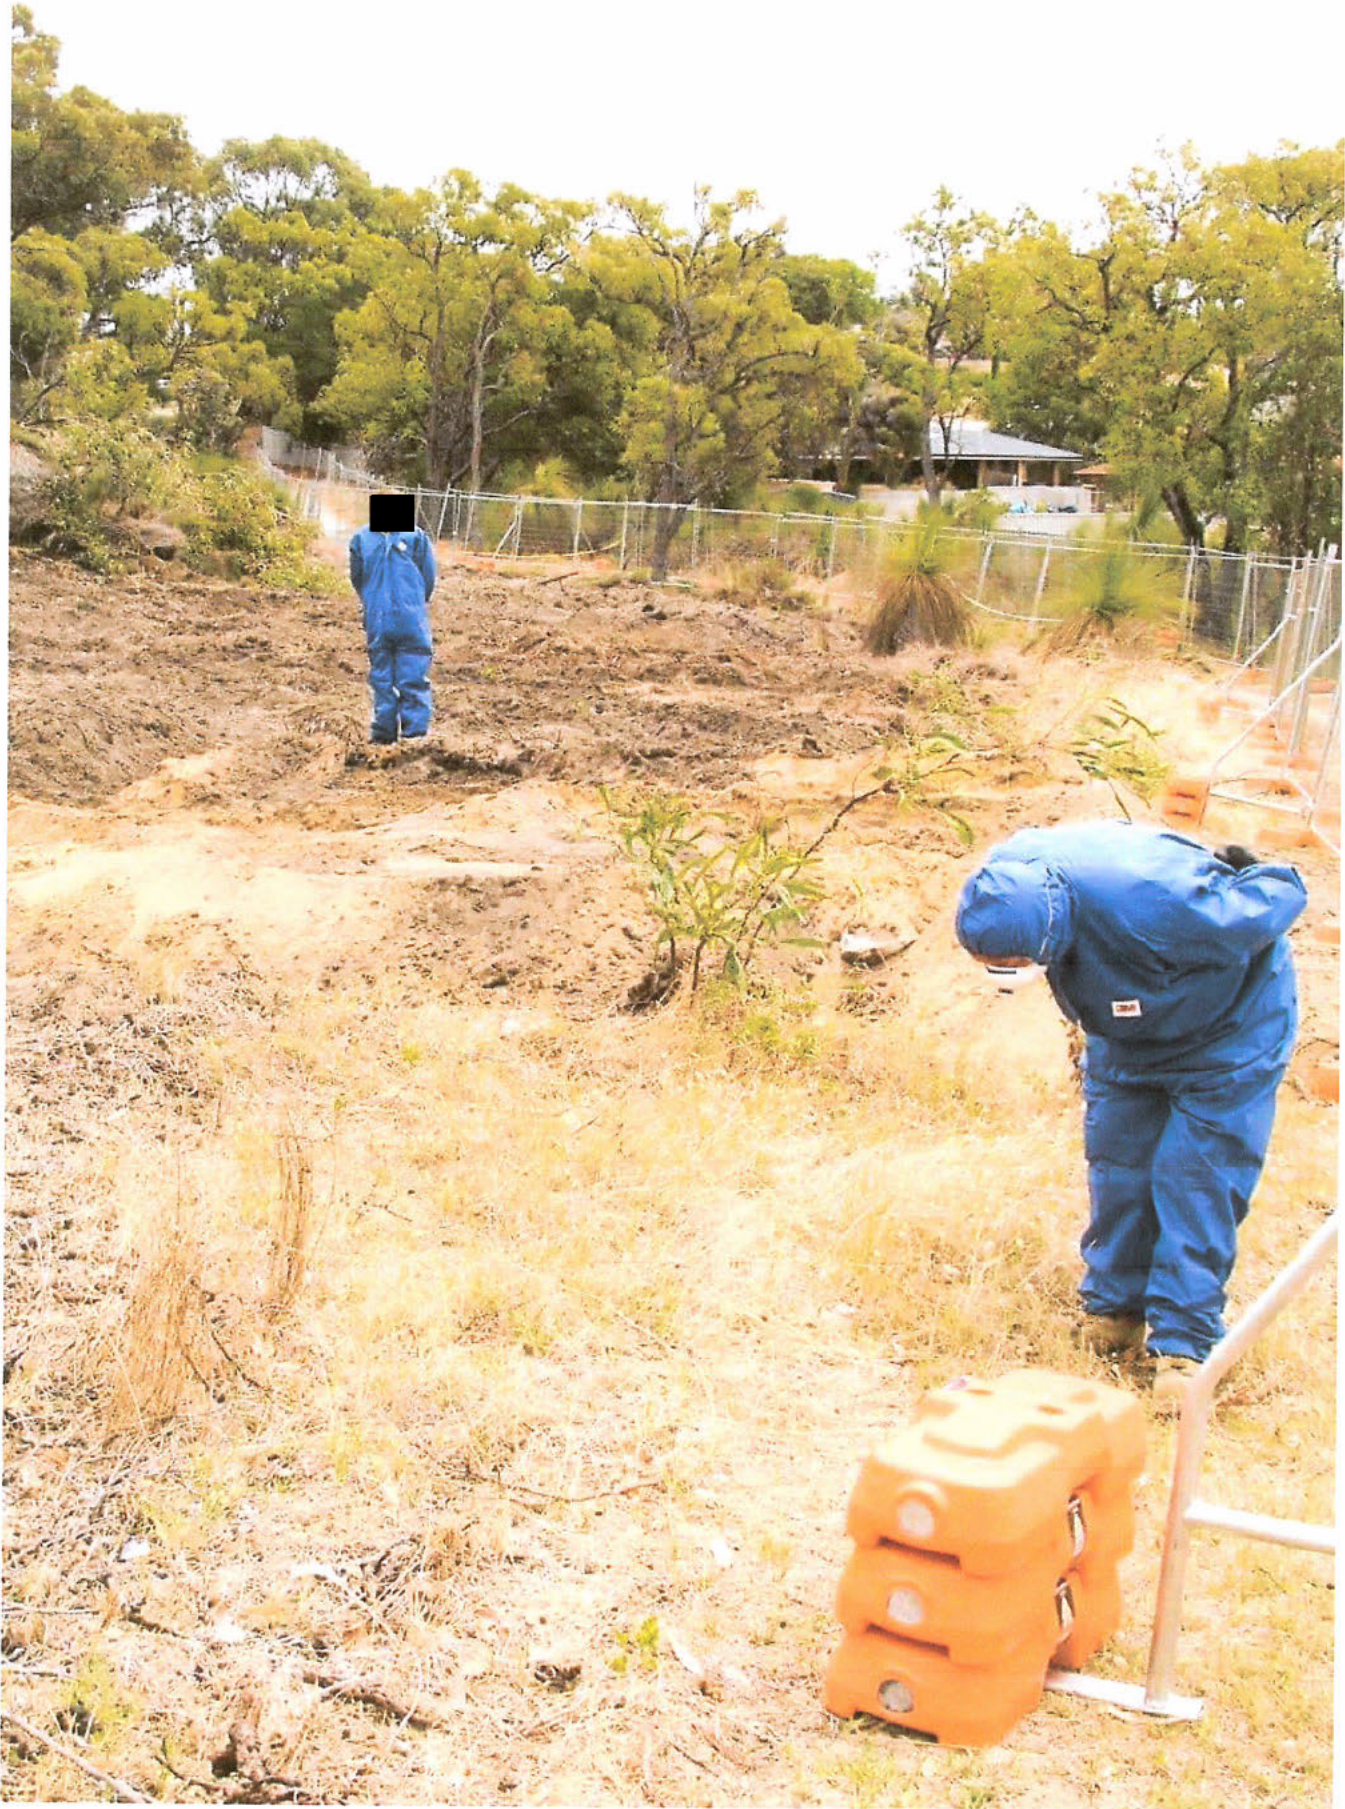
Note: One asbestos removalist is not wearing a hood as an integral part of the appropriate personal protective equipment. This is a clear breach of Section 20 of the Occupational Safety and Health Act 1984.

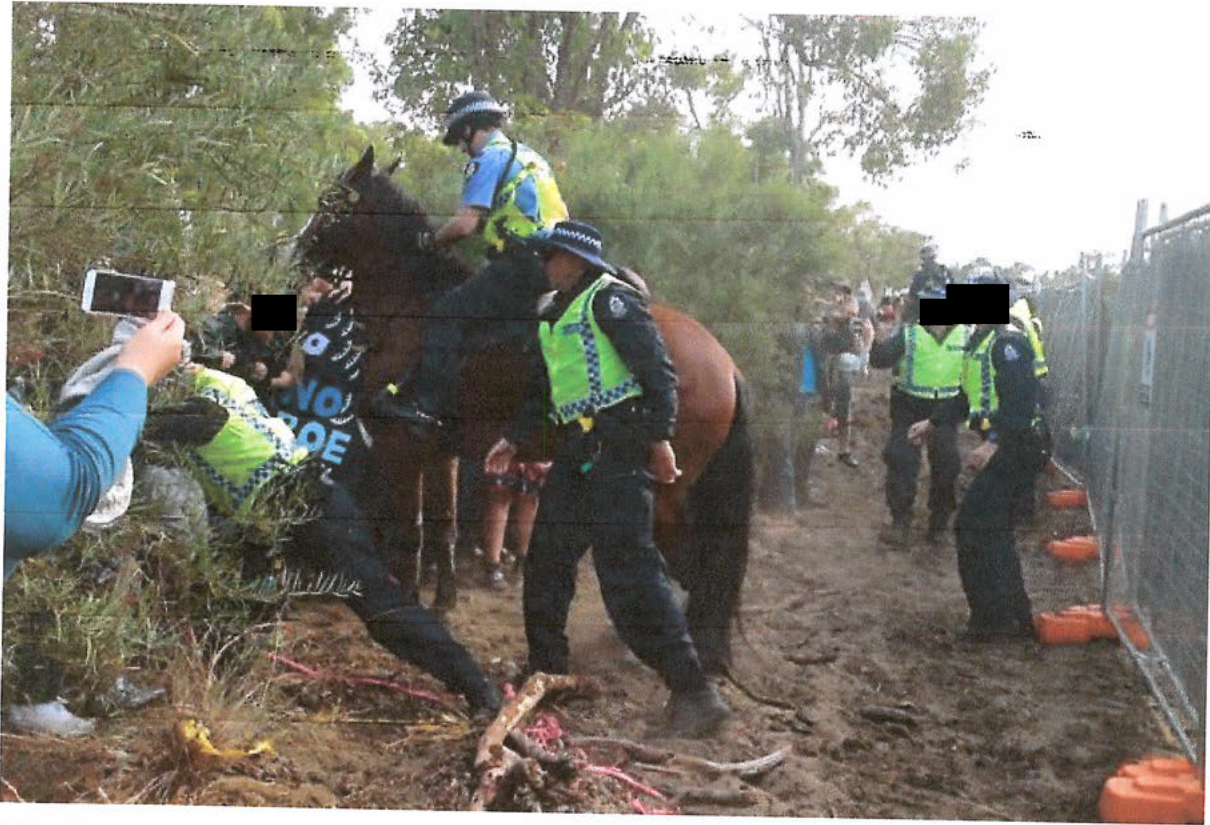
Police inside the contaminated area without wearing approved respirators to prevent asbestos exposure.

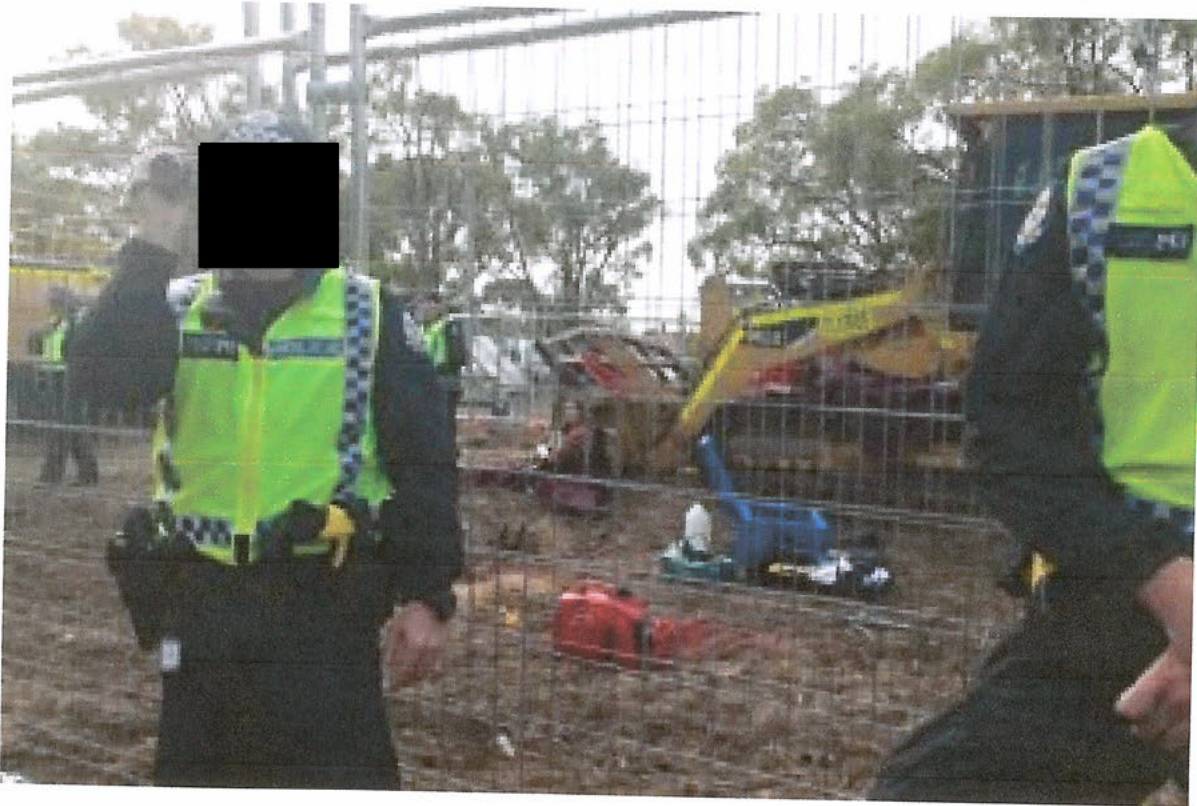
Police inside and outside the contaminated area not wearing appropriate respirators to protect them from asbestos exposure.

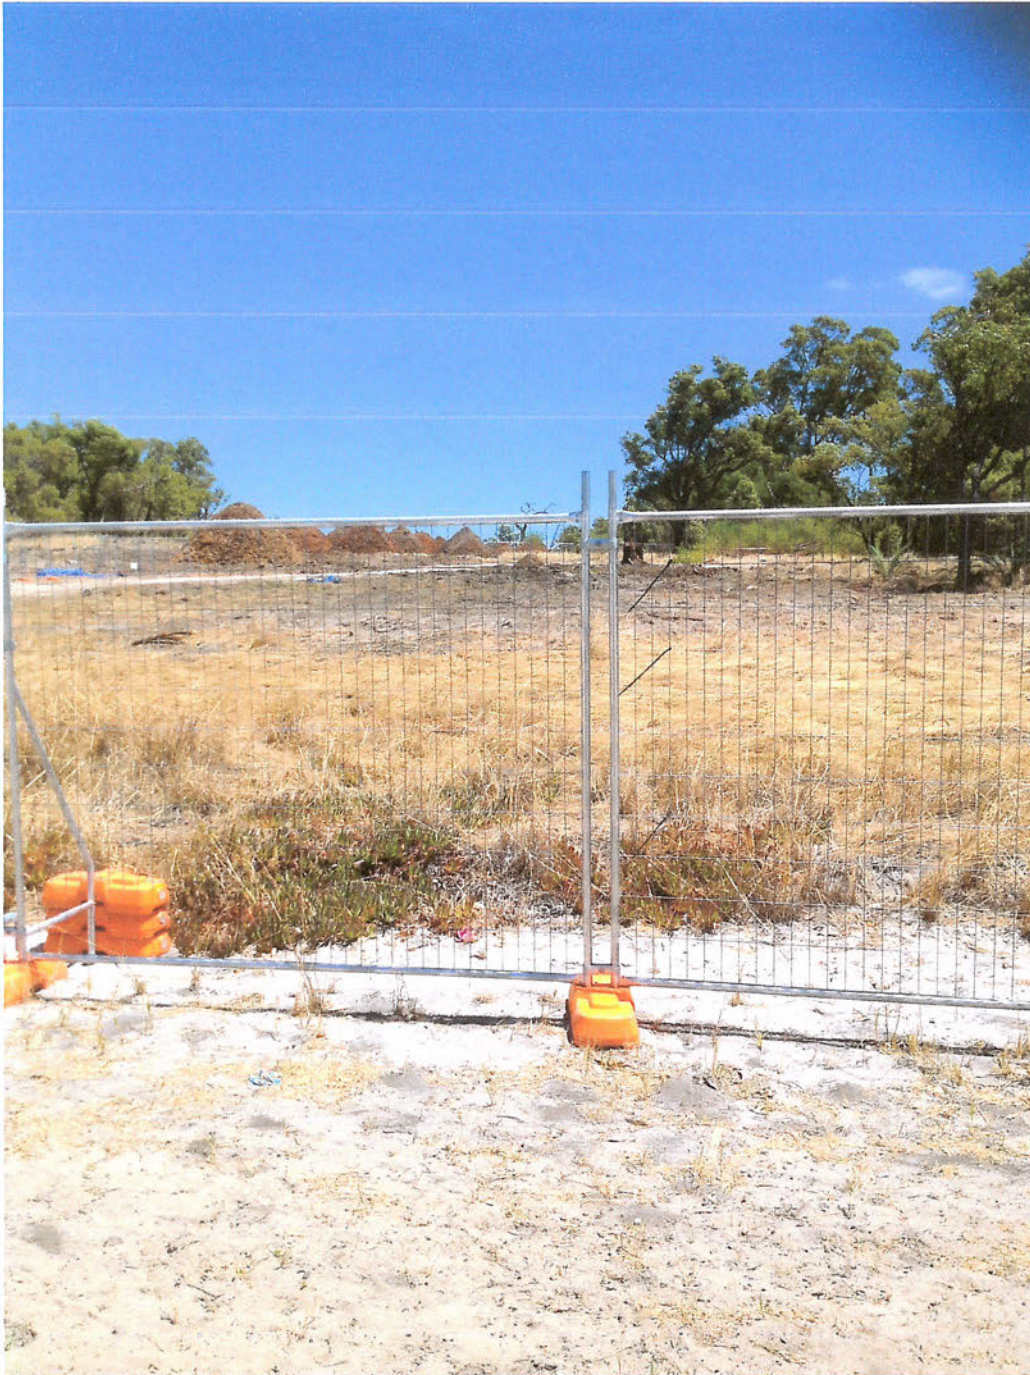
Large piles of mulched vegetation cleared from the site by bulldozers almost certainly will contain asbestos fibres.

The ground where this was taken from could also still contain fibres. Respirable fibres are less than 3 microns in diameter and cannot be seen with the naked eye.
