ROE HIGHWAY EXTENSION – Ministerial Statement 1008, EPBC Act Referral  
2009/5031 – Request to halt or 'stop the work until issues raised are resolved.

I am writing to you as a concerned local resident about breaches of compliance with the Fauna Management Plan and the Construction Environmental Management Plan by the Building Roe 8 contractors.

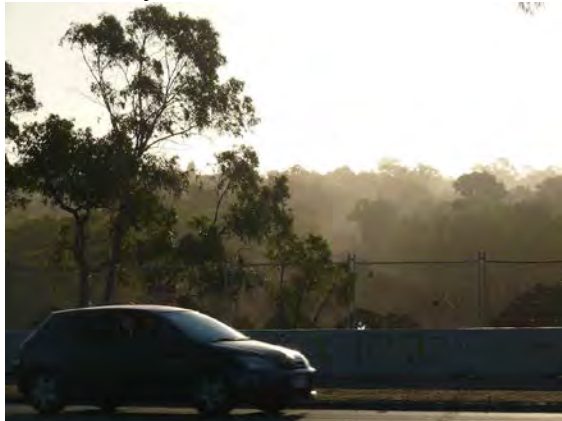
21<sup>st</sup> January, west side North Lake Road

19<sup>th</sup> January 2017 clearing continued in the North Lake Road and Progress Drive site. No water cart was utilised.

20<sup>th</sup> January 2017 clearing continued in the North Lake Road and Progress Drive site. No water cart was utilised.

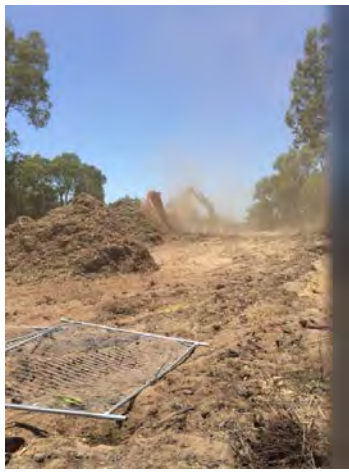
17<sup>th</sup> January from Coolbelup Avenue end

18<sup>th</sup> January 2017 mulching continued at the west end of the Coolbelup site without a water truck being used. Bulldozing of the roundabout and slip road area continued at the east end of the site, a water truck was present and used for the first time but inadequately. Intermittent watering of the area was insufficient to dampen the dust.

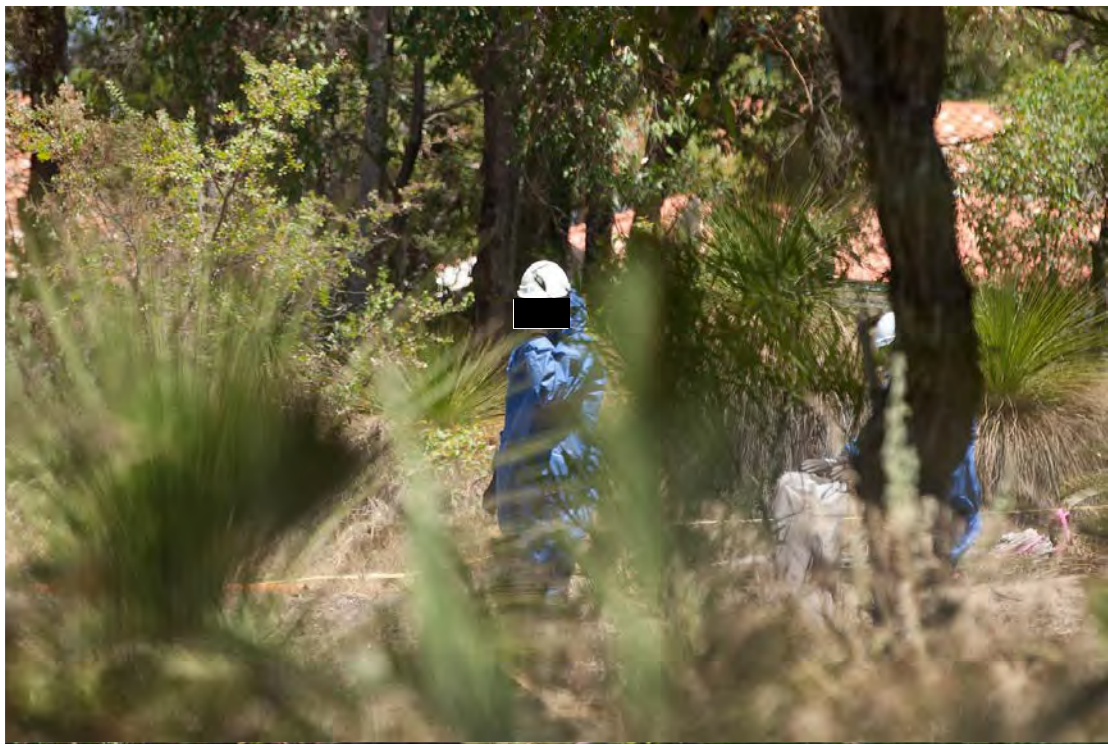
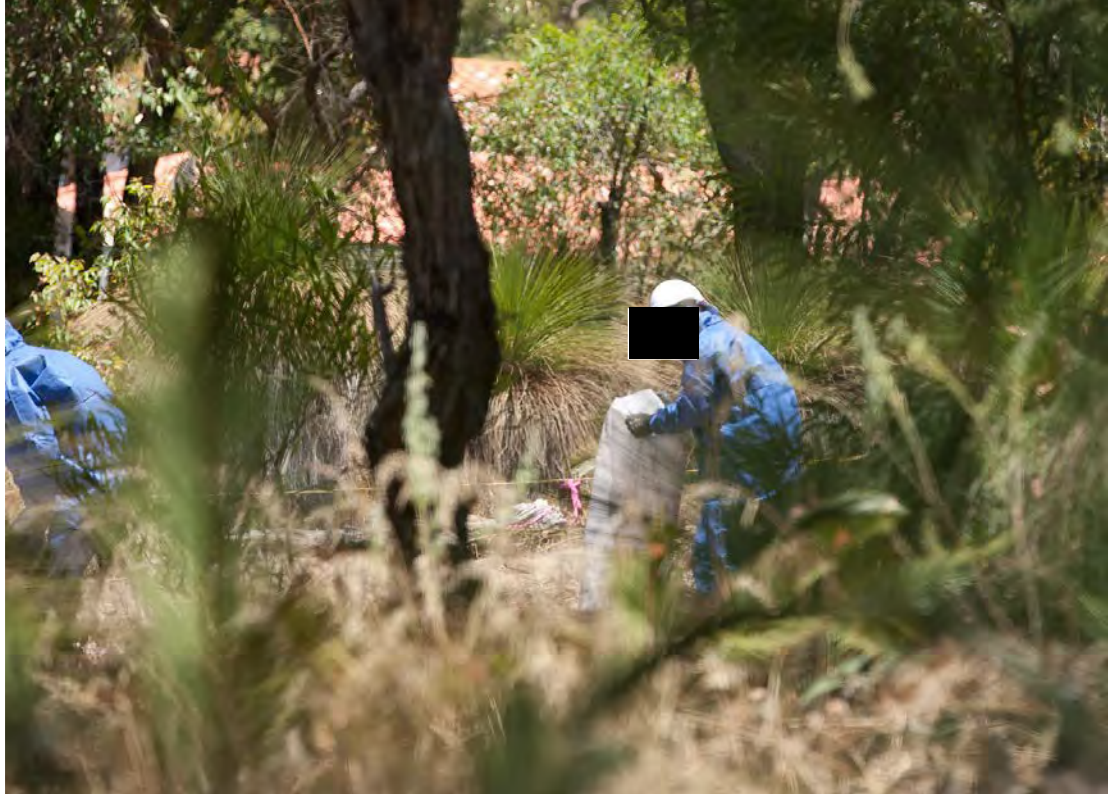
Asbestos removal took place from the Malvolio site on the afternoon of 13<sup>th</sup> January whilst clearing was taking place. The following two photographs were taken that afternoon on Malvolio Road, opposite number 20.

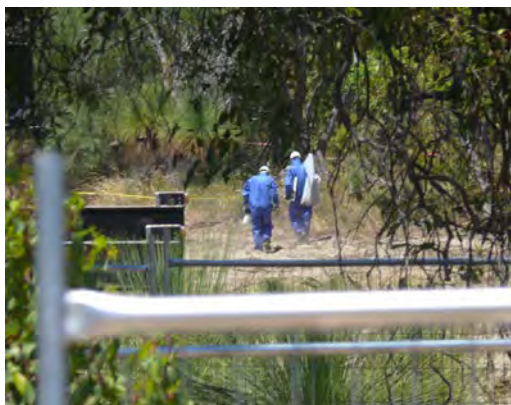
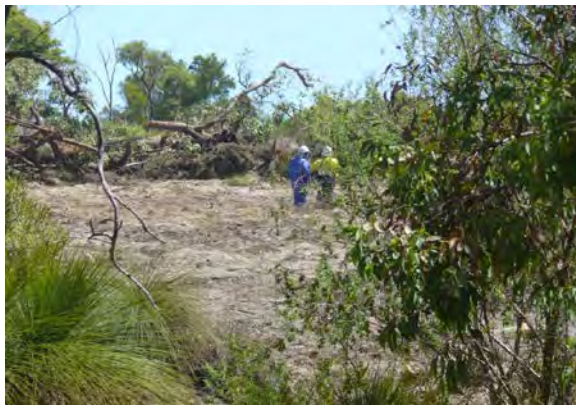
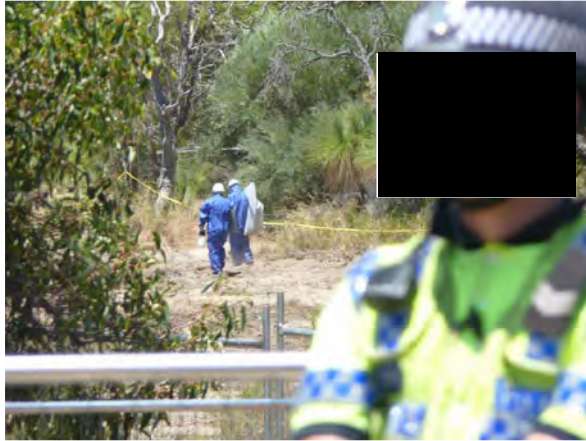
The following three pictures were taken from the east side of North Lake Road on the morning of 20<sup>th</sup> January post clearing the previous day.

This clearly poses a risk to public health, let alone the health of construction workers and the police.

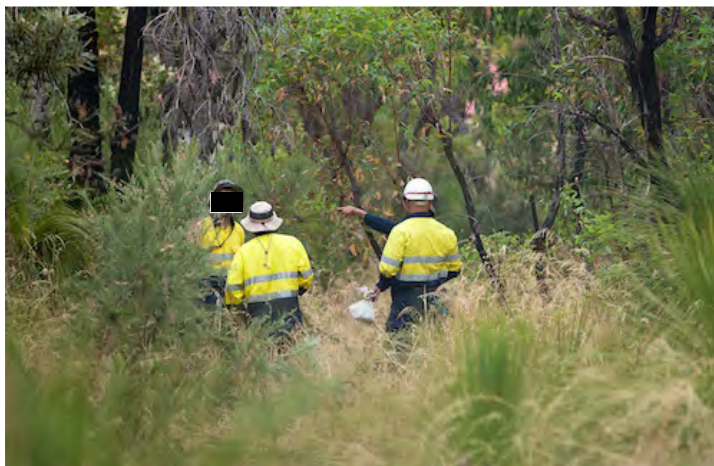
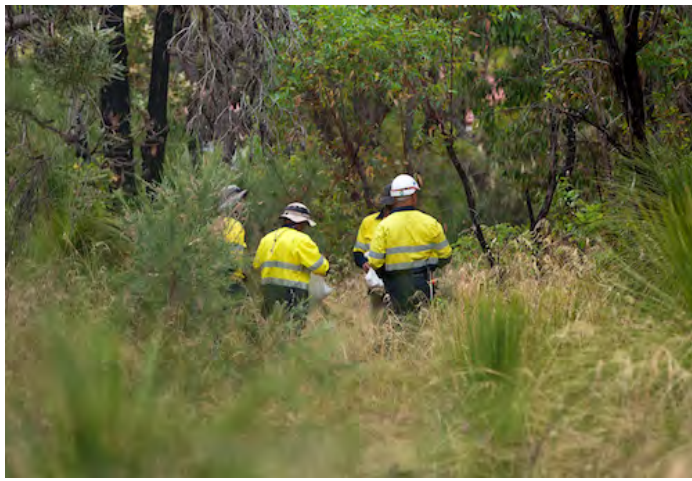
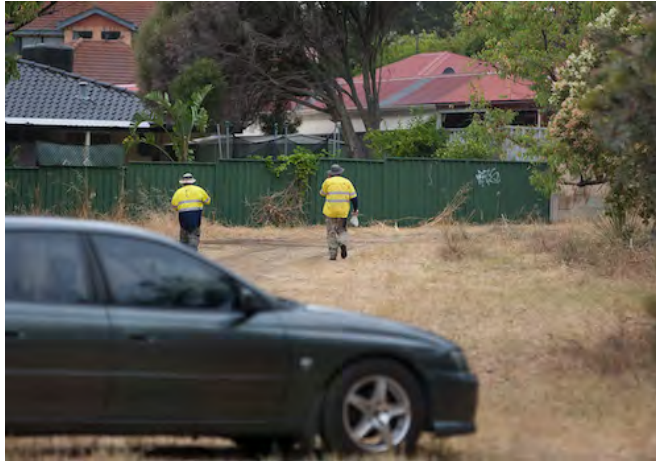
13th January 2017: bandicoots are removed from the Coolbelup bushland approximately two hours before clearing commenced. The picture below shows bandicoots in bags.

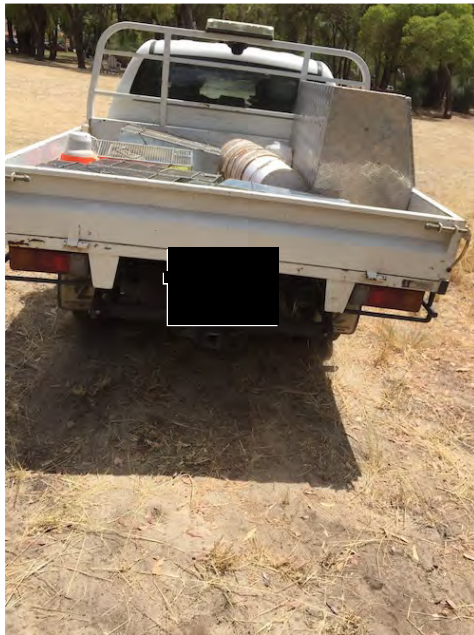
11.00am on 18<sup>th</sup> January the trappers' ute containing full bandicoot cages exits the east end of the Progress Drive site, picture below. Clearing commenced at @ 4pm that day.

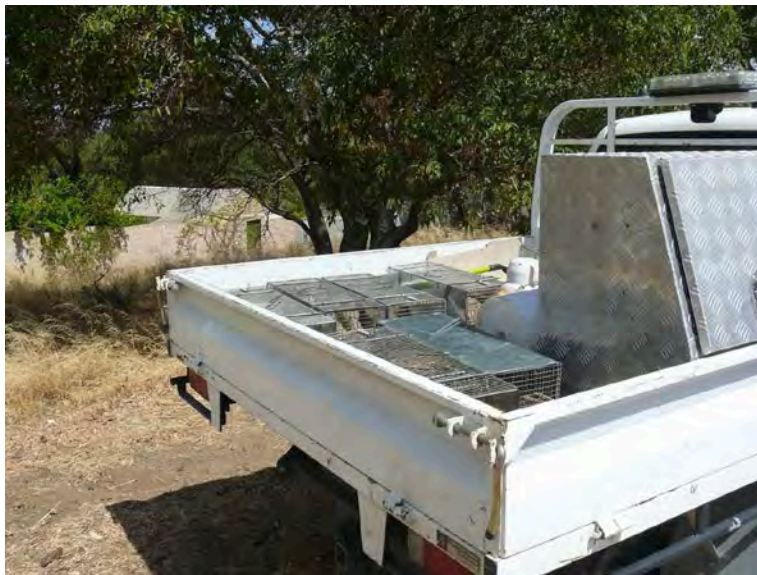
3.35pm on 18<sup>th</sup> January. This picture shows the trappers ute leaving the west end of the Progress Road site with full cages 90 minutes before clearing commenced.

If the traps were closed during the day bandicoots could not have been trapped and removed at 3.35pm.

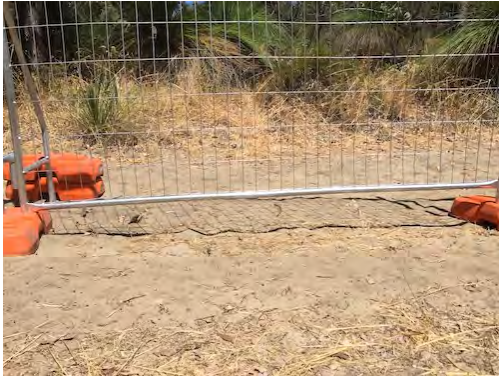
North west end Malvolio Road

No netting at all was used at any time at the Coolbelup site.

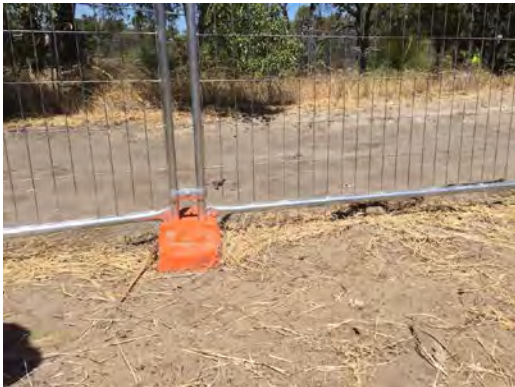
North East side North Lake road

Partial netting was used at the Progress site:

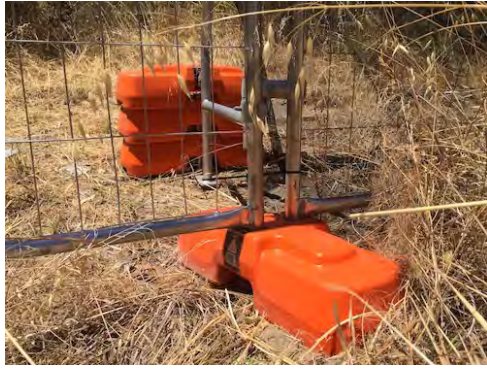
East end of Hope Road site

Partial netting is being used at the site at the east end of Hope Road:

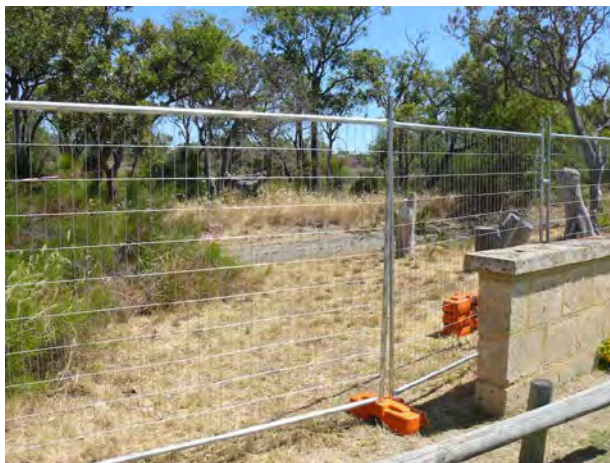
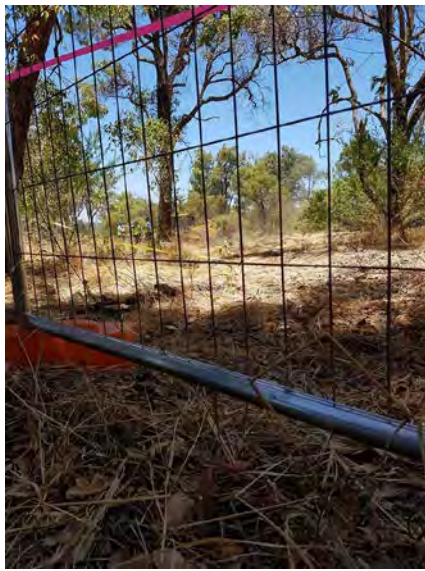
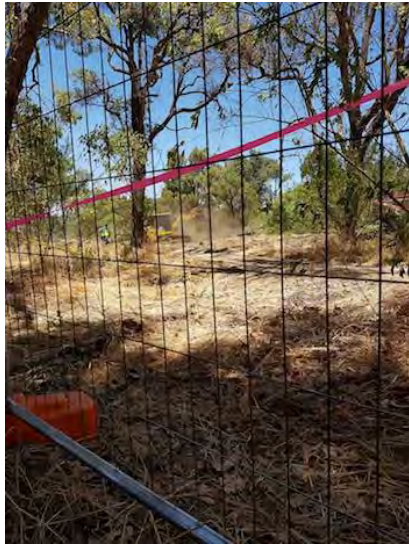
The following three pictures show clearing taking place with no netting on the fences on 20<sup>th</sup> January:

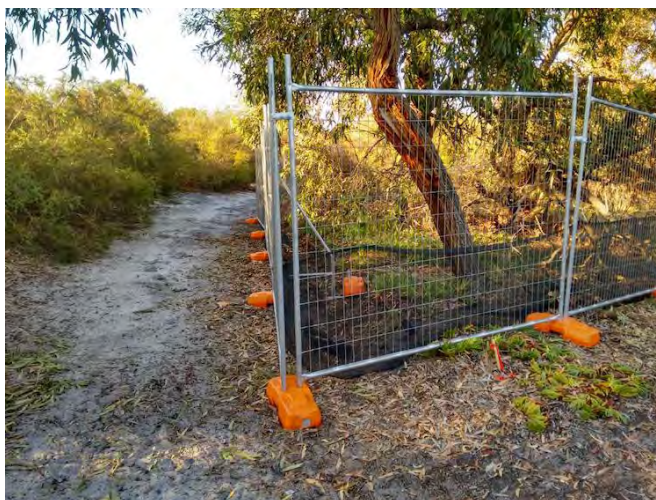
Where netting is being used it is not being dug into the ground as required in Table 7 but is being covered with dirt.

This picture was taken in the north east corner of the fencing near the Kissing Gate in the wetlands area on Saturday 21<sup>st</sup> January and shows the netting has not been dug in.

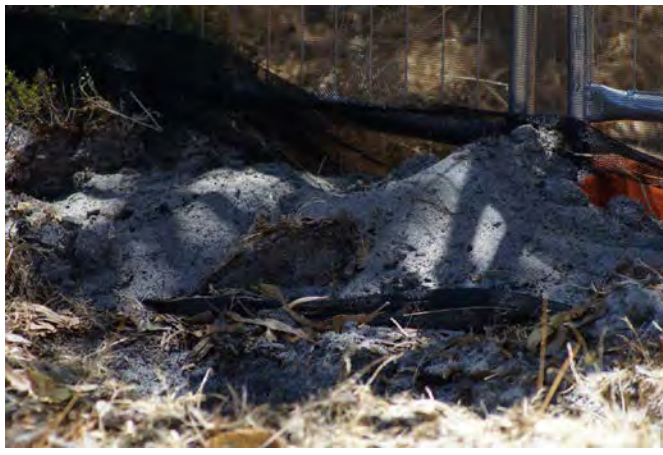
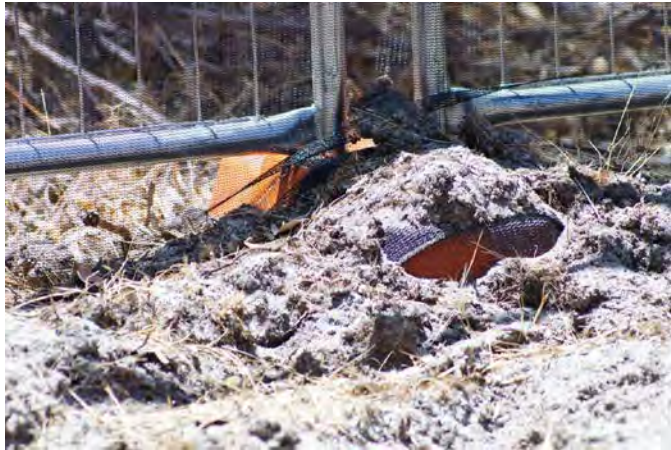
The following two pictures are from other parts of the wetlands site, taken on Monday 23<sup>rd</sup> January, also showing that the netting has not been dug in but covered with soil to prevent it blowing up in the wind.

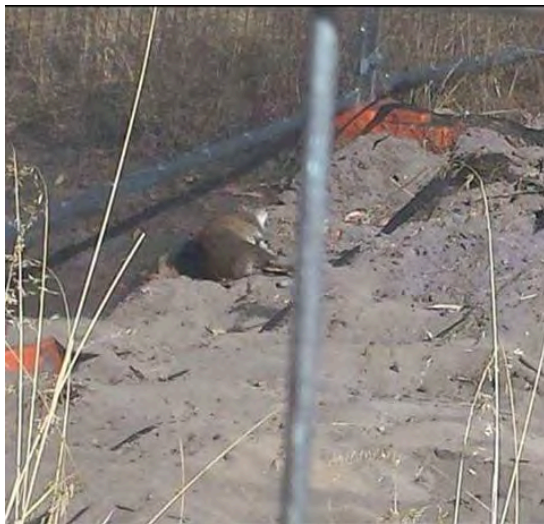
This picture of a dead bandicoot by netting covered with dirt and not dug in was taken on 17<sup>th</sup> January in the Progress Road site:

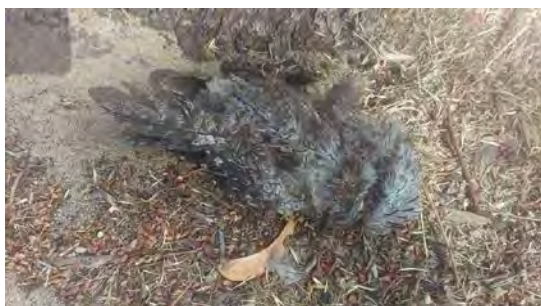
I have attached an excel file with details of some of the other dead bandicoots that have been found. I have reports of many more. In addition other species are being found dead such as this Tawny Frogmouth, pic 20<sup>th</sup> January:

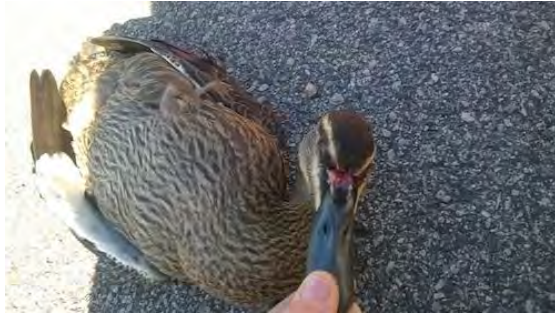
and this duck found yesterday morning, 23<sup>rd</sup> January, having flown into a temporary fence.

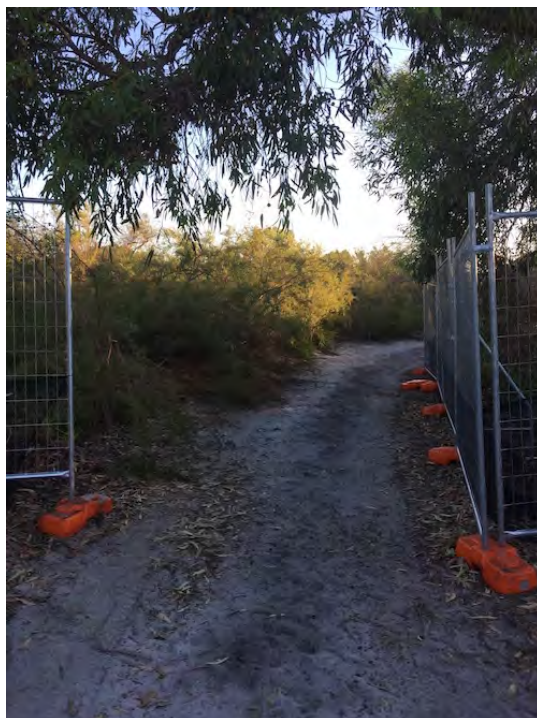
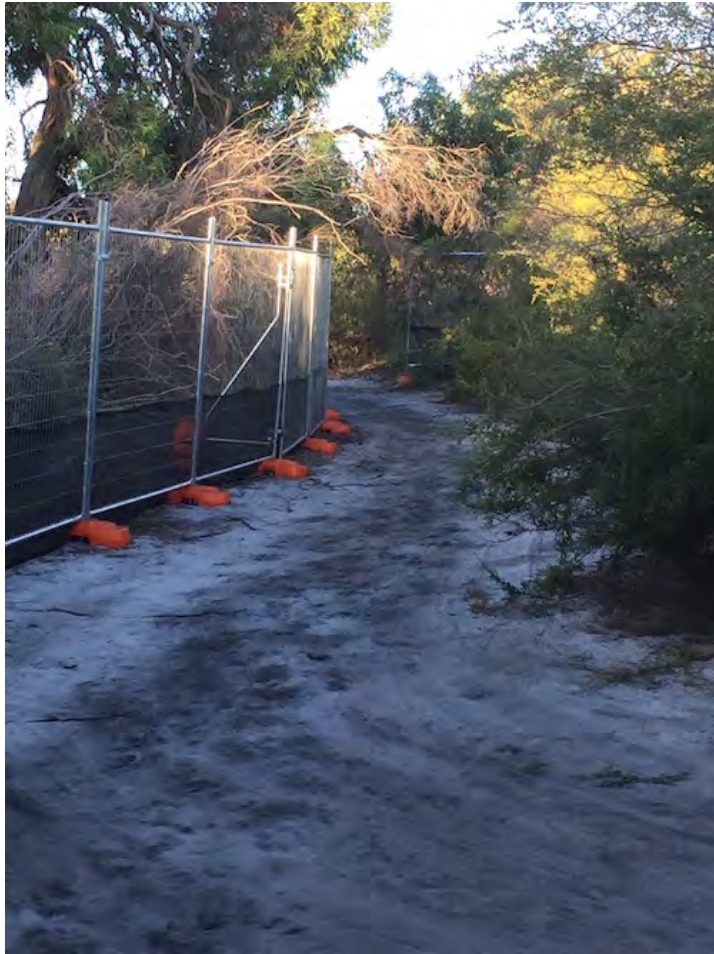
*I believe that trapping in the second section commenced on Monday 23rd January. The two photographs below were taken at the north west corner of section two, east of section one, at approximately 6.30pm yesterday evening, Tuesday 24th January, showing that the area being trapped is not fully enclosed in contravention of Table 7 of the Construction Environmental Management Plan, please see below.*

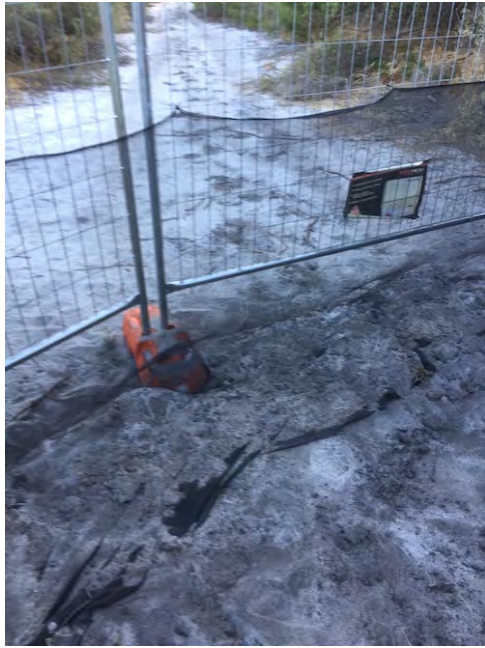
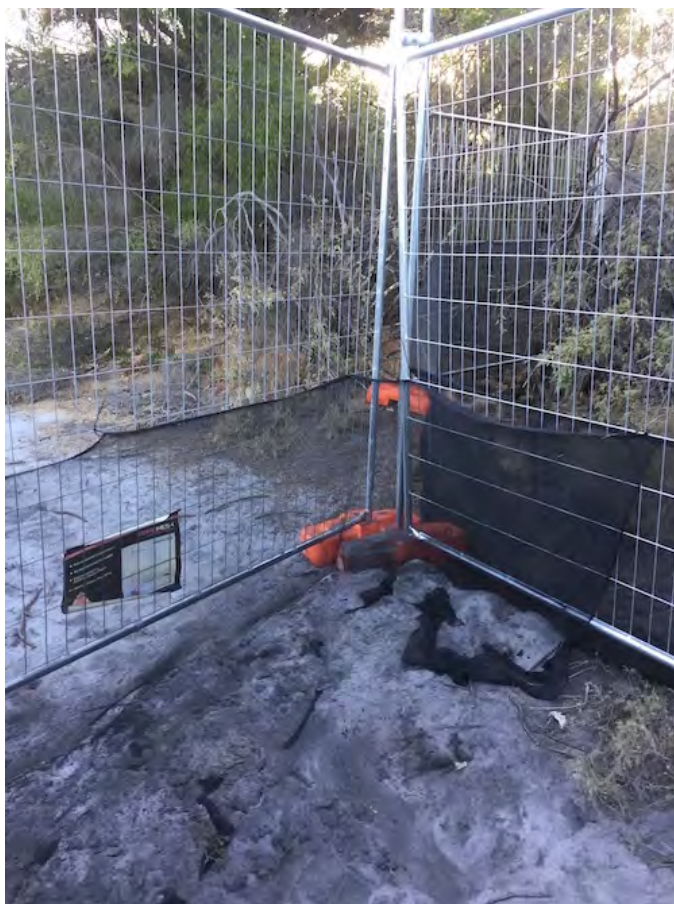
*The following two photographs, taken a few moments later on the south west corner of section two shows the edges of the fence netting is not dug into the ground again contravening table 7 of the Construction Environmental Management Plan which states:*

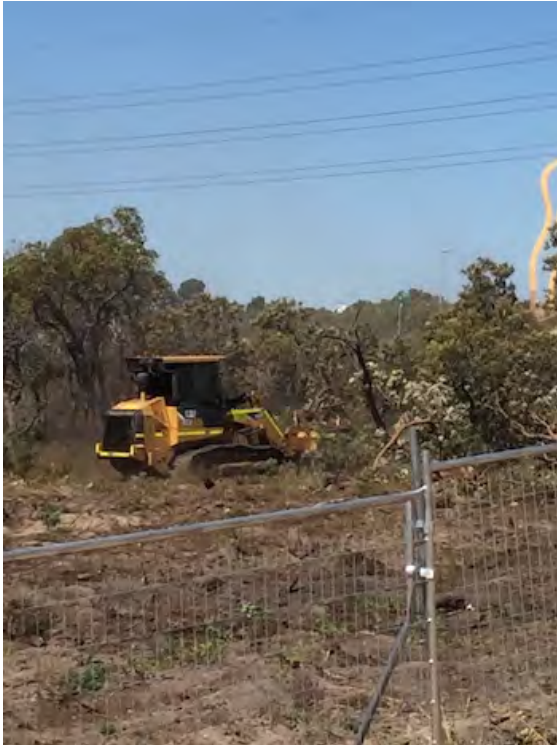
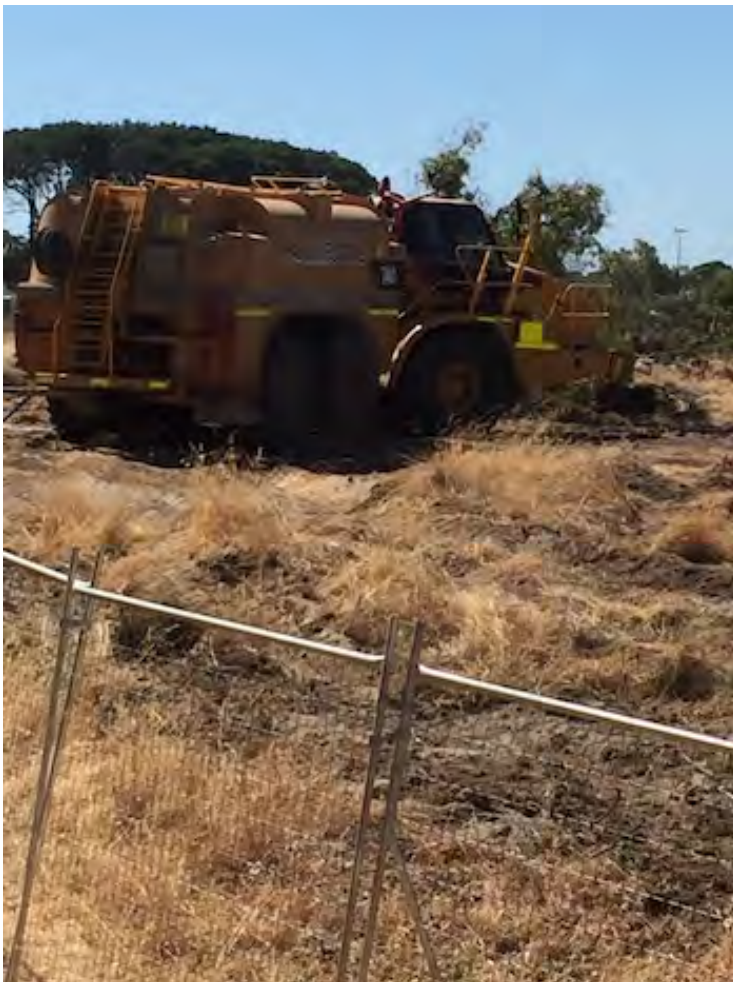
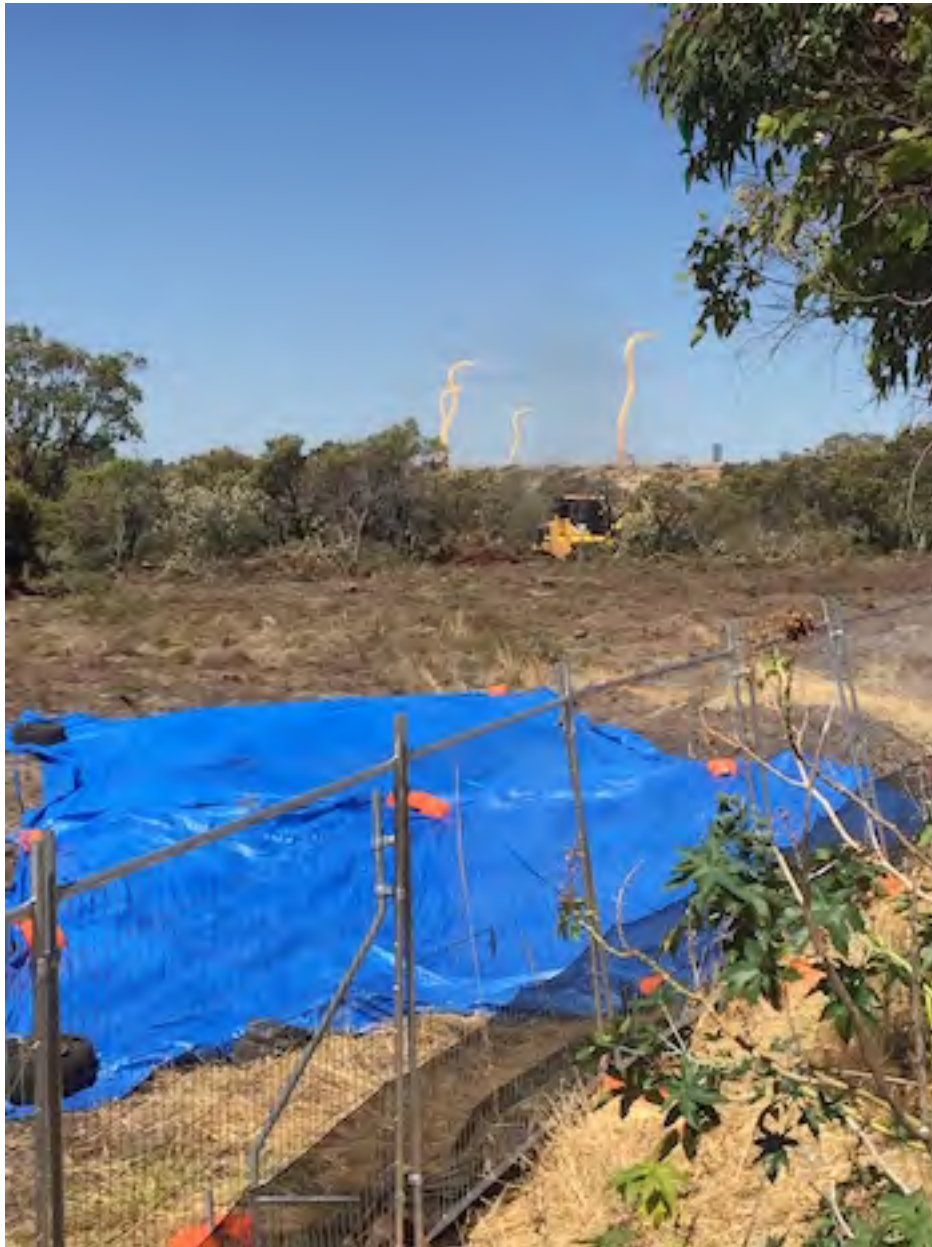
*In addition, at 3.30pm this afternoon, 25th January, I witnessed clearing at the east end of Hope Road at the site known as Gilchrist/Freeway. As can be seen from the photos below water suppression is not being used. Please see The Construction Environmental Management Plan, section 2, table 6. There is a water cart on site but it is not being utilised. In addition, the third photograph shows blue plastic covering what I presume to be asbestos or other contamination in an area that has already*

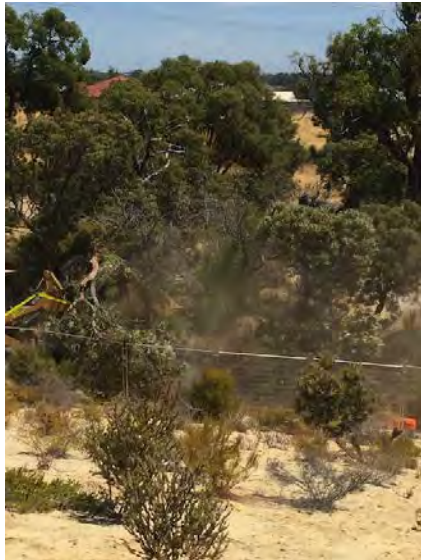
Clearing this morning was in the Gilchrist/Freeway site. While there was a water truck on site, its use was inadequate and the levels of dust constituted a health risk.

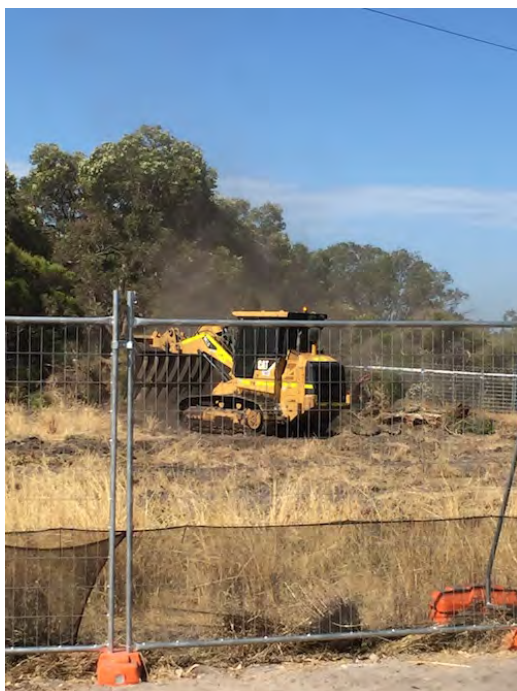
When clearing commenced in Stage 1 in the wetlands site, half the area was cleared before the water truck arrived.

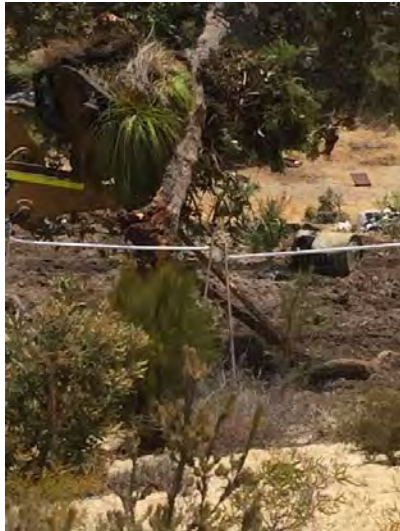
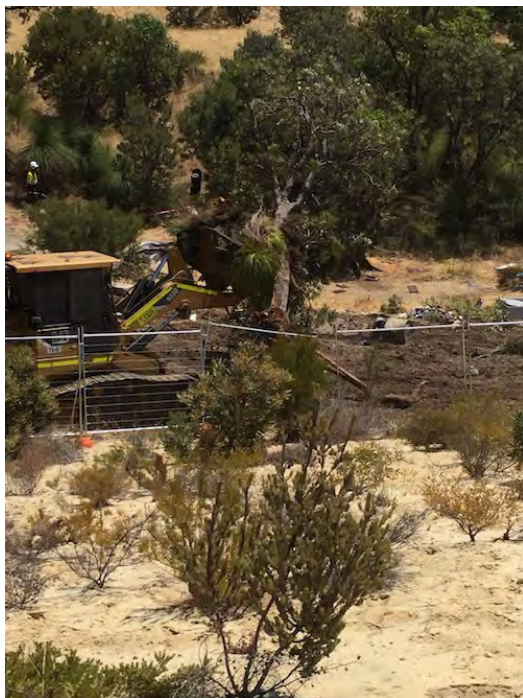
The bulldozer continued to clear as the barrel leaked unidentified liquid:

1. Cease work and notify site supervisor.
2. Investigate cause.
3. Contain site of potential contamination (e.g. bunding) to prevent any spread of contaminants and fence to prevent any unauthorised access until status of the material has been confirmed and corrective actions implemented (if required).
4. Sample and analyse material to confirm contamination status of material and remediation requirements.
5. If contamination confirmed, report to DER.
6. Develop and implement Remediation Action Plan if required on advice from DER.
7. Work will commence once the status of the material has been confirmed and corrective actions implemented (if required).

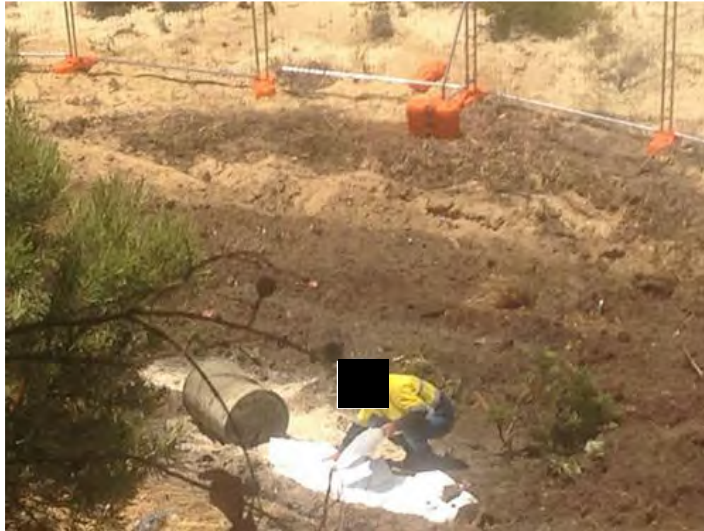
It was not until the bulldozer had cleared that area that any attempt was made to deal with the potential contaminant:

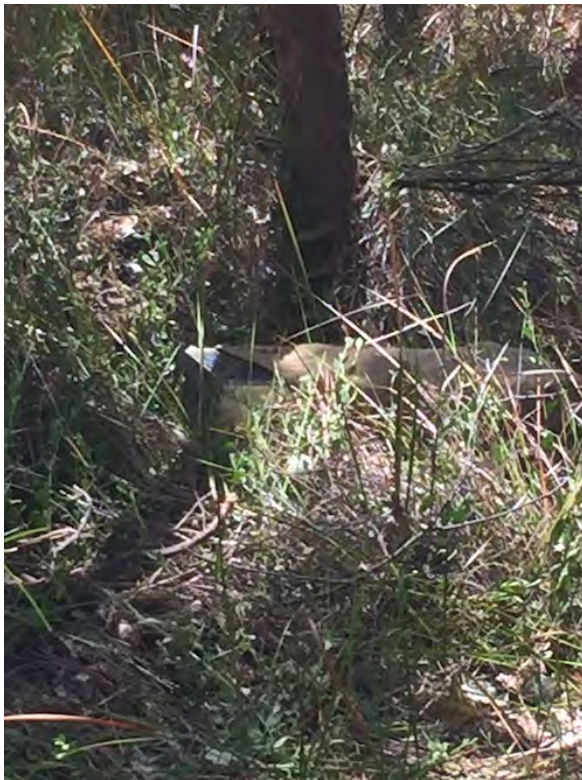
The first photograph was taken at 11.30am this morning and shows an open bandicoot trap. Due to the construction fencing it was difficult to take a picture from an angle that shows the front of the trap but I had two friends with me and all of us could clearly see that the trap was open. The temperature today is forecast to reach a high of 39°C. I draw your attention to Table 7 of the Plan which states that:

□ in hot weather (i.e. above 30°C and/or for consecutive days) traps will be closed after checking and reopened in the late afternoon to avoid captures in the heat of the day which can result in mortality

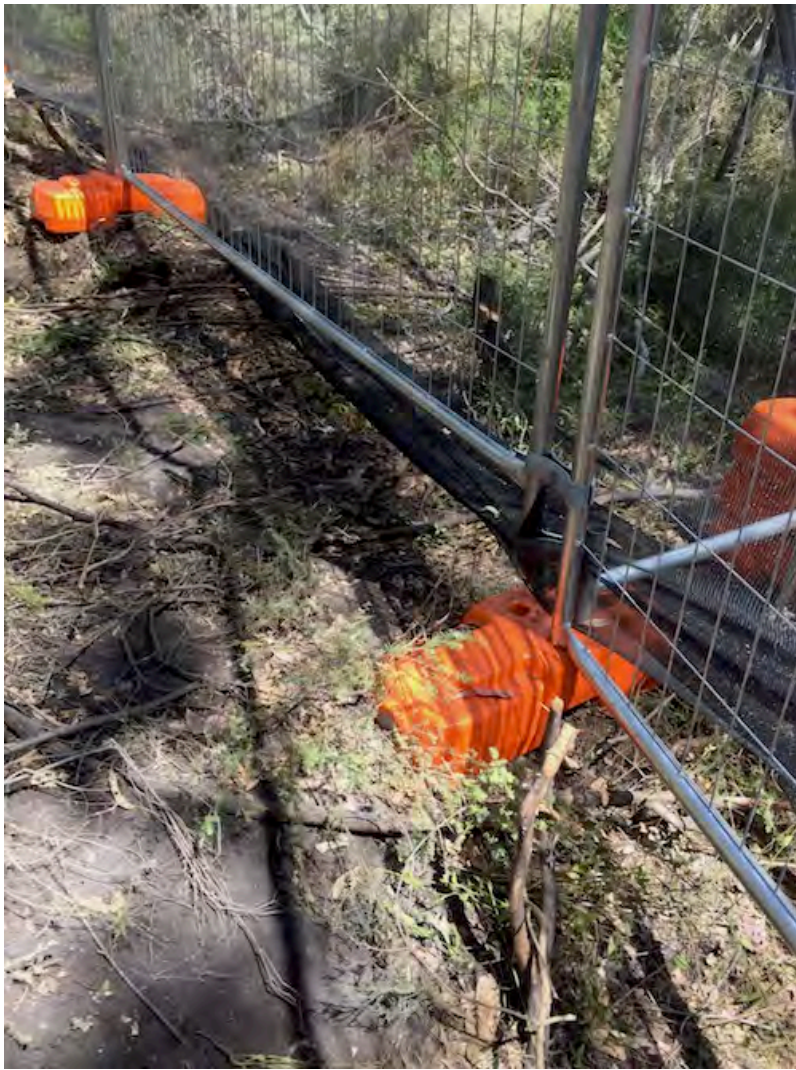
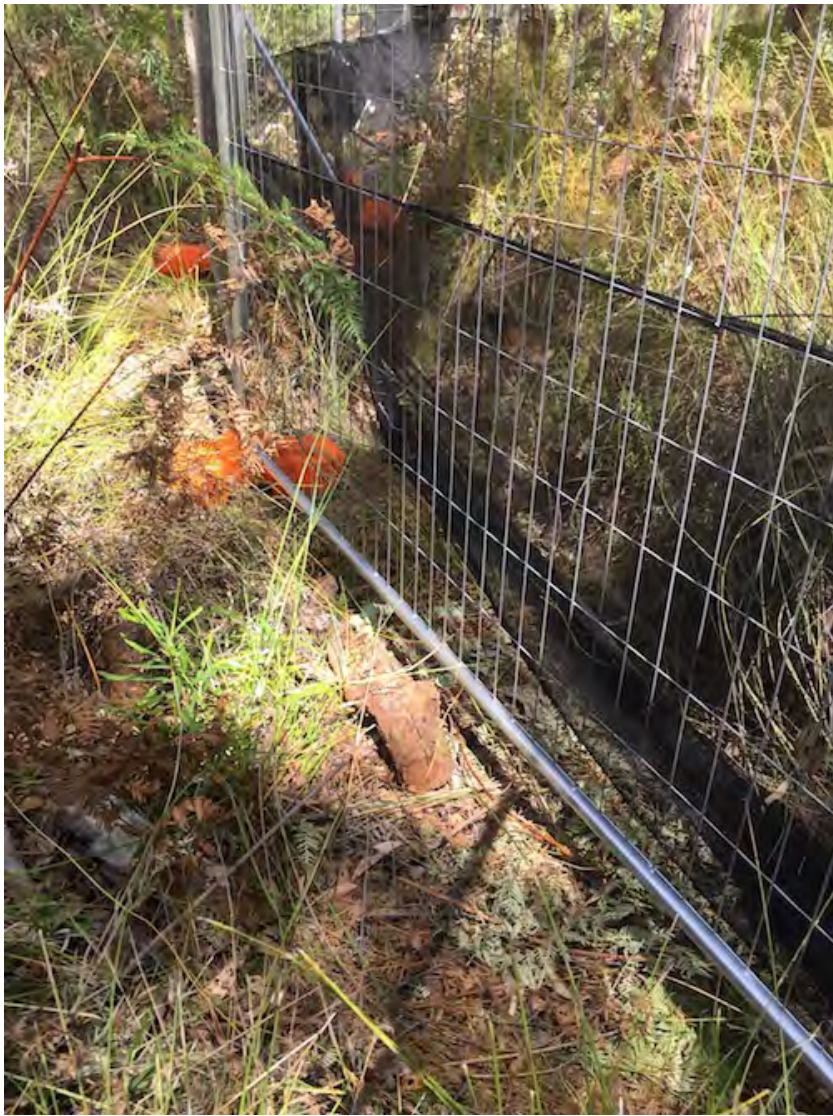
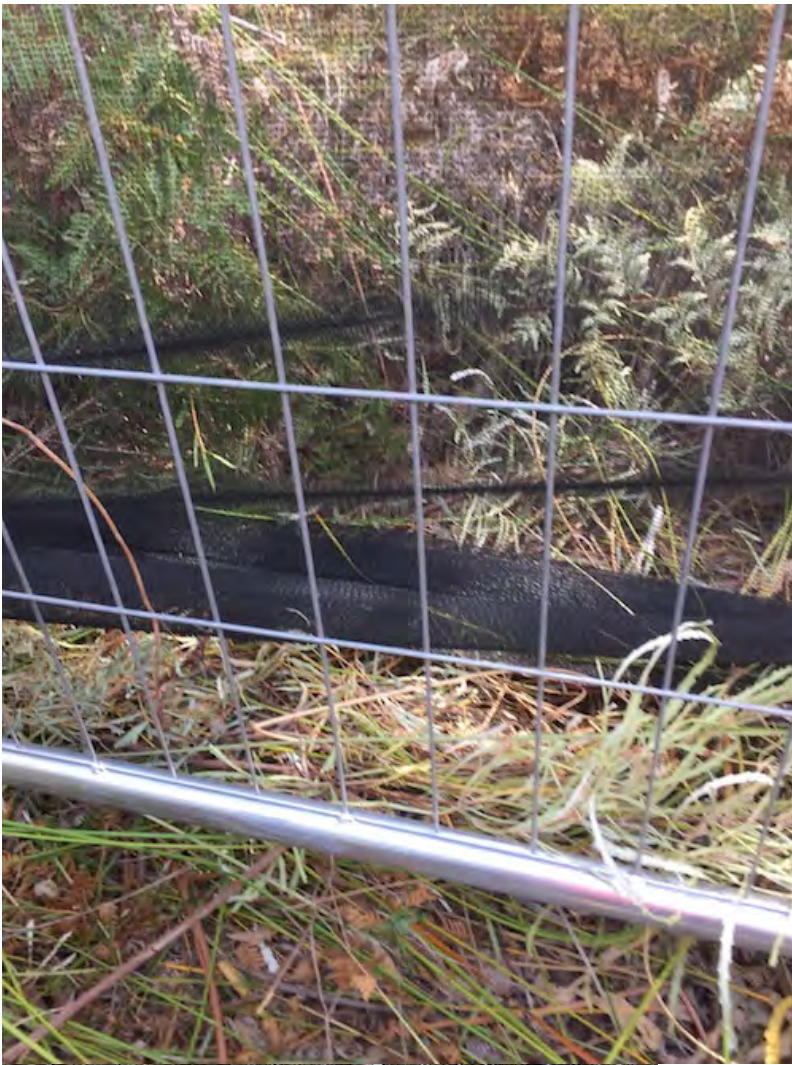
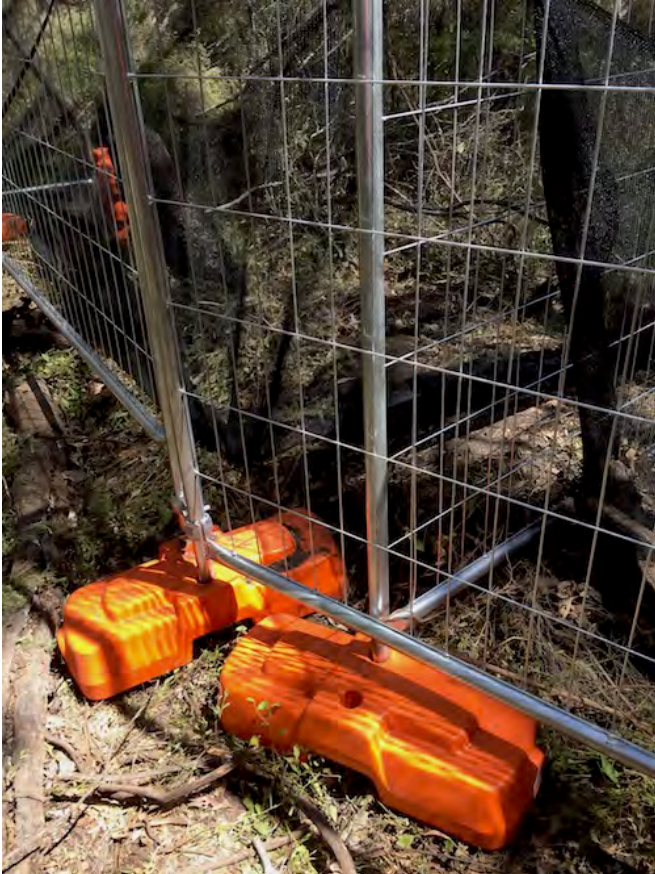
The following photographs, also taken this morning, show fencing in the southern section of Stages 4 and 5. No attempt has been made to dig the netting into the ground at any point along this section. Table 7 of the plan states:

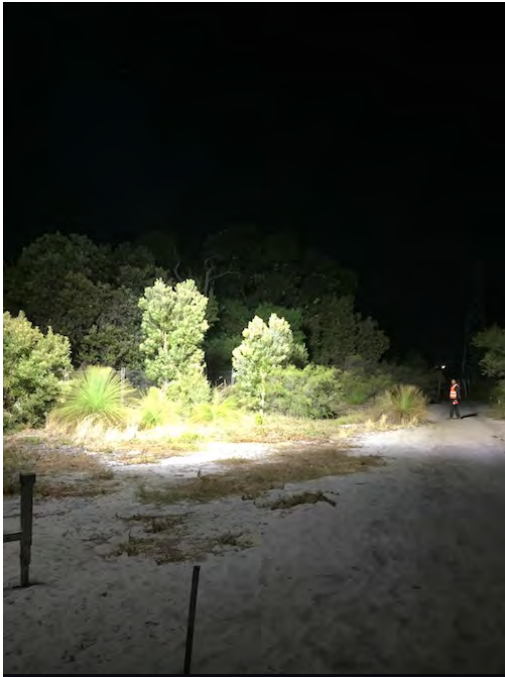
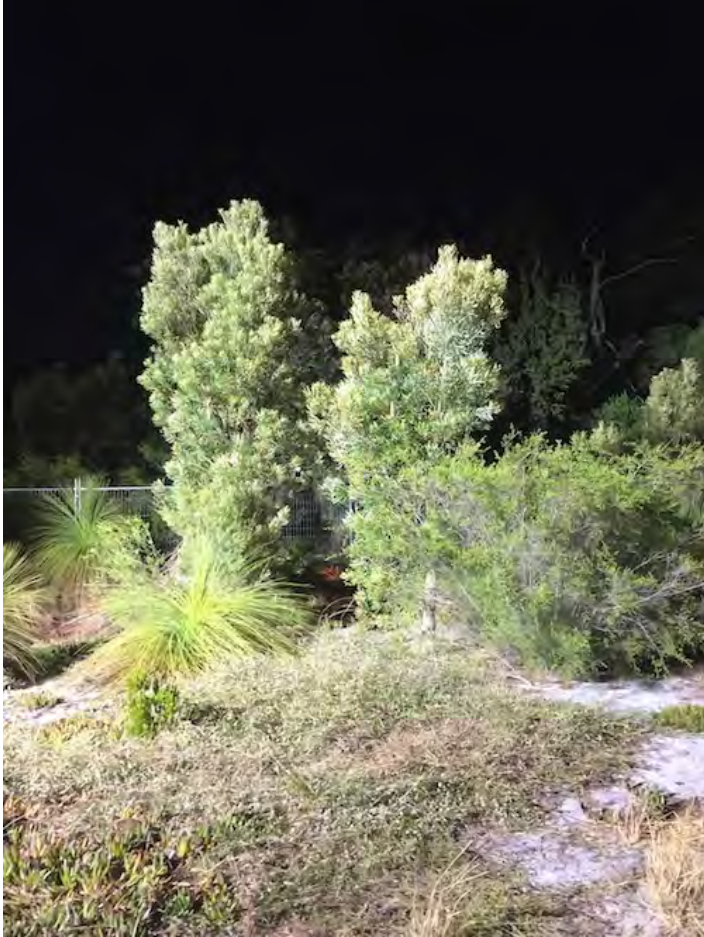
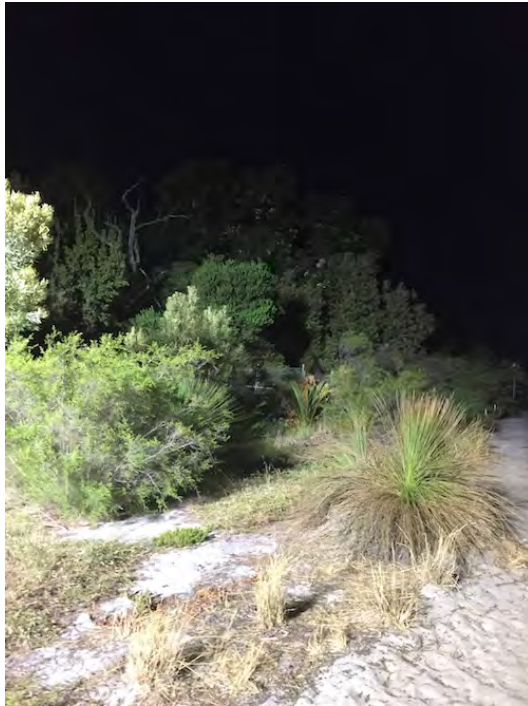
Whilst it was a relief to see that additional bandicoot traps have been set in Stage 6 of the wetlands site, particularly in the area I highlighted in my email last night, Sunday 5th February, it is still alarming that there are floodlights operating in this area all night. The following three photographs were taken at 5am this morning. One of the three trapping areas in the stage is directly behind the illuminated trees. In addition there are security guards stationed very close to this trapping area and to the trapping area in the south west corner of Stage 6.

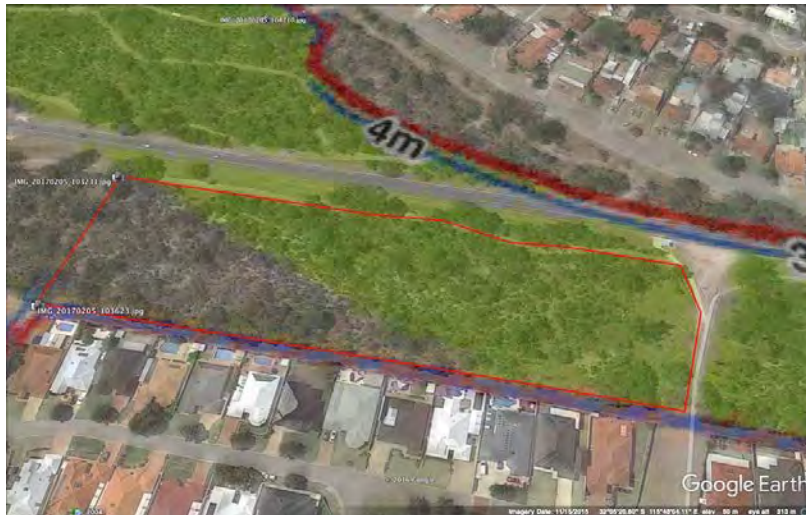
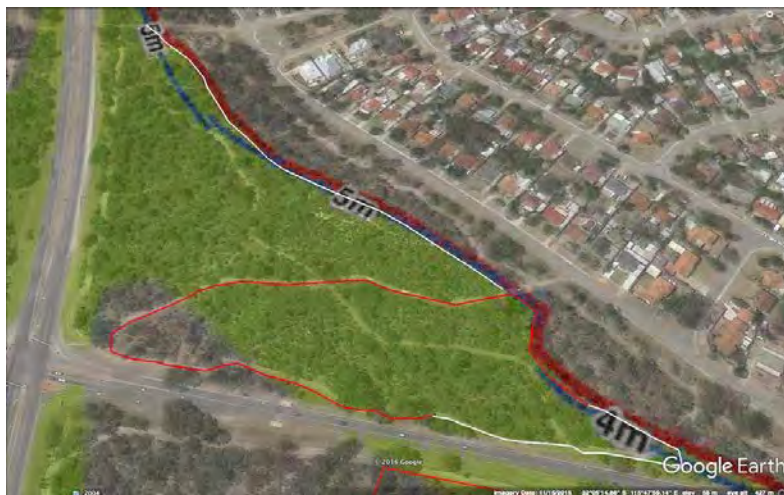
I would also like to draw your attention to the areas currently being fenced in the west. The following two images show the designated areas for clearing of native vegetation highlighted in green, taken from the Project Infrastructure Plan and overlaid onto Google Earth. The thin red line on both maps shows the construction fence that has been erected in the past week. This is accurate as it has been pin-pointed by GPS.

The white line in the second image is where the fence will be continued - orange fence footings have already been laid out.

The fence, marked by the thin red line, clearly includes areas that are not designated for clearing as the fence line includes areas that are not highlighted in green. The fencing does however correspond with the map of the Project Development Envelope, also contained in the Infrastructure Plan. Is it possible that the construction company is using the wrong map for reference when setting the fences?

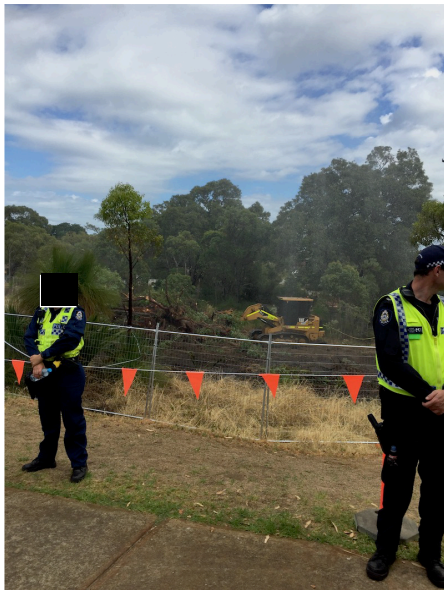
As I mentioned on the telephone the water truck did not arrive on site yesterday (Thursday 9th February) until two and a half hours after clearing commenced. Whilst there was light rain at the time this was not sufficient to dampen the soil. When S1 and S2 of the west end section were cleared on Tuesday 7th February the water truck was only on site intermittently. Please see Table 6 of the Construction EMP for Dust Management Actions. The photo shows dust rising in a residential area during clearing of S1, west end, with no water truck on site.

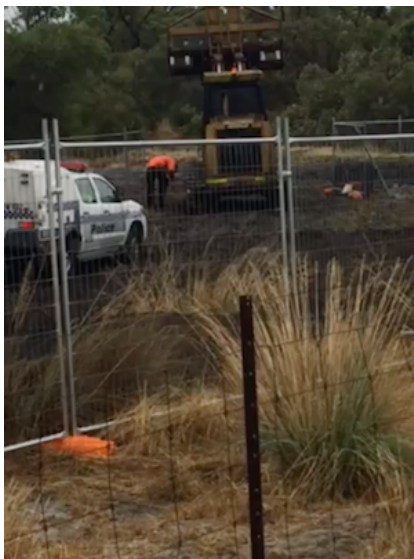
In addition, as we discussed yesterday, the bulldozer was given a cursory clean with a spade whilst still inside Stage 6, an uninterpretable dieback area, in the wetlands.

Inspect vehicles and machinery prior to entry/exit into the site and prior to exit from infested, unmappable and uninterpretable areas that may contain dieback to ensure it is free from soil/organic material.
