ROE HIGHWAY EXTENSION – Ministerial Statement 1008, EPBC Act Referral  
2009/5031 – Request to halt or 'stop the work until issues raised are resolved.

I am writing to you as a concerned local resident about breaches of compliance with the Fauna Management Plan and the Construction Environmental Management Plan by the Building Roe 8 contractors.

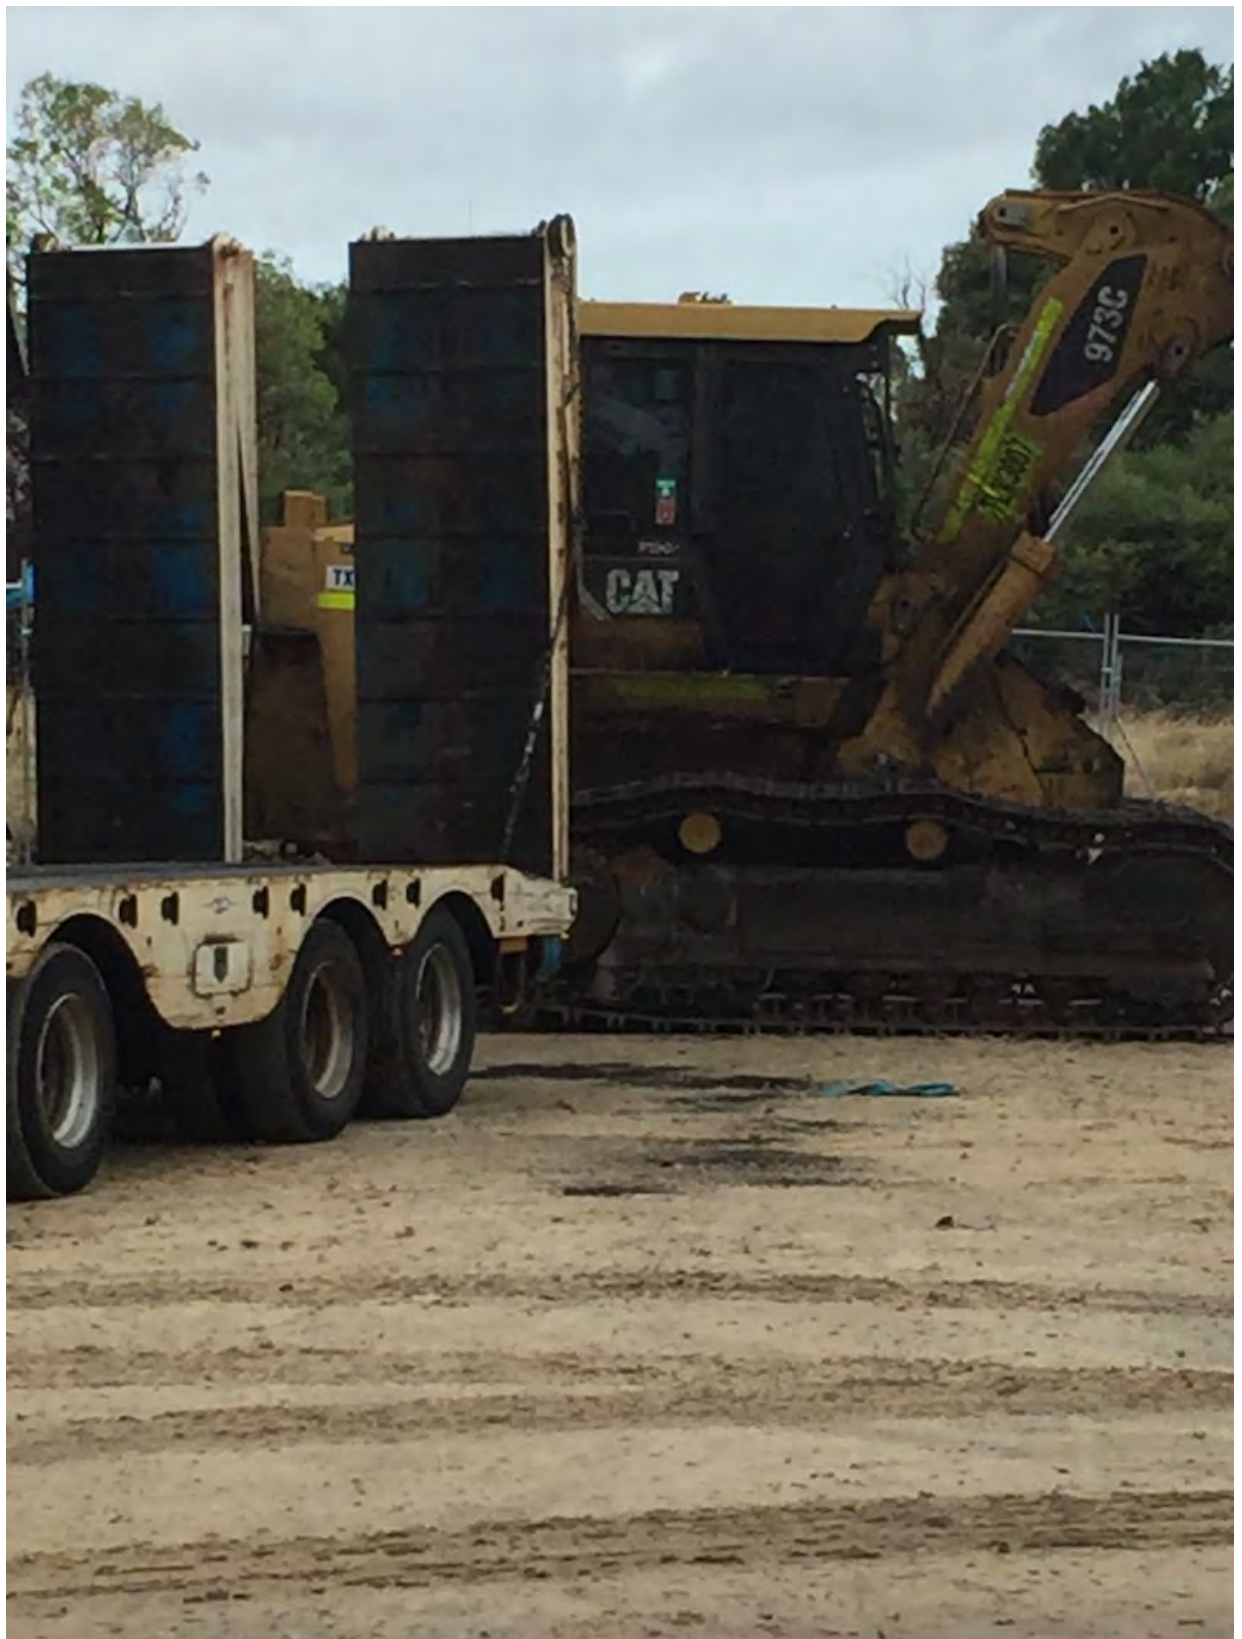
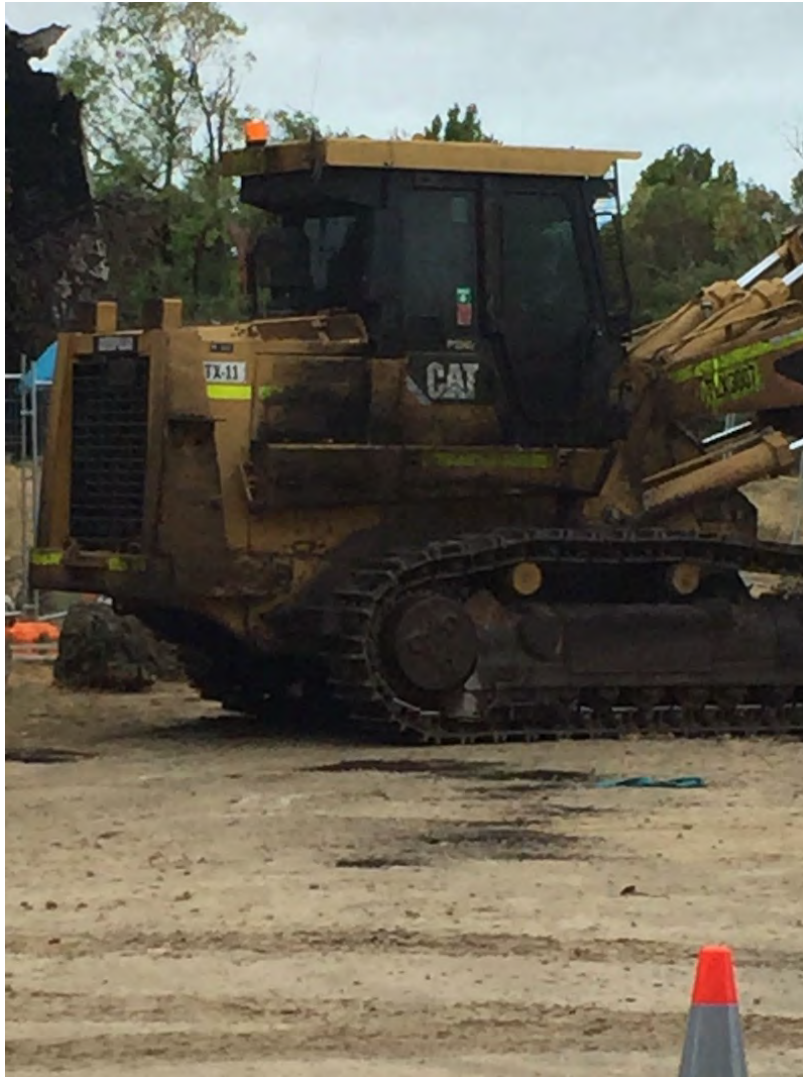
It was then put on a truck and transported to the west end. It was unloaded at the intersection of S3 and S4. You can clearly see that the cleaning whilst still in the wetlands area was superficial at best.

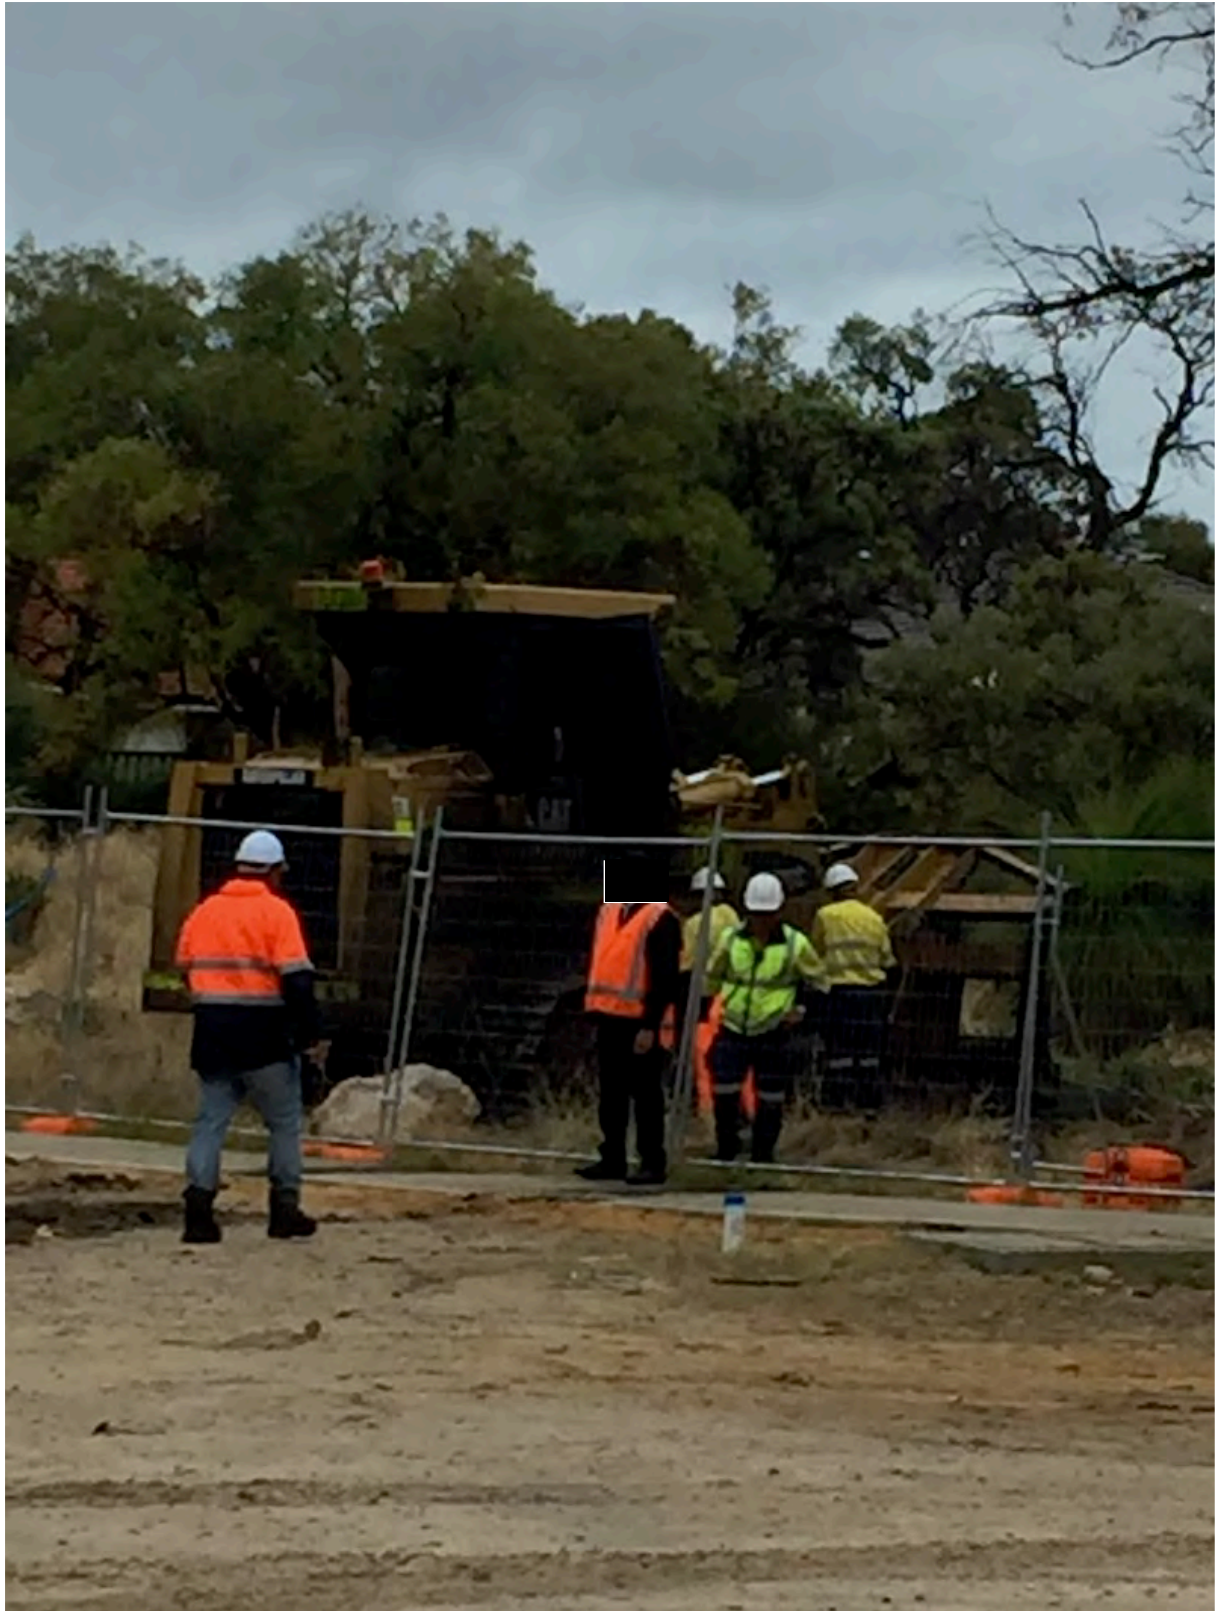
The bulldozer then commenced clearing - with soil from S6 wetlands still on the underside.

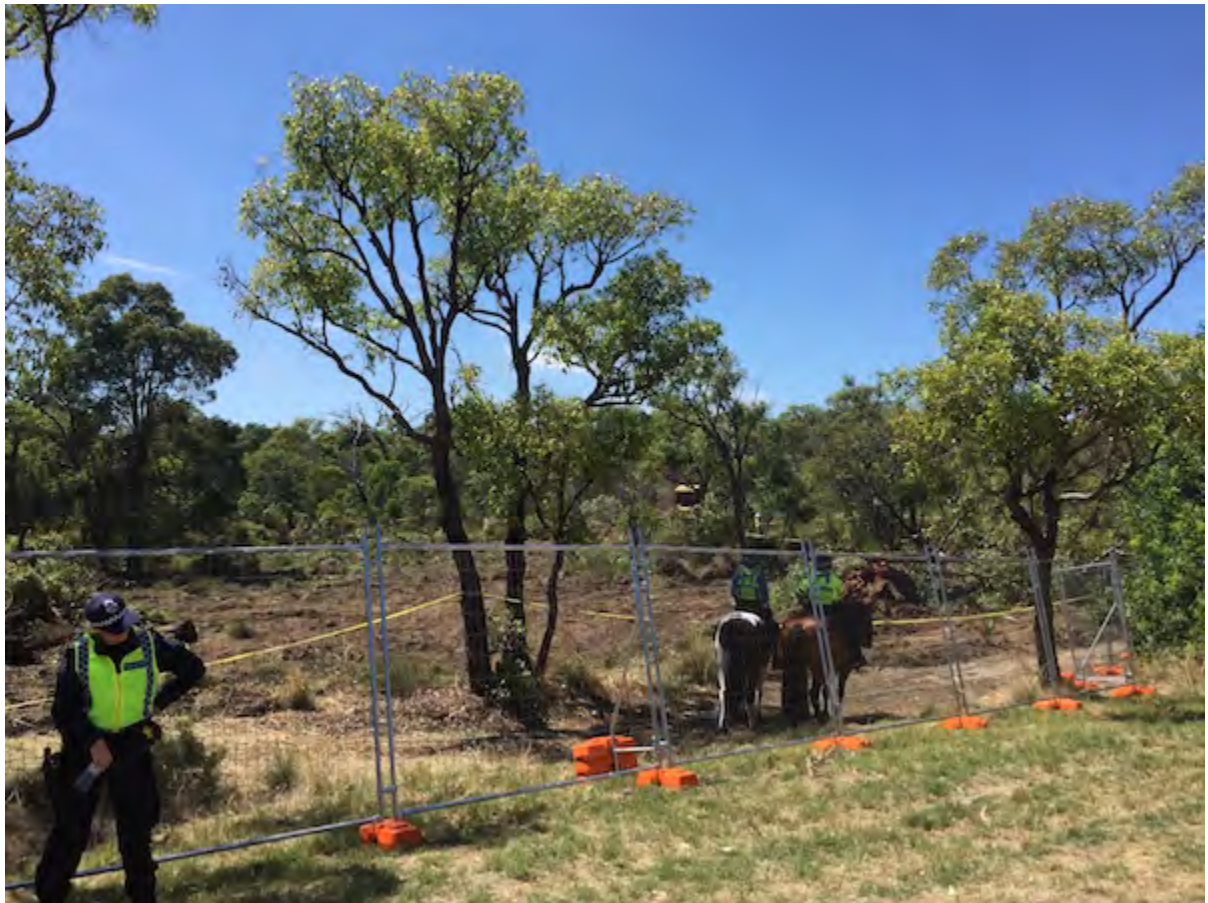
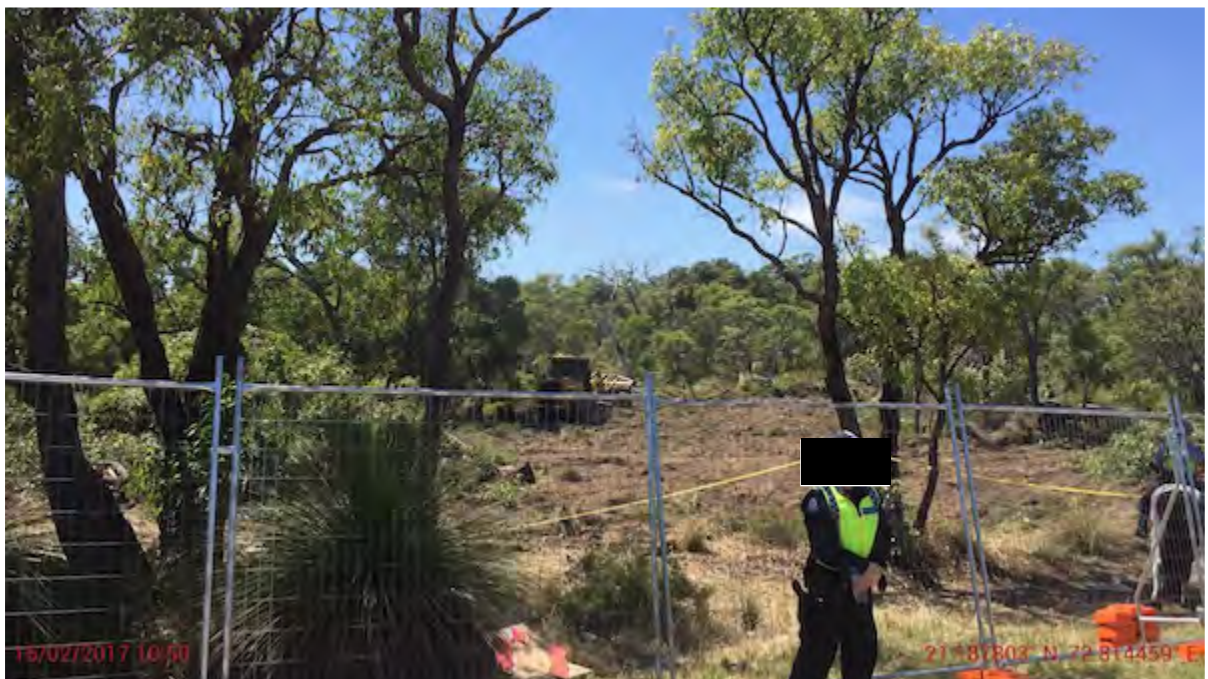
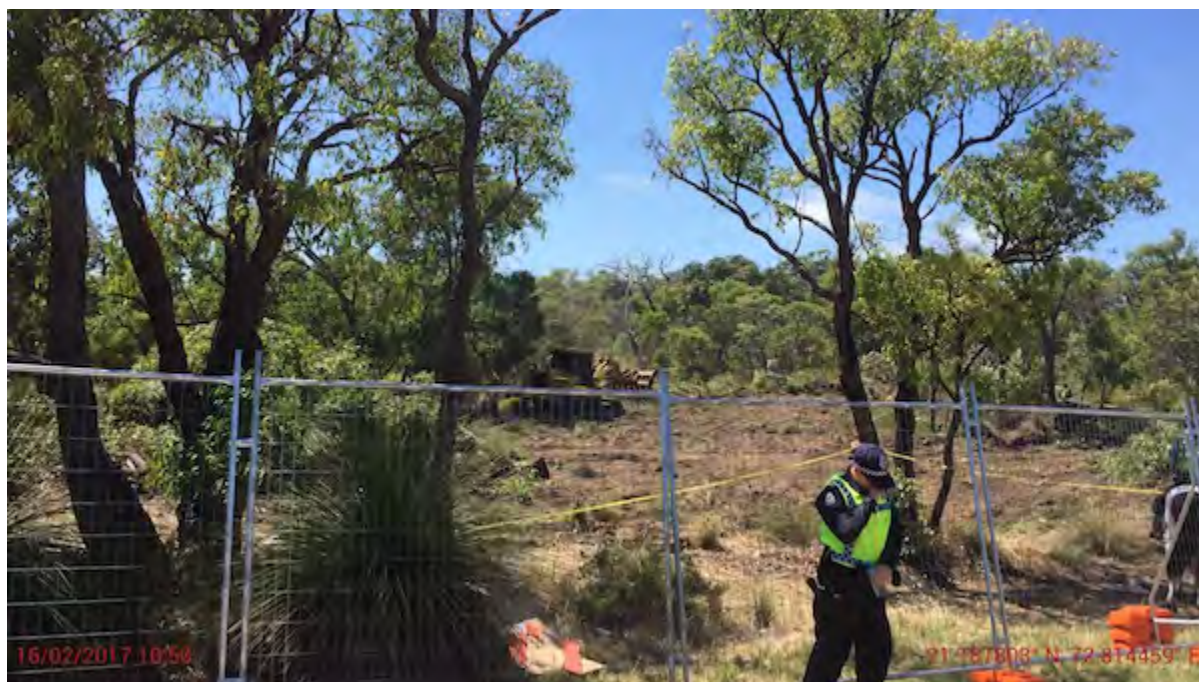
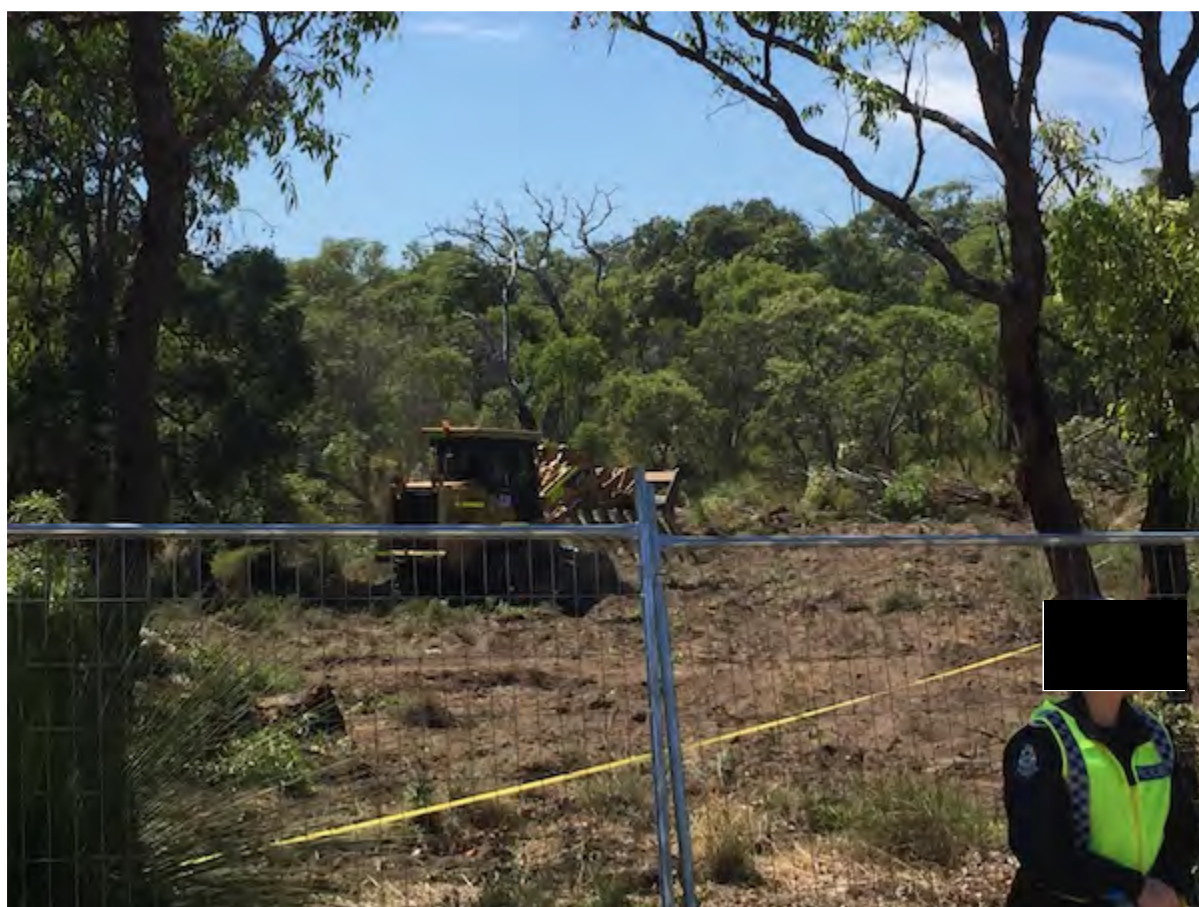
The following four photographs show clearing with no dust suppression at around 10.50am this morning.

The Construction Environmental Management Plan states, section 2, table 6, that "Water carts are to be operational at all times in dry and windy conditions (October to April)" and to "commence dust suppression immediately on visual evidence of dust lift".

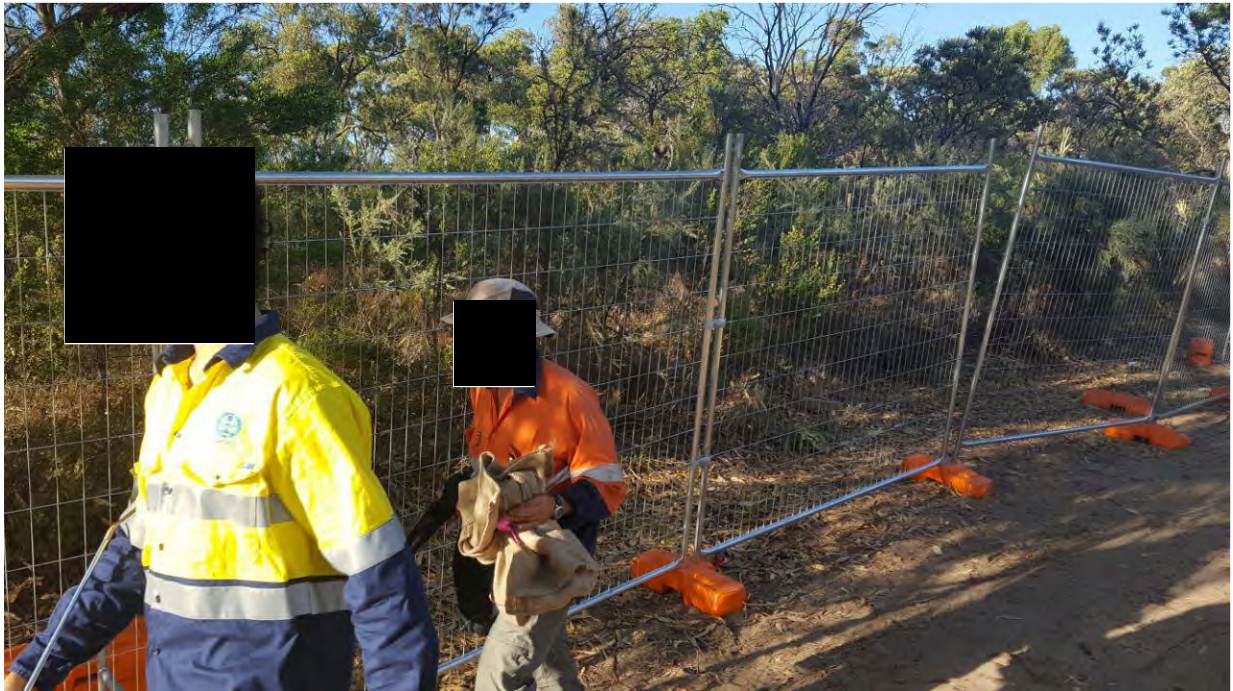
The next photograph shows trappers leaving Section 7 at 7.15am this morning with trapped bandicoots. This was the second night of trapping in this section. Following the presentation of this evidence that southern brown bandicoots have been trapped in S7 this morning, Thursday 16th February, protocols laid out in Table 7 of the Fauna management Plan for the completion of a successful trapping program have not been achieved and clearing in this area cannot be carried out before two clear nights have been achieved.

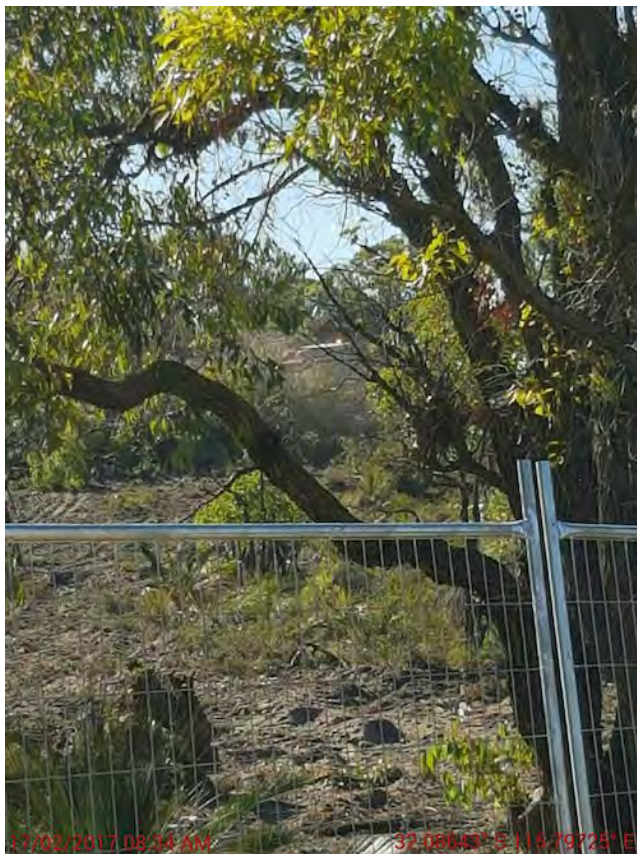
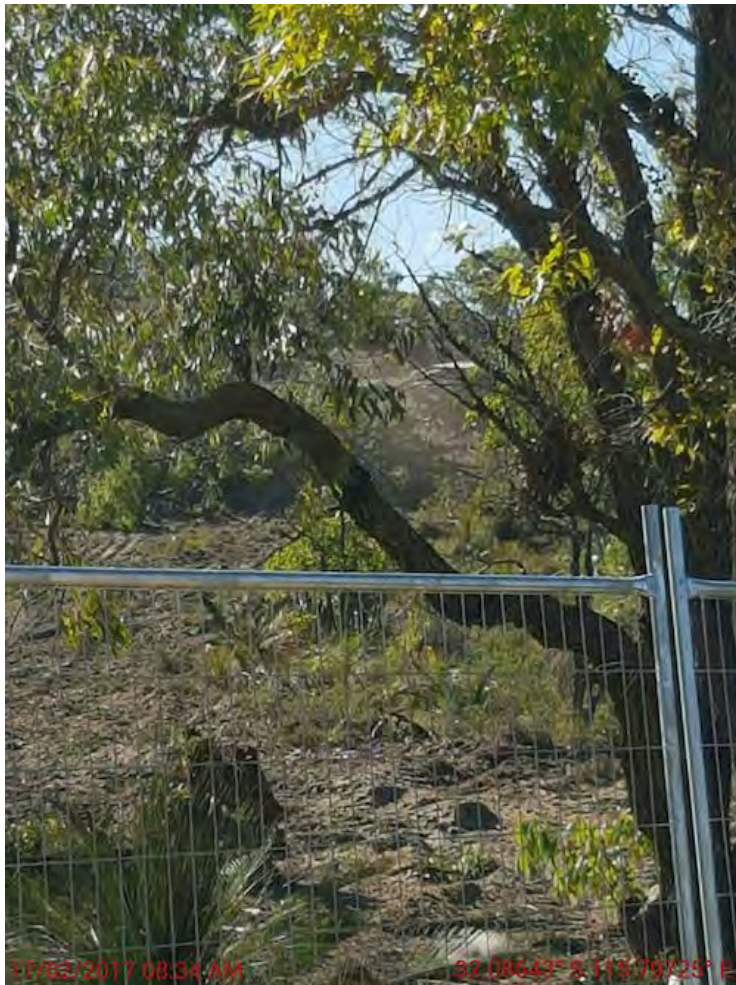
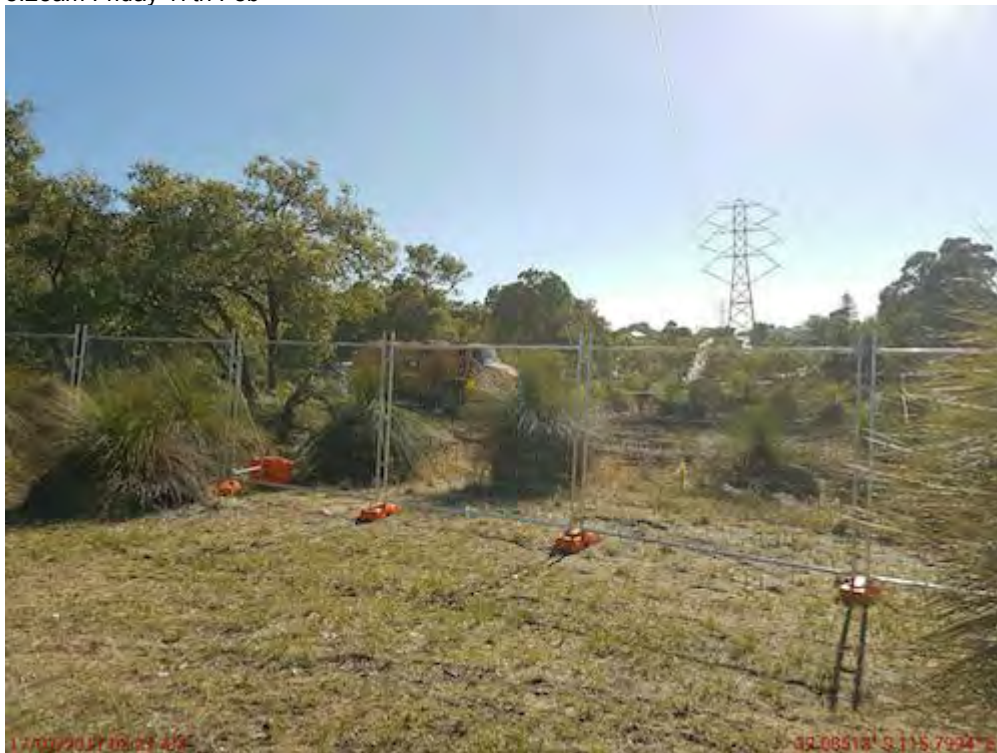
The Construction Environmental Management Plan states, section 2, table 6, that "Water carts are to be operational at all times in dry and windy conditions (October to April)" and to "commence dust suppression immediately on visual evidence of dust lift".

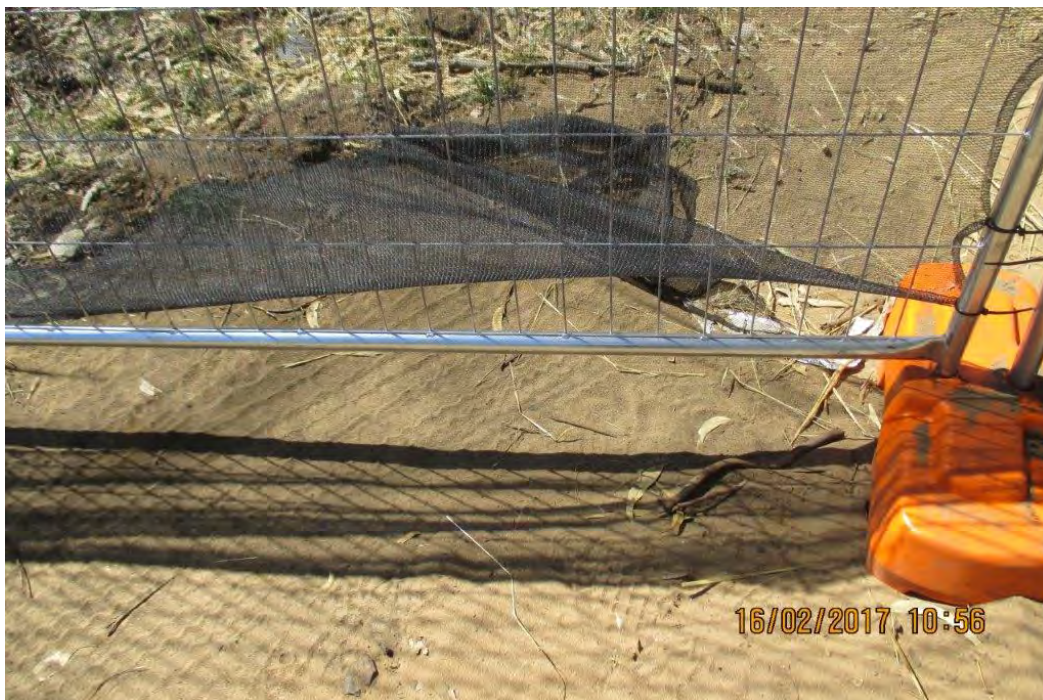
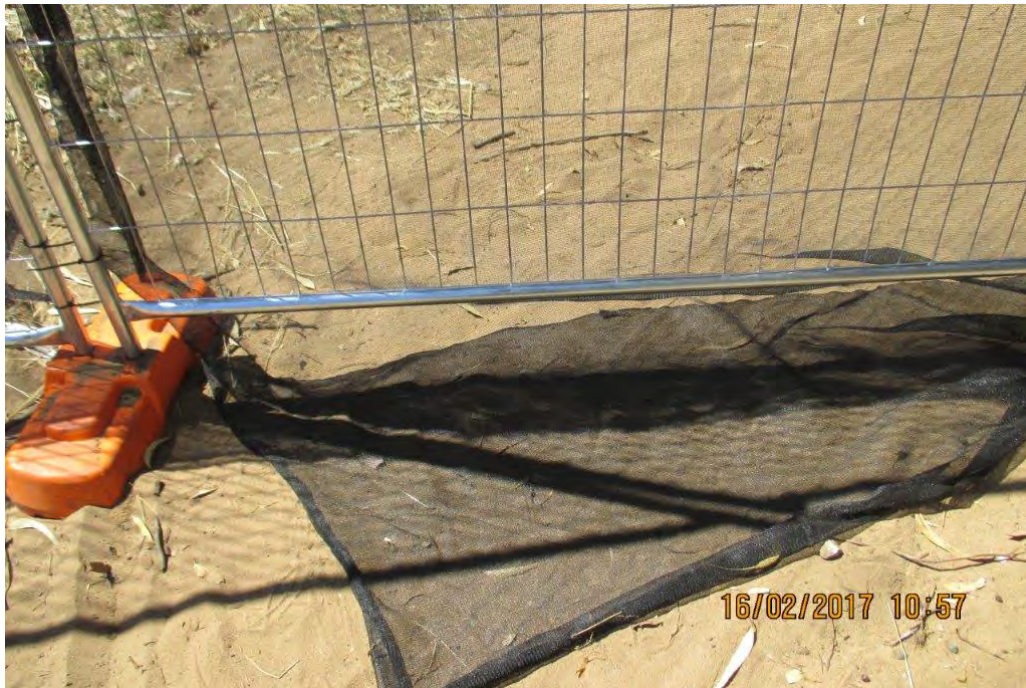
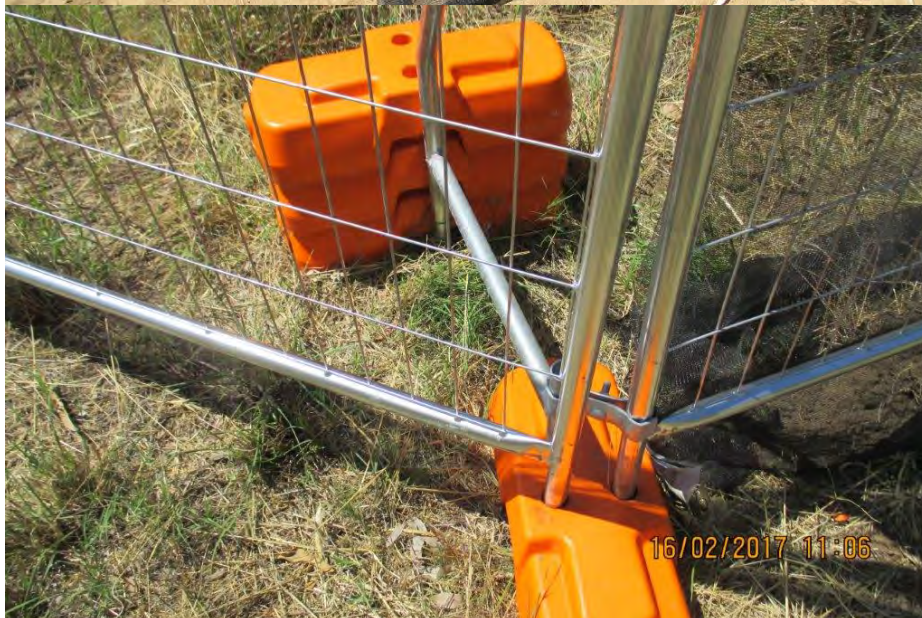
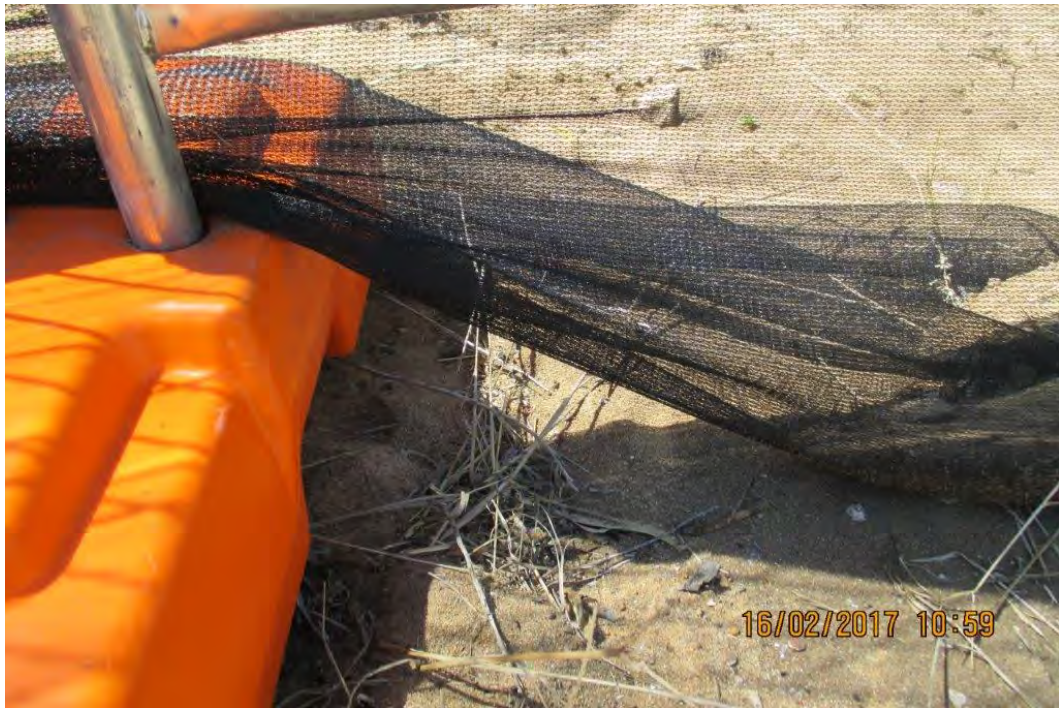
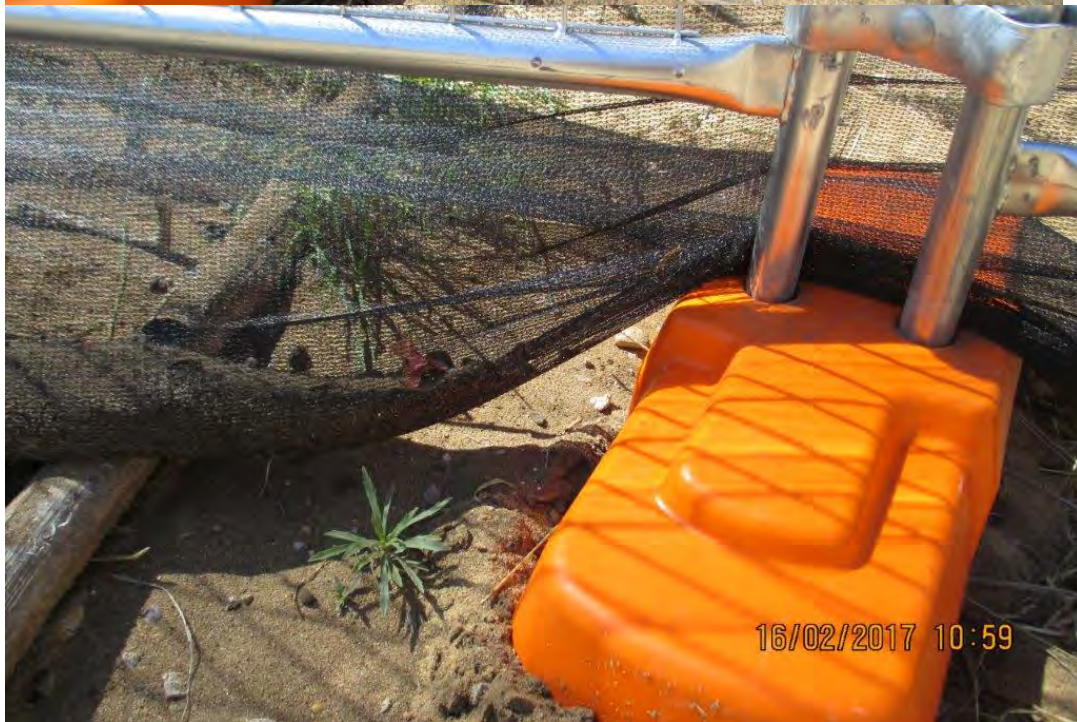
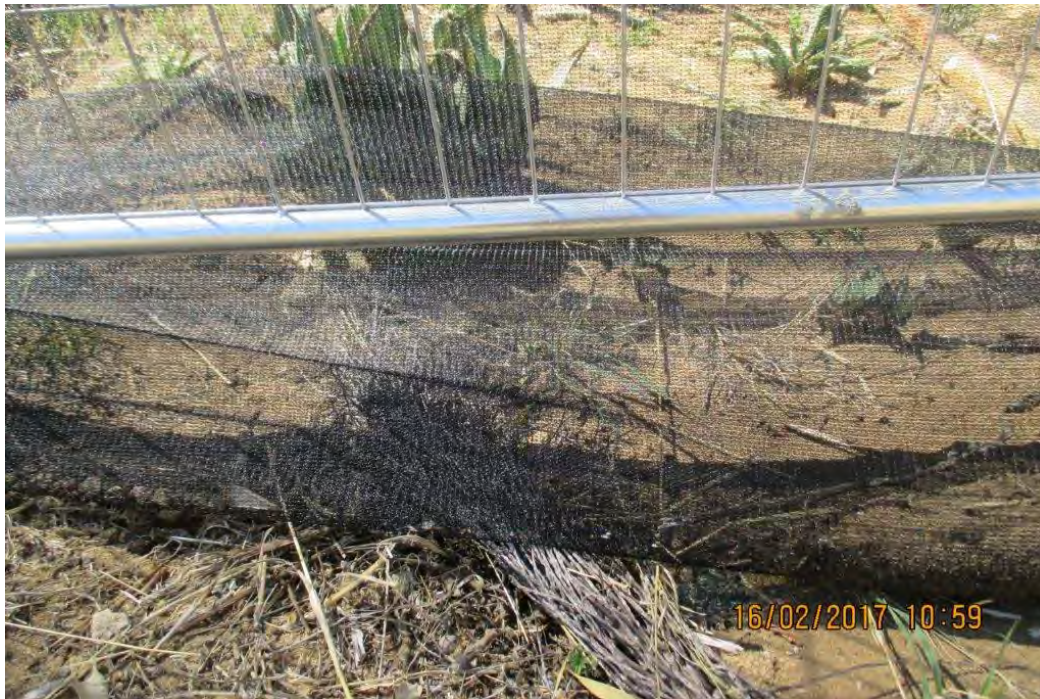
The following seven photographs were taken this morning of the fencing of section seven. They show fencing without netting, inadequately placed netting, and gaps in the netting around fence footings. There is no netting along the section adjacent to Stock Road.

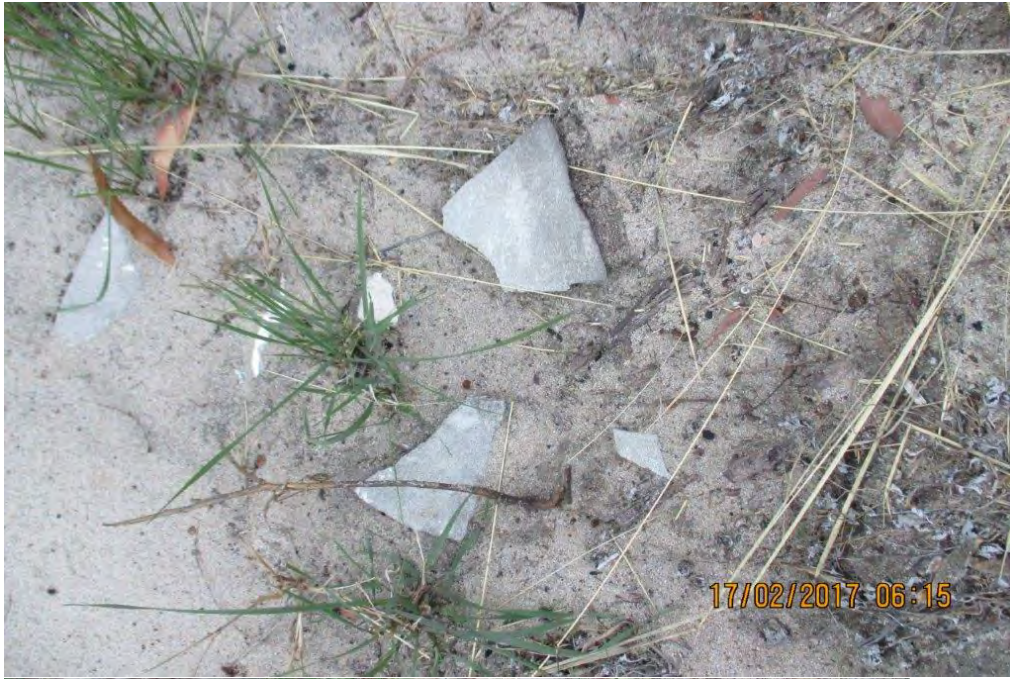
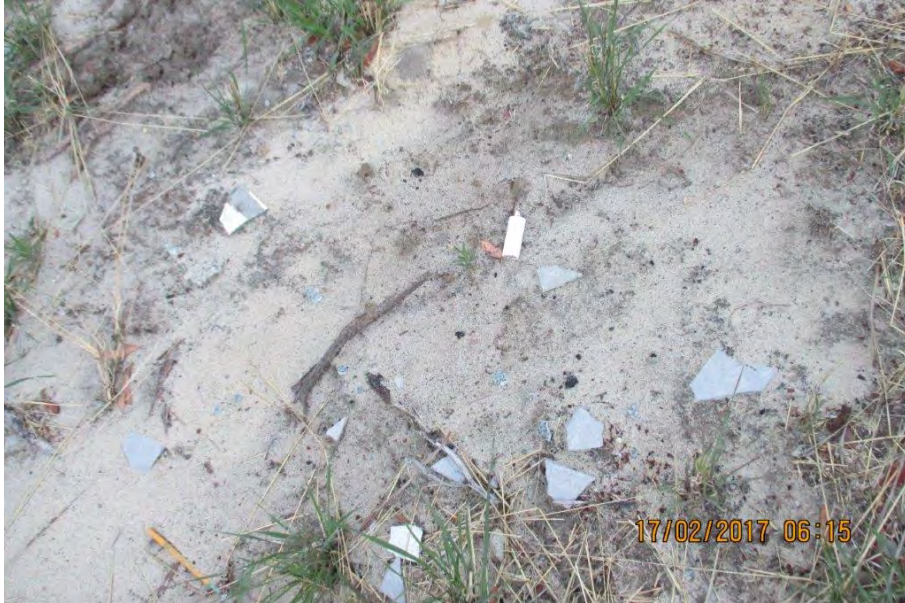
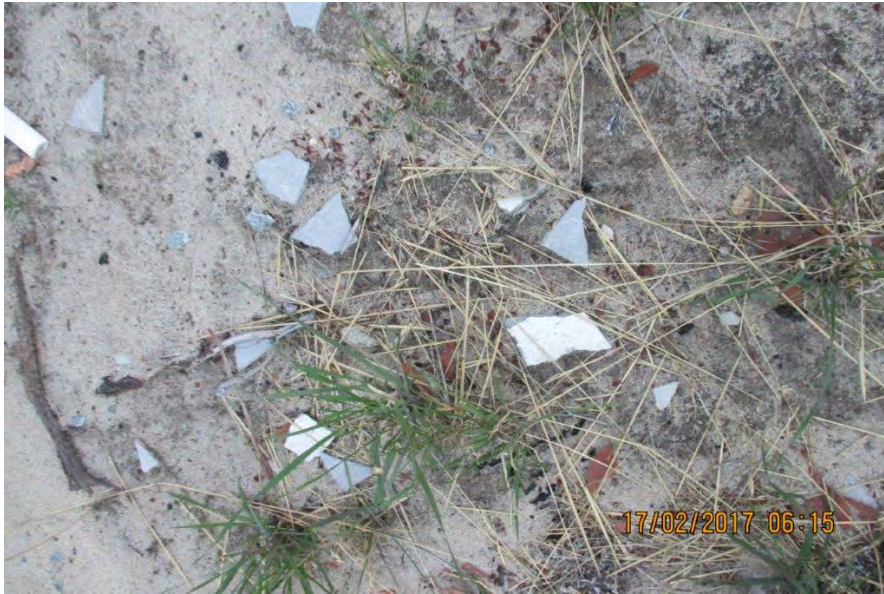
The final three photographs were taken this morning and show broken asbestos on the ground within section 7.

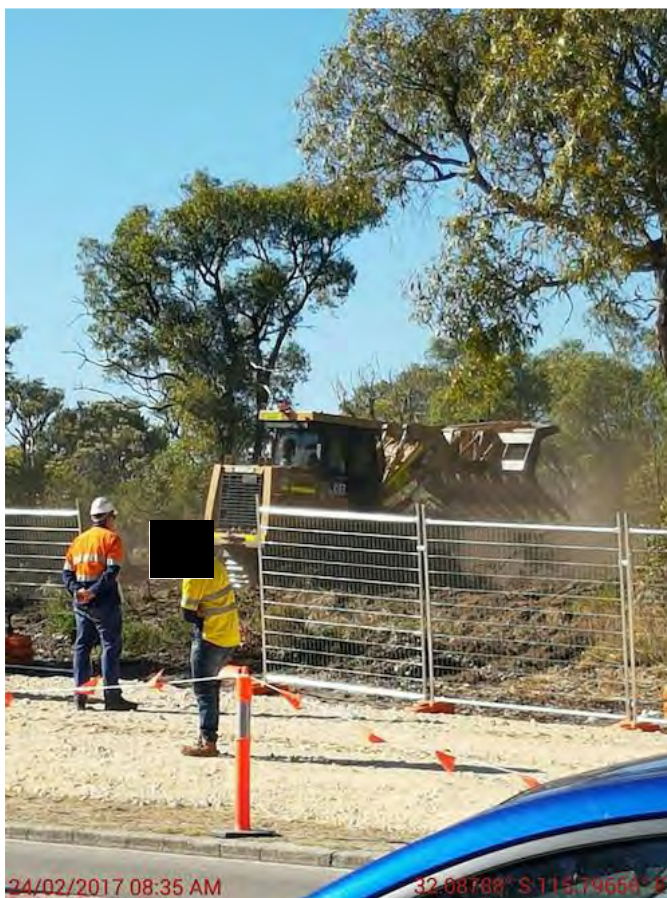
Image 6: Dust at 8.35am Friday 24th February

Clearing almost immediately commenced without a water truck on site for around 90 minutes. When the water truck eventually arrived dust suppressing was ineffectual. The Construction Environmental Management Plan states, section 2, table 6, that “Water carts are to be operational at all times in dry and windy conditions (October to April)” and to “commence dust suppression immediately on visual evidence of dust lift”.

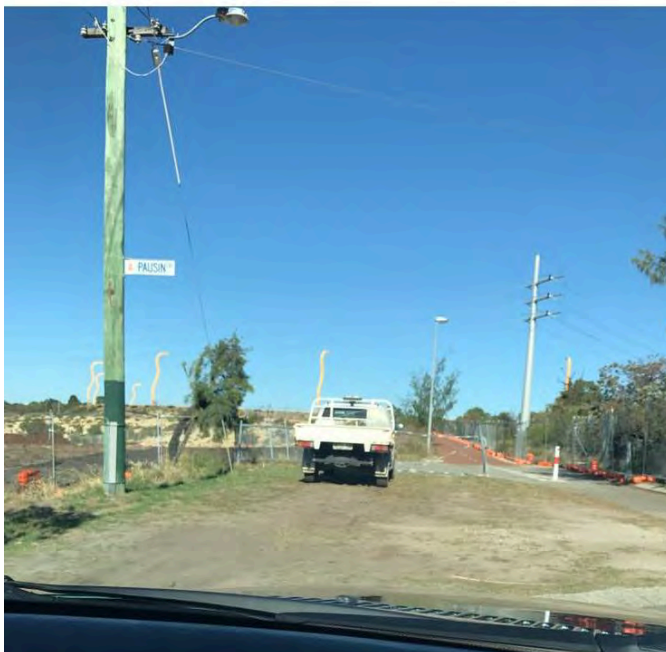
Image 10: Trappers' ute at Tetlow, 4.38pm Friday 24th Feb.

The temperature on Friday 24th Feb reached 36.5°C. It remained at over 30°C until early evening. The following photograph shows the trappers' ute at the Tetlow site at 4.38pm on Friday 24th February when the trappers arrived to open the traps. The temperature was @ 35°C at that time.

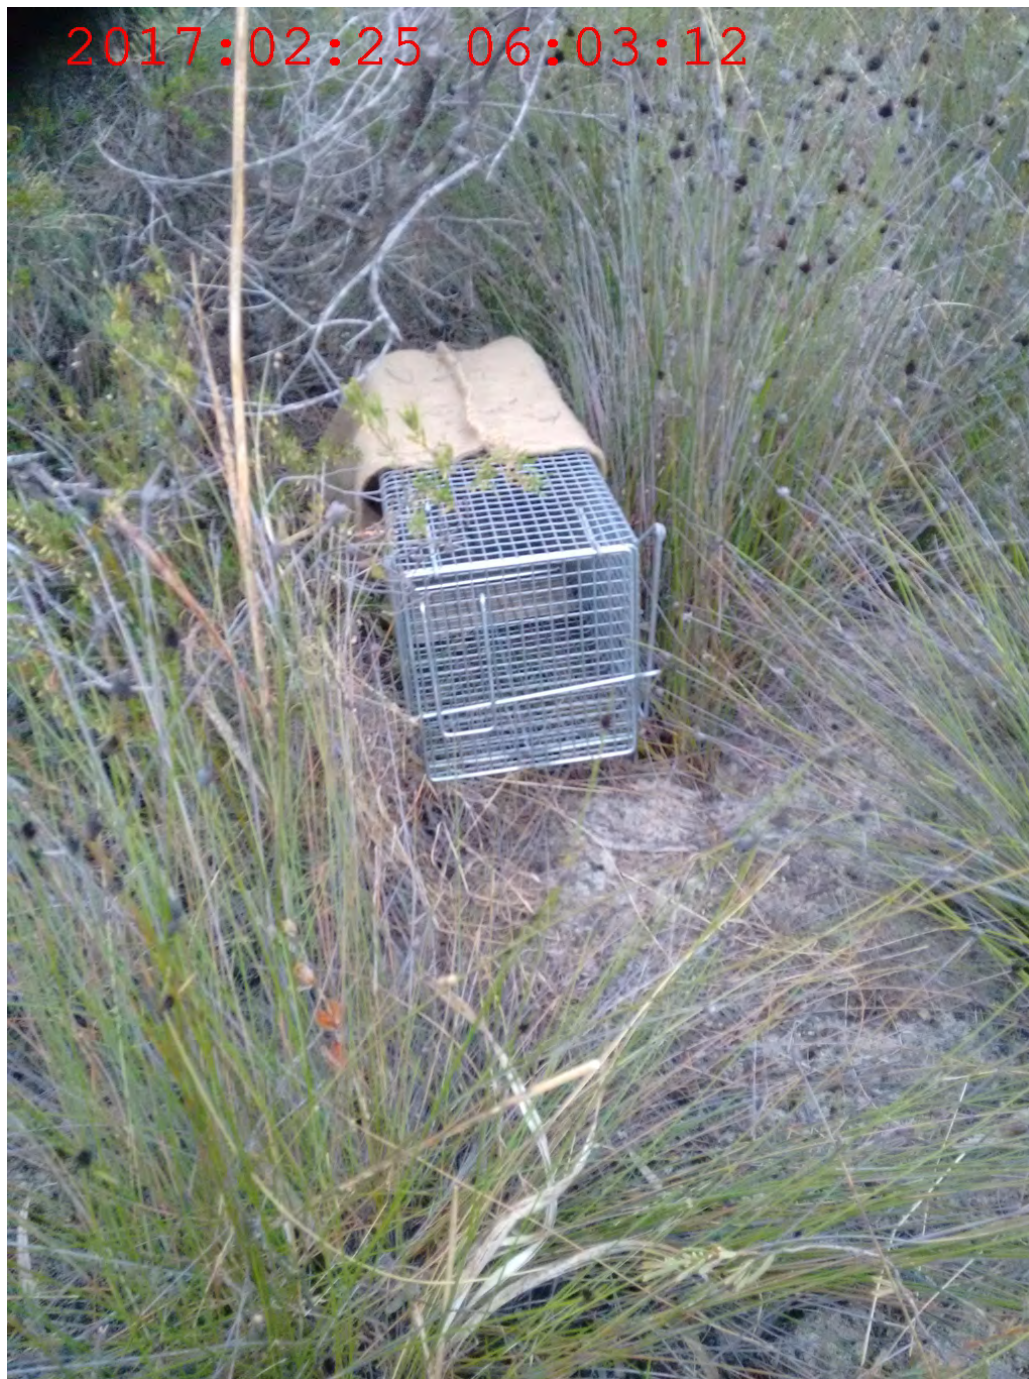
Image 14: closed trap 6.03am, Tetlow.

The following image shows a trap in Tetlow section closed at 6.03am.

The trappers did not arrive on site until 6.10am. The following image is a transcript from an on-line conversation showing that the trap was closed before the trappers arrived on site.

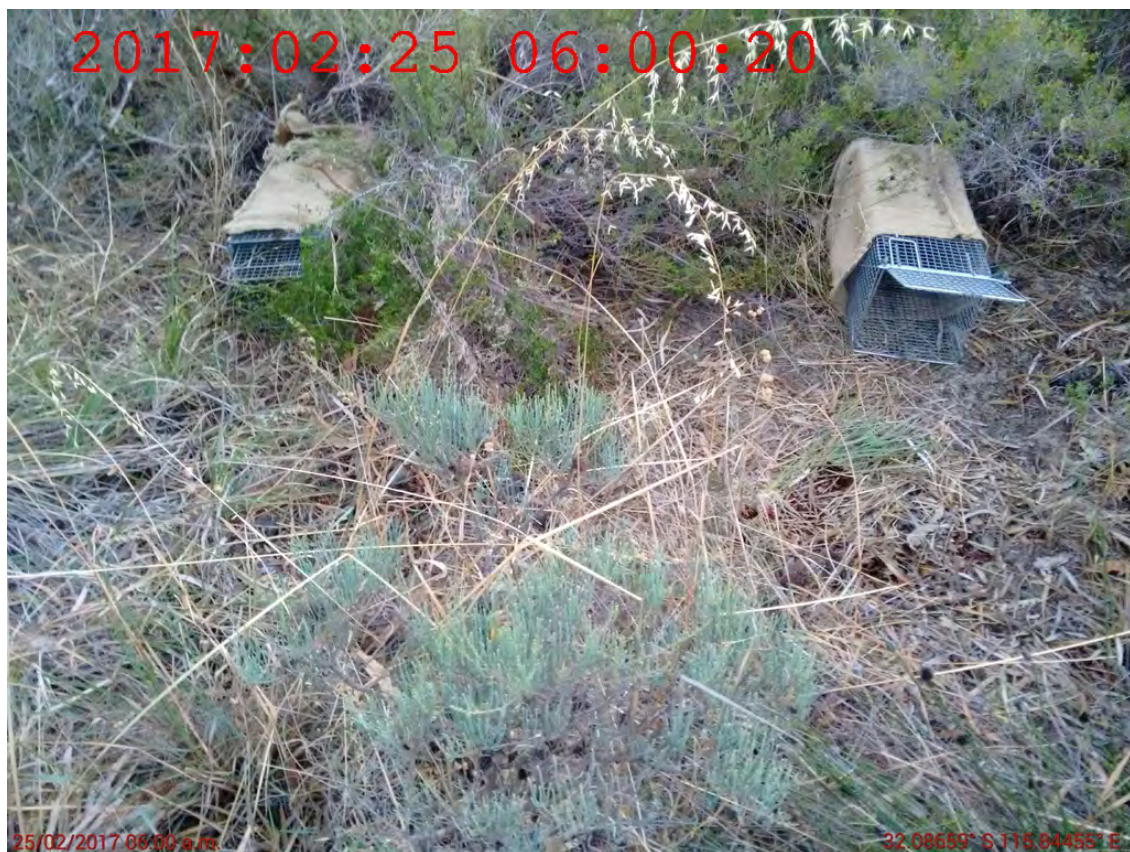
Image 16: 6.00am Tetlow, Sat 25th Feb

The few traps that were open were poorly set: exposed, insufficiently camouflaged and set too close together: The likelihood of catching two bandicoots in the same area is extremely low due to both their solitary nature and home range occurring between 1 and 7 ha (Department of Environment and Conservation 2012).

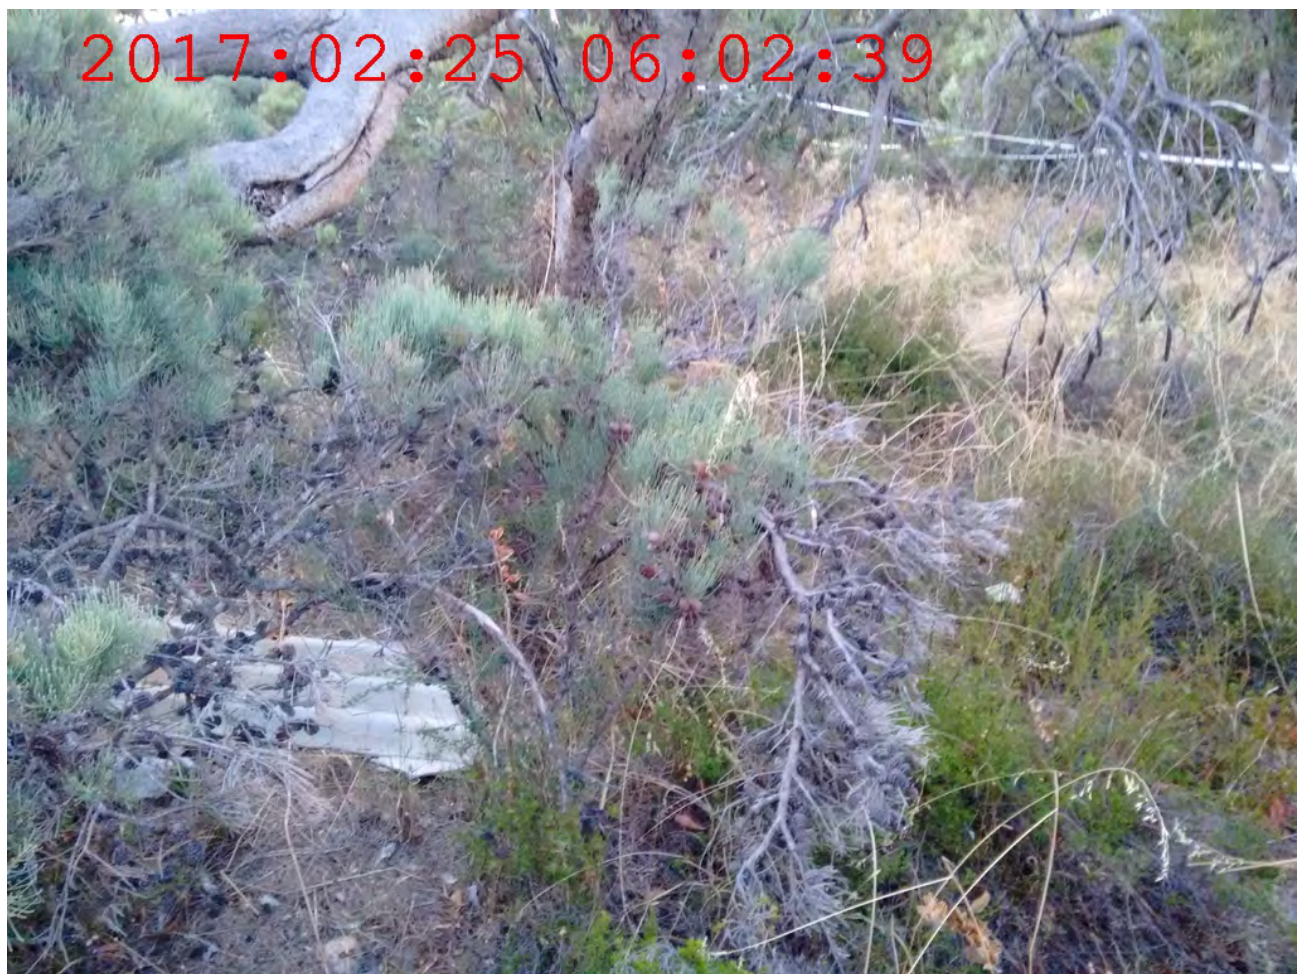
In addition we observed asbestos that was not removed from the site prior to clearing.

Image 17: asbestos on Tetlow site, 6.02am Sat 25th Feb
