ROE HIGHWAY EXTENSION – Ministerial Statement 1008, EPBC Act Referral  
2009/5031 – Request to halt or 'stop the work until issues raised are resolved.

I am writing to you as a concerned local resident about breaches of compliance with the Fauna Management Plan and the Construction Environmental Management Plan by the Building Roe 8 contractors.

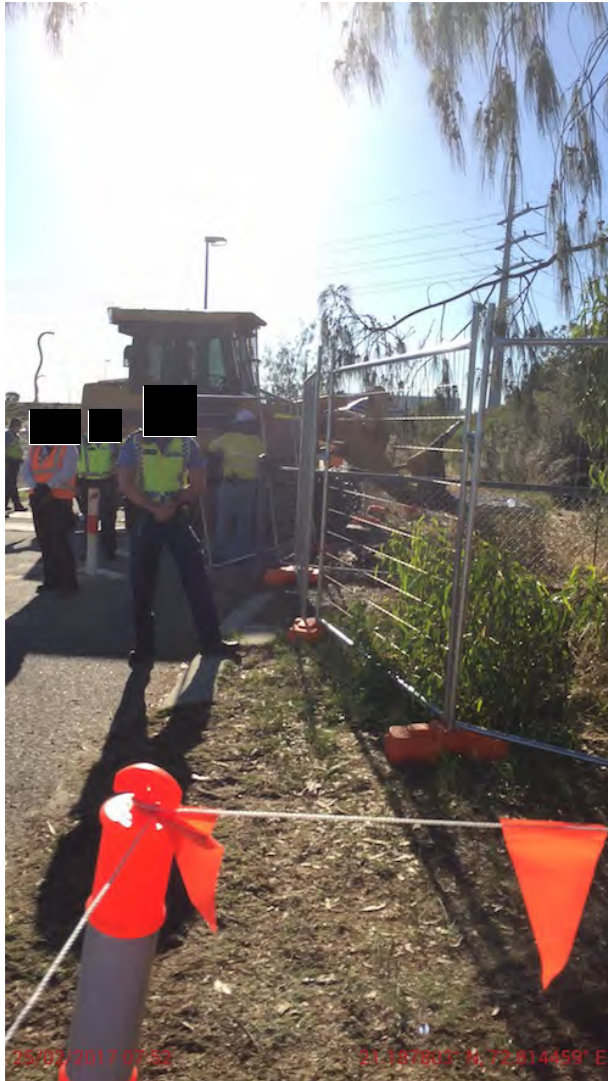
Image 18: bulldozer arriving 7.52am, Sat 25th Feb

The bulldozer arrived at the Tetlow site at 7.52am

Clearing immediately commenced. The water truck had arrived but was several hundred meters away and did not arrive at the Tetlow site until clearing had been taking place for around 30 minutes. Then it was inadequately utilised all morning. The following images show the water truck at some distance from the clearing zone and dust levels in a clearing site that is less than 50m from residential dwellings - whose occupants had not been advised that clearing was imminent. The Construction Environmental Management Plan states, section 2, table 6, that “Water carts are to be operational at all times in dry and windy conditions (October to April)” and to “commence dust suppression immediately on visual evidence of dust lift”.

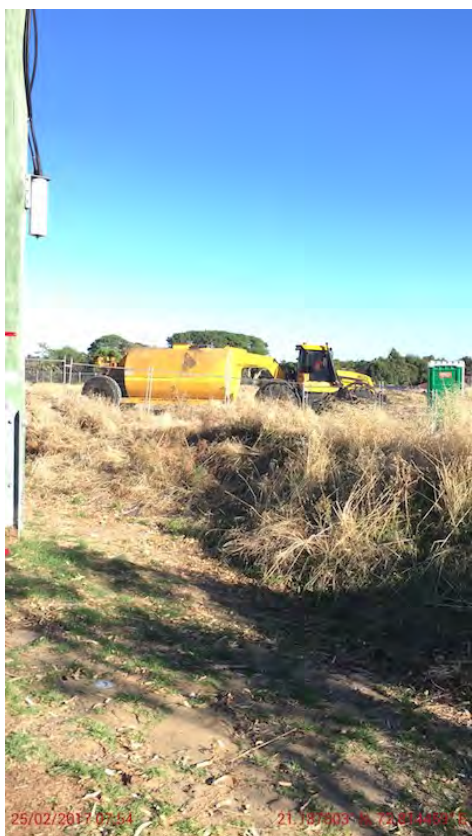
Image 19: water truck several hundred meters away, 7.54am, Sat 25th Feb

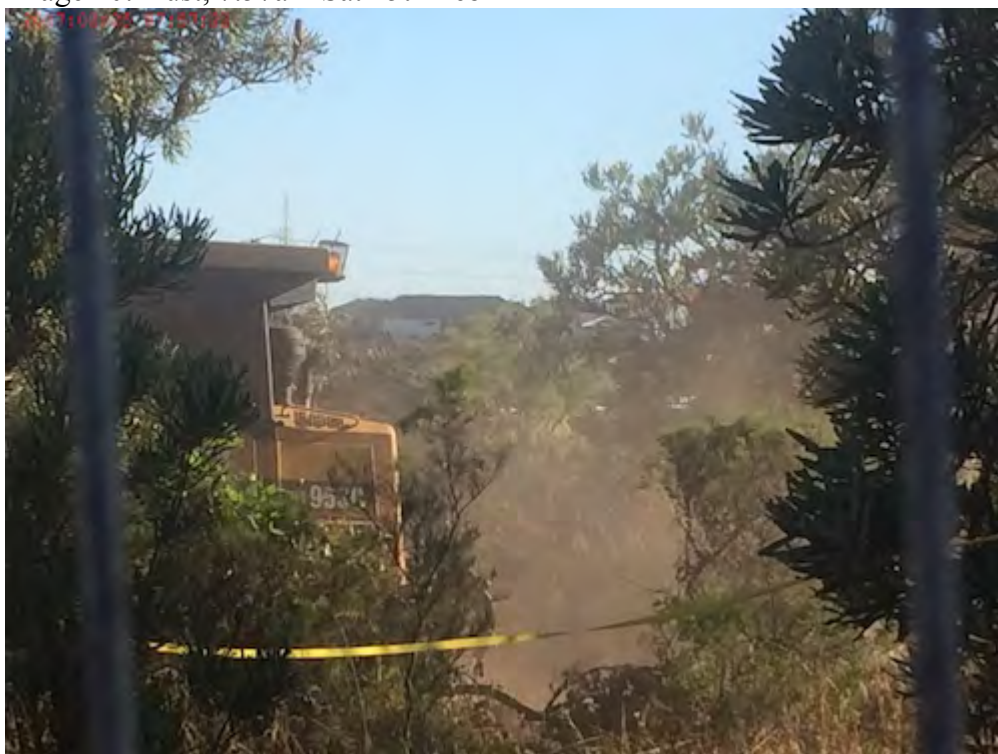
Image 20: Dust, 7.57am Sat 25th Feb
