PROPOSED CONSTRUCTION
OF
PROJECTS TWO AND THREE OF
THE CHRISTMAS ISLAND NEW HOUSING PROGRAM

STATEMENT OF EVIDENCE

TO THE
PARLIAMENTARY STANDING COMMITTEE
ON PUBLIC WORKS

NOVEMBER 2011

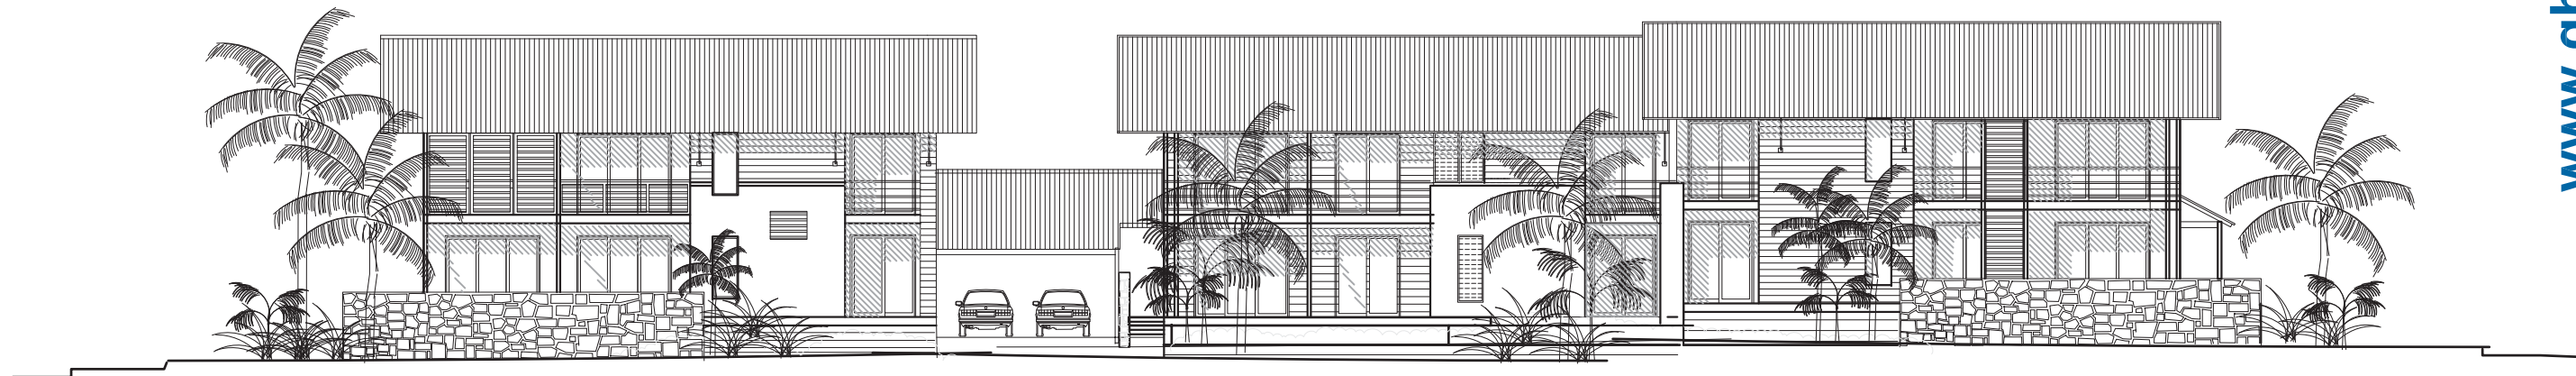
Indicative Street Elevation

Indicative Elevations of Preliminary Concept Master plan. Elevations demonstrate, scale, varied streetscape and articulation to facades.

Note: Roof form could be varied to provide further articulation to main streetscape. The inclusion of 1 x (2- Type D Walk-up units) into Project 1 is acceptable, provided it can be demonstrated it sits well in the site plan and contributes to the overall streetscape.

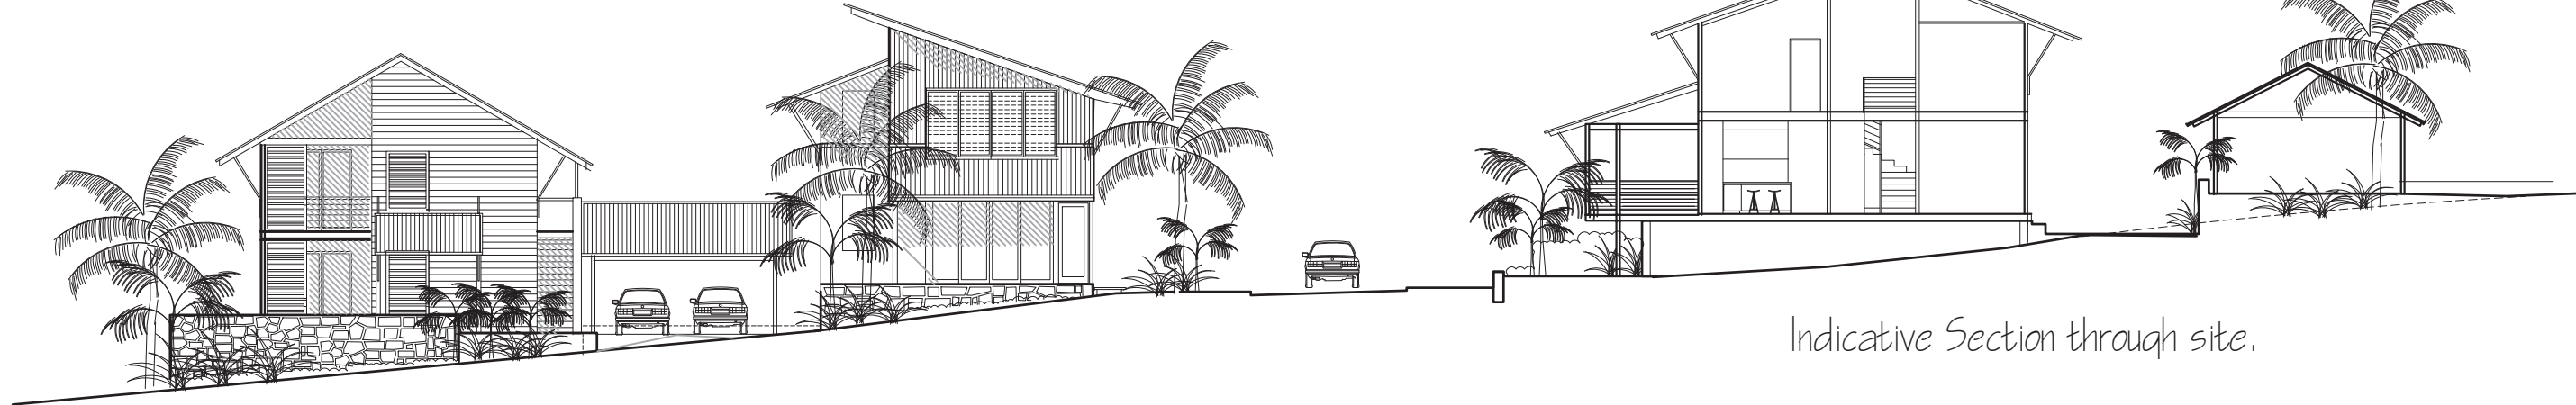
Indicative Section through site.

Unit Types, can be elevated with varying roof form, mix of materials, and minor detail changes to present an articulated streetscape, which contributes to an overall tropical aesthetic.

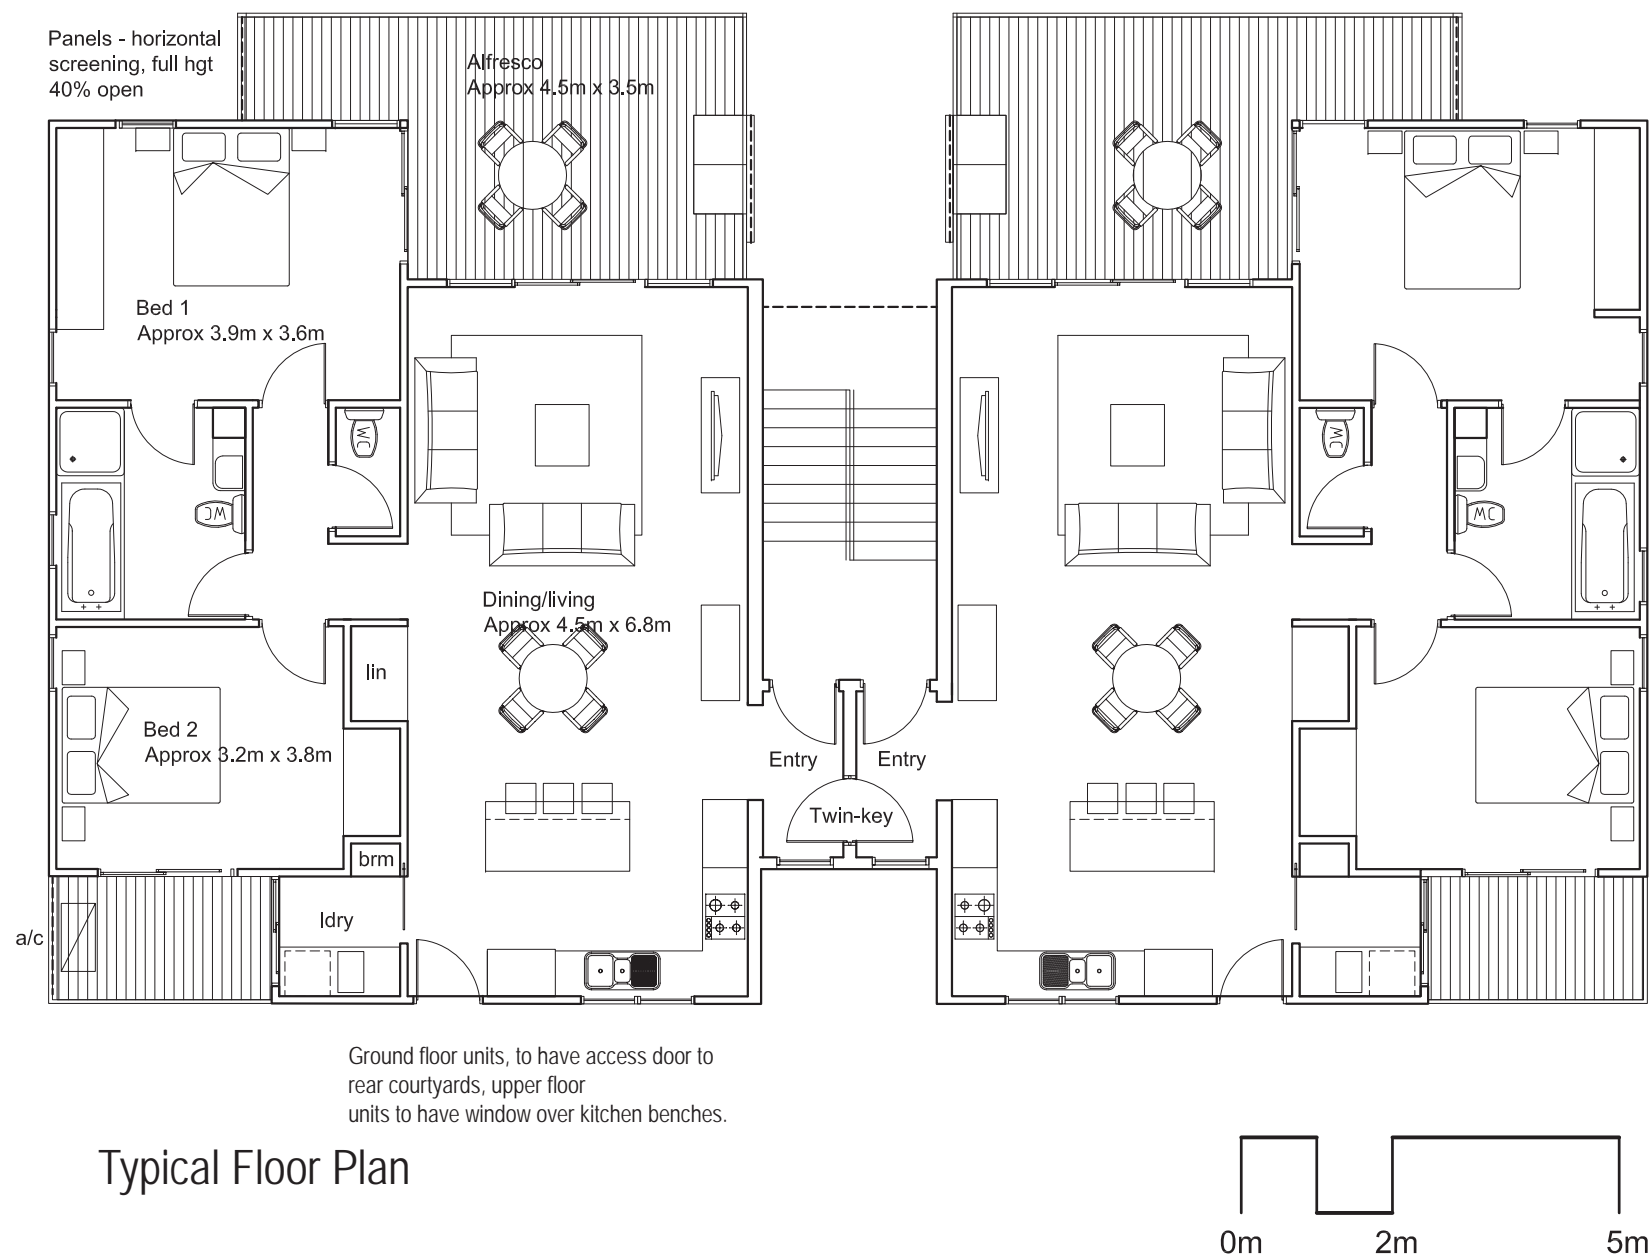
Typical Floor Plan

Indicative Floor Plans - Drumsite 2 Bedroom Walk-up Type D

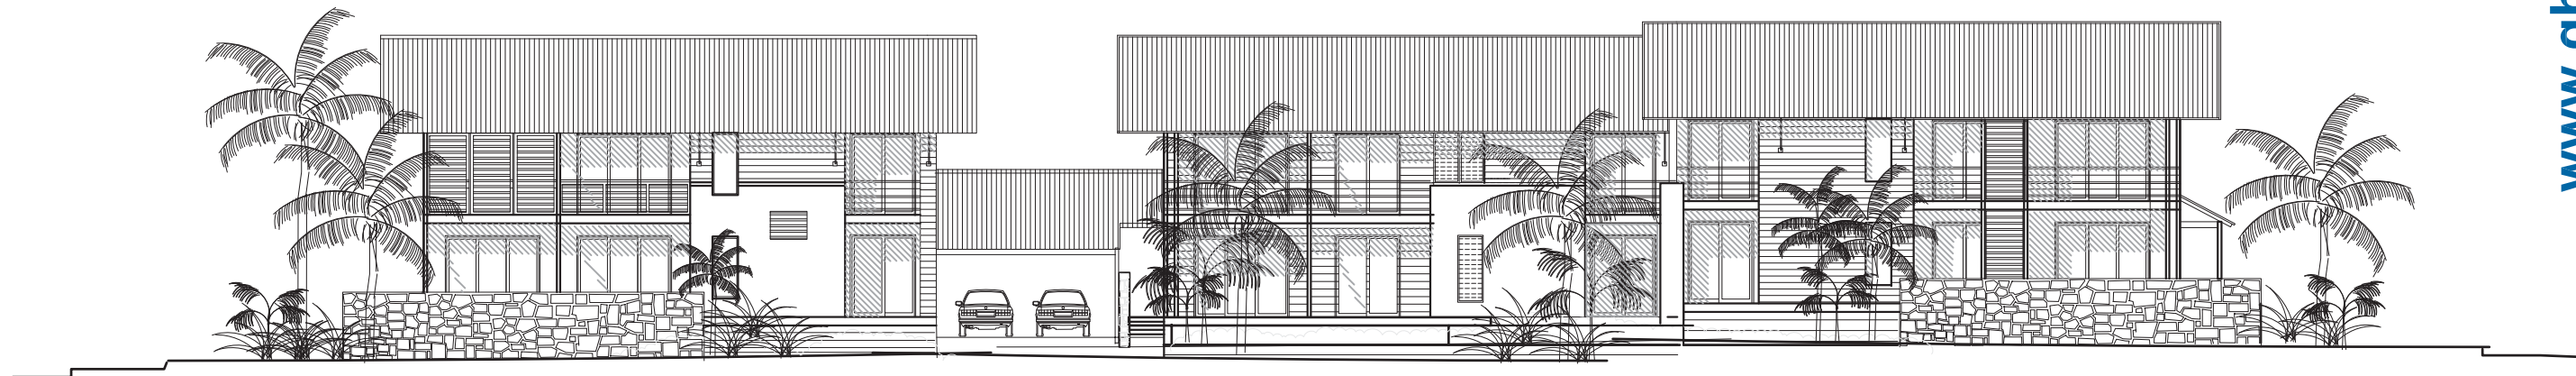
Indicative Street Elevation

Indicative Elevations of Preliminary Concept Master plan.
Elevations demonstrate, scale, varied streetscape and articulation to facades.

Note: Roof form could be varied to provide further articulation to main streetscape.
The inclusion of 1 x (2- Type D Walk-up units) into Project 1 is acceptable, provided it can be demonstrated it sits well in the site plan and contributes to the overall streetscape.

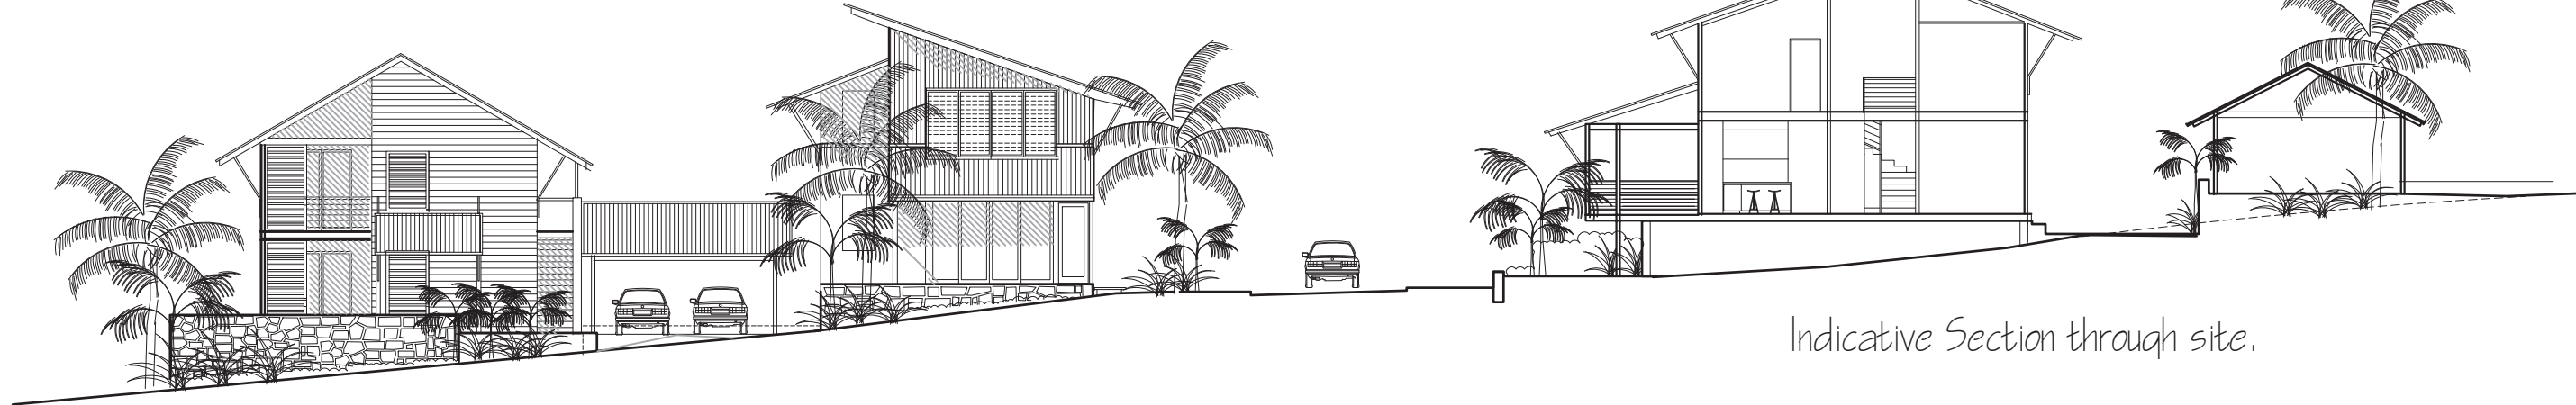
Indicative Section through site.

Unit Types, can be elevated with varying roof form, mix of materials, and minor detail changes to present an articulated streetscape, which contributes to an overall tropical aesthetic.

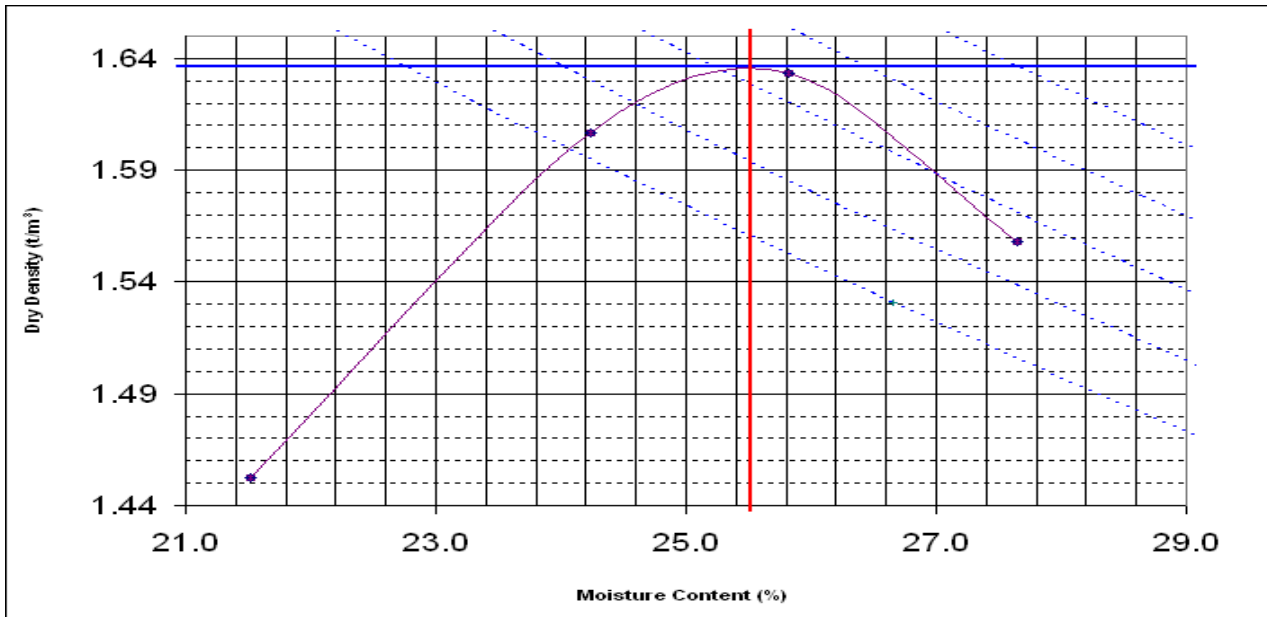
AS 1289.5.2.1 (Modified Compactive Effort)

Modified Effort	
Maximum Dry Density (t/m³)	1.64
Optimum Moisture Content (%)	25.5
% Retained 19.0mm	6
% Retained 37.5mm	5
Air Voids Curves:	Voids %: 0 - 2 - 4 - 6 - 8 at SPD: 2.99
