Australian Government
Director of National Parks

Annual Report on the DOTARS-DNP Christmas Island Minesite to Forest Rehabilitation (CIMFR) Program

April 2004 - June 2005

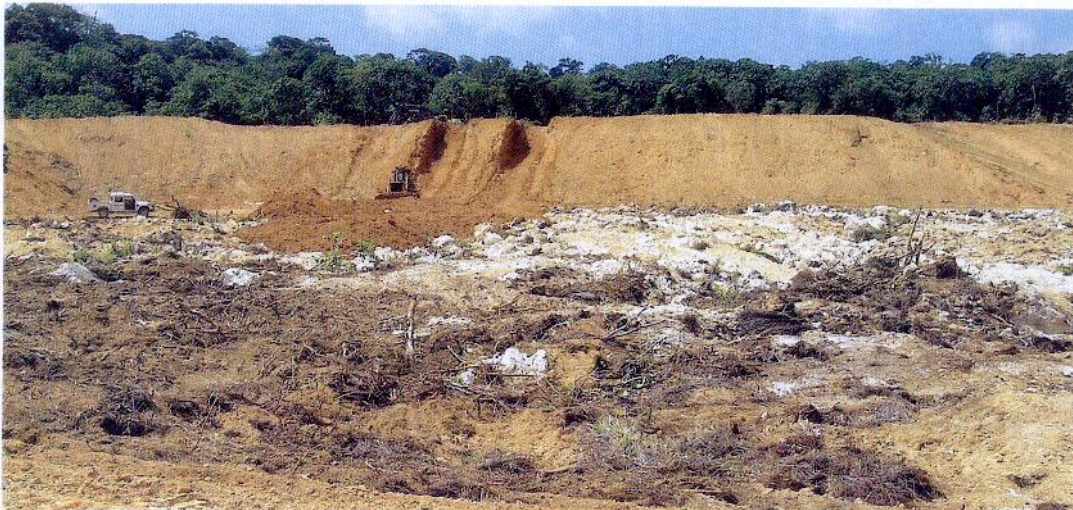
Earthworks underway at mine field 20E in October 2004

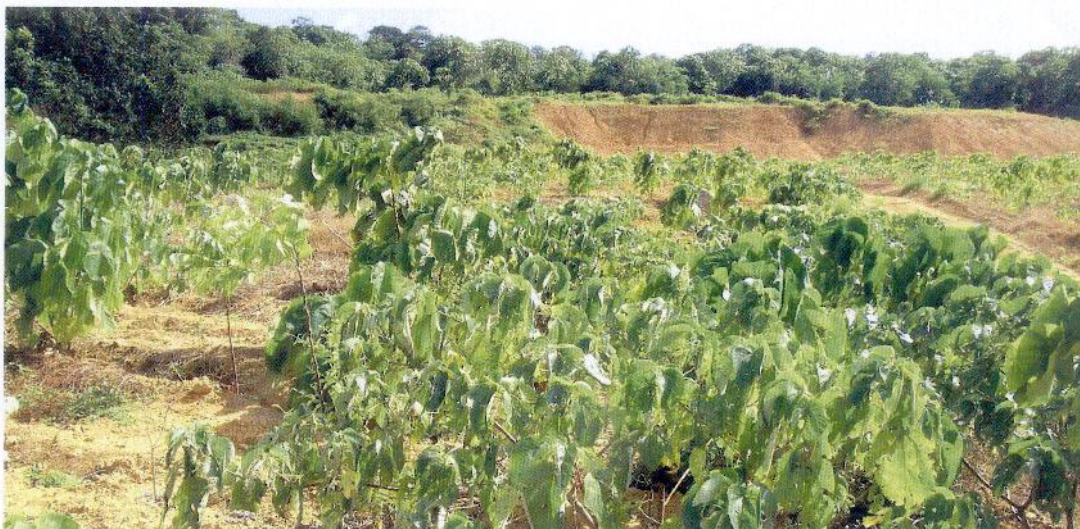
Five month old native trees in mine field 20E in August 2005

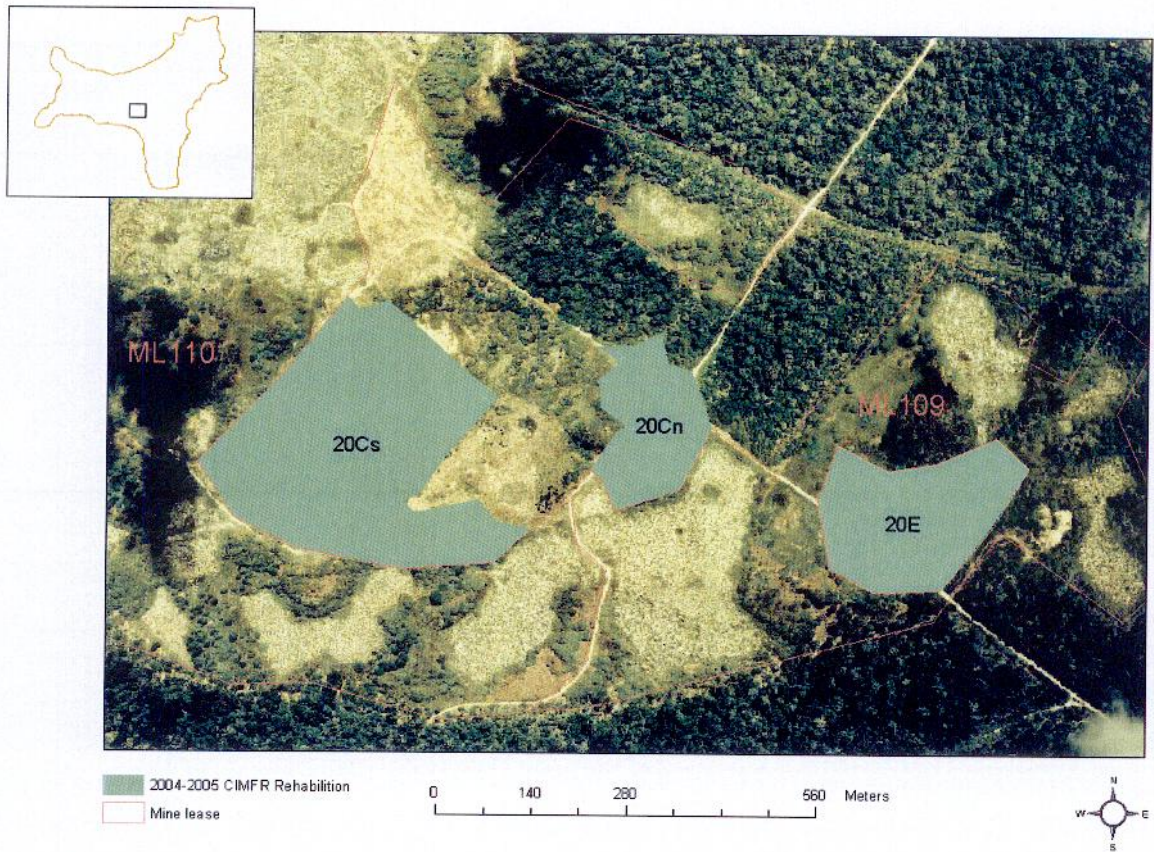
Figure 3: Areas in mine field 20 targeted for rehabilitation by the CIMFR program in 2004-2005.

Rehabilitation earthworks and fieldwork took place throughout 2004 and 2005 in the abandoned mine field 20, which is adjacent to the existing mine leases 109 and 110 (Figure 3). Within mine field 20, there were three main rehabilitation sites that were targeted by the CIMFR program, coded as 20E, 20Cn, and 20Cs.

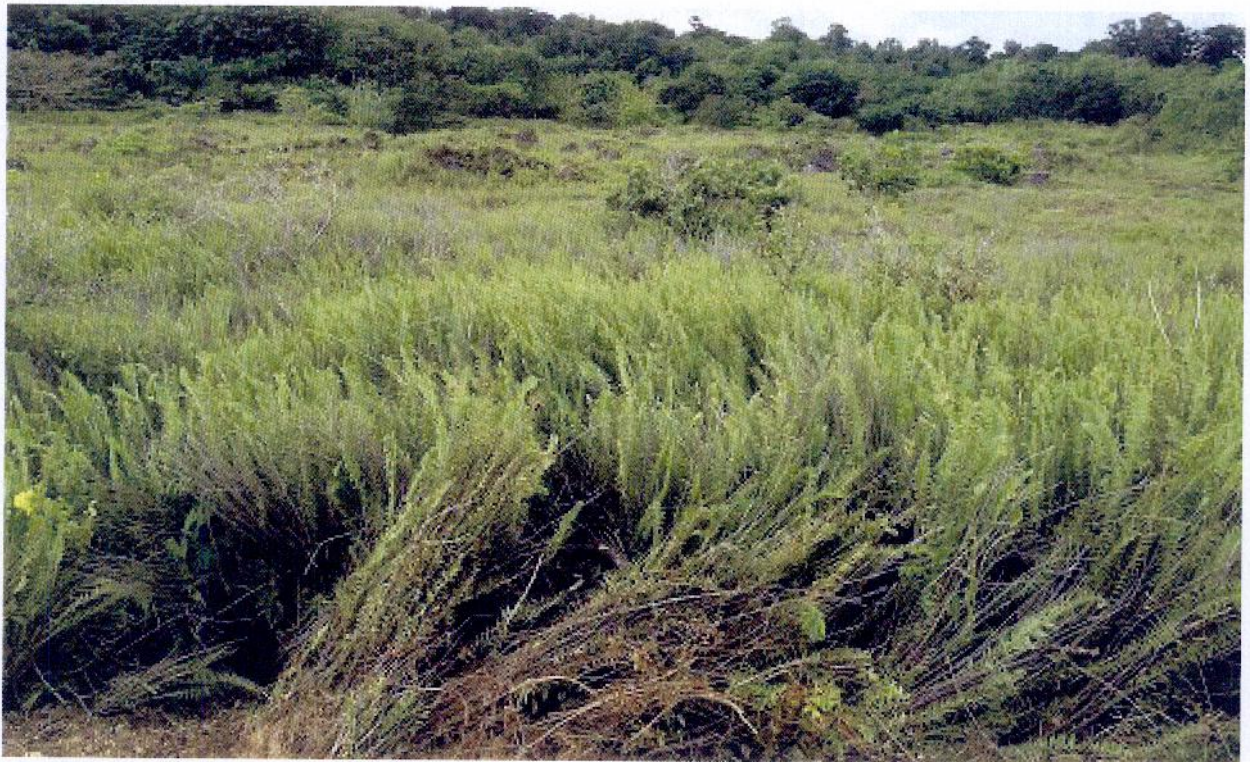
Figure 4: Abandoned mine field 20E covered in fern and rimmed with exotic trees prior to the commencement of rehabilitation earthworks.

This mine field was a mixture of pinnacles and flat ground both covered with fern and weeds, and pockets of remnant soil with some natural regeneration (Figure 4). Extensive areas were also infested with weeds and required suppression. Some of these invasive weeds were from earlier rehabilitation programs that used exotic species.

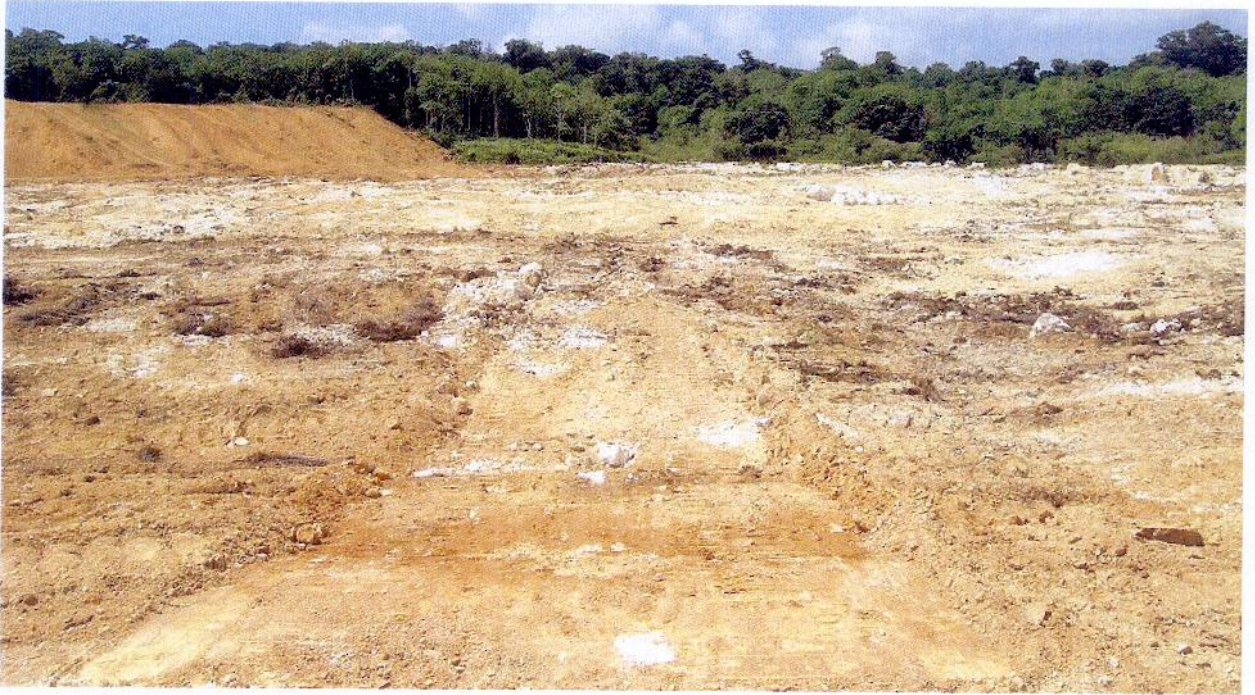
Figure 5: Mine field 20E cleared, pinnacles flattened, and the stockpile face cleared ready for soil loading and haulage.

Rehabilitation earthworks in mine field 20 were undertaken from August to December 2004. Extensive earthworks, road formation, and earth haulage were required over much of area due to the pinnacled nature of the site and the lack of topsoil (Figure 5). Only a few small areas on this minesite had remnants of existing topsoil and showed positive natural regeneration. Local contractors who provided the earthmoving machine operators were schooled in the particular style of earthworks required for tropic rainforest rehabilitation throughout August to December 2004 (Figure 6, 7, 8, & 9).

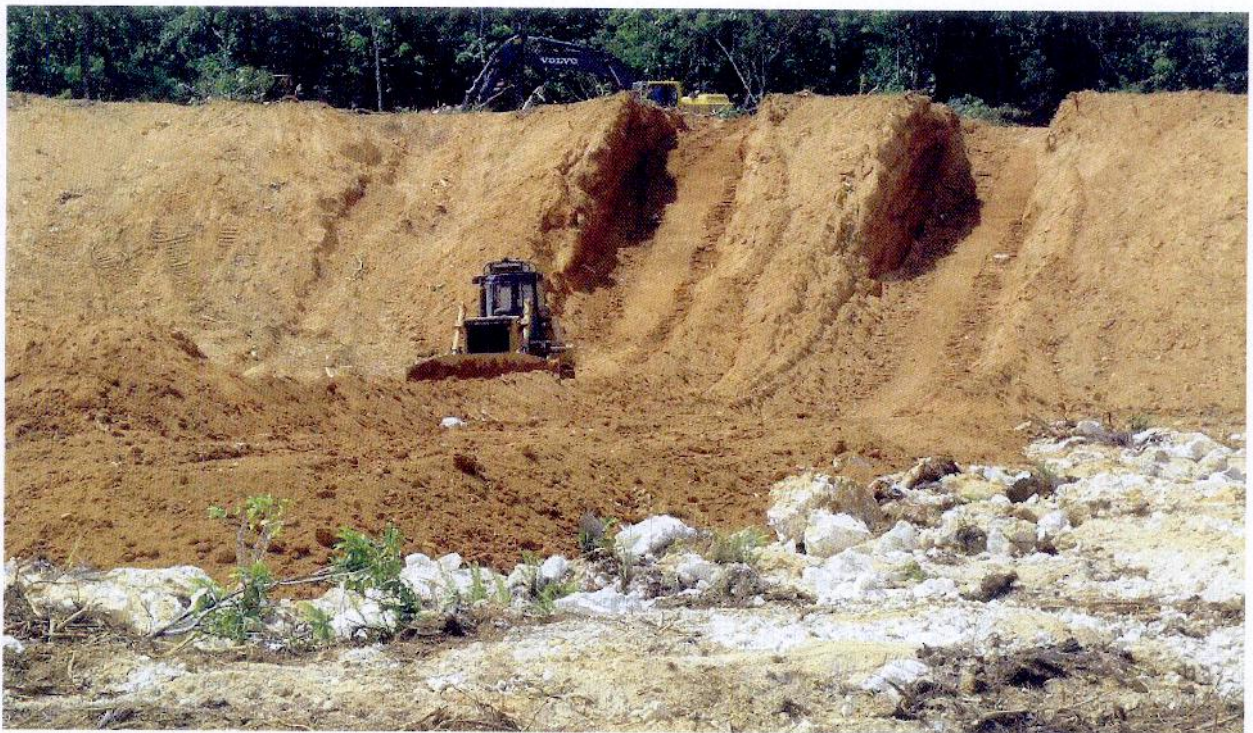
Figure 6: Earthmoving contractors slotting stockpiles to build up the soil profile in the adjacent abandoned section of mine field 20E.

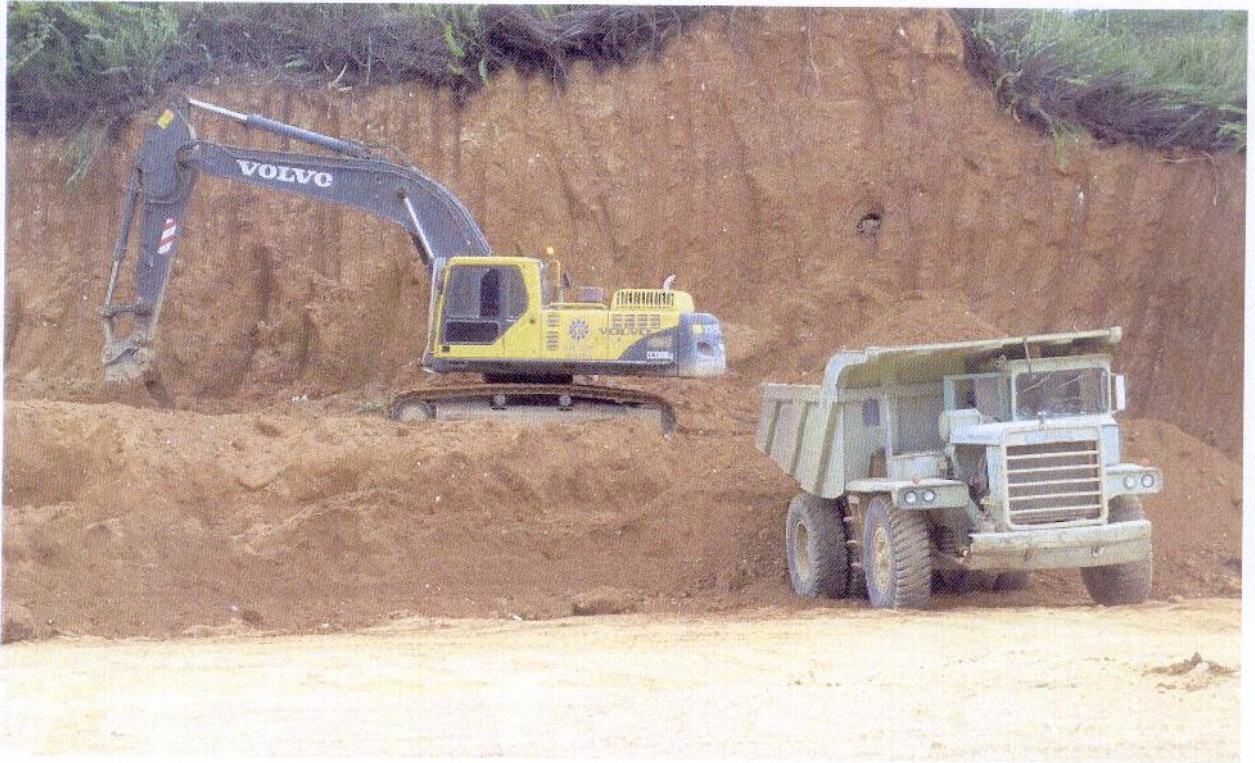
Figure 7: Earthmoving contractors loading 30 tonne dump trucks from a stockpile at mine field 20C.

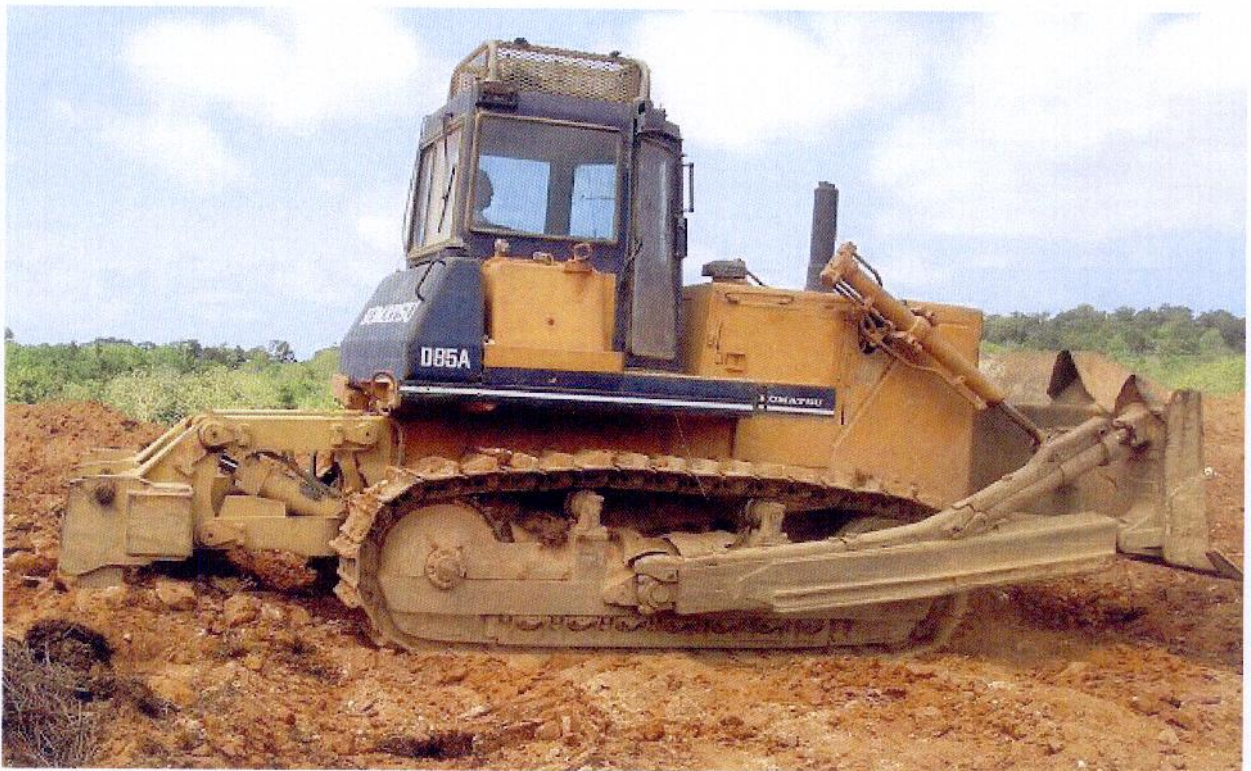
Figure 8: D8 dozer doing a final rip of planting beds in mine field 20C before planting.

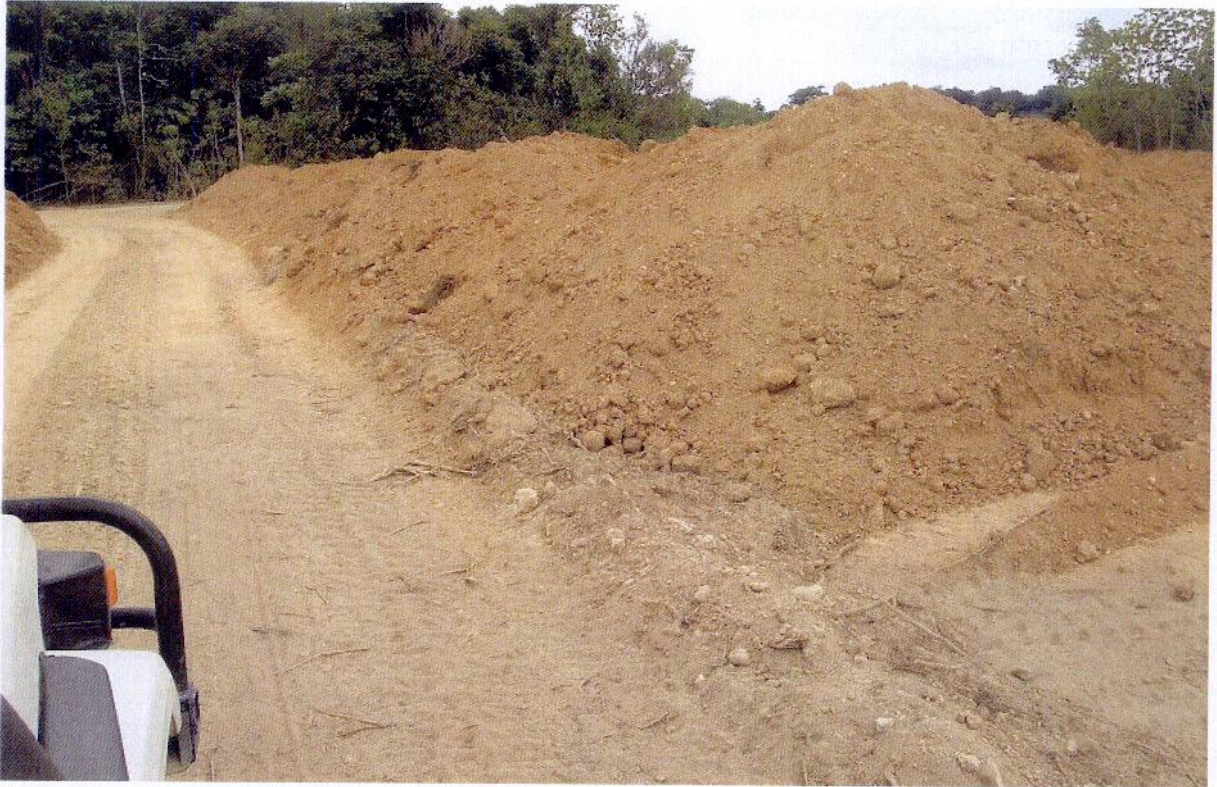
Figure 9: Rehabilitation planting beds formed up in mine field 20C ready for planting.

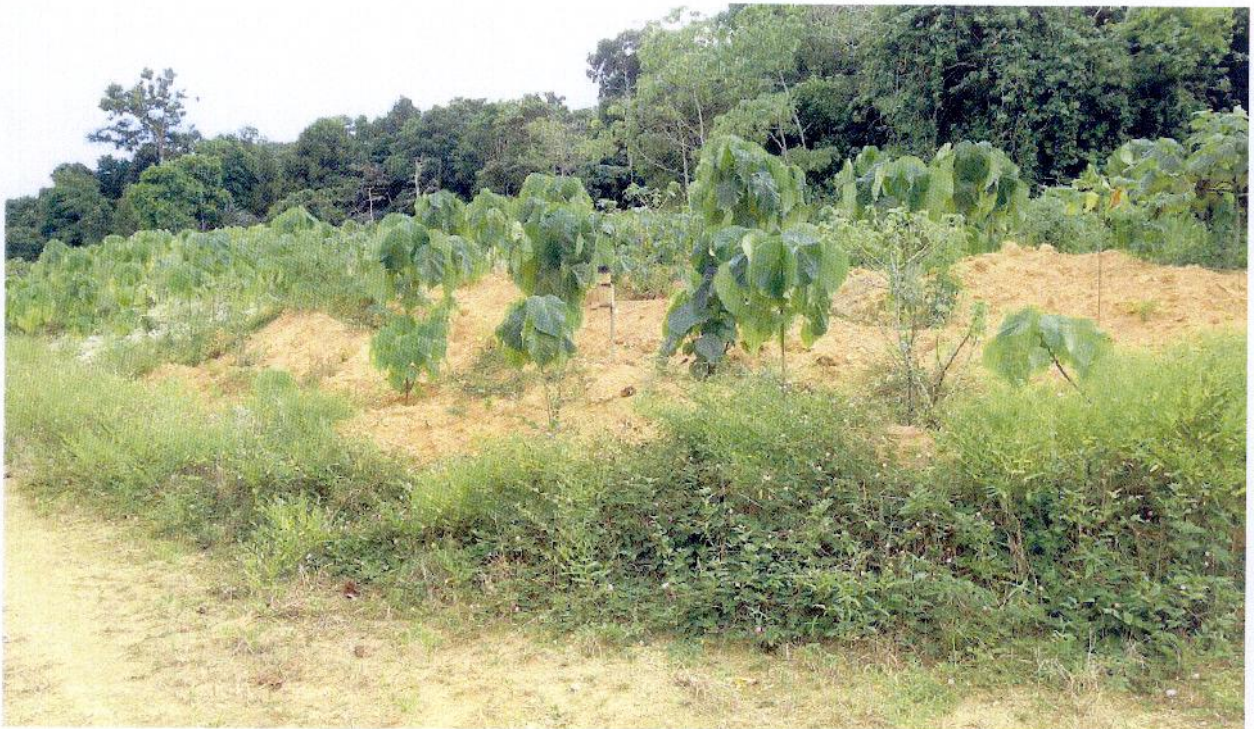
Figure 10: Four months after rehabilitation planting was completed in mine field 20C in March 2005.

From January to March 2005, 28,000 of the seedlings raised in the CINP Nursery were planted into prepared rehabilitation beds (Figure 10 & 11). The rainfall for the wet season during planting was disappointing as it was well below average in quantity, number of rain days, and length. The wet was late to start, inconsistent, and early to finish. Fertilisation and weed suppression took place from January to June 2005, and will continue in these new plantings until the forest becomes established in approximately four to five years time (Figure 12).

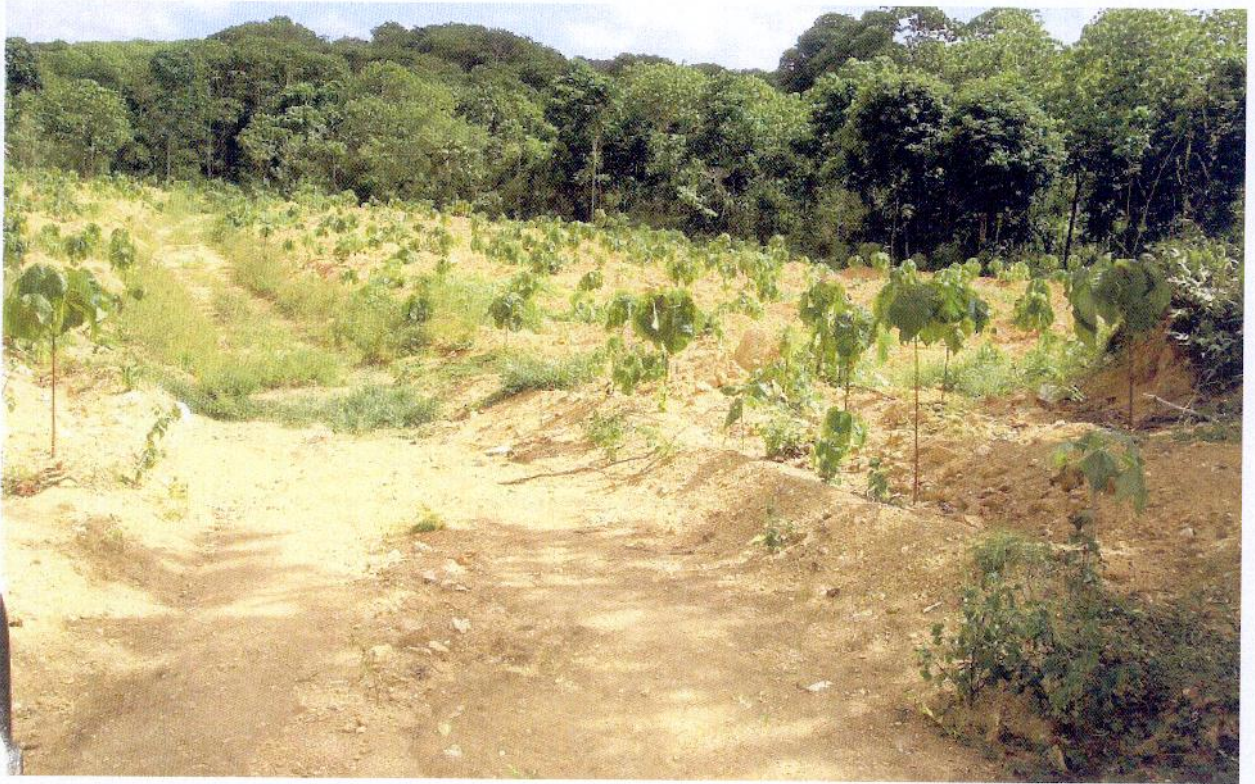
Figure 11: Four months after rehabilitation planting was completed in an eastern section of mine field 20C.

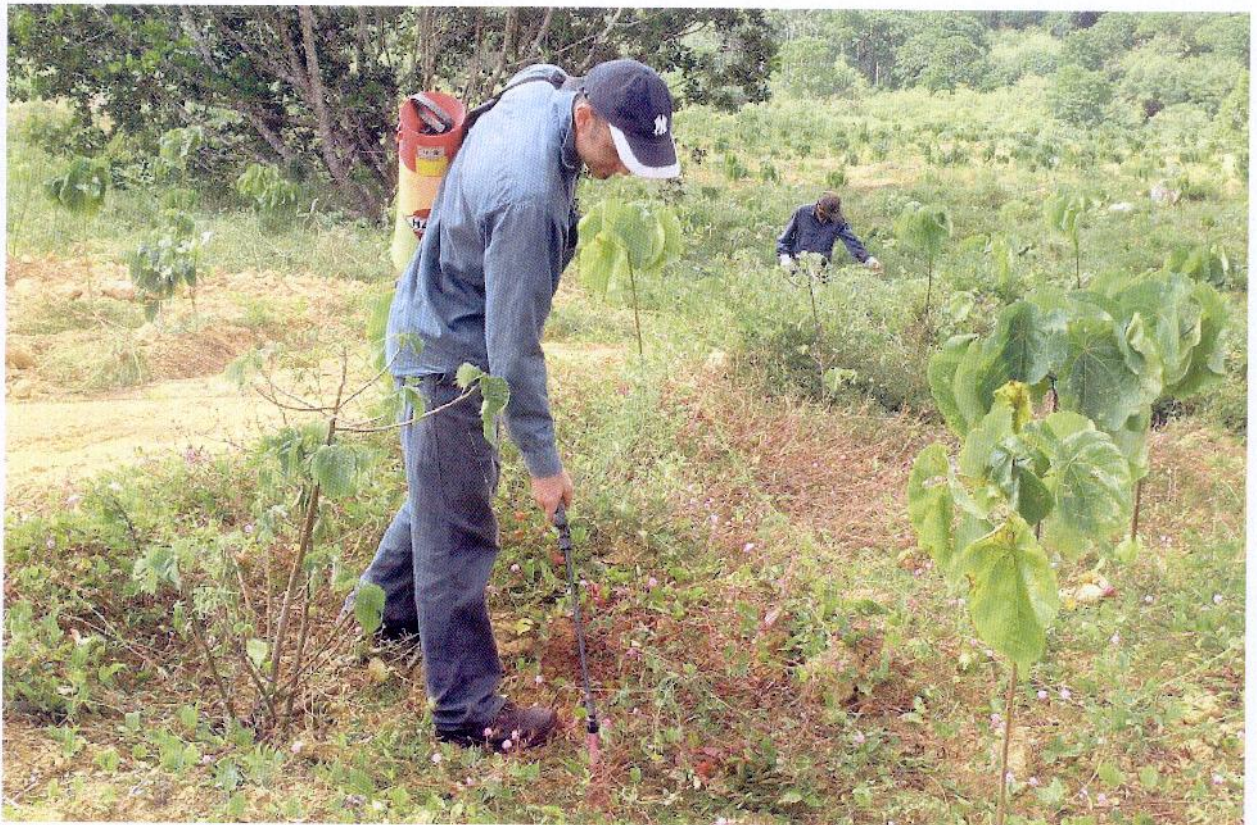
Figure 12: CINP field personnel suppressing weeds in mine field 20E rehabilitation plantings.

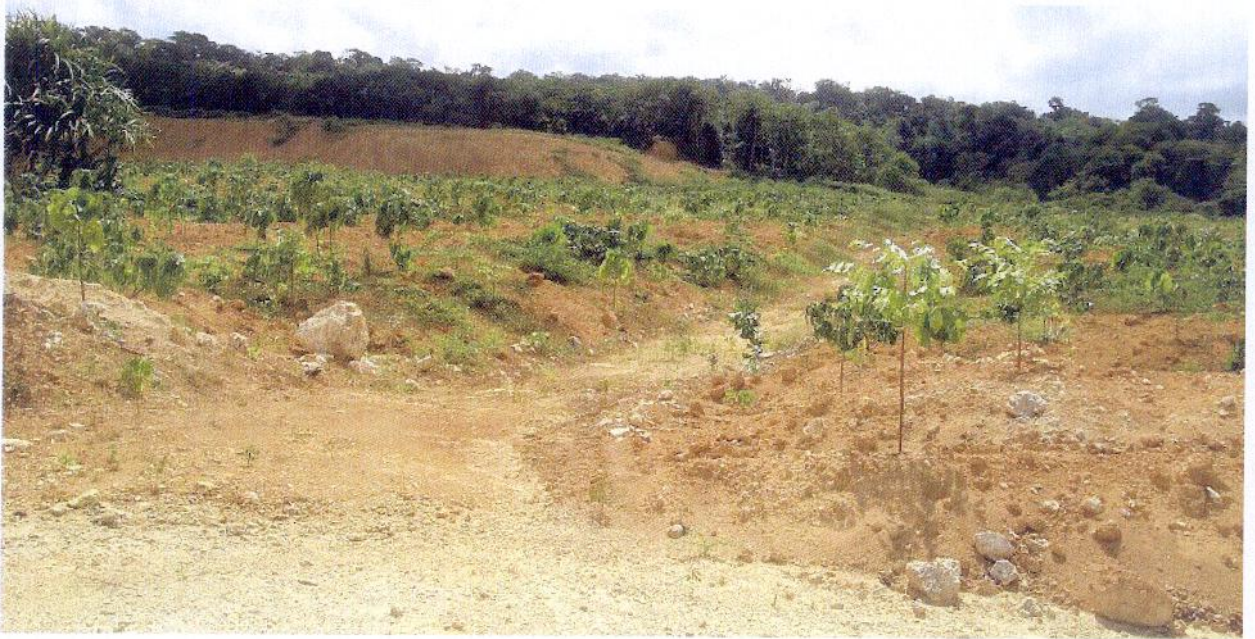
Figure 13: Mine field 20E four months after earthworks, planting, and the suppression of the majority of weeds.

During this cycle, approximately nineteen hectares of abandoned mine field 20 were rehabilitated by the program (Figure 13). A further two hectares scheduled for rehabilitation

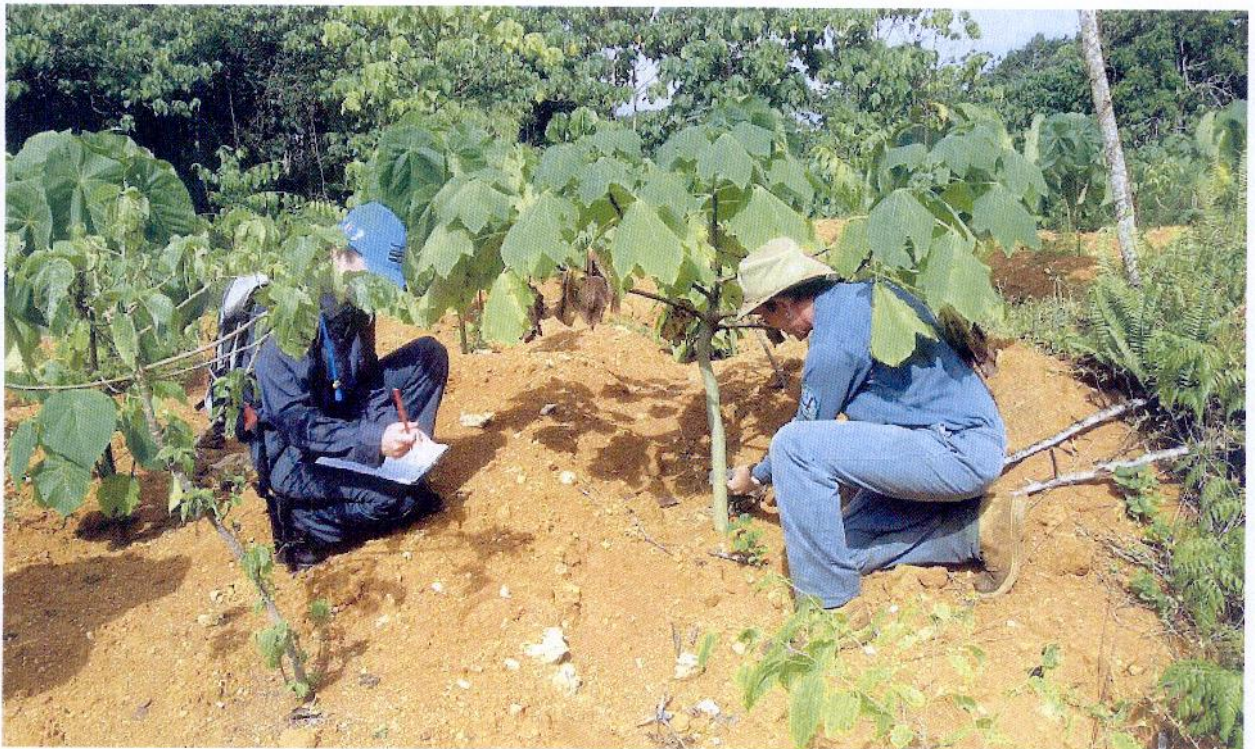
Figure 14: CINP field personnel collecting biological and edaphic data in the rehabilitation site at mine field 20C four months after planting.

during this cycle were suspended after a field assessment at the end of 2004 found that vehicular access has been lost to the site due to a lack of road maintenance and good forest regrowth around the outside of the site. This site will be reassessed if the PRL reopen the access road on their neighbouring mine lease. Rehabilitation monitoring by CINP took place in June 2005, and involved the sampling of native flora, fauna, and soil characteristics in the newly rehabilitated site (Figure 14, Table 1).

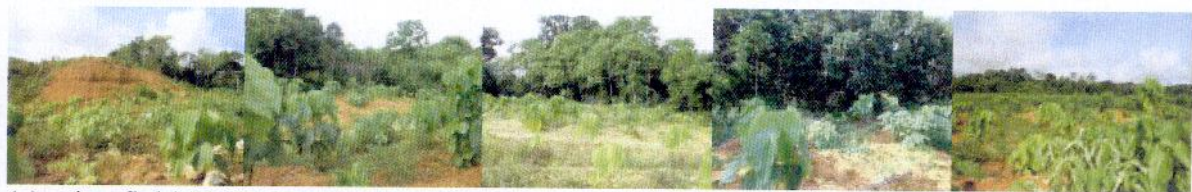
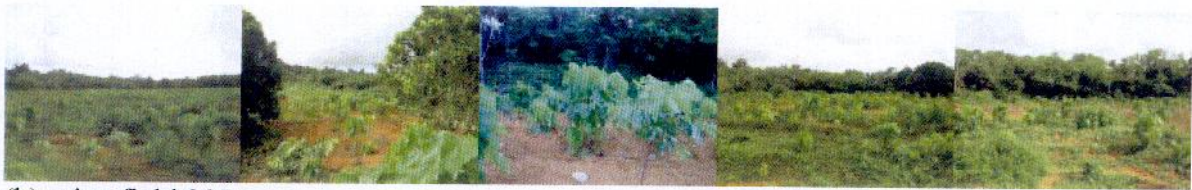
(a) mine field 20C

(b) mine field 20E

Figure 15: Photographs from each monitoring transect in mine field 20E and 20C taken four months after planting.

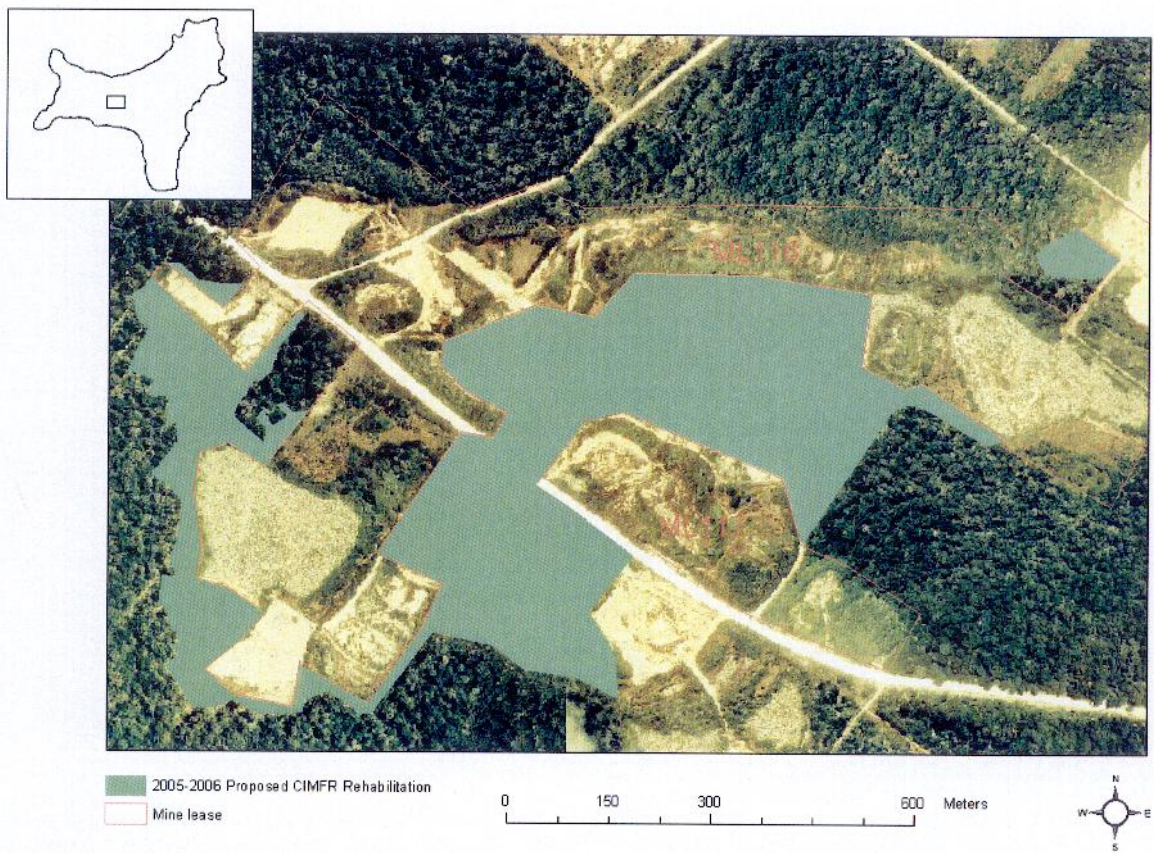
Figure 17: Areas in mine field 23 targeted for rehabilitation by the CIMFR program in 2005-2006.

Approximately thirty hectares in this field have been earmarked for rehabilitation by the CIMFR program in this next cycle (Figure 17). Rudimentary access roads have been pushed into mine field 23 to more closely assess the condition of the landscape for the upcoming rehabilitation earthworks in 2005 (Figure 18). Unlike mine field 20 which was relatively flat, phosphate mining has left behind extensive rocky ridges, cliffs, steep slopes, gully ravines, terraces on several different levels, and the usual fields of rocky pinnacles at mine field 23 (Figure 19 & 20). As a consequence, rehabilitation earthworks in 2005 will require different strategies used in 2004, and earthwork contractors will have to be retrained in new techniques to flatten and resoil this site.

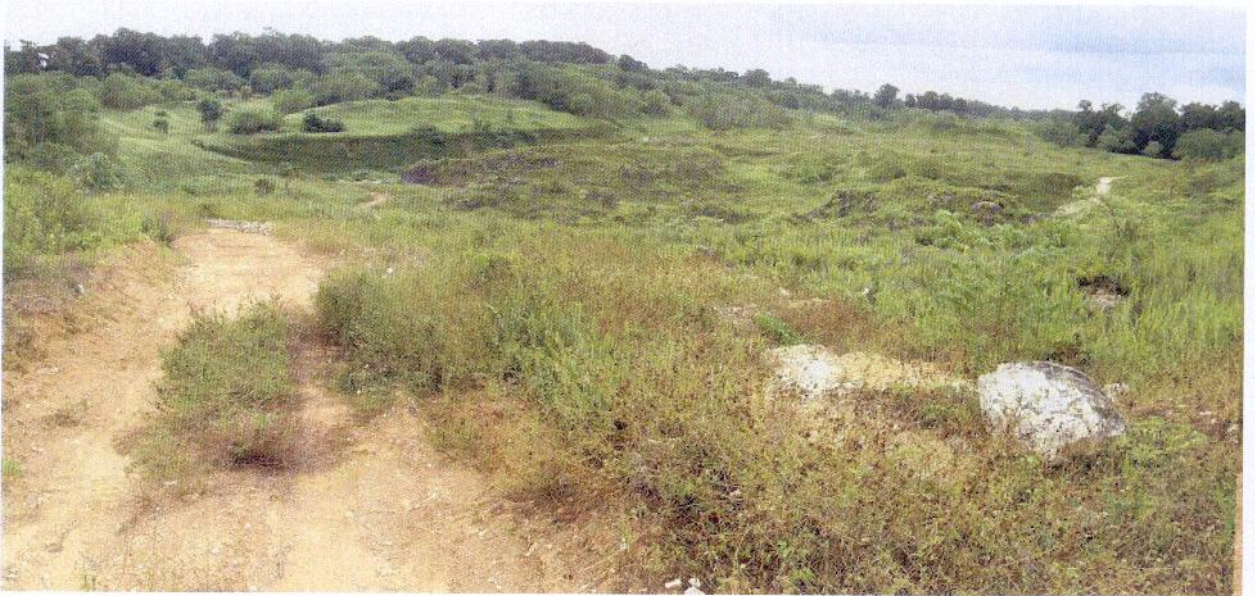
Figure 18: Site of 2005-2006 CIMFR rehabilitation at mine field 23, adjacent to ML116 and 117.

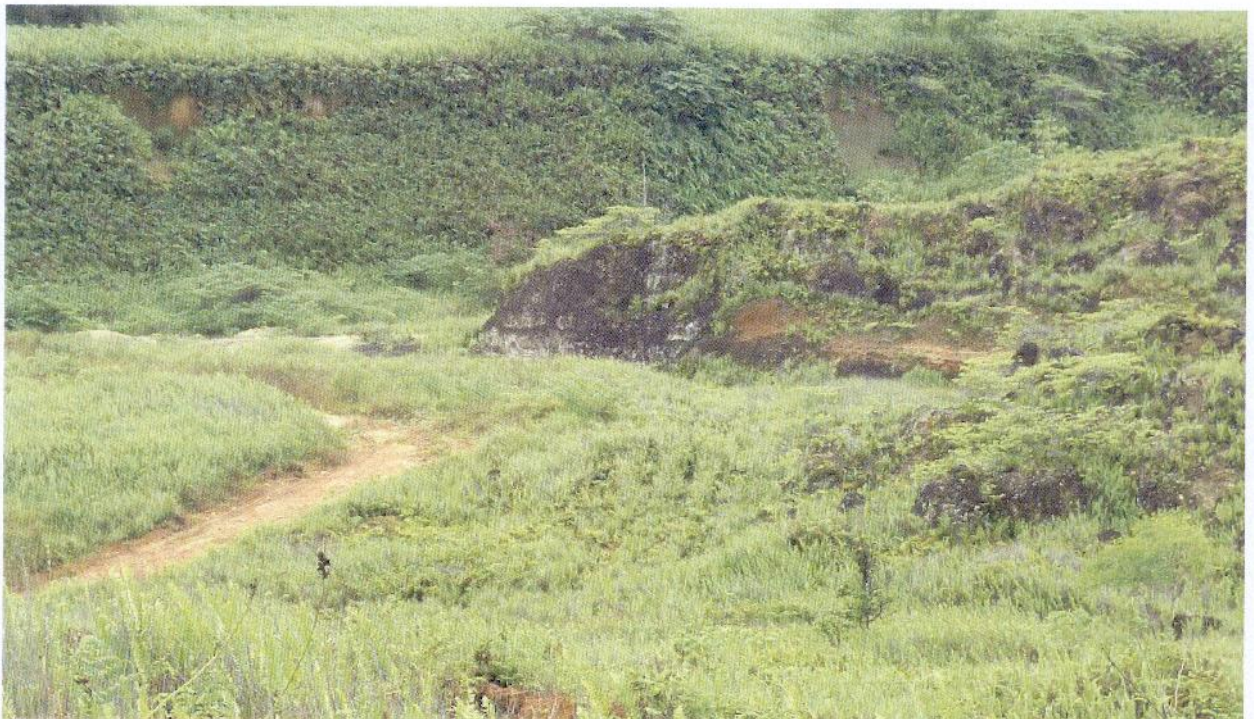
Figure 19: High rocky ridges (~20 m) cliff edges (~30 m) typically left behind after mining at mine field 23.

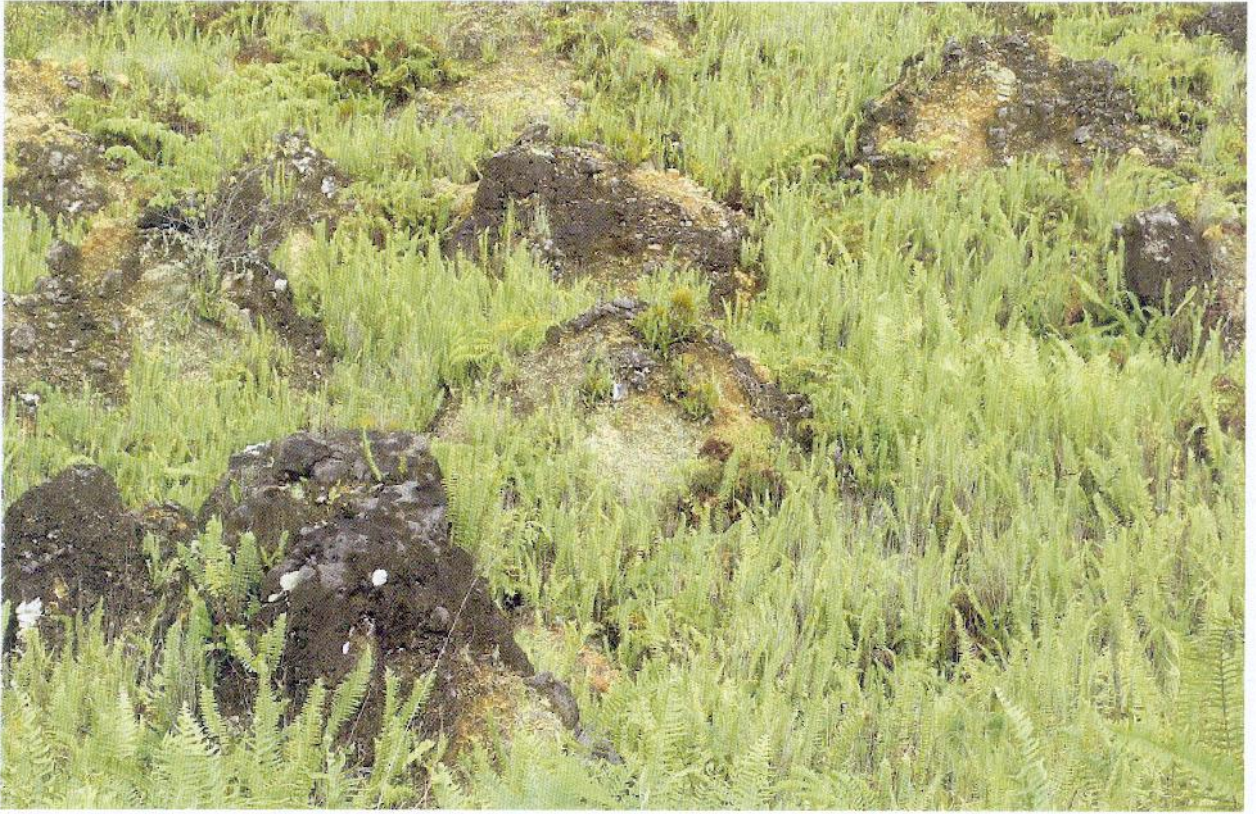
Figure 20: Rocky pinnacles (~2 m) typically found at mine field 23.
