Senate Finance and Public Administration Legislation Committee —Budget Estimates Hearing—May 2011

Answers to Questions on Notice

Parliamentary departments, Department of Parliamentary Services

Topic: **Disability Access**

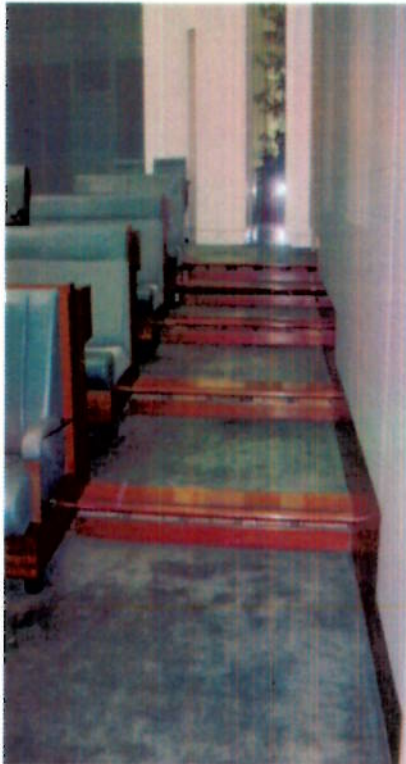
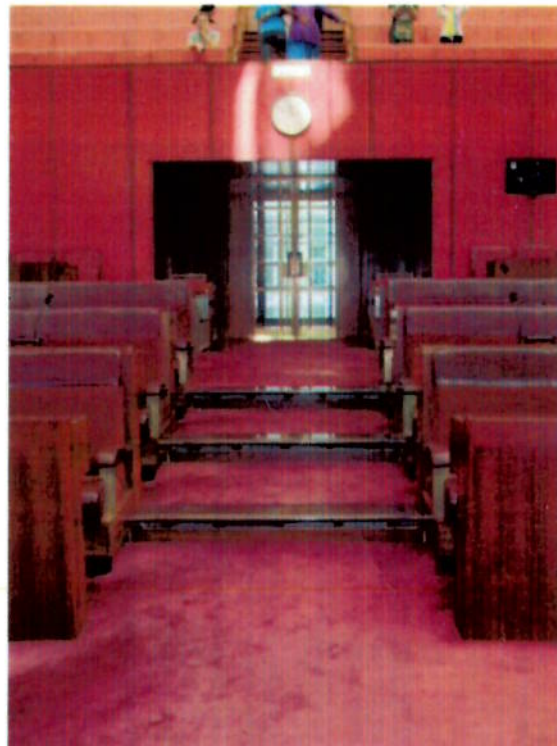
The main barrier for wheelchair accessibility is the internal steps, and access to seats on the graduated levels in both chambers.

Options considered such as stair-climbers mounted on the walls of the House of Representatives would not only impact on design integrity, but would only allow access to the advisor's benches, not the members benches. Stair climbers mounted in aisles would present a trip hazard for ambulant members as well as blocking their egress in an emergency situation.

The benches themselves with armrests that do not fold out of the way are also a barrier for a person in a wheelchair attempting to transfer themselves, or be assisted to transfer. A person in a wheelchair transfers to their stronger side, and the double benches limit their position within the chamber. An extremely disabled person in an electric wheelchair may be able to get to a lower level using a stair-climber system or similar wheelchair platform, but without a hoist,

Access for a disabled parliamentarian is therefore likely to involve a compromise, as it must be acknowledged that without significant modification (i.e. redesign of both chambers to widen aisles, redesign benches, replace steps with ramps and platforms) a wheelchair user cannot access every seat no matter what equipment is installed.

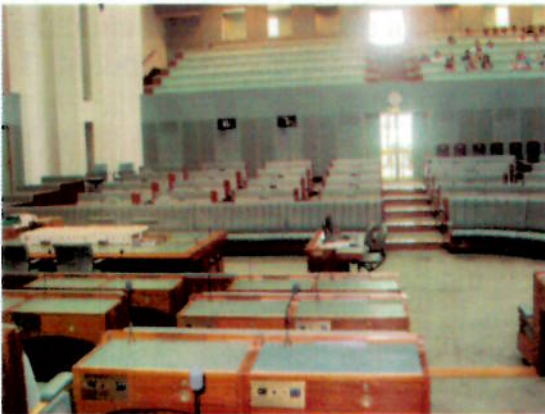
Additionally, the gaps between the benches are between 500mm and 300mm when not a designated aisle-way, which is insufficient for wheelchair access.

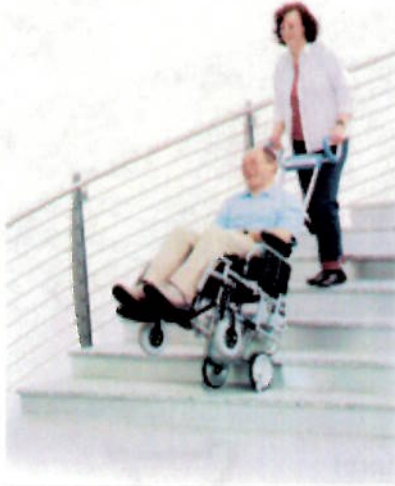
The Scalamobil is a lightweight compact stairclimbing device for wheelchairs that easily manages even narrow and winding stairs. Scalamobil can be adapted to hundreds of brands of wheelchairs as well as to various aids for children. Together with our [Scalachair X3](#) the Scalamobil is also useful for people who are not dependent on a wheelchair, but have problems with climbing stairs of all kinds. It is important to know that handling the Scalamobil does not call for physical strength. Due to its light weight and moderate dimensions, it is a device which is very easy to transport. Easily and quick dismantled it fits in the back of any vehicle.

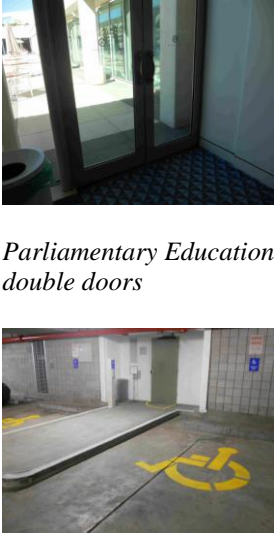
<p><i>Parliamentary Education double doors</i></p> <p><i>Typical powered entry doorway from Reps/Senate car parks</i></p>
<p>Passenger Lifts</p>			
13	Passenger lifts – carpet	Ensure carpet pile height in lifts is not greater than 11mm; or replace altogether with hardstand surface.	N/A
<p>Taxi</p>

No	Item	Recommendation(s)	Photo
			<p><i>Marble flooring at Marble Foyer.</i></p>
12	Doorways - automation	<p>Ensure the doors connecting the Parliamentary Education room with the Queens Terrace and doors connecting to rooftop domain are power operated. Currently doors are heavy to operate.</p> <p>Investigations to be undertaken for heavy-weight entry doorways that connect to key or high-traffic areas – eg, the double doors at the bridge links – to be power operated.</p> <p>Ensure fully automated hinged doors are programmed to remain open for a reasonable period of time – 15 seconds is recommended.</p>

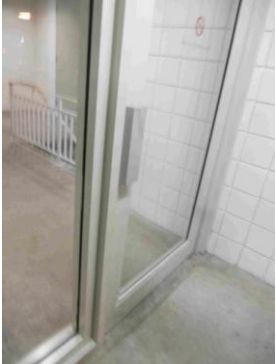
<p><i>Example of a current staff accessible car parking bay</i></p>
17	Staff accessible parking – paths of travel	<p>On every basement level where there is staff accessible car parking, ensure car park main entry doorways each have a minimum clear width of 850mm. Currently 770mm clear width.</p>

No	Item	Recommendation(s)	Photo
		area, immediate provision is recommended.	
Accessible Parking			
16	Accessible parking setout	<p>Ensure all accessible car parking bays have a clear width of 3.2m. Currently some have a clear width of less than 3.2m.</p> <p>Ensure all accessible car parking bays each have a minimum internal length of 5.4m. Currently all have a length of 5.0m.</p> <p>Any reconfiguration of accessible car parking is to maintain minimum of 2 per cent accessible parking up to 1000 spaces or part thereof, and 1 per cent for each 100 spaces thereafter.</p> <p>Any additional accessible car parking is to comply with AS 2890.6(2009) – that is, a 2.4m-wide bay and an adjacent 2.4m-wide hatched shared area.</p>

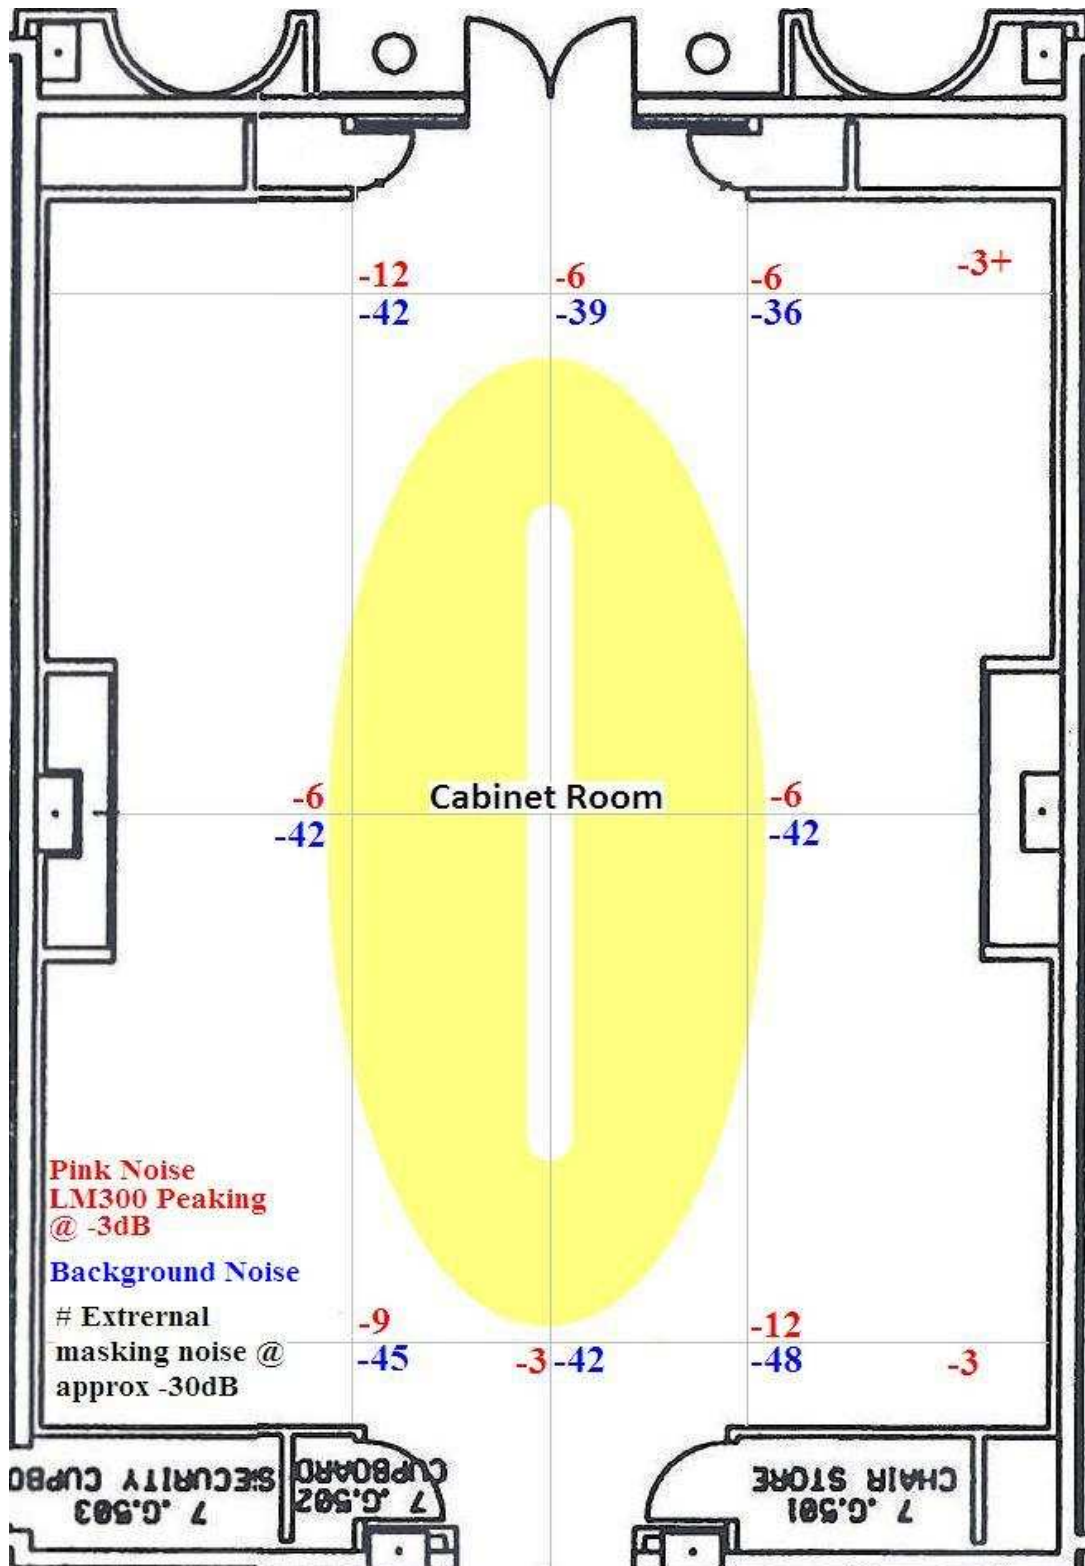
A31 Cabinet Room

Due to system integrity issues, this room was only partially tested with a low level pink noise source. During commissioning and certification by T4, this venue was compliant to a very stringent standard.
