# Post Incident Analysis Report

**MFB Burnley Complex  
450 Burnley Street  
Richmond VIC 3121**

Lacrosse Docklands  
673-675 La Trobe Street, Docklands  
25 November 2014

Report No: **1403134A**

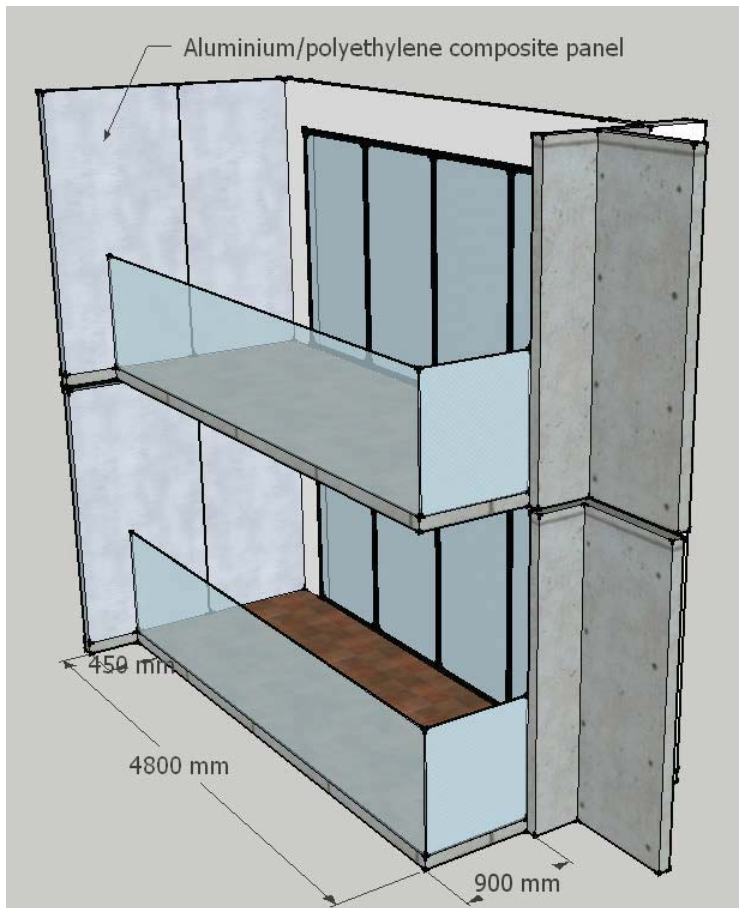
Figure 8 - Simplistic 3D interpretation of the balcony layout

The northern end of these balconies are bounded by 900mm concrete panels, which leaves the remaining 900mm balcony depth cantilevering out beyond the building face. A 1 metre high glazed balustrade is fitted to the remaining northern edge of the balconies and returns along the length of the eastern edge and butts into the southern wall.

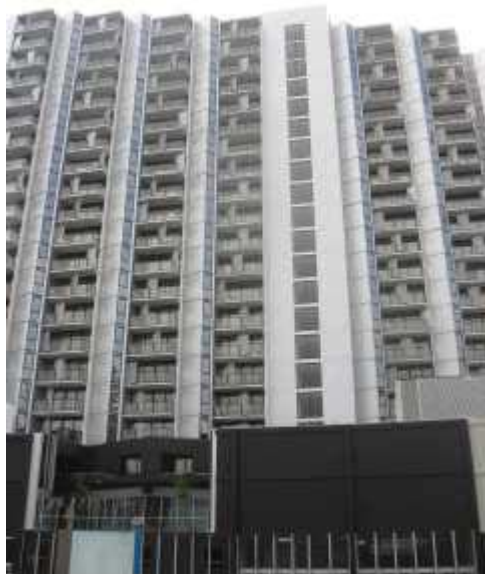
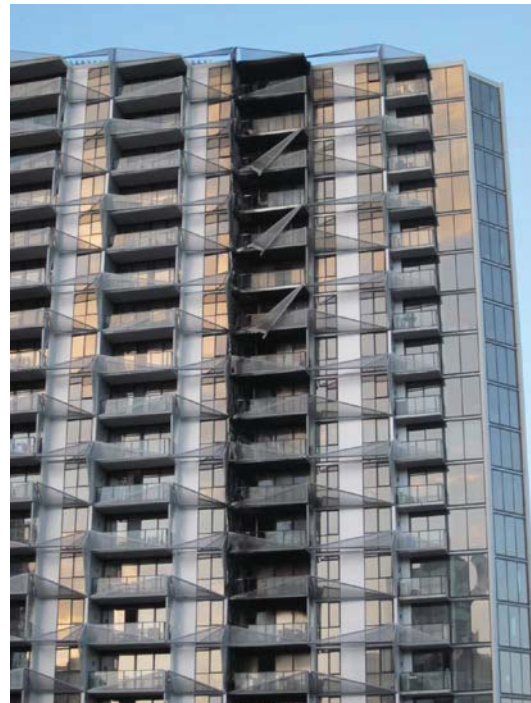
Photo Prior To Fire

Photo Post Fire

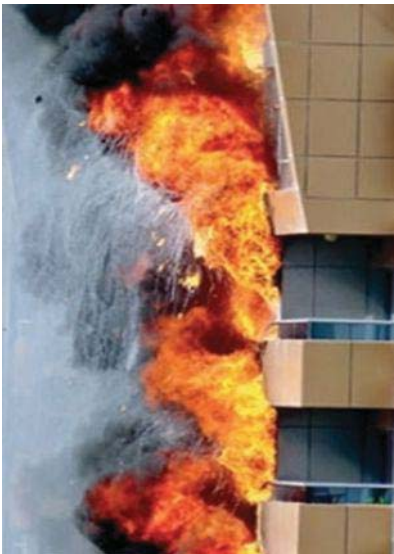
### Saif Belhasa Building, Tecom, Dubai 2012

- *13 storey residential building;*
- *Aluminium/polyethylene composite panel façade;*
- *Fire origin – 4th floor;*
- *Fire description – “fire rapidly spread to reach the top of the building”*

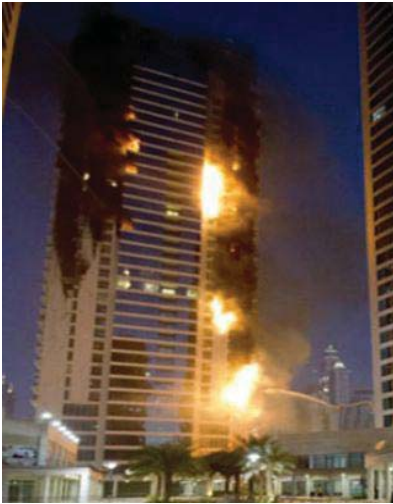
## Tamweel Tower, Dubai, 2012

- 34 storey residential building (contains mixed use)
- Aluminium/polyethylene composite panel façade;
- Fire origin – roof level
- Fire description - “spread down the exterior of the building.”
