Deepwater Horizon Accident Investigation Report

September 8, 2010

Analysis 5A. Well Integrity Was Not Established or Failed

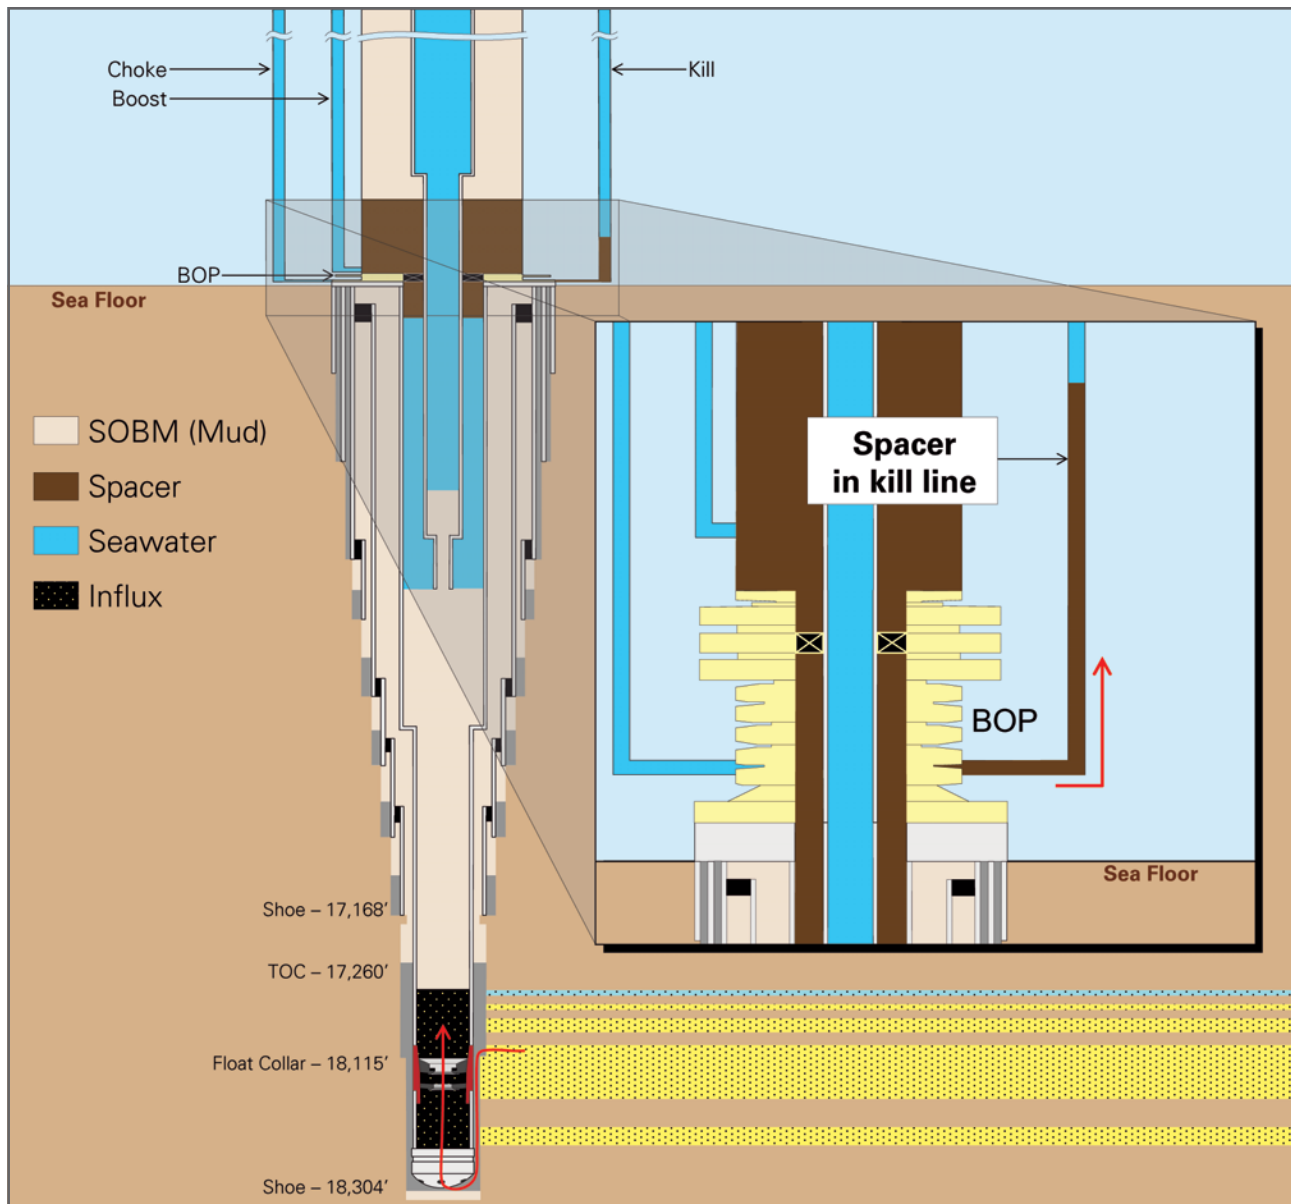
Figure 3. Possible Movement of Spacer into the Kill Line.

The BP Macondo well team provided broad operational guidelines for the negative-pressure test. The rig crew and well site leader were expected to know how to perform the test. The rig crew began the negative-pressure test by monitoring the drill pipe flow. According to witness accounts, this was the rig crew's preferred practice. However, the *Application for Permit to Modify (APM)* to MMS for the Macondo well temporary abandonment stipulated that the negative-pressure test should be conducted by monitoring the kill line. The well site leader noticed the discrepancy and after a discussion with the rig crew, preparations for continuing the negative-pressure test were made by bleeding the kill line. According to witness accounts, between 3 bbls and 15 bbls of seawater flowed from the kill line, which was then shut in.

From 18:00 hours to 18:35 hours, the drill pipe pressure increased from approximately 50 psi to 1,400 psi. To resume the negative-pressure test, the kill line was filled and then opened, 0.2 bbls flowed, and no further flow was observed from the kill line during a 30-minute period of monitoring. The drill pipe pressure was constant at 1,400 psi.

This pressure of 1,400 psi on the drill pipe was misinterpreted by the rig crew and the well site leaders. According to witness accounts, the toolpusher proposed that the pressure on the drill pipe was caused by a phenomenon referred to as ‘annular compression’ or ‘bladder effect.’ The toolpusher and driller stated that they had previously observed this phenomenon. After discussing this concept, the rig crew and the well site leaders accepted the explanation. The investigation team could find no evidence that this pressure effect exists.

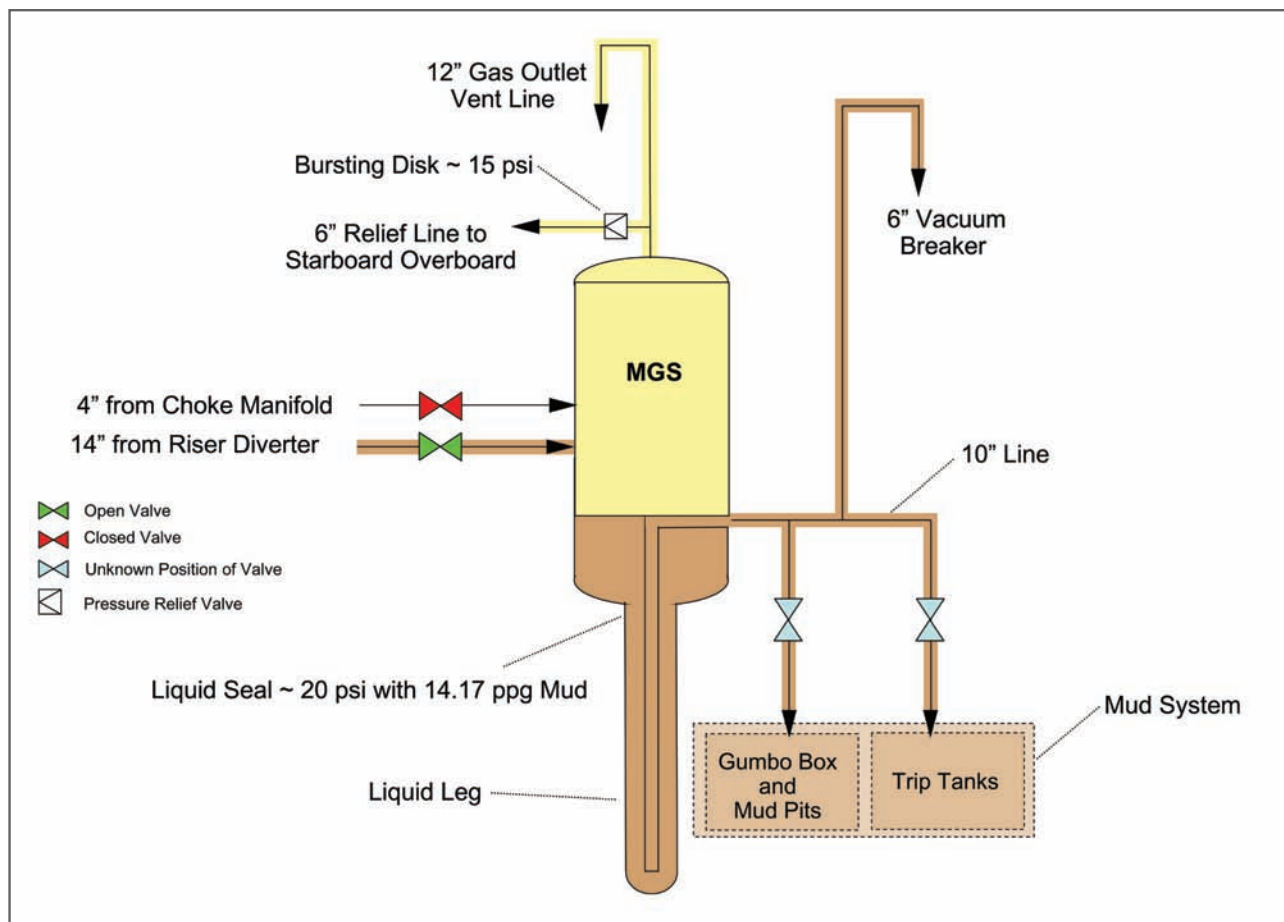
Figure 5. Mud Gas Separator.

The diversion of fluids overboard, rather than to the MGS, may have given the rig crew more time to respond and may have reduced the consequences of the accident.

Transocean's shut-in protocols did not fully address how to respond in high flow emergency situations after well control has been lost. Well control actions taken prior to the explosion suggest the rig crew was not sufficiently prepared to manage an escalating well control situation.

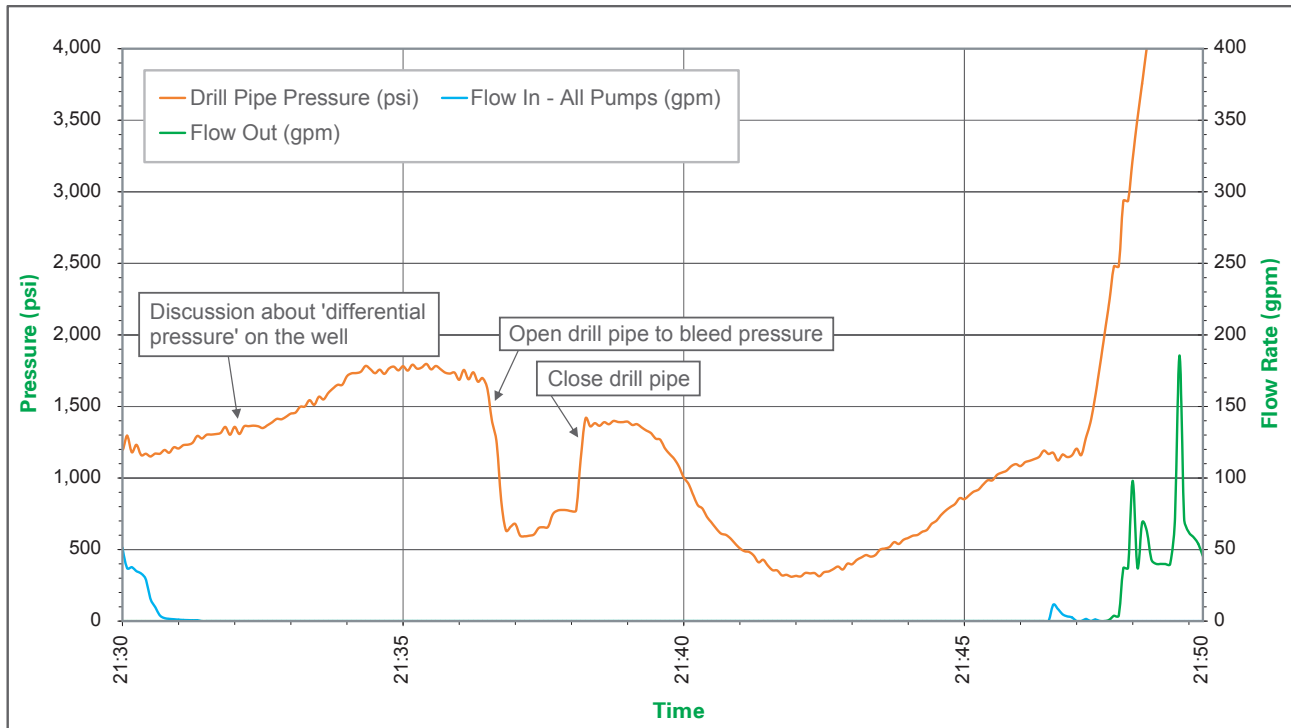
Figure 15. Investigation of Pressure Responses After Shutting Down Pumps (Real-time Data).

- The sudden pressure changes between 21:36 hours and 21:38 hours were indicative of a bleed-off at the surface. Modeling supported the bleeding of the drill pipe at the surface through a 4 in. surface line as the likely action taken at this time because the pressure response is immediate. (Refer to Figure 15.) A pressure transient caused by a pressure drop deep within the well would have been indicated by a slower pressure change on the real-time data.

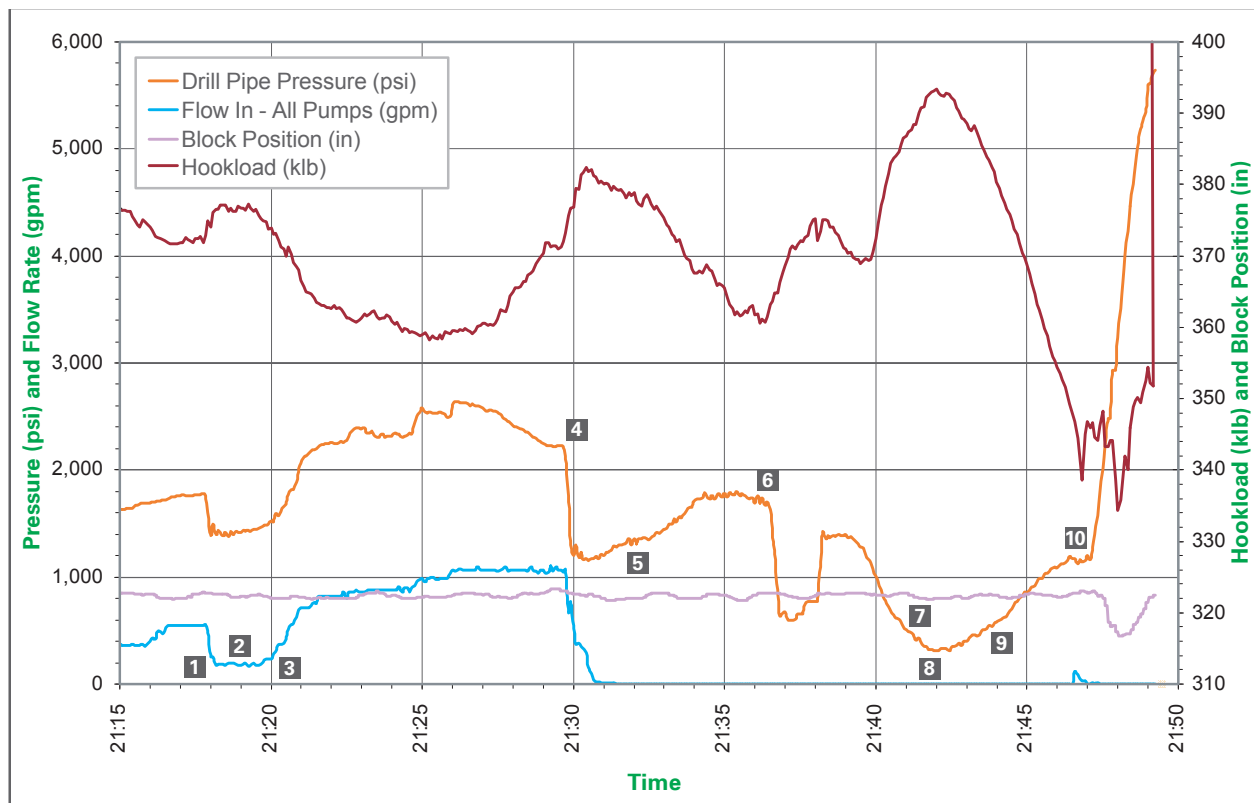
Figure 17. Interpretation of Well Control Response (Real-time Data).

- Analysis shows that to create the pressure increase observed on the drill pipe from 21:42 hours to 21:47 hours, the annular preventer was over 99% closed (but not fully sealed) around the drill pipe. If the annular preventer was fully closed and sealed during this time period, the pressure increase would have been more immediate. (Refer to *Analysis 5D. The Blowout Preventer Did Not Seal the Well* of this section for a detailed explanation.)

- One of two possible actions would have caused the rapid pressure increase to 5,730 psi from 21:47 hours to 21:49 hours:
 - The rig crew possibly first closed an annular preventer and then closed a VBR in accordance with Transocean’s protocol for handling well control events.

- The rig crew possibly first closed an annular preventer and then increased its closing pressure to create a seal.

| <ul style="list-style-type: none"> 1 Pressure relief valve on pump #2 opens; toolpusher called to rig floor. 2 All pumps shut down except boost pump. 3 Assistant driller called to pump room. 4 Pumps shut off. 5 Toolpusher and driller discuss 'differential pressure.' 6 Opening of 4" surface line to bleed pressure. | <ul style="list-style-type: none"> 7 Mud/water flows onto rig floor and then unloads through the derrick. 8 Diverter and annular preventer activated; diverted to mud gas separator. 9 Well site leader and senior toolpusher receive calls from rig floor; annular preventer attempting to close. 10 BOP sealing. |

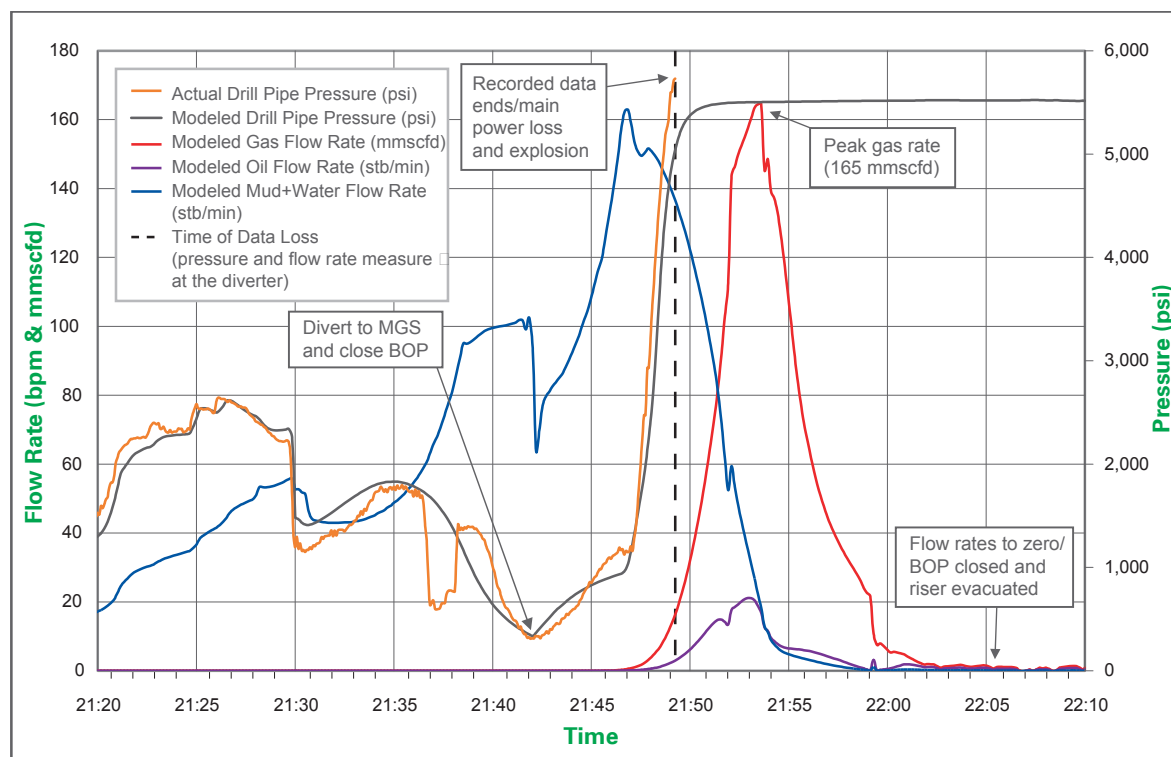
Figure 1. OLGA® Well Flow Modeling Prediction of Fluid Outflow from the Riser.

Figure 1 shows the predicted flow rates of mud/water, gas and oil. At approximately 21:46 hours, the gas reached the surface, and over a 5-minute period the flow of gas increased to more than 140 mmscfd. Simultaneously, the flow of mud and water to the surface reduced from 140 bpm to 20 bpm. The modeled timeline of flow to the surface aligns with eyewitness accounts described in *Table 1*.

Based on the assumption that the BOP remained closed and sealed around the drill pipe, *Figure 1* shows that predicted flow tails off approaching 22:00 hours, though it is evident from the actual event that this did not occur. (Refer to *Appendix W. Report–Dynamic Simulations Deepwater Horizon Incident BP.*) The failure modes that may have allowed the flow to continue are described in *3.5 Sustaining the Flow Following the Closure of the BOP* of this analysis.

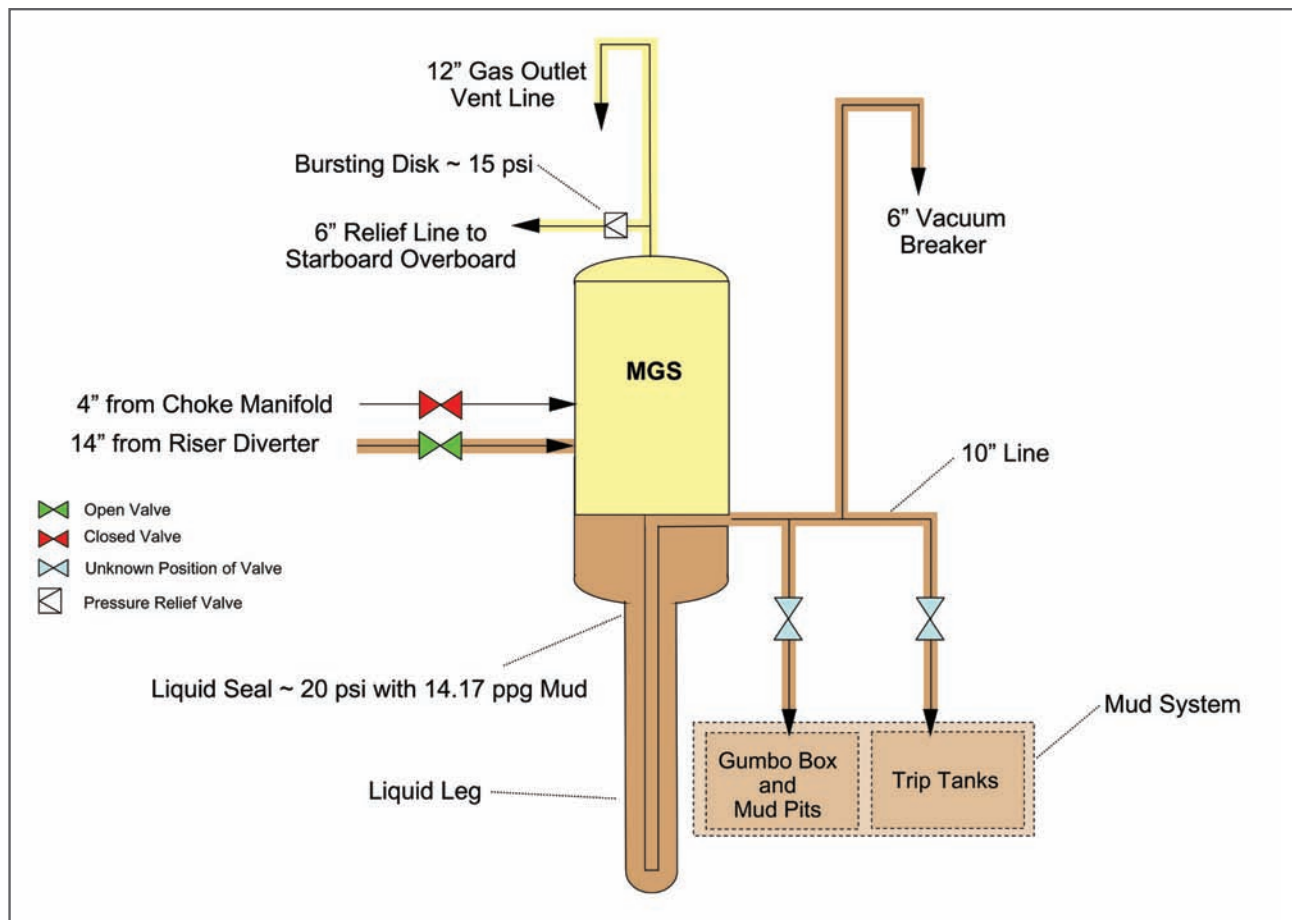
Figure 3. Simplified Drawing of the MGS.

- 14 in. inlet line from the riser diverter.
- 4 in. inlet line from the choke manifold.
- 12 in. outlet vent line terminating at the top of the derrick.
- 10 in. liquid outlet that could be lined up to either the gumbo box or the trip tanks.
- 6 in. relief line flowing overboard to the starboard side.
- 6 in. vacuum breaker terminating approximately one-third of the way up the derrick.

Because the 12 in. MGS outlet vent and the 6 in. vacuum breaker vent were goosenecked, they would have diverted flow back down toward the rig.

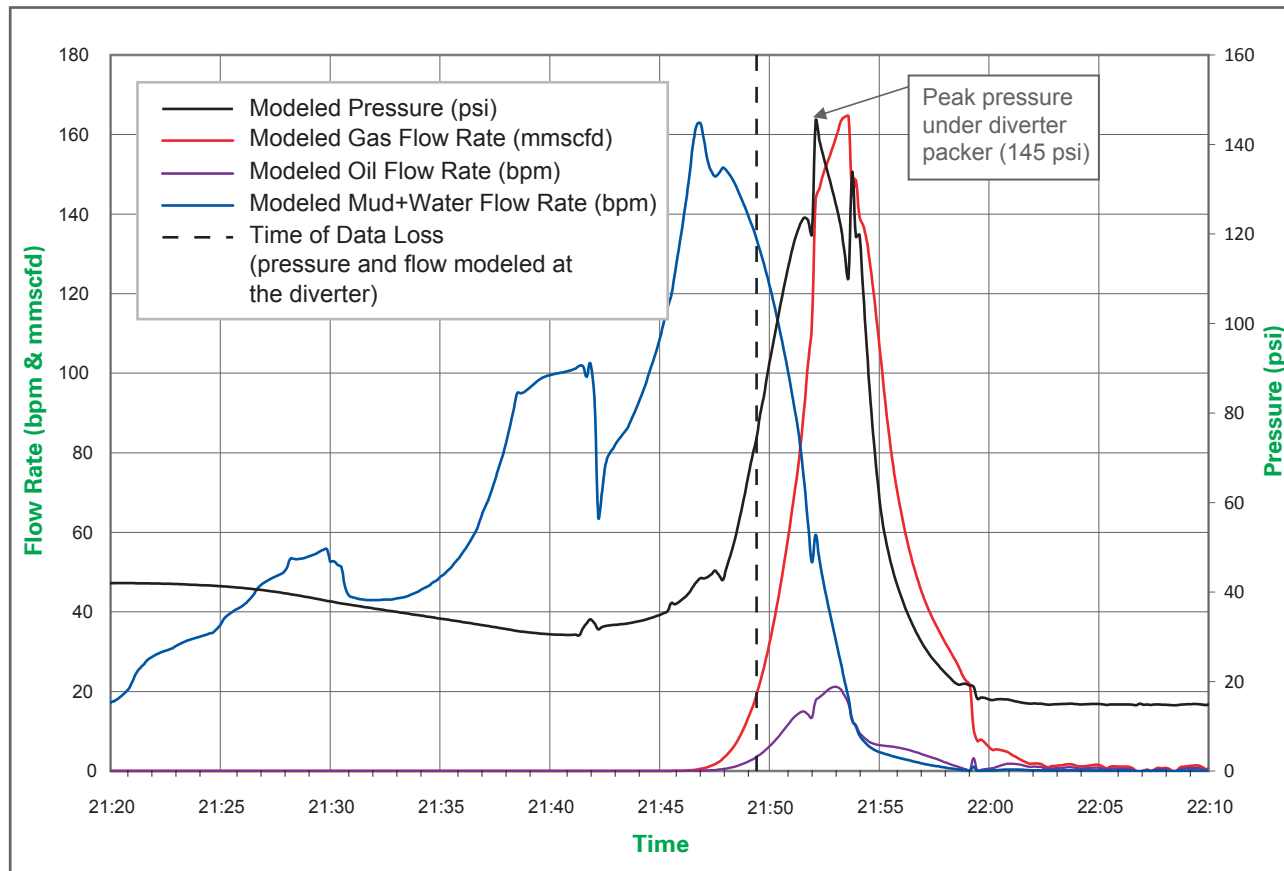
Figure 4. OLGA® Well Flow Modeling Prediction of Backpressure and Flow at the Diverter Packer.

A simplified model of surface equipment was used to determine the backpressure at the diverter packer. As shown in *Figure 4*, this pressure could have reached 145 psi.

At these pressures it was possible that some components of the MGS vessel such as flange connections began to fail, but it was unlikely that the vessel itself ruptured.

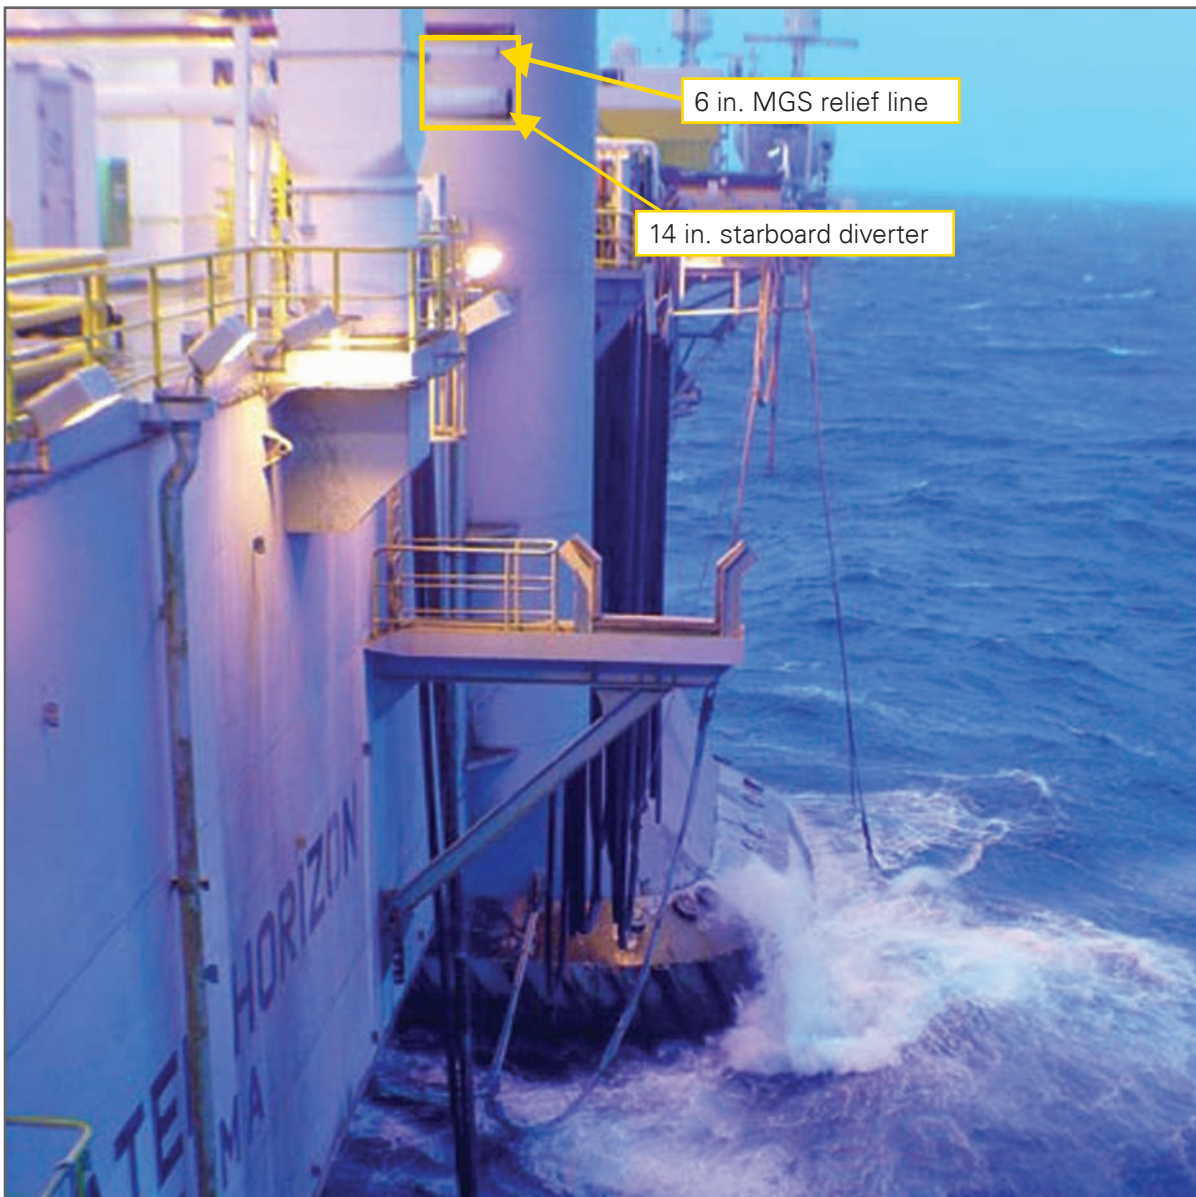
Figure 6. Photograph of Starboard Overboard Lines.

The photograph in *Figure 6* shows that the 6 in. MGS relief line was routed along the same path as the main 14 in. starboard diverter and terminated at the same location on the starboard side of the rig.

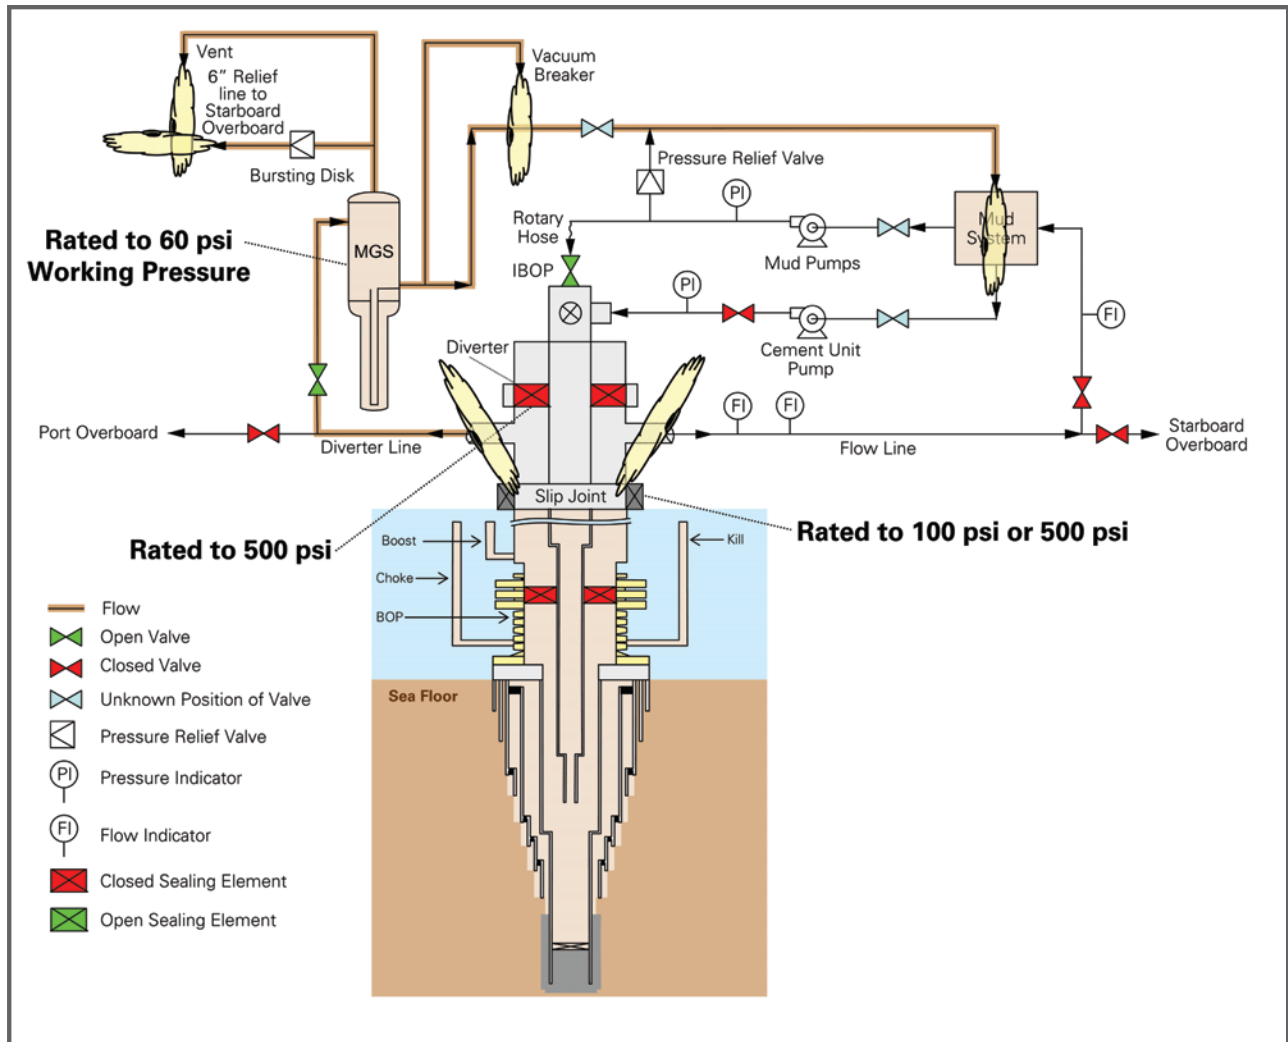
Figure 8. Schematic of Postulated Hydrocarbon Release Locations.

In addition to the MGS 12 in. vent, gas may also have vented onto the rig (Refer to Figure 8.) from the following places:

The case presented in this analysis assumes that the 12 in. MGS vent and the 10 in. MGS liquid outlet to the gumbo box, the riser slip joint seal, the MGS 6 in. bursting disk and the 6 in. MGS vacuum breaker vent were all open flow paths. *Figure 8* is a simplified illustration of these open flow paths.

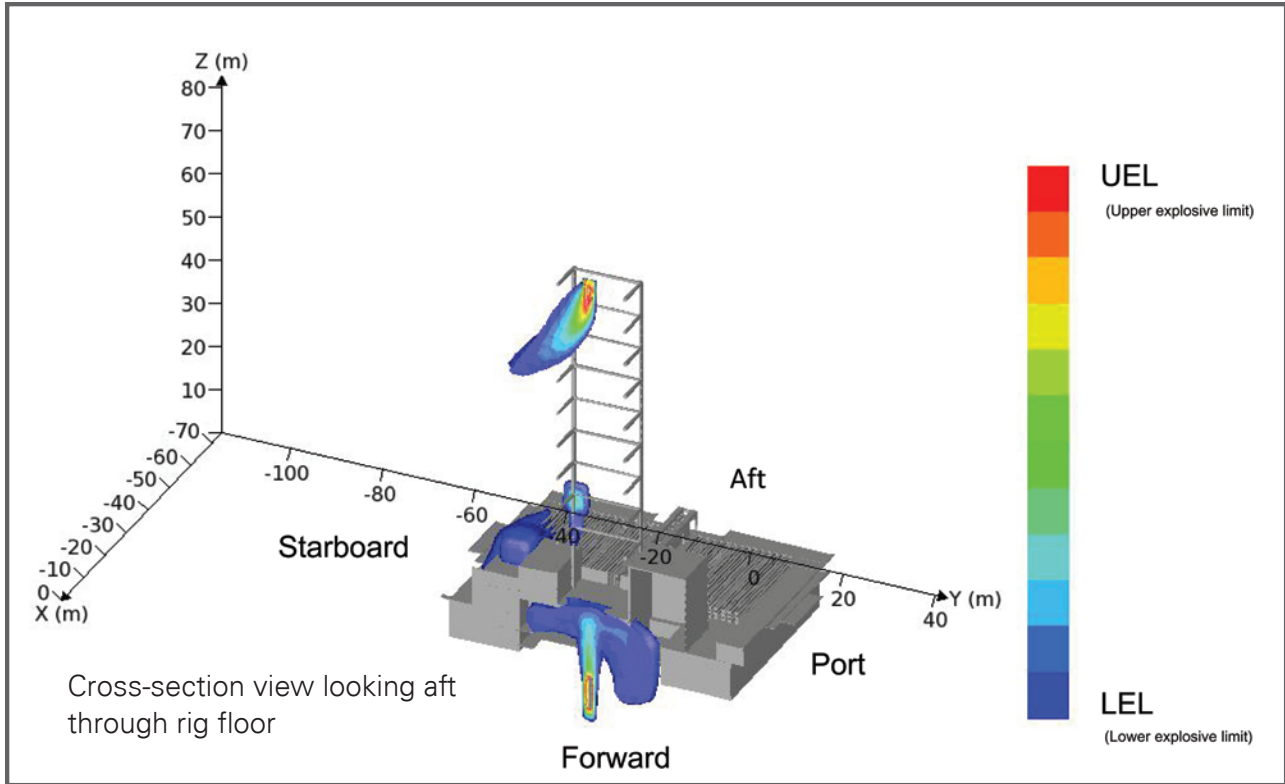
Figure 9. Vapor Dispersion at 100 Seconds.

The graphics in *Figure 9* and *Figure 10* show the modeled outcomes of gas rapidly dispersing across the drilling rig. Gas could have also migrated into enclosed spaces under the deck through the mud system or through the HVAC supply fans for the engine rooms.

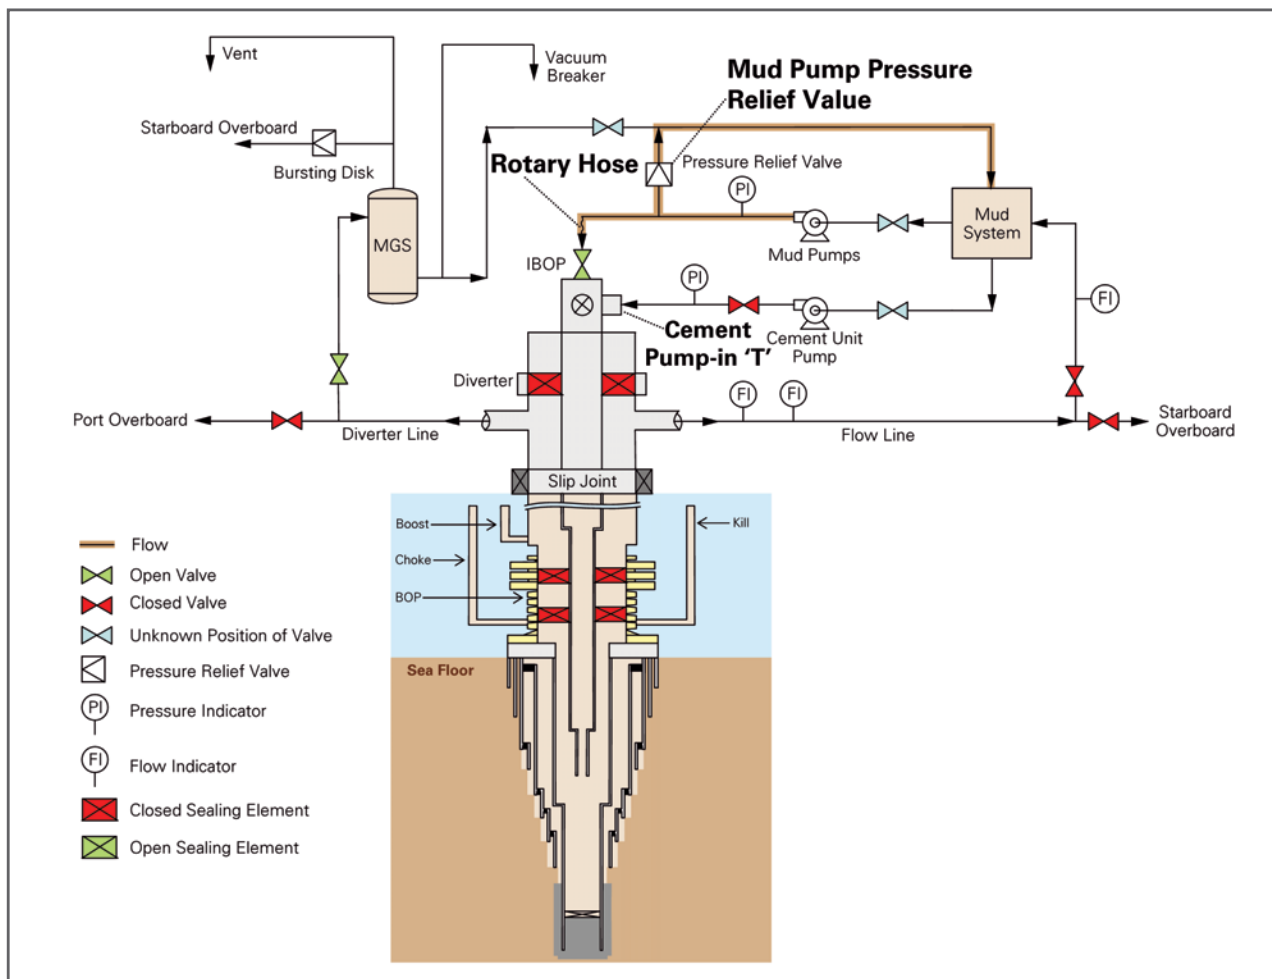
Figure 11. Relevant Surface Equipment Downstream of the IBOP at ~21:47.

It was important to clarify the position of the internal blowout preventer (IBOP) valve, as this determines the number of potential flow paths to the surface if the BOP had closed and sealed. The simplified process flow diagram in *Figure 11* shows that there were two pressure indicators (PIs), each of which was recorded via the real-time data system. One PI measured drill pipe pressure from upstream of the IBOP, and one measured drill pipe pressure from downstream of the IBOP.

With the IBOP open, there were a number of potential failure modes that may have created flow paths that sustained the fire following the initial hydrocarbon release from the riser (Refer to Figure 11):

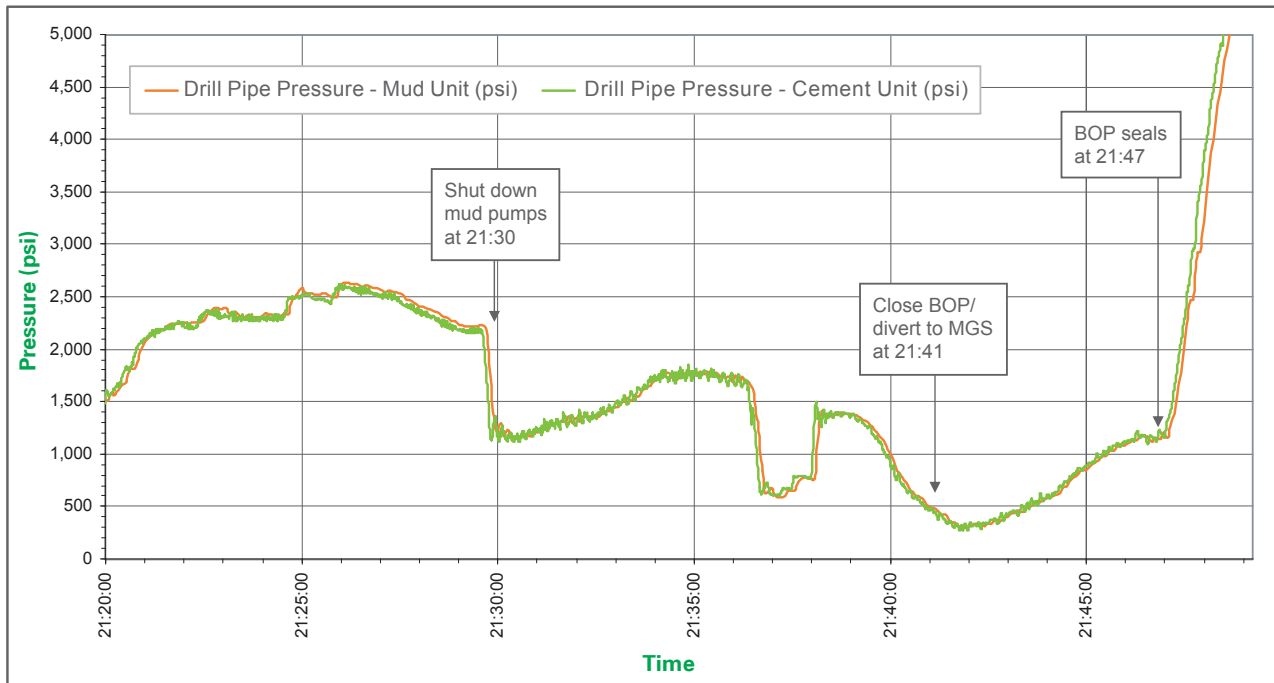
Figure 12. Drill Pipe Pressure Measured at Cement Pump PI and Mud Pump PI.

Figure 12 shows the pressure trend data from each of the PIs during the 30 minutes prior to the loss of power and the explosions. The fact that the trends tracked almost identically over a significant range of changing pressures indicates that the IBOP must have been open.

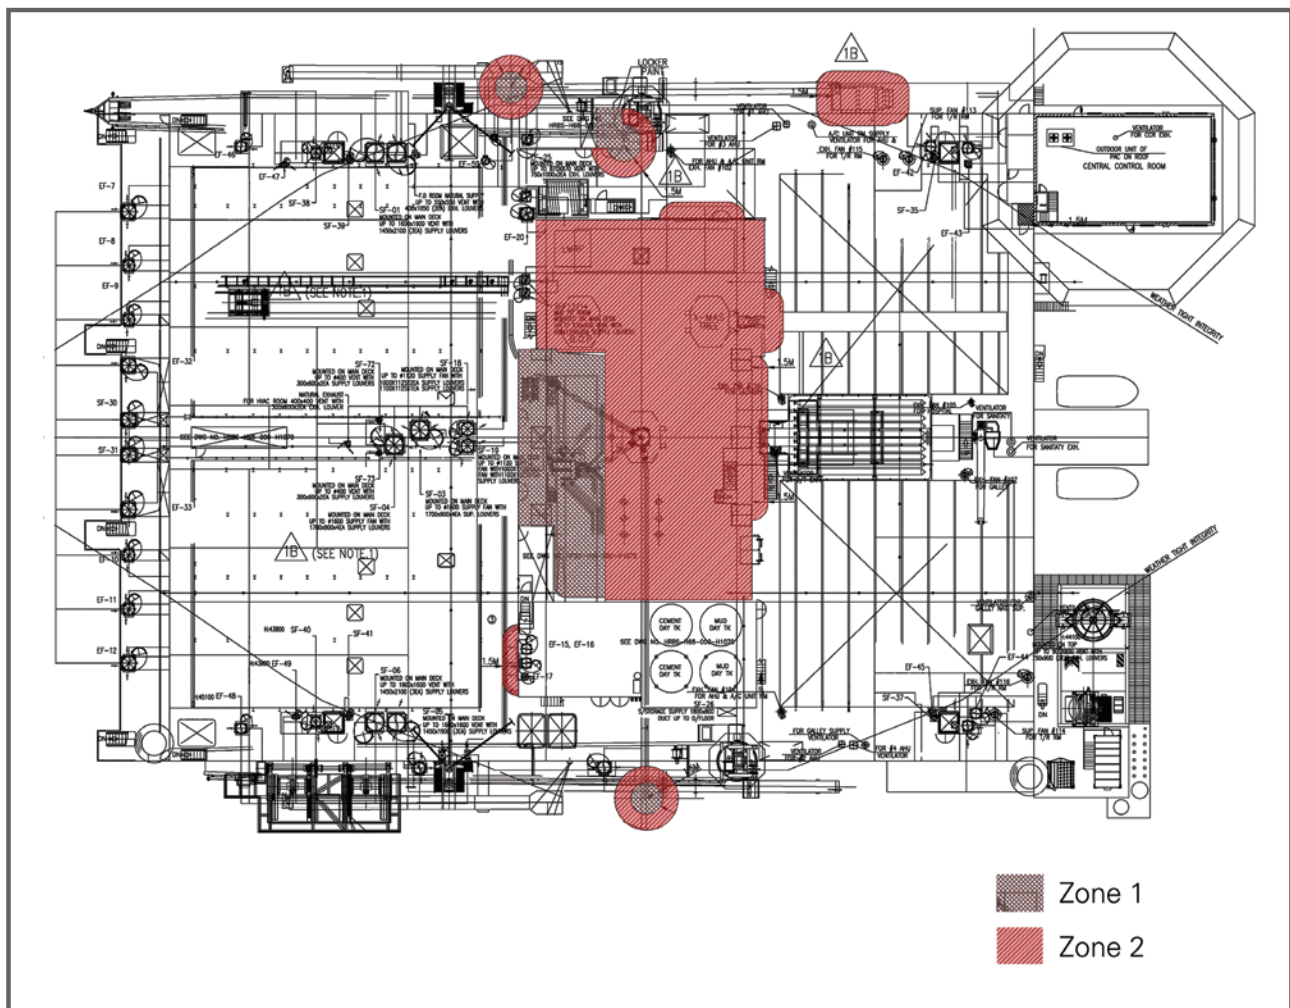
The extent of electrically classified areas on *Deepwater Horizon* appeared to be consistent with normal industry practices; however, for gas release events beyond the drill floor, multiple ignition sources could have existed. (Refer to Figure 17.)

Figure 17. Hazardous Area Classification—Main Deck.

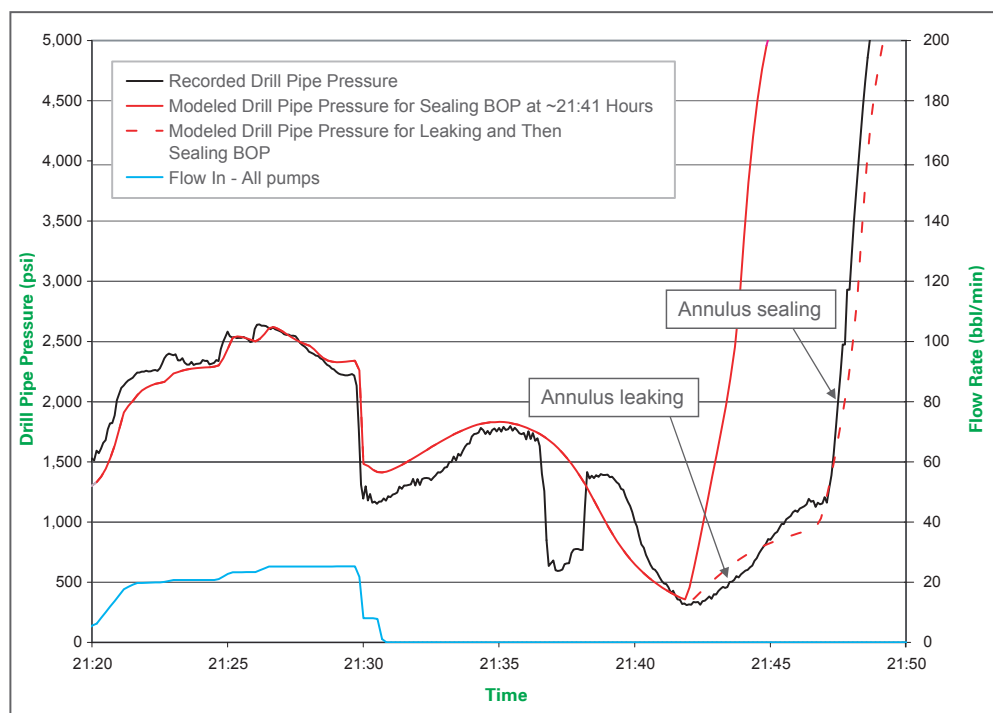
The recorded surface data, from approximately 21:41 hours to 21:49 hours on April 20 (the time at which Sperry-Sun real-time data stopped transmitting), is critical to understanding the BOP operation prior to the explosions. The data suggests that the normal mode of BOP operation sealed the annulus less than 2 minutes prior to the loss of data transmission just before the explosions. (Refer to 6. *Modes of BOP Operation* of this analysis, which provides a discussion of BOP normal and emergency modes of operation.) The BOP closed, but it was slow to seal. Based on the evidence and analysis to date, it is not certain which BOP components were operated to seal the annulus prior to the explosions. It is likely that a variable bore ram (VBR) eventually sealed the annulus.

As established in *Analysis 5B.*, the rig crew activated the BOP at approximately 21:41 hours. *Figure 1* shows the results from the OLGA® well flow modeling of the BOP as activated at 21:41 hours and closing and sealing the annulus in 30 seconds (solid red curve). (Refer to *Appendix W. Report—Dynamic Simulations Deepwater Horizon Incident BP*) However, the recorded drill pipe pressure (solid black curve) indicates that the annulus was sealed approximately 5 minutes later than the OLGA® well flow modeling predictions. Further OLGA® well flow modeling of the BOP closing in 30 seconds, but allowing leakage past the annular preventer for 5 minutes before fully sealing the annulus, resulted in a drill pipe pressure (dashed red curve) that closely followed the recorded pressure. This analysis indicates that the BOP closed within the expected time, but it did not fully seal for another 5 minutes.

Figure 1. Drill Pipe Pressure—OLGA® Well Flow Modeling of Drill Pipe Pressure for a Closing BOP Versus Recorded Data.

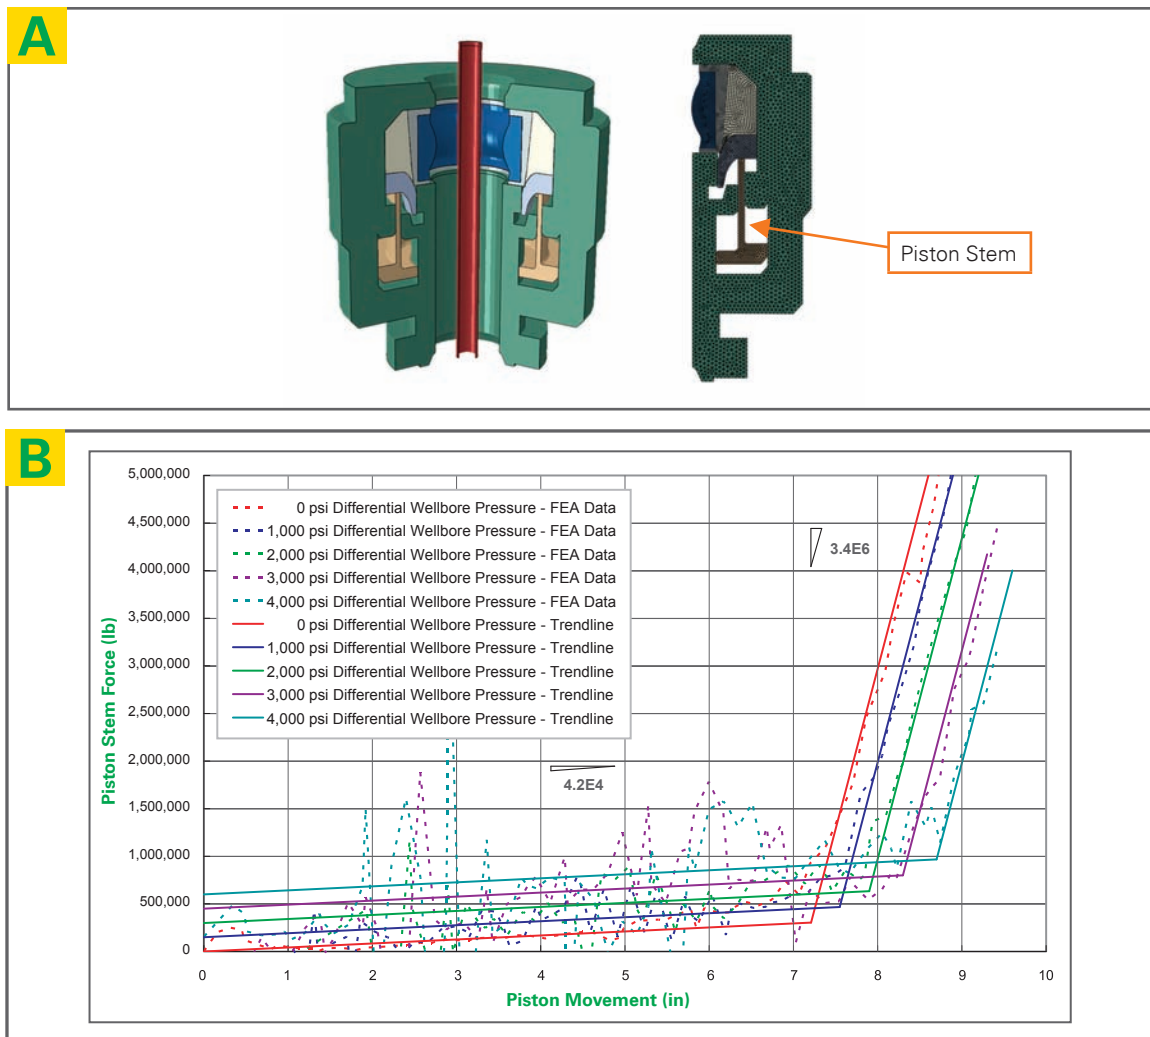
Figure 3. Finite Element Analysis of an Annular Preventer.
(A) Model Representation of an Annular Preventer Closing Around a Drill Pipe.
(B) Analysis Output for Piston Stem Force Versus Movement at 5,000 ft. WD for Various Wellbore Pressures.

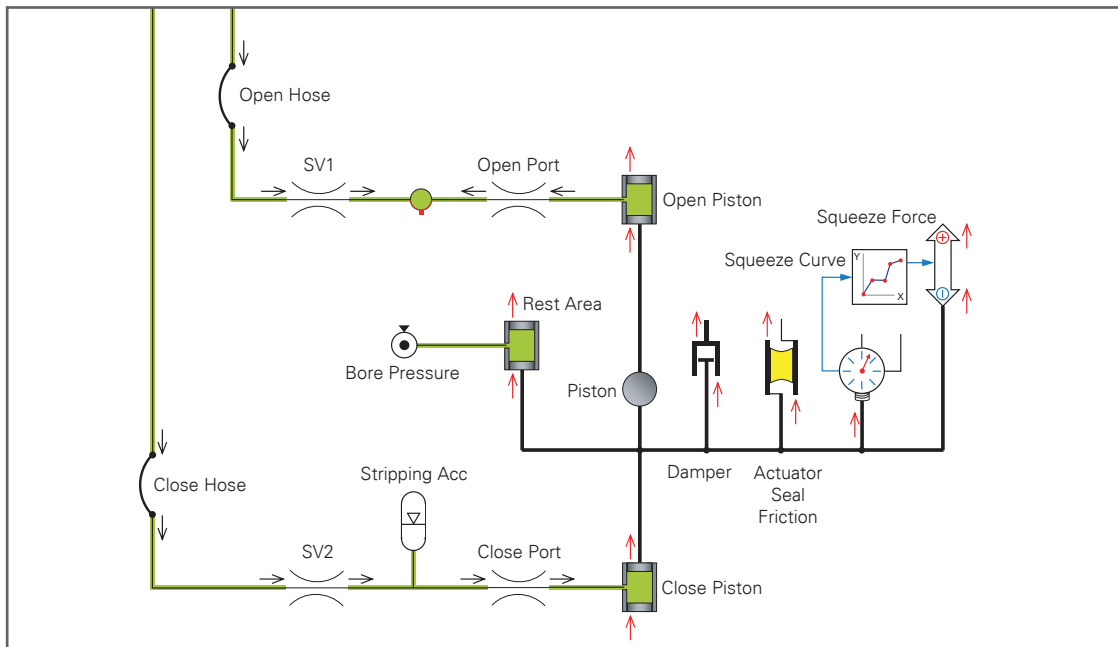
Figure 4. Model Representation of Hydraulic Control for Annular Preventer.

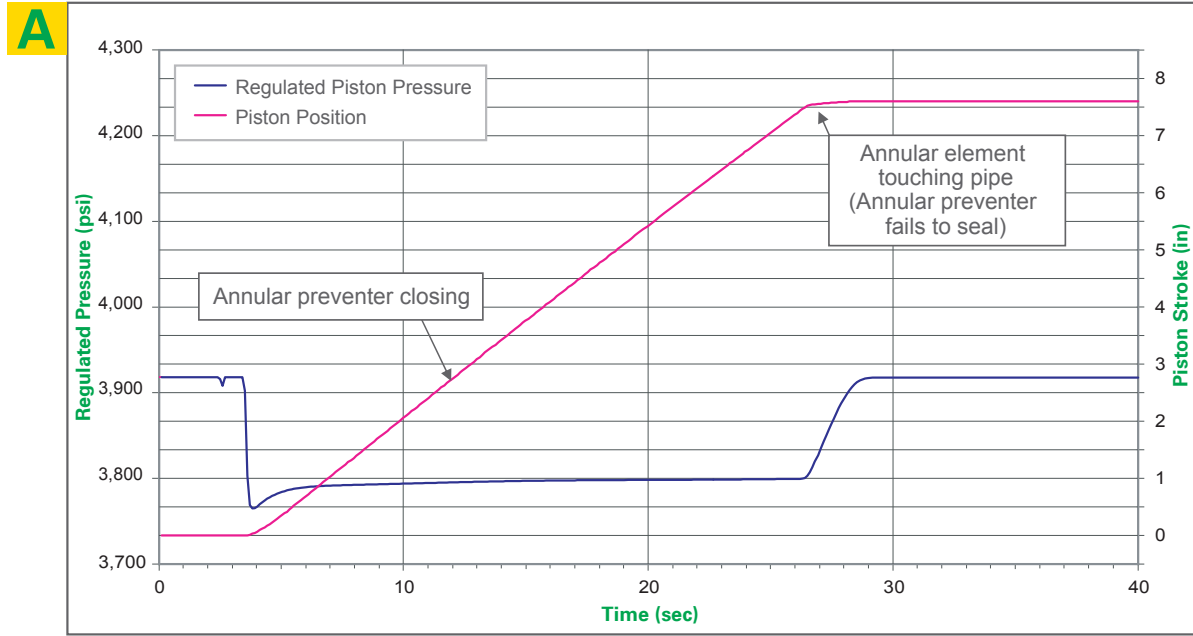
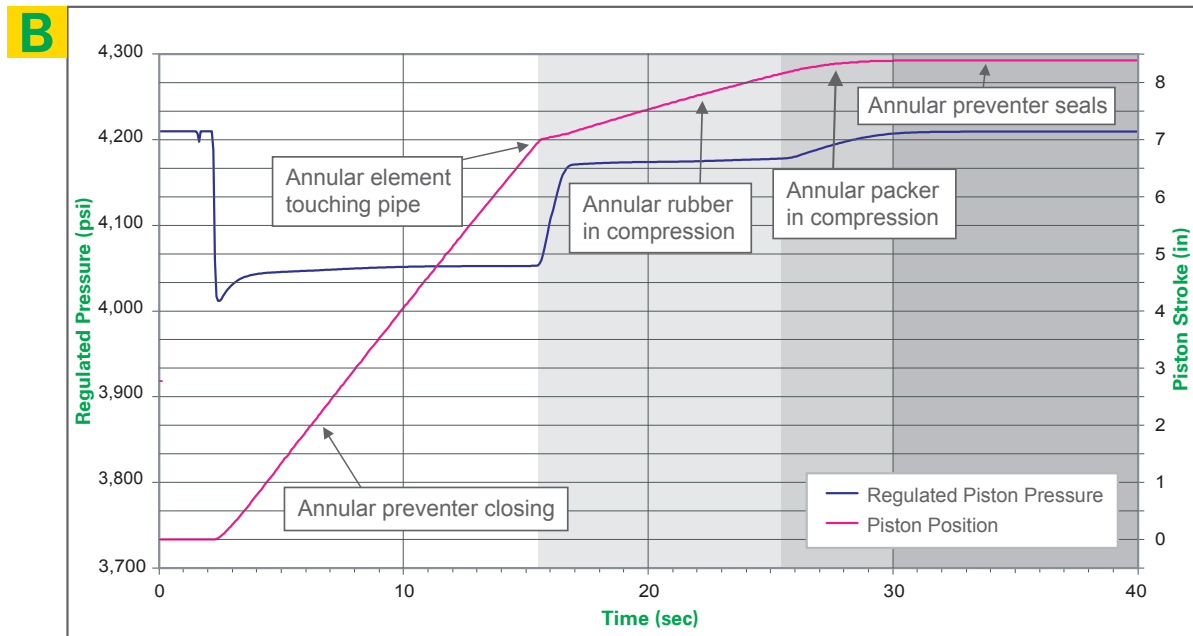
Figure 5 shows the dynamic response of an annular preventer at 5,000 ft. water depth (WD) operating under 1,700 psi and 2,000 psi regulated closing pressures. (Refer to Figure 5.) (Hydraulic pressures in this analysis are quoted in terms of differential pressure, which is the difference between the hydraulic system pressure and the hydrostatic pressure at the sea bed.) The wellbore pressure at the time of the closure of the annular preventer was approximately 2,500 psi. To represent an annular preventer closing in a flowing condition, the simulated pressure in the BOP was increased from 2,500 psi to the shut-in pressure of approximately 8,000 psi as the annular preventer elastomeric element was about to touch the drill pipe.

The dynamic response of the annular preventer operating under 1,700 psi regulated pressure indicated that the annular preventer failed to seal due to rapid increase in wellbore pressure as shown in *Figure 5(A)*. Hydraulic analysis further indicates that an annular preventer would seal around the pipe under a regulated pressure setting of 2,000 psi, as shown in *Figure 5(B)*.

Figure 5. Hydraulic Analyses of an Annular Preventer.
(A) Regulated Pressure of 1,700 psi.
(B) Regulated Pressure of 2,000 psi.
 (All pressures in the figure include hydrostatic head at the seabed.)
