Deepwater Horizon Accident Investigation Report

September 8, 2010

Analysis 5A. Well Integrity Was Not Established or Failed

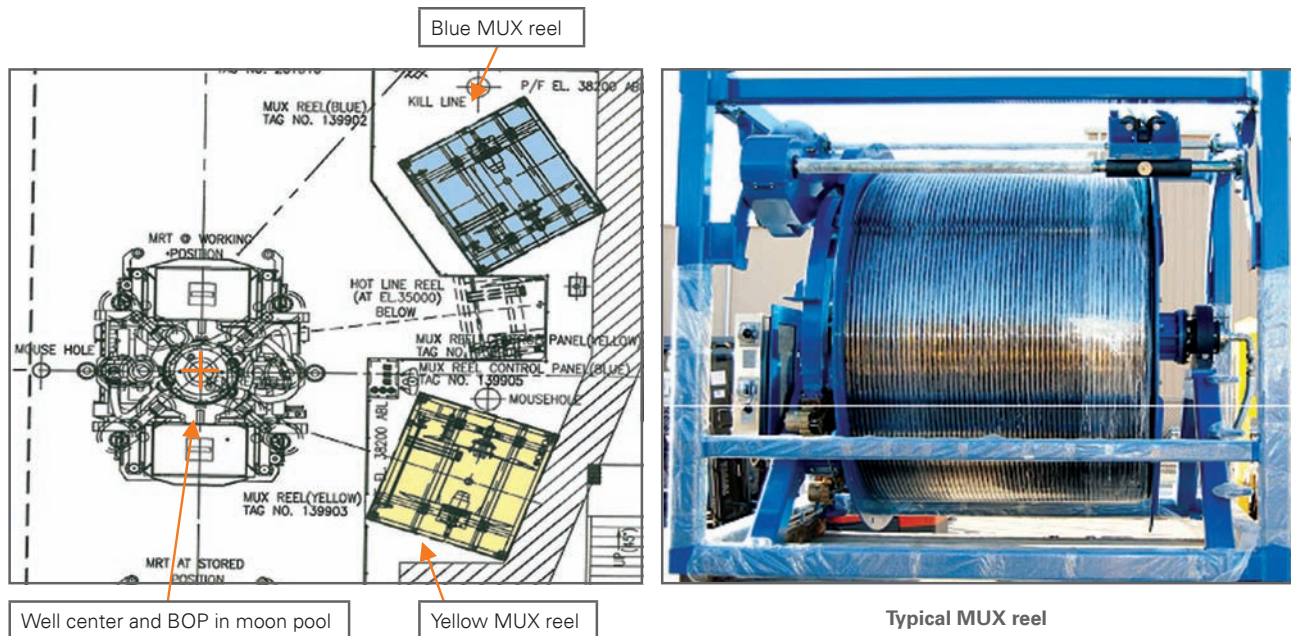
Figure 6. Moon Pool Layout Showing the Location of Blue and Yellow MUX Reels.

The MUX reels were located in the moon pool area within the explosion and fire zone. (Refer to Figure 6.) Since the MUX cables were not protected against explosions or fire, it is very likely that the early explosion and fire damaged the MUX reel slip rings and the cables to the extent that the communication line and electrical power required to initiate the high-pressure BSR and EDS functions were no longer available.

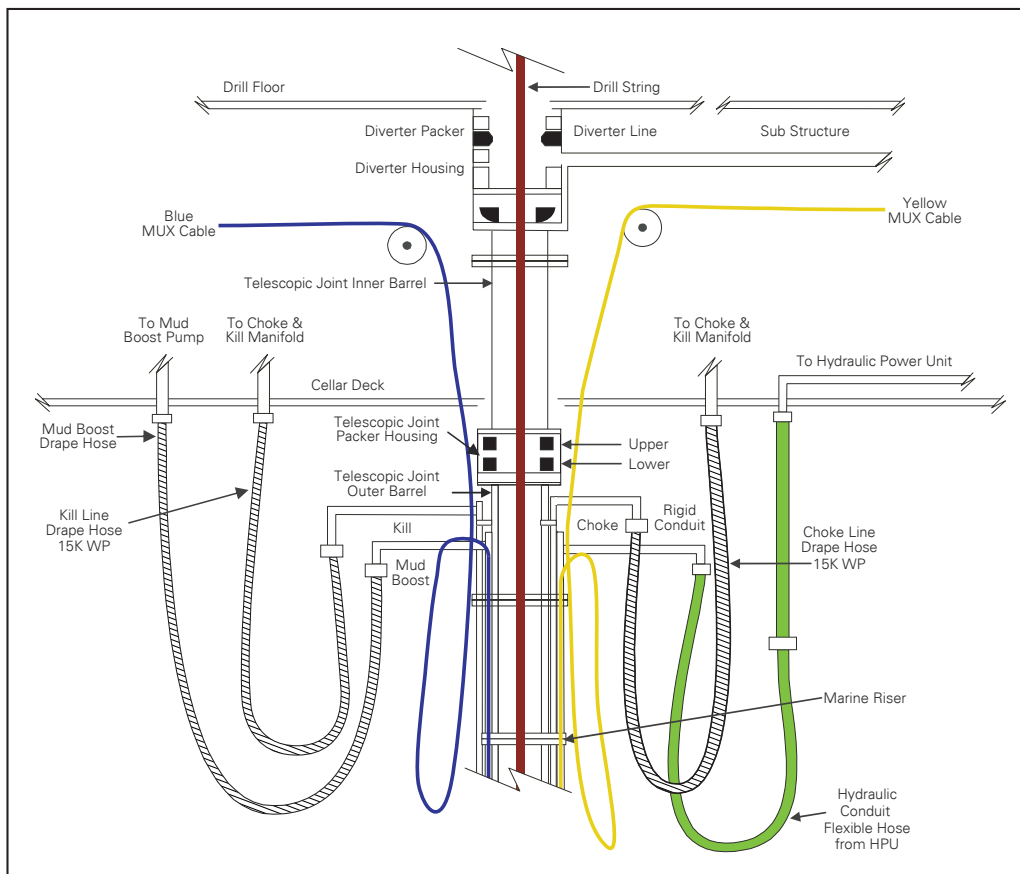
The AMF sequence is initiated when electrical power, communications and hydraulic pressure are lost to both pods. To initiate an AMF, all three services must fail (i.e., after damage to the MUX reels or cables and to the hydraulic conduit, caused by explosions and fire). As indicated in 3.1 of this analysis, the MUX cables, which carry electrical power and communications, were vulnerable to explosion and fire damage. Though the hydraulic conduit flexible hose was less vulnerable to damage than the MUX cables, it was located close to the MUX cables in the moon pool and could have been damaged by the explosions and fire. (Refer to Figure 7.)

Figure 7. Typical Configuration of Flexible Hoses in the Moon Pool.
(Hydraulic conduit flexible hose is shown in green).

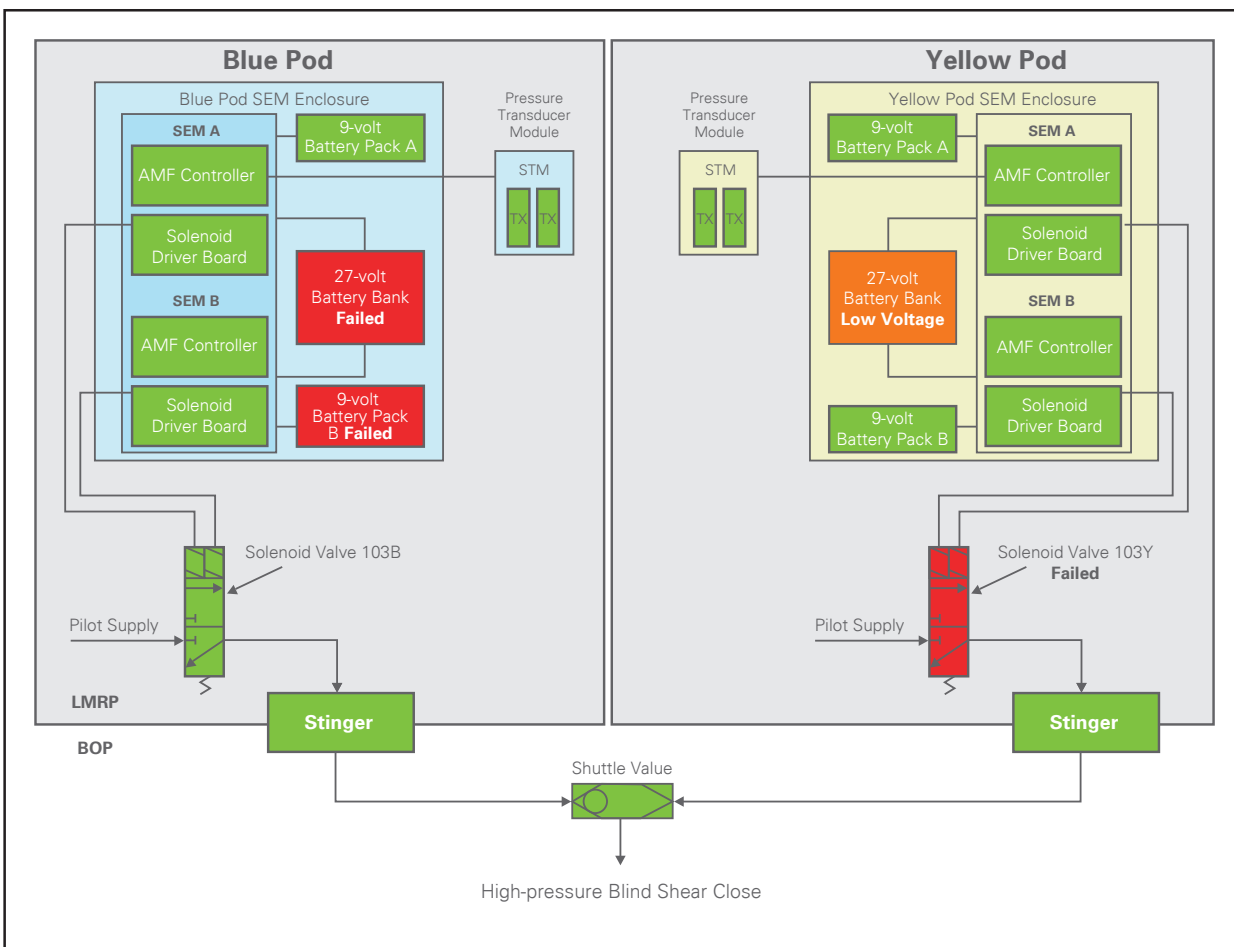
During the yellow pod test performed by Transocean and Cameron after the accident, both coils on solenoid valve 103 failed to energize, suggesting electrical coil faults. The investigation team found no evidence that this failure occurred after the accident; rather, the team concluded that this failure condition very likely existed prior to the accident. (Refer to 5.1 *Maintenance* of this analysis.) A faulty solenoid valve 103 would mean that the yellow pod could not have performed the AMF sequence, as no pilot

Figure 8. Simplified Schematic of the AMF Control System.

Figure 8 shows a simplified schematic of the AMF system. There were two 9-volt battery packs and a 27-volt battery bank (made up of 3 packs of 9-volt batteries connected in series) in each pod. These batteries were not rechargeable. The 9-volt AMF battery packs were used to power the AMF card processors. When the AMF was enabled, these batteries provided continuous power to the AMF cards. The 27-volt battery bank was used to provide power to the 24-volt rated AMF card relays, the pressure sensors and the solenoid valves that were used in the AMF sequence, including solenoid valve 103.

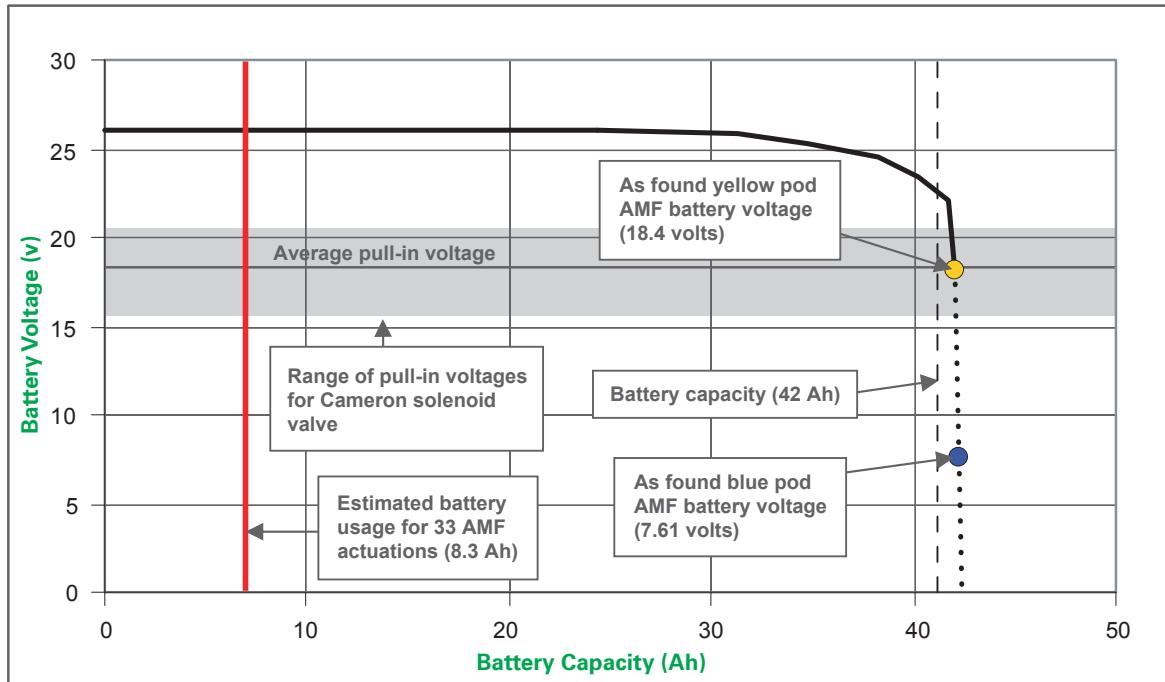
In 2004, Cameron, the BOP manufacturer, issued an engineering bulletin, *EB 891D*, recommending that battery banks be replaced after one year of operation or when the number of actuations exceeds 33 for that year, whichever comes first. The discharge curve for a 27-volt battery bank indicates that after 33 actuations, the battery bank would have expended only 20% of its expected life, as measured in ampere hours (Ah). The measured charge of 7.61 volts on the 27-volt battery bank was past the expected annual usage and was beyond the design life of the battery bank. (Refer to Figure 9 and *Appendix X. Deepwater Horizon Blue Pod AMF System Batteries.*)

The investigation team considers that it is very likely that the charge at the time of the accident would have been insufficient to activate the AMF.

The available maintenance records from 2001 to 2010 indicate that during this period, the AMF batteries were changed at a frequency less than the manufacturer's recommendation. The BOP control diagnostic functionality did not include measuring the charge on the AMF batteries. Transocean maintenance records for AMF batteries are discussed in 5.1 of this analysis.

Figure 9. Discharge Curve for a 27-volt AMF Battery Bank.

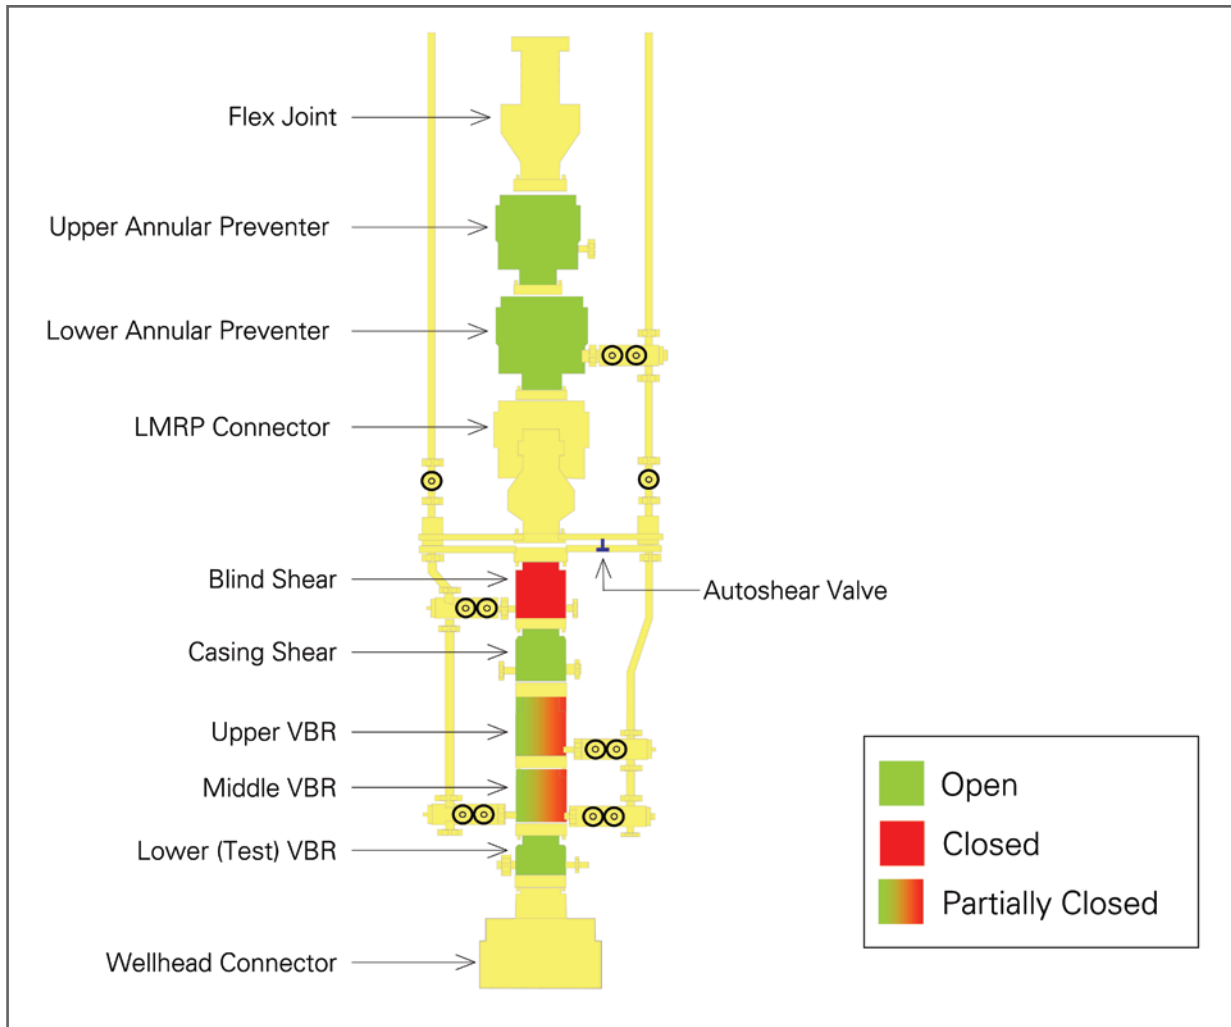
Based on these findings, the investigation team concluded that the upper, and possibly the middle, VBRs were likely closed by the rig crew.

Figure 13 shows the likely status of the BOP rams immediately after the initiation of autoshear.

Figure 13. Likely Status of BOP Rams Immediately After Autoshear Initiation.

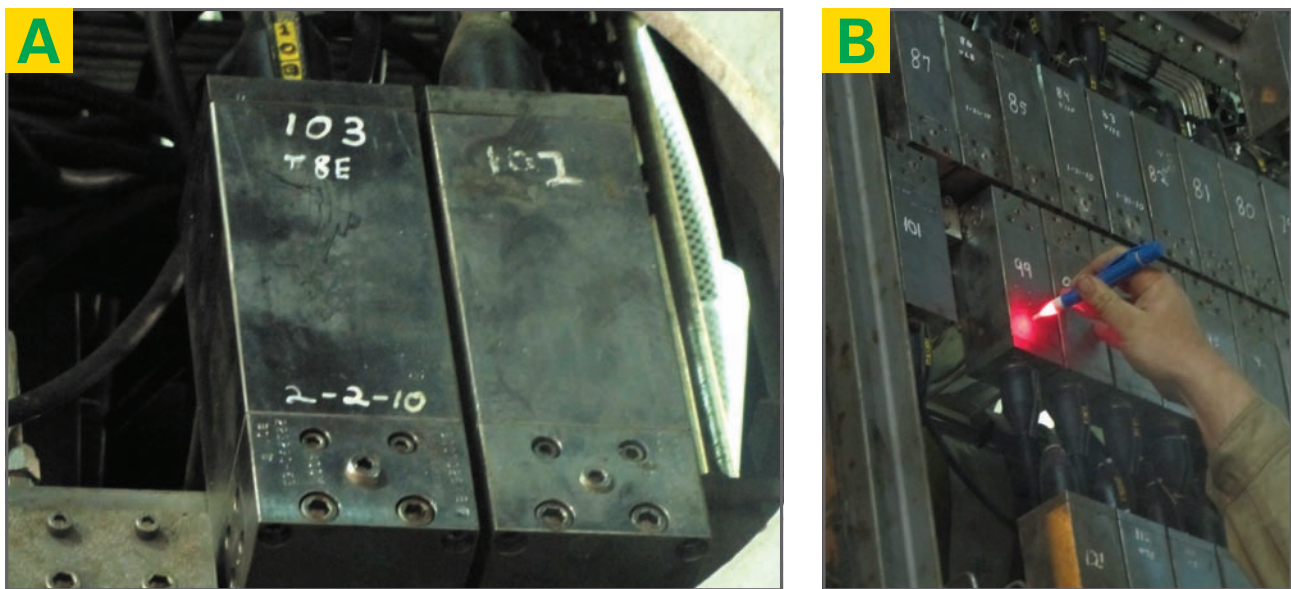
Figure 16. (A) Photograph of Solenoid Valve 103 in the Yellow Pod. **(B)** Testing of Solenoid Coils.

- Solenoid valve 103 in the yellow pod, which was required to operate the high-pressure BSR close function, was found to be defective. (Refer to Figure 16.) This solenoid valve also had a non-OEM electrical connector installed.
- Solenoid valve 3A in the yellow pod, which was required to increase the upper annular preventer regulator pressure, was also found to be defective.

- The investigation team considers that even if the yellow pod batteries had sufficient charge, the status of the solenoid valve 103 would have prohibited the closure of the BSR from the yellow pod.

The control system was capable of identifying the coil defects in solenoid valves 103 and 3A in the yellow pod and logging them in the event logger. A failure mode effects and criticality analysis (FMECA) performed as part of a BOP assurance analysis of *Deepwater Horizon* BOP stack identified this failure mode. As stated in the FMECA report, when this failure is detected, the mitigation is "Switch to alternate pod, secure well and pull LMRP."

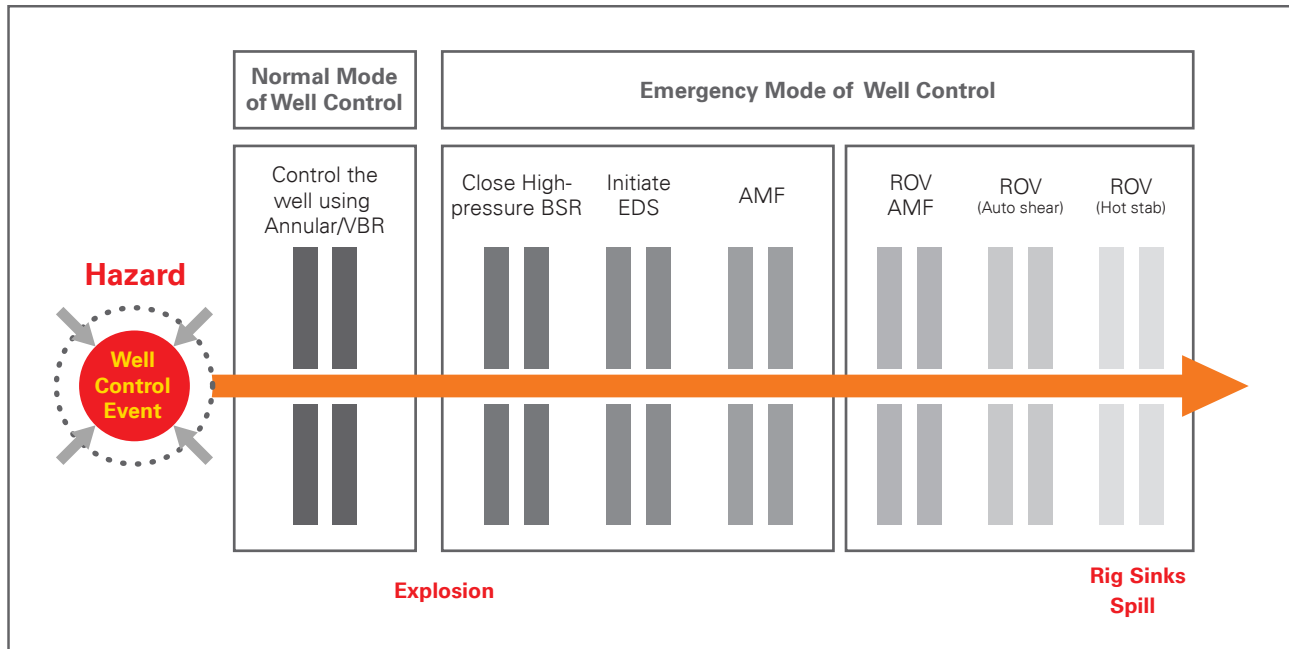
Figure 20. BOP Well Control Modes of Operation.

- **AMF:** an automatic means of closing the high-pressure BSR when electrical power, electronic communication and hydraulic pressure are all lost. AMF is designed to mitigate the risk caused as a result of catastrophic failure of the riser with the resultant reduction of hydrostatic head of mud in the riser to seawater hydrostatic head. This function had to be manually armed by rig personnel from the BOP control panel and required at least one operational control pod. The accumulators on the BOP stack were the only source of hydraulic power for this function. The investigation team concluded that the AMF very likely did not function due to the condition of critical components in the control pods.

- **ROV-initiated AMF:** a simulation of AMF conditions to close the high-pressure BSR by using an ROV to cut power/communication and hydraulic lines at the LMRP. This was attempted hours before the rig sank, but the investigation team concluded that the AMF very likely did not function due to the condition of critical components in the control pods.

The rig crew attempted the normal mode of BOP system operation (using an annular preventer and possibly a VBR) prior to the accident. The emergency mode of well control shown in *Figure 20* relates to the period after the accident, but only the ROV hot stab intervention continued after the rig sank.
