Submission 40 - Welding Technology Institute of Australia

SUPPLEMENTARY SUBMISSION TO THE SENATE INQUIRY INTO: THE FUTURE OF AUSTRALIA'S STEEL INDUSTRY

POLICY PROPOSAL: SAFETY OF FABRICATED STRUCTURAL STEEL

Bussellton Pedestrian Bridges Visual Examination and Commentary Regarding Weld Quality >

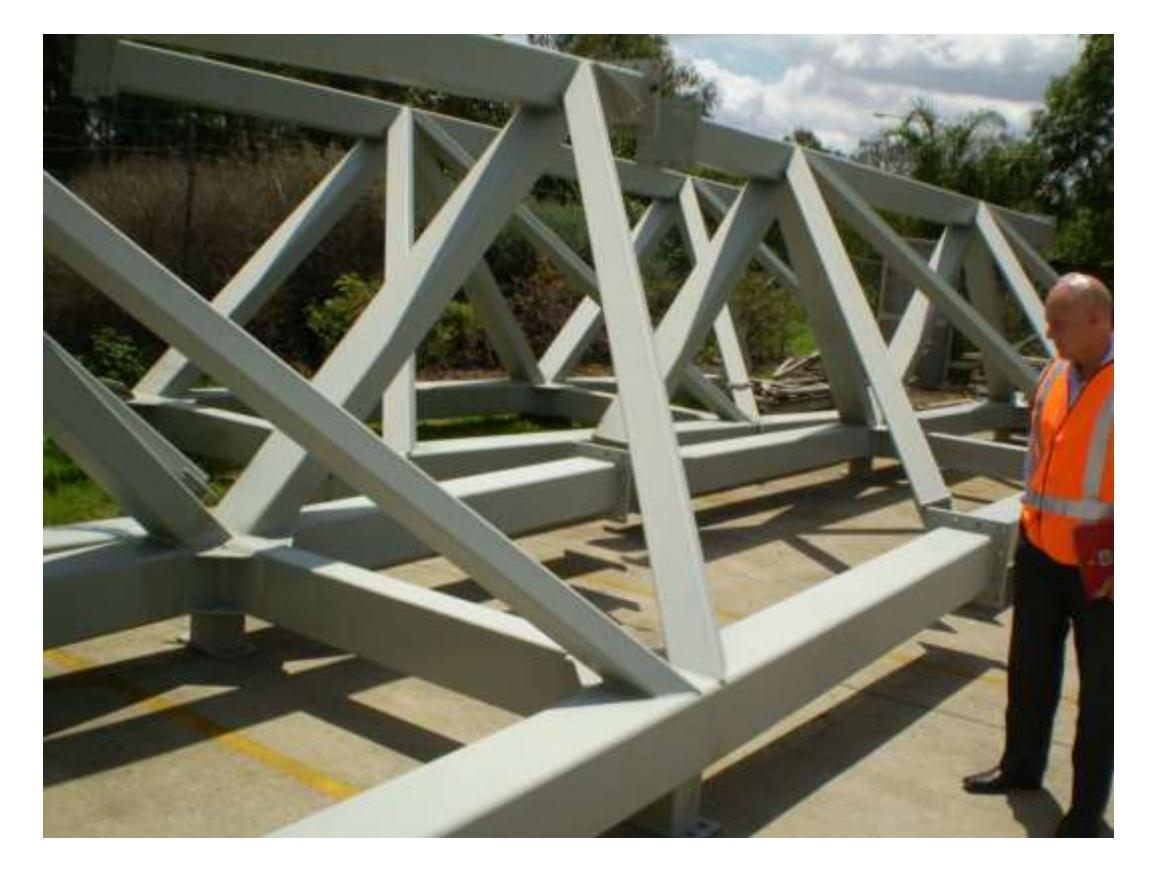
Overall view of the structure

The truss structure shown below was tendered locally but fabricated overseas and imported against this contract. The fabricator responsible for importation of the truss structure went into insolvency. The construction illustrated significant defects and deflected after erection requiring rectification. The builder undertook significant repairs on site, including reinforcing the areas where cracking occurred in the junction between cross beams and main truss beams and welding reinforcing tubing alongside sections of the cross beams that had split.
