## Submission 40 - Welding Technology Institute of Australia

## **SUPPLEMENTARY SUBMISSION TO THE SENATE INQUIRY INTO: THE FUTURE OF AUSTRALIA'S STEEL INDUSTRY**

### **POLICY PROPOSAL: SAFETY OF FABRICATED STRUCTURAL STEEL**

### Bussellton Pedestrian Bridges Visual Examination and Commentary Regarding Weld Quality >

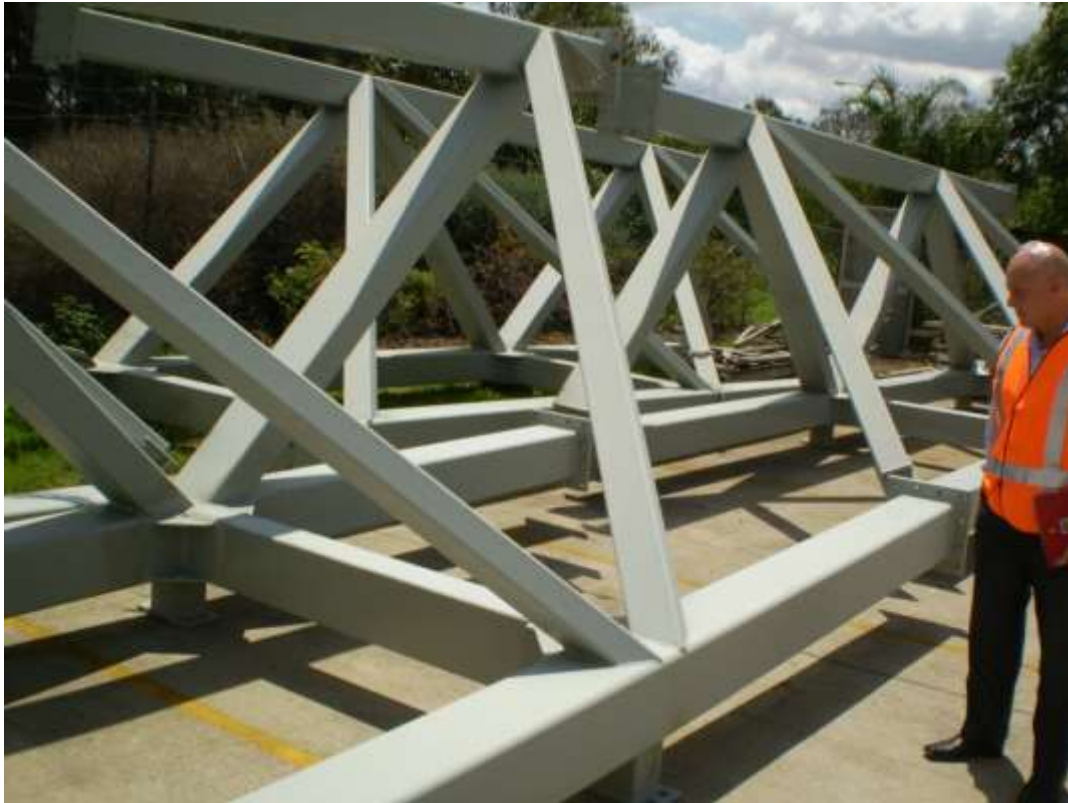
### **Overall view of the structure**

The truss structure shown below was tendered locally but fabricated overseas and imported against this contract. The fabricator responsible for importation of the truss structure went into insolvency. The construction illustrated significant defects and deflected after erection requiring rectification. The builder undertook significant repairs on site, including reinforcing the areas where cracking occurred in the junction between cross beams and main truss beams and welding reinforcing tubing alongside sections of the cross beams that had split.
