# INTERIM REPORT

## Perth Children's Hospital asbestos

## PERTH CHILDREN'S HOSPITAL ASBESTOS

An interim report on the discovery of asbestos  
within imported atrium roof panel products  
used in the construction of the new  
Perth Children's Hospital

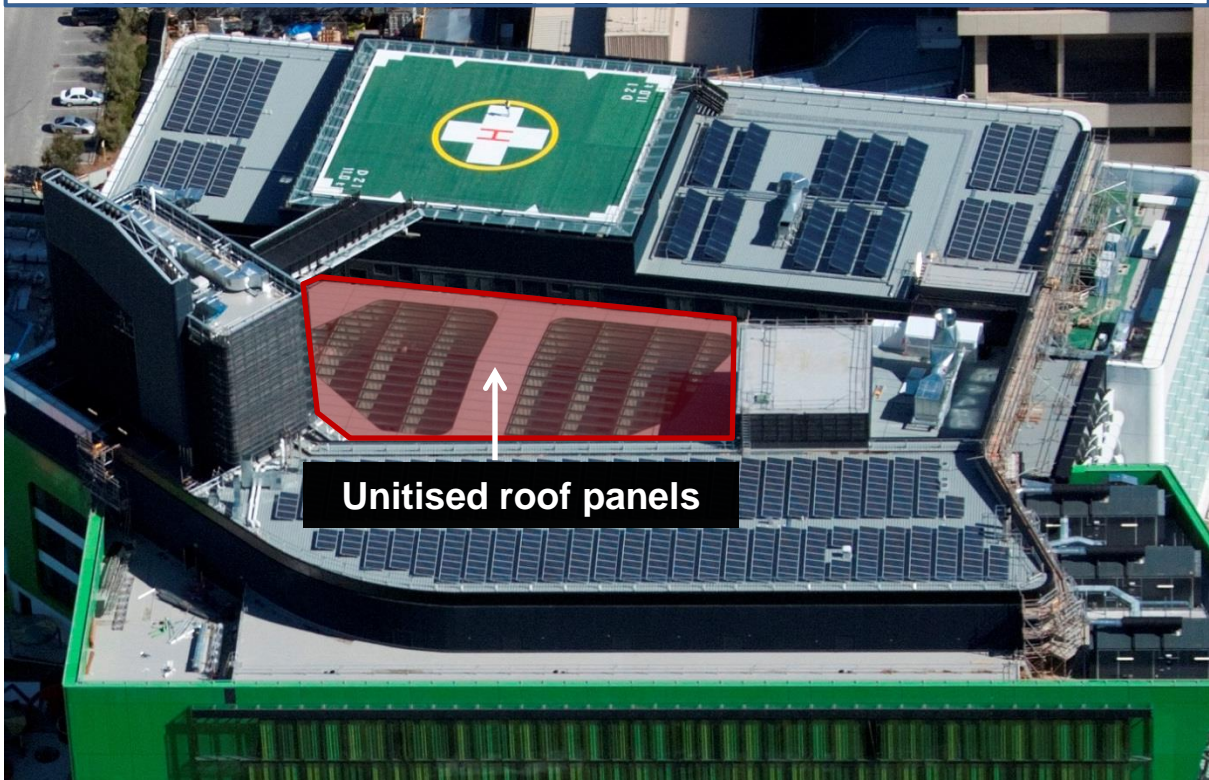
**Photograph 2**  
Helipad at Perth Children’s Hospital

The URPs are a bespoke design situated immediately adjacent to the roof-top helicopter landing pad, and over the atrium section, and as such, were required to meet a stringent acoustic performance requirement (see Photograph 2).
