Inquiry into the Aviation Accident Investigation (Pel-Air)

**BUREAU OF AIR SAFETY INVESTIGATION
REPORT**

Investigation Report 9301743

**Piper PA31-350 Chieftain
Young, NSW,
11 June 1993**

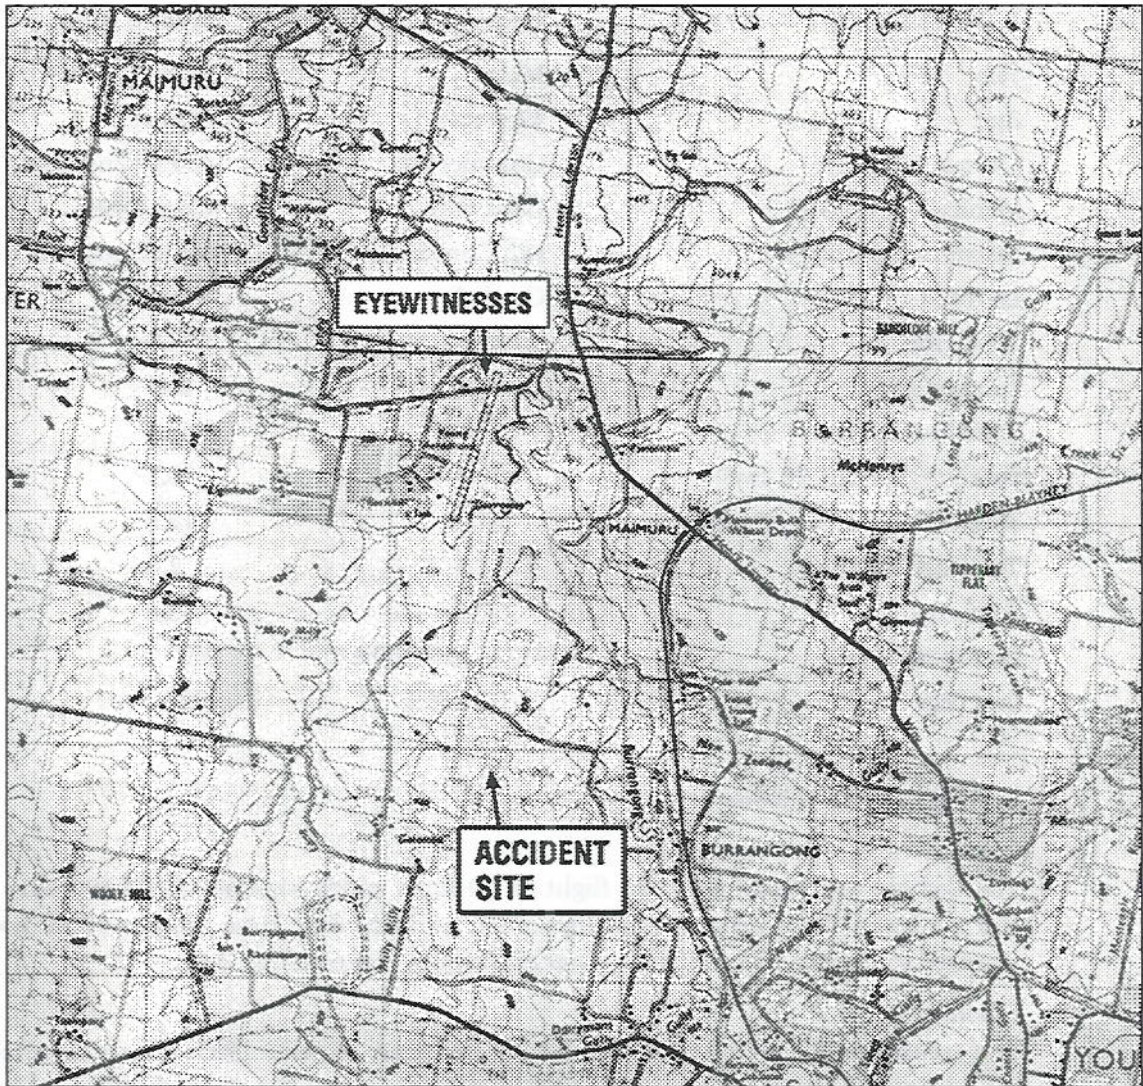
Figure 2 Locality map showing accident site in relation to Young Aerodrome

aircraft (VH-NDU) was significantly lower than another aircraft approaching from the east (VH-XML). Shortly after VH-NDU turned onto an apparent base leg the navigation lights were lost to sight. Almost immediately a fireball was observed, consistent with the final position of the aircraft (see figure 2).

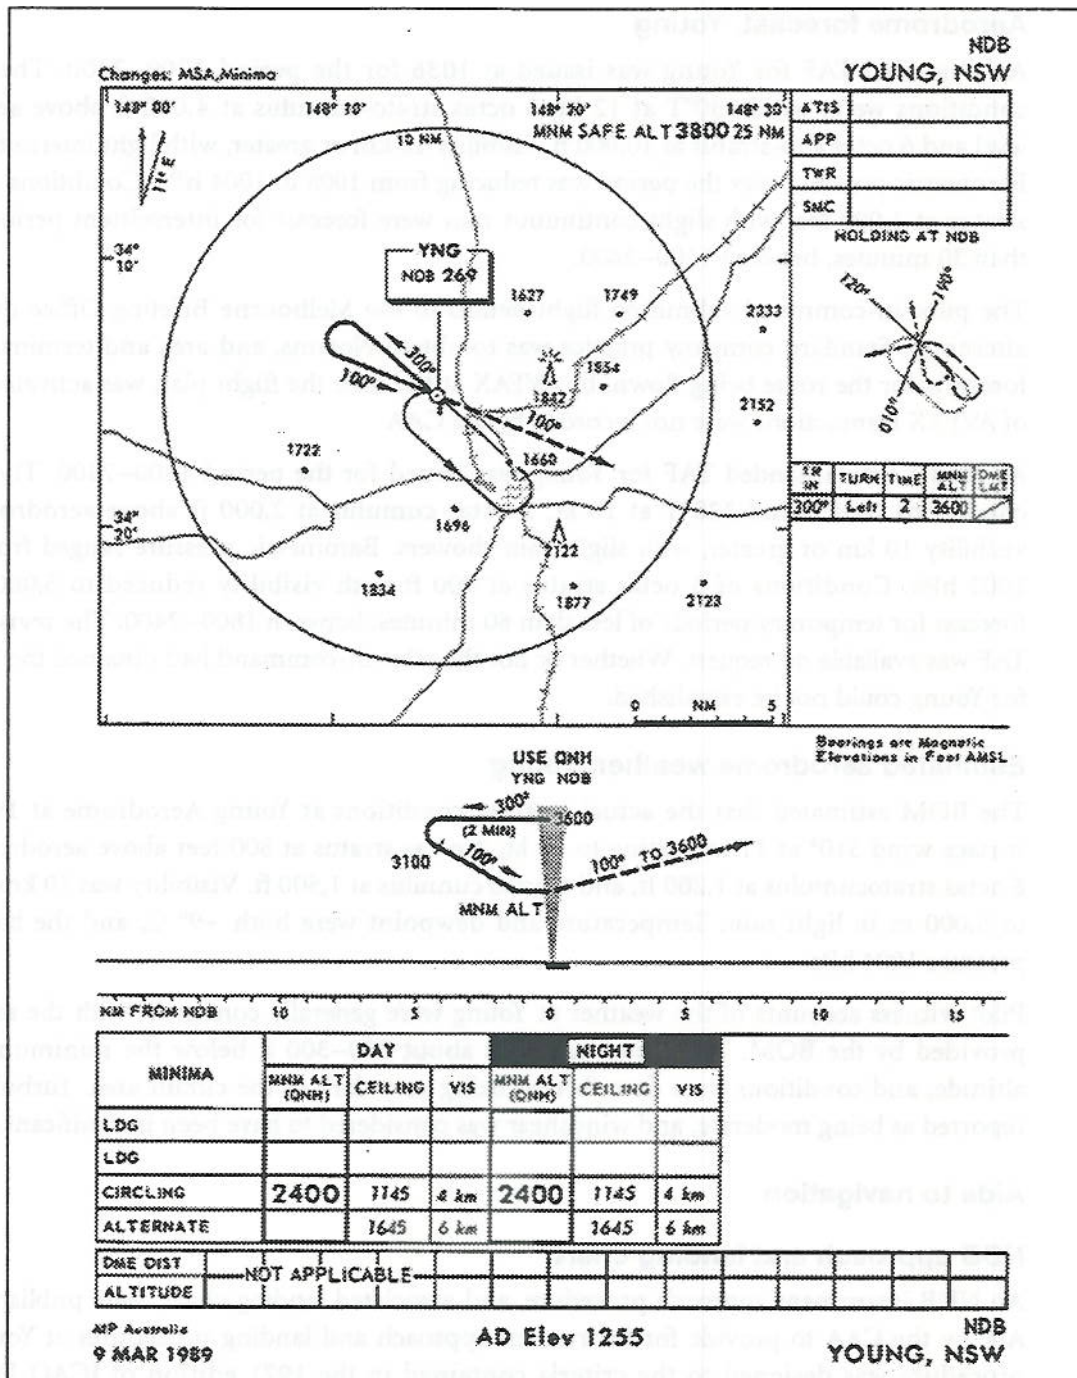
Figure 3 Young NDB Approach Chart

The significant difference between the two types of instrument approach charts is that new criteria charts have landing minima determined by aircraft performance category. The design of 'old criteria' NDB approach charts, including Young (see figure 3), provided an obstacle clearance of at least 400 ft within the circling area at the circling minima, the circling area being the area within a 3 NM radius of the aerodrome reference point.

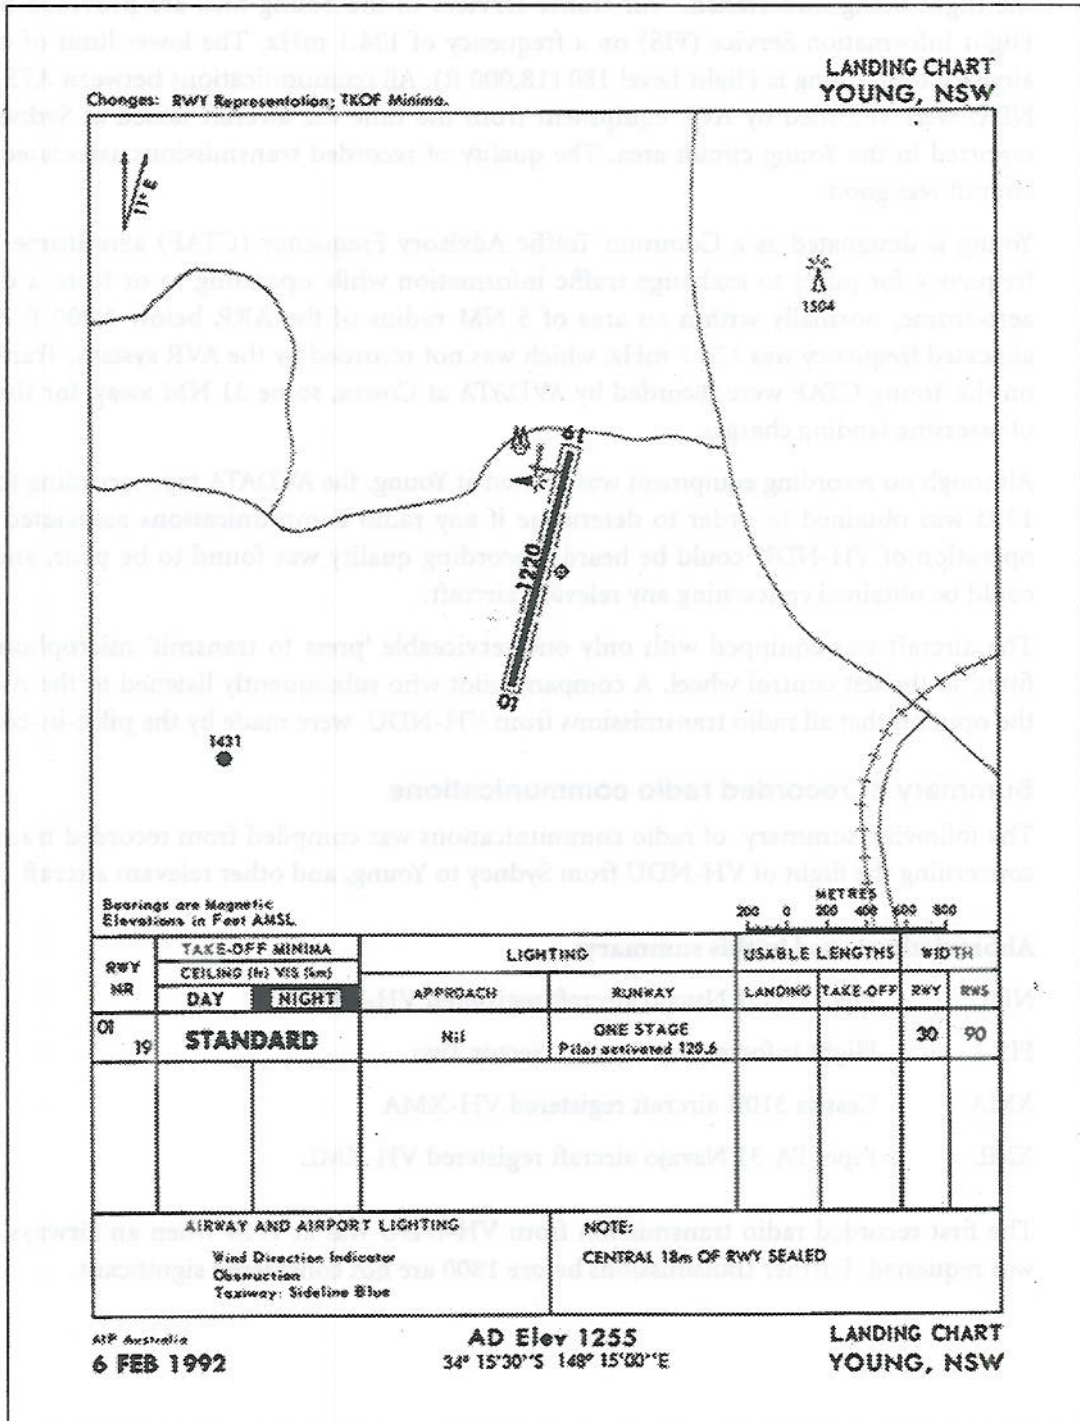
Figure 4 Young Landing Chart

With the exception of the 1,255 ft aerodrome elevation, the approach chart did not indicate the height of terrain or obstacles within the circling area. The landing chart (see figure 4) indicated a low intensity, steady red, obstruction light at an elevation of 1,504 ft, about 1,950 m from the ARP,

bearing 033°. An unlit spot elevation of 1,431 ft, was also indicated at a distance of about 1,945 m from the ARP, bearing 230°. The IAL chart legend states that a spot elevation does not necessarily indicate the highest terrain in the immediate area. This is repeated with a caution in AIP/DAP 1-1. The terrain struck by the aircraft was not marked on the NDB approach chart, and lay outside the boundary of the landing chart.

The aerodrome lies in a valley surrounded by low hills. Within the 3 NM radius aerodrome circling area the only illuminated obstacle is a hill, at an elevation of 1,504 ft, about 1,950 m from the ARP, bearing 033° (see figure 4). The steady red obstacle light is reported to have been illuminated and functioning normally. No visual approach slope guidance systems are installed.

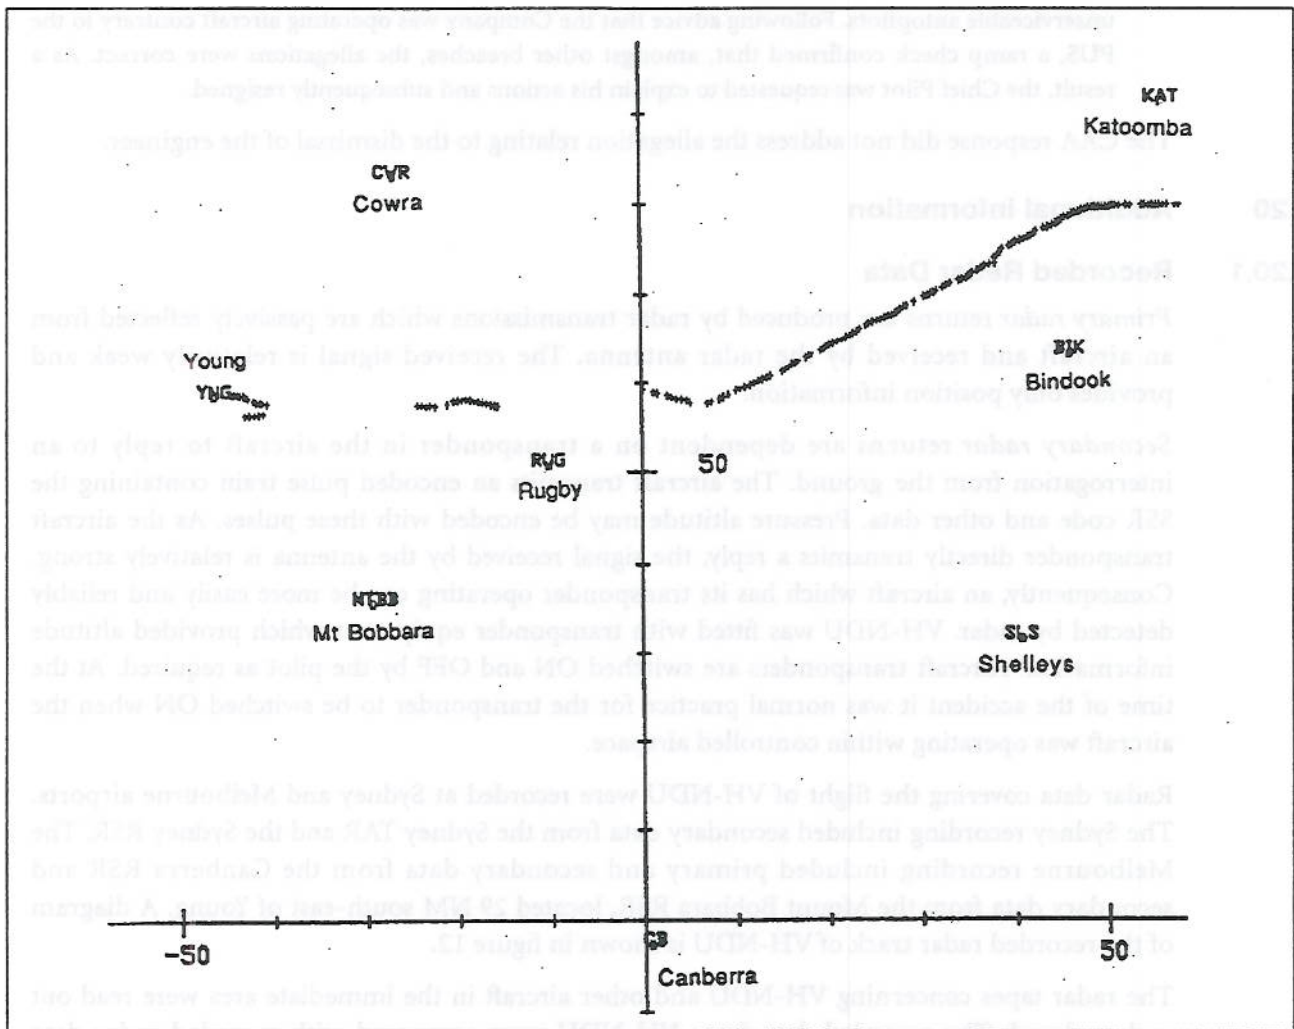
Figure 12 Diagram of plotted radar track of VH-NDU

Radar data covering the flight of VH-NDU were recorded at Sydney and Melbourne airports. The Sydney recording included secondary data from the Sydney TAR and the Sydney RSR. The Melbourne recording included primary and secondary data from the Canberra RSR and secondary data from the Mount Bobbara RSR, located 29 NM south-east of Young. A diagram of the recorded radar track of VH-NDU is shown in figure 12.

- d. At 1819 the aircraft passed 13.5 NM to the south-east of Riley. At 1824 the aircraft changed track to the right and tracked approximately towards Young. From this time the primary returns from VH-NDU were received intermittently.

- e. Radar coverage plots for Canberra RSR show that terrain shielding occurs in the Young area at low altitudes. This was consistent with radar data recorded during the test flight which indicated that an aircraft needed to be at an altitude of at least 3,400 ft for primary returns to be received by Canberra RSR.

- f. The last radar data received from VH-NDU were eight primary returns which were recorded between 1905:40 and 1907:35. They showed VH-NDU approaching Young on a track of about 270°, consistent with the entry to a NDB approach.
- g. Only primary radar data was received from VH-XML and the last recorded return was from a position 12 NM south-east of Young.
- h. The transponder of VH-XMA was left selected ON. As a result, secondary radar data was received by Mount Bobbara and showed the aircraft's track inbound from Cowra. The recorded manoeuvres and altitudes were consistent with those described by the pilot of that aircraft. The last recorded return from VH-XMA was consistent with the aircraft tracking on a left base leg for runway 01 at a pressure altitude of 1,900 ft.

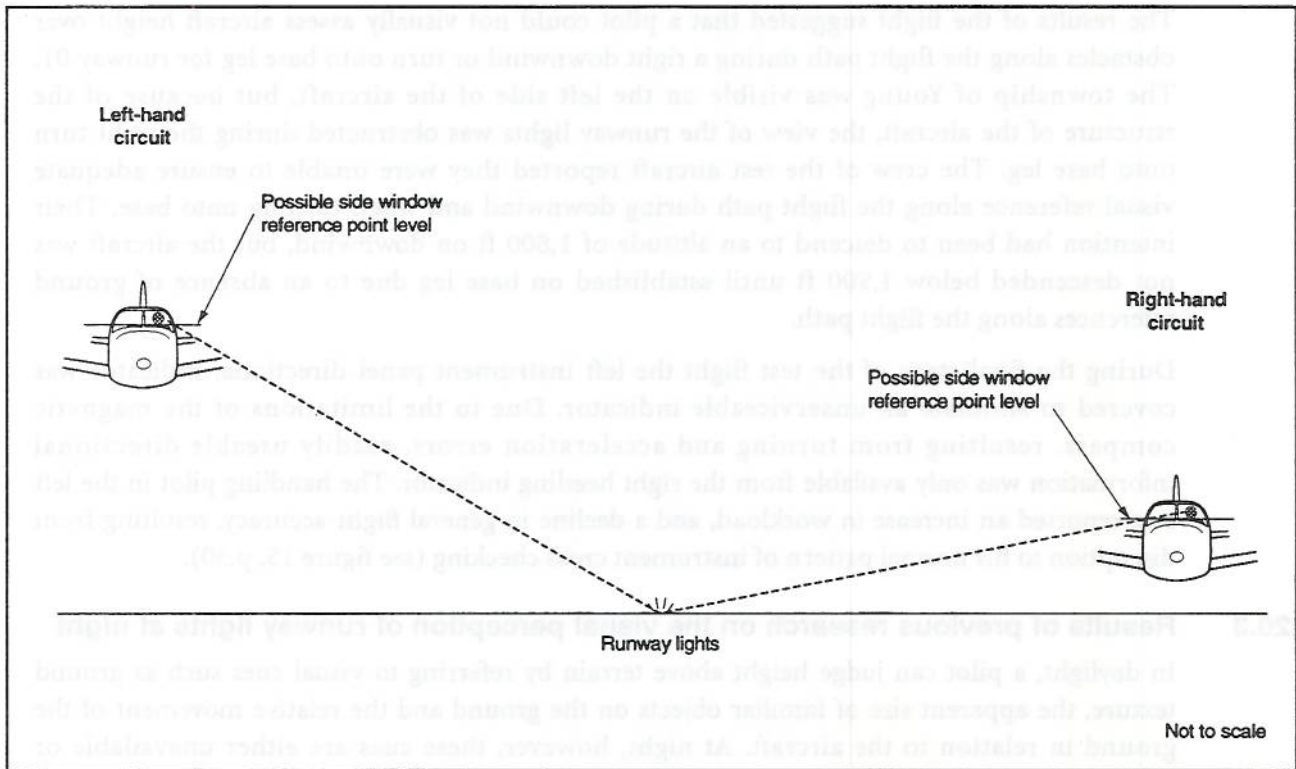
Figure 13 A diagram showing the difference between viewing runway lights from the downwind leg of left and right circuits when positioned in the left cockpit seat.

It was also considered that under certain circumstances, a pilot flying a right circuit may get the impression that the aircraft is higher than normal. This illusion could occur to a pilot who has developed the habit of visually judging circuit height and position by relating the position of the runway lights to some feature of the aircraft, such as a particular position in a side window. Such a rule of thumb which worked satisfactorily for the more typical left circuits could lead a pilot to descend lower to achieve the same picture when making right circuits (See figure 13). Like most habits, such a practice could be carried out unconsciously. In this case it would be an example of negative transfer, where a pilot transfers a habit from a situation

where it works successfully, to a new situation where it is inappropriate. This phenomenon would not occur on final approach, when the runway appears normally in the front windscreen.

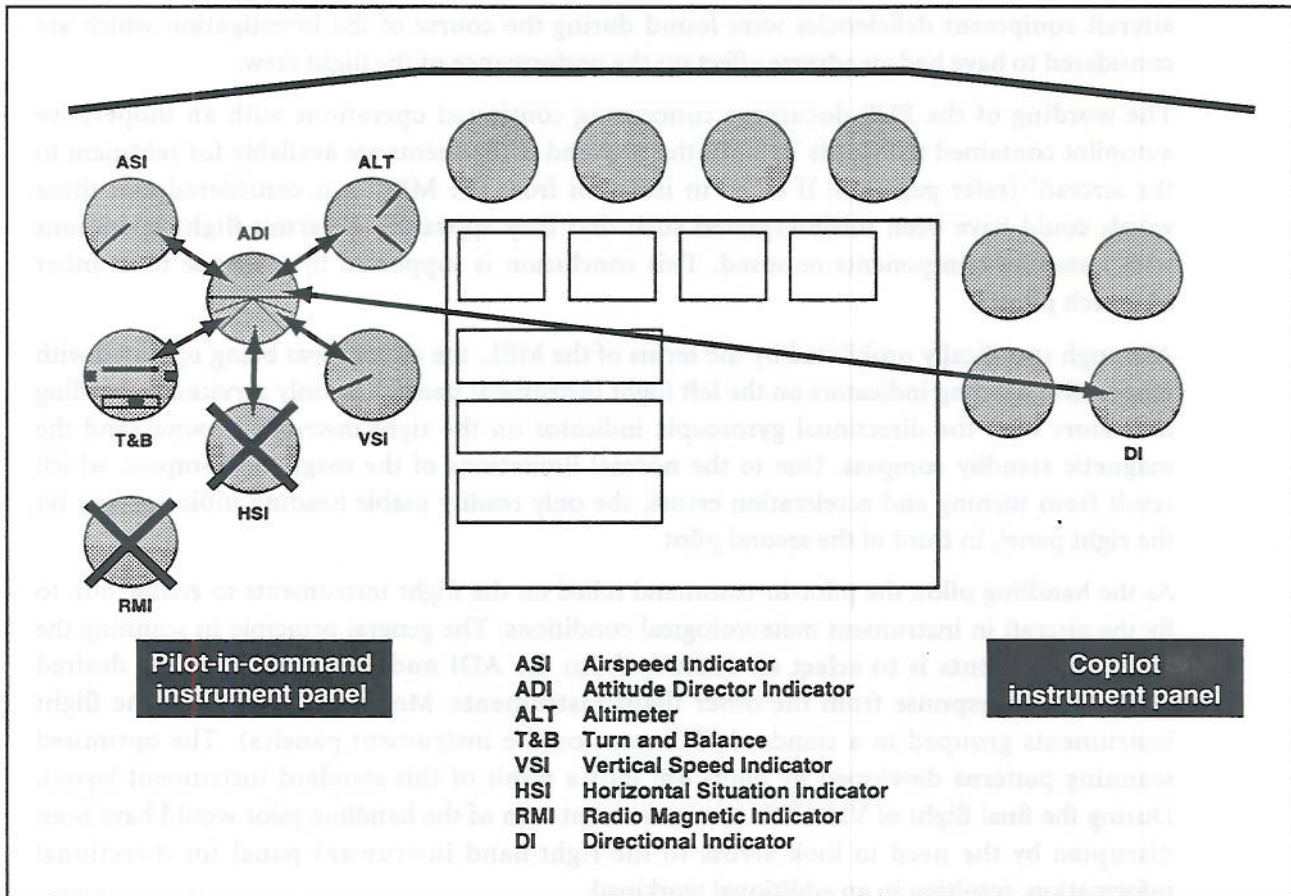
Figure 15 Diagram of the pilot-in-command's flight instrument scan pattern superimposed on a representation of the cockpit instrument panels in VH-NDU.

During the final stage of the test flight the left instrument panel directional indicator was covered to simulate an unserviceable indicator. Due to the limitations of the magnetic compass, resulting from turning and acceleration errors, readily useable directional information was only available from the right heading indicator. The handling pilot in the left seat reported an increase in workload, and a decline in general flight accuracy, resulting from disruption to his normal pattern of instrument cross checking (see figure 15, p.50).

The visual cues available to the flight crew were inadequate as a sole reference to judge terrain clearance accurately during the circling approach at night. The position of the crash site and the aircraft track indicated that the crew were aware of their lateral position in relation to the runway, but were not aware of their true vertical position. Descent below the minimum circling altitude required the maintenance of sufficient visual reference to facilitate terrain avoidance. The visual cues available to the crew on the night were insufficient to provide for this. Those cues which were available could have been misinterpreted, as a result of:

- the position of the aircraft in the circuit;
- the cockpit seating position of the pilot-in-command;
- negative habit transfer;
- focal trap effect.
