QUALITY SYSTEM COMPLIANCE VENDOR / SUPPLIER AUDIT REPORT

Qantas Airways Limited

**Contracted Maintenance – SIAEC Singapore "D" Check on
Qantas Aircraft VH-OJO V/C: T7105**

AQD Audit ID: 06/SPT/10

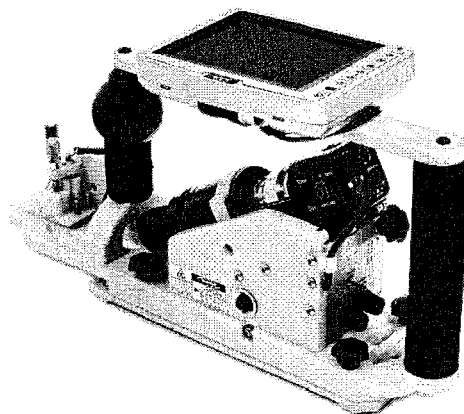
The major difficulty in using the LMM is the depth of field at full zoom which gives an image magnification of approximately $M=170$.

The width of the viewed section of metal when at full Zoom (4.5) is about 52.5 thou. Or about 1.3mm. The depth of field is only 6 thou, or about 0.15mm. **This is very small.**

Therefore the LMM **MUST** be held **STEADY!** The weight of the LMM is 1.9kgms. Therefore after 10 to 20 mins a rest is needed. Various techniques are taught in the training class to make the task as easy as possible. One **MAJOR** recommendation pointed out in training is the use of a **TEAM** to carry out the Inspection. The recommended team is 3 persons. But always no less than 2! The solution is that the team rotate inspection duties! Highly important is that all team members have all the required knowledge and skills to take any role in the Inspection. Critical is that the team member holding the LMM is supported by at least 1 other team member. The technique being "One Holds the LMM, the Other Adjusts as required." The reason that we suggest 3 team members is operational safety. The third person maintains "Situational Awareness". He watches out for cables around feet, etc. His position is recommended always to be close to the InspectCam to assist with pressing the store key! It has been observed that most users have adopted a 3 team approach.

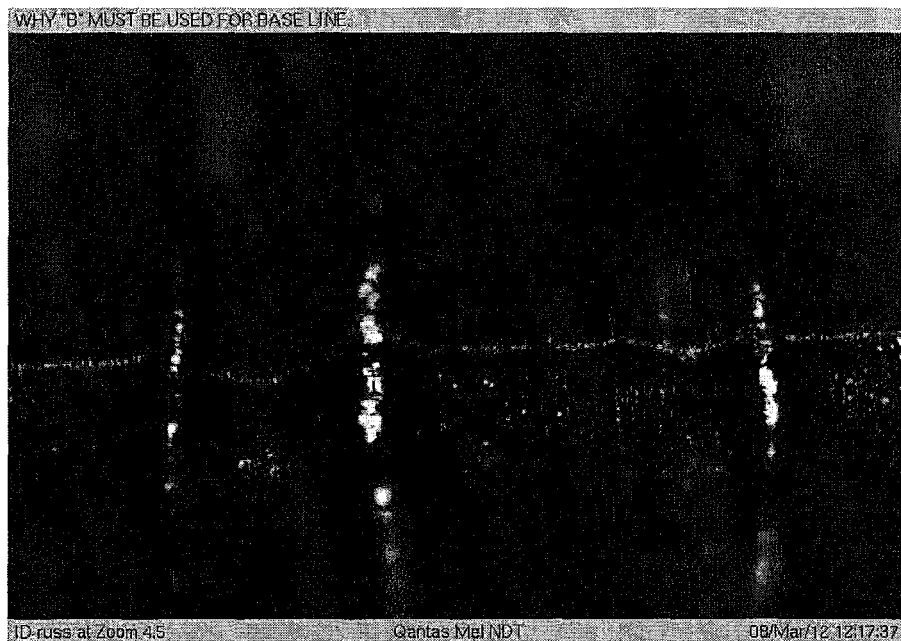
Image 2

Above is the RAW captured Image, shows 3 "Lands with damage between them". The Base line is required to join undamaged surfaces. Hence we draw the Base Line as shown below.

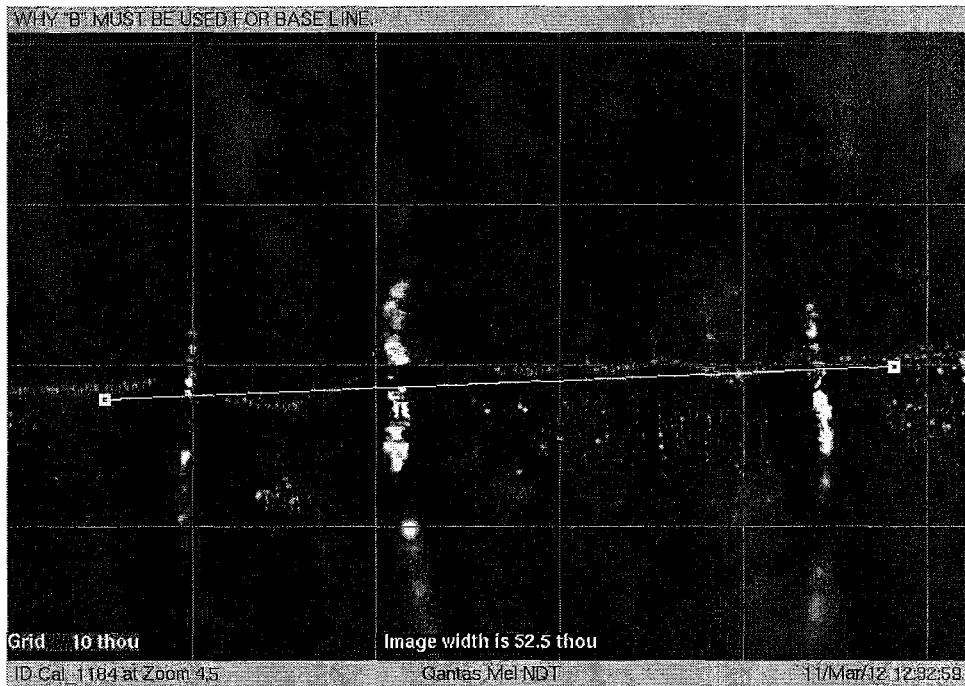
Image 3

The damage that is of concern is always BELOW this Line!

Note that this line is NOT drawn as a vector, but as a "stair case approximation".

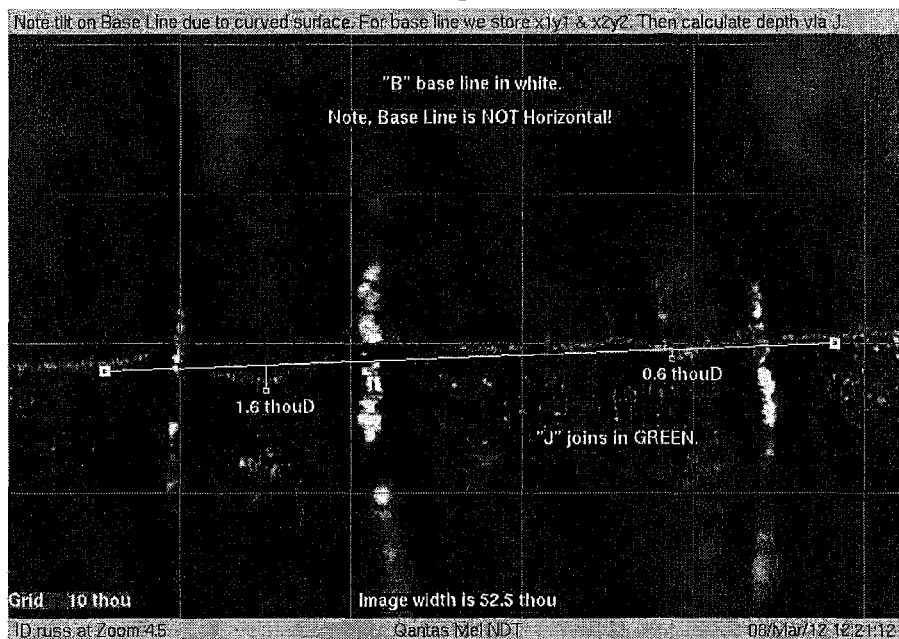
Image 4

Note that a "J" line just touches the base line, no small square is shown.

The recommended procedure now is to use "J" to join up to the base line.

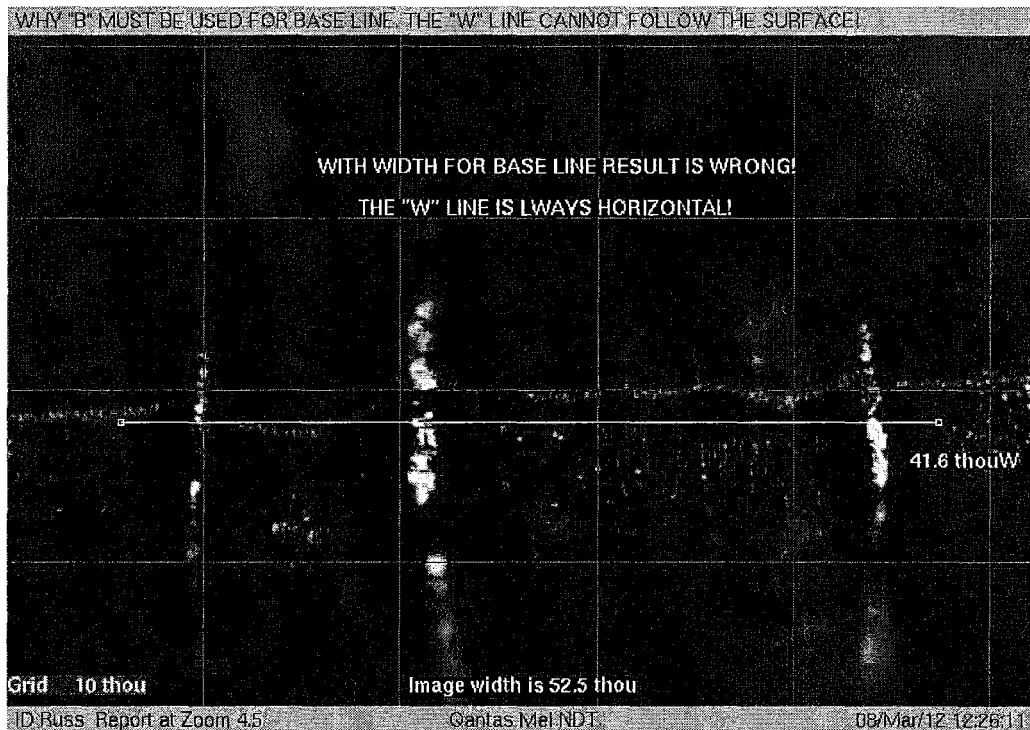
Image 5

Using a "W" as a base line would result in the following!

This line cannot be used to reference the damage of the Scribe Line!

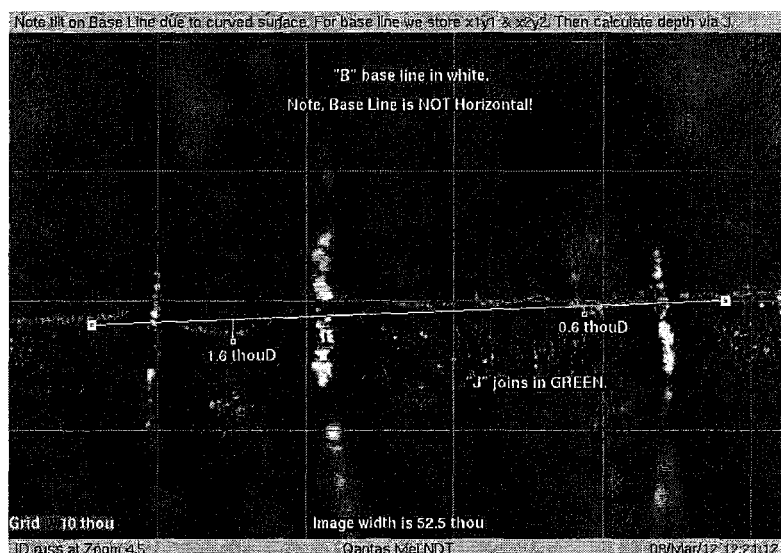
As can be seen from the above two samples, the top one with "D", the lower with "J", only a small difference. But "J" is more accurate!

To clear the confusion we always train to use "J".
